Mt. Aire Gardens

Level 1 Reserve Study

Report Period – 01/01/2021 – 12/31/2021

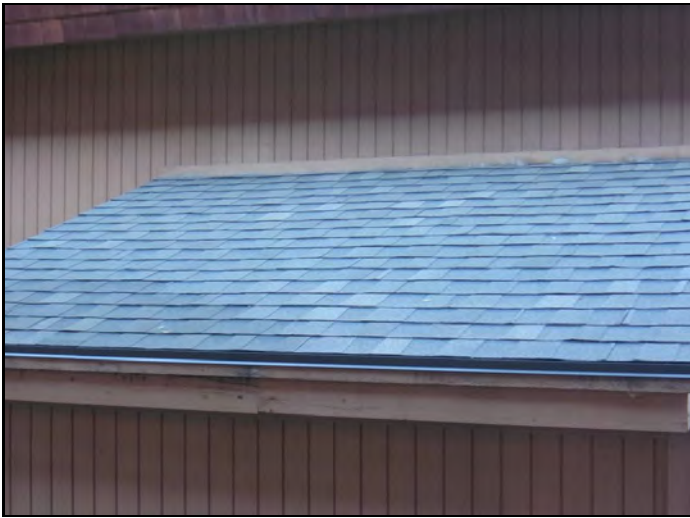
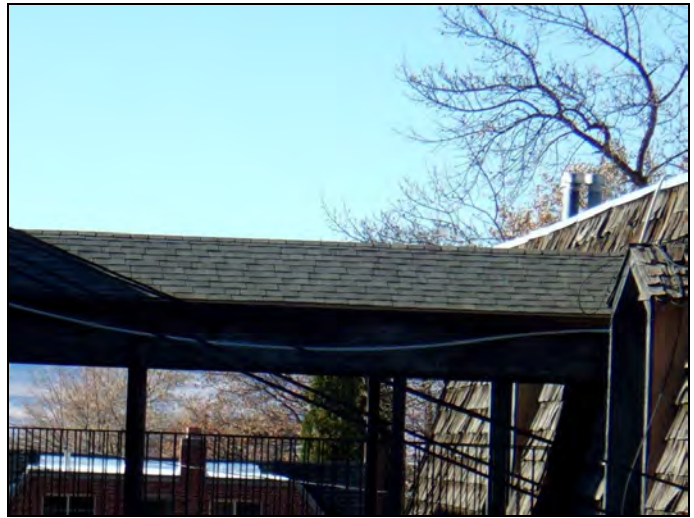
Comp #: 105 Roofs - Replace

The roofs are in good condition. We recommend funding to replace this component approximately every 20 - 25 years. Remaining life based on current age.

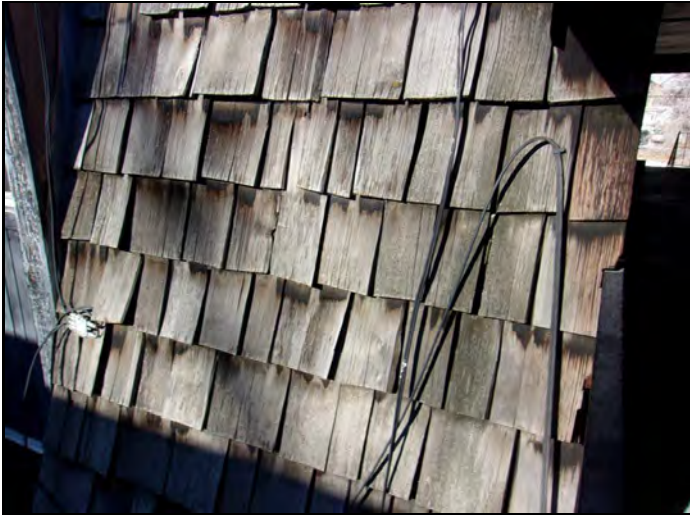
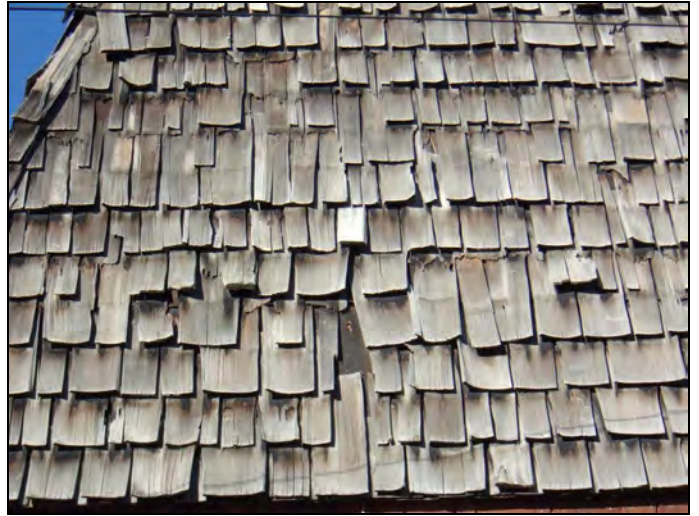
Comp #: 107 Wood Shake Mansards - Replace

The wood shake roof is in poor condition. We recommend funding to replace this component approximately every 25 - 35 years. Remaining life based on current age and condition.

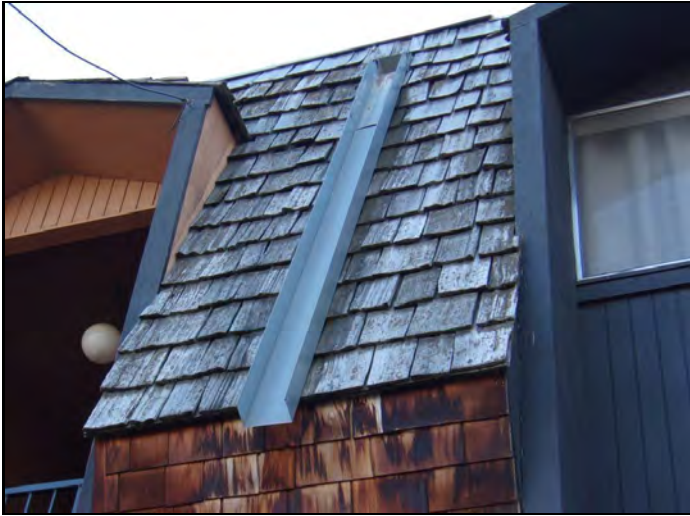
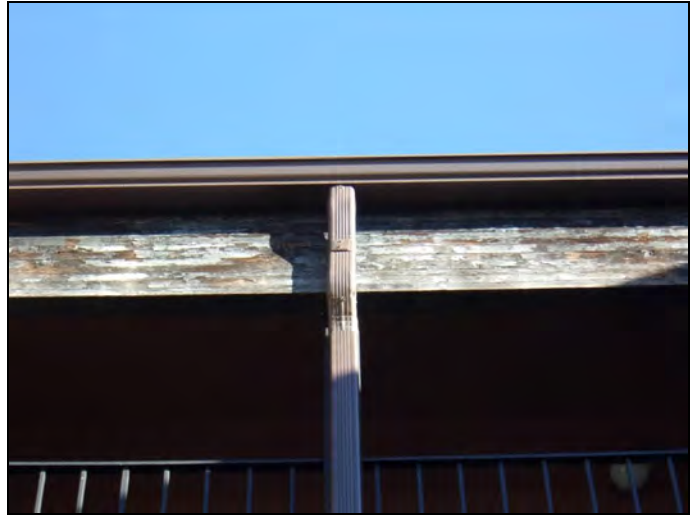
Comp #: 120 Rain Gutters/Downspouts - Replace

The rain gutters and downspouts are in good to fair condition. We recommend funding to replace this component approximately every 25 - 30 years. Remaining life based on current age.

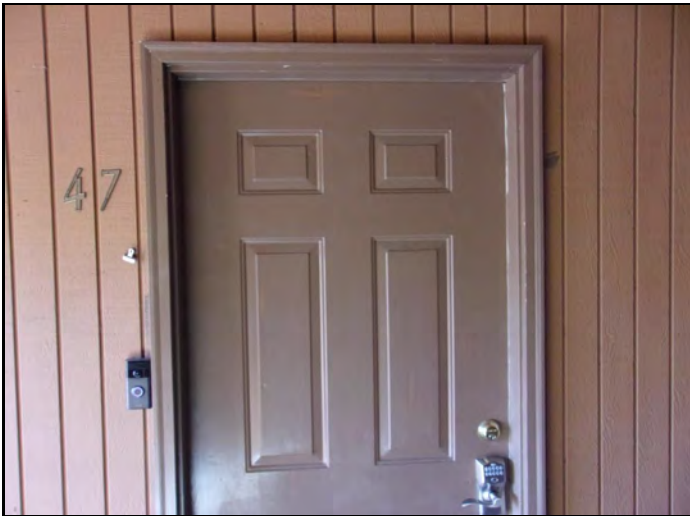
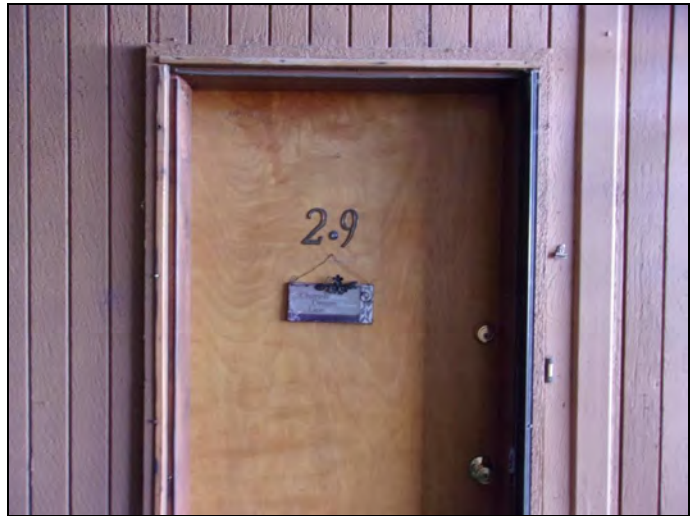
Comp #: 204 Doors - Repaint/Refinish

The painted door surfaces are in fair to poor condition. We recommend funding to repaint this component approximately every 8 - 10 years. Remaining life based on current average condition.

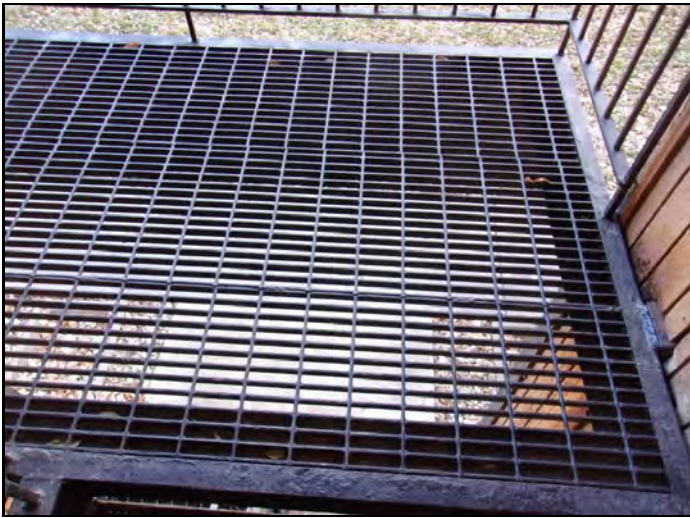
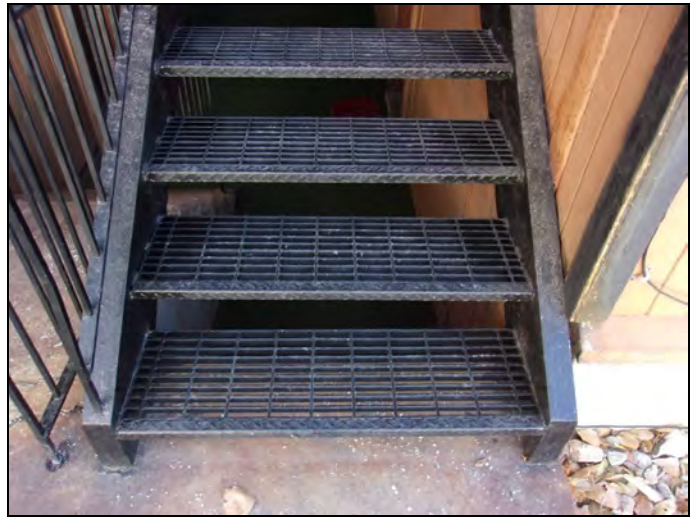
Comp #: 212 Metal Surfaces - Repaint

The painted metal surfaces are in good to fair condition. We recommend funding to paint this component approximately every 6 - 8 years. Remaining life based on current condition.

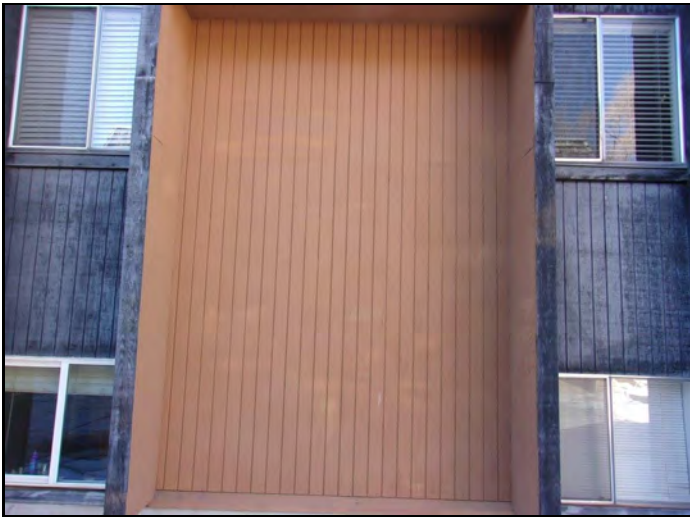
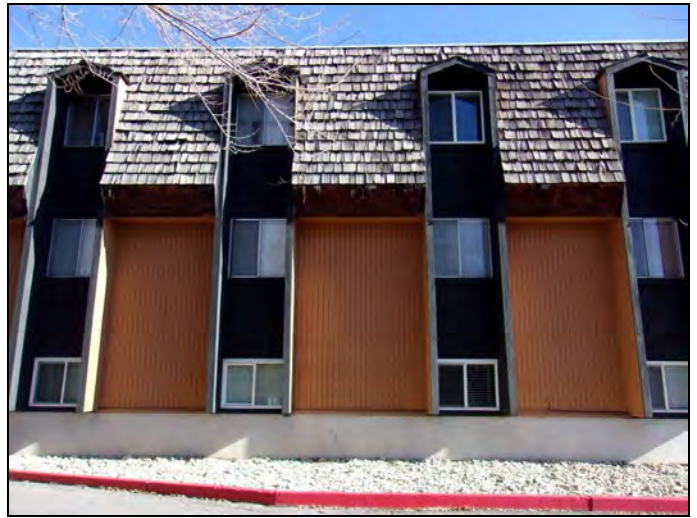
Comp #: 215 Building Exteriors & Fence - Repair/Repaint

The painted surfaces are in fair to poor condition. We recommend funding to repair/repaint this component approximately every 8 - 10 years. Remaining life is based on current condition.

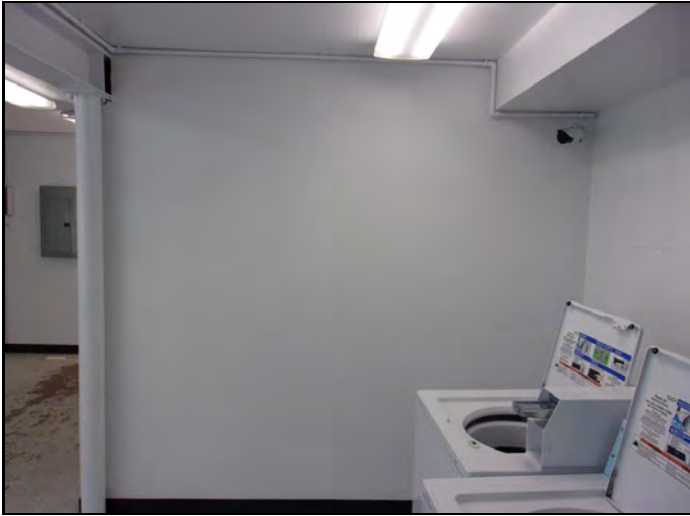
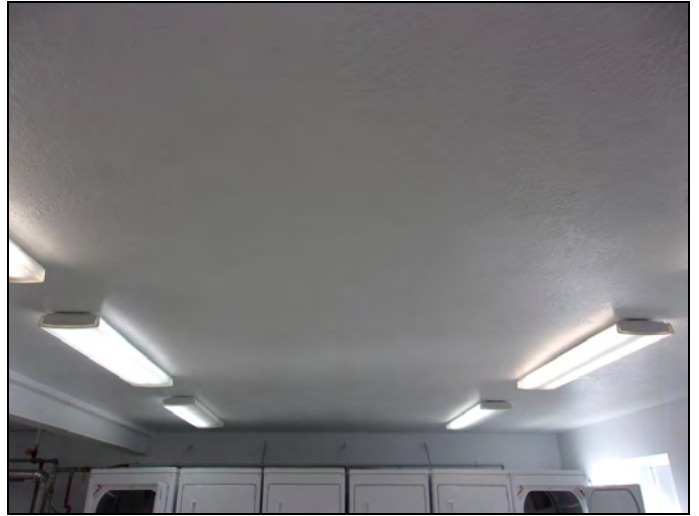
Comp #: 216 Laundry Room - Repaint

The painted surfaces are in good to fair condition. We recommend funding to repaint this component approximately every 8 - 10 years. Remaining life based on current age.

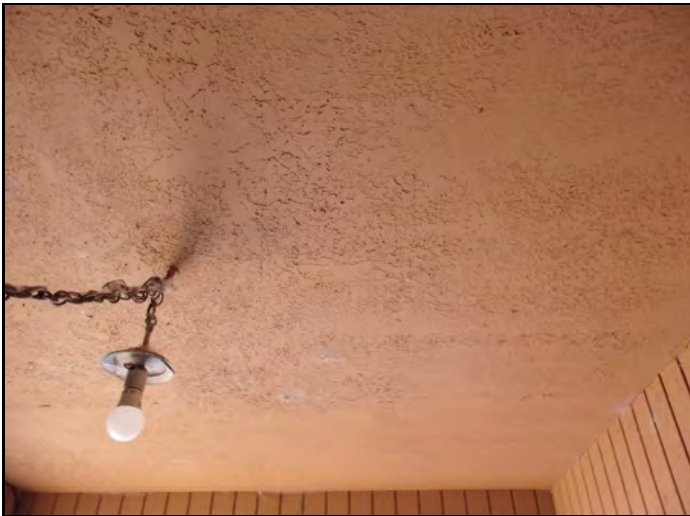
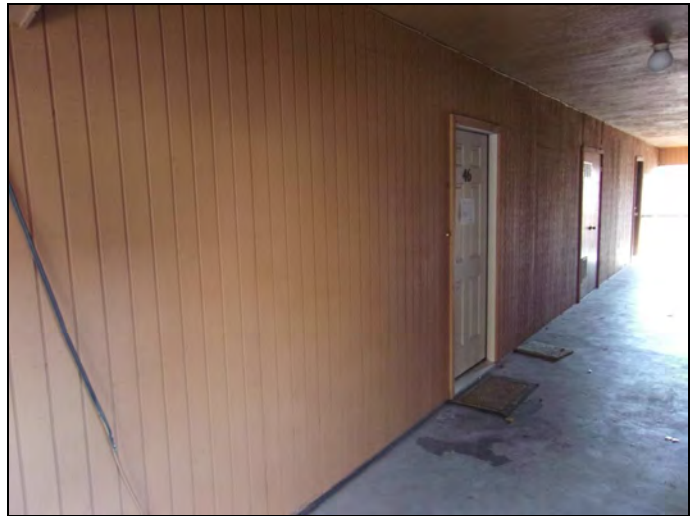
Comp #: 219 Breezeway Walls/Ceilings - Repair/Repaint

The painted surfaces are in good to fair condition. We recommend funding to repair/repaint this component approximately every 8 - 10 years. Remaining life is based on current age.

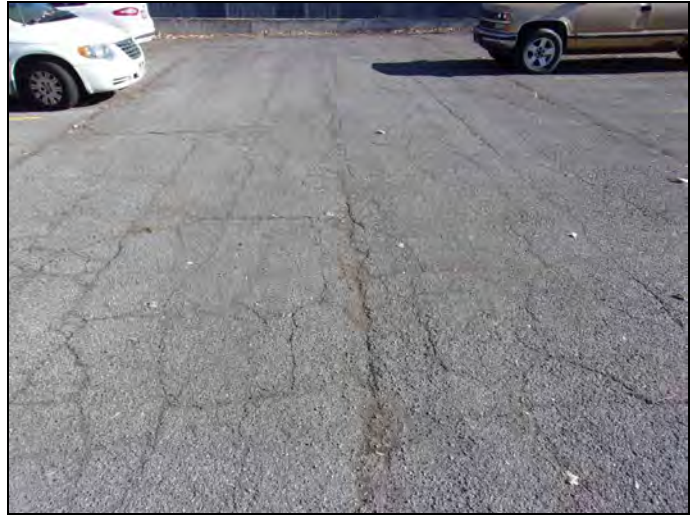
Comp #: 401 Asphalt - Major Rehab

The asphalt surfaces are in fair to poor condition. We recommend funding for a major rehab of this component approximately every 25 - 30 years. Remaining life based on current age and condition.

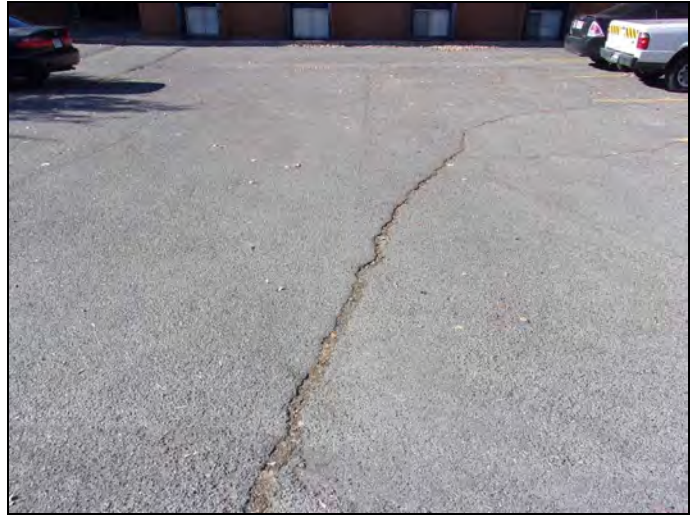
Comp #: 402 Asphalt - Seal Coat

The asphalt seal coat is in poor condition. We recommend waiting until Component #401 Asphalt Major Rehab has been performed before performing the next seal coat. We recommend funding to seal this component approximately every 3 - 5 years. Remaining life based on current condition.

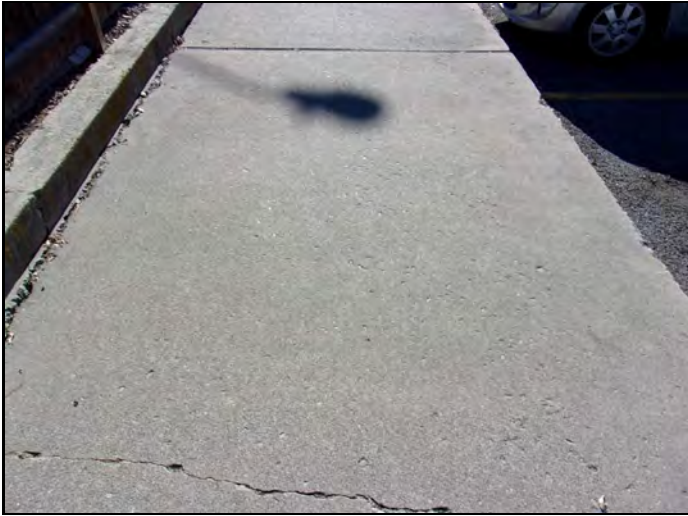
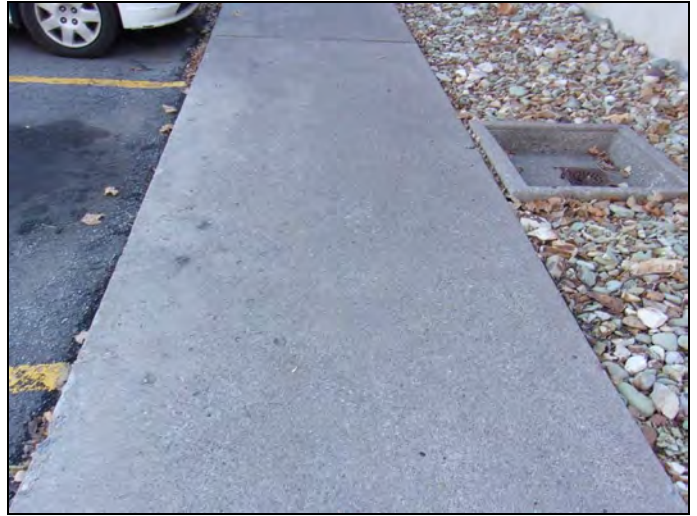
Comp #: 403 Concrete - Partial Repair/Replace

The concrete is generally in fair condition. This component has an extended useful life under normal conditions. We recommend funding to make repairs and partially replace this component approximately every 10 years. Remaining life based on current age.

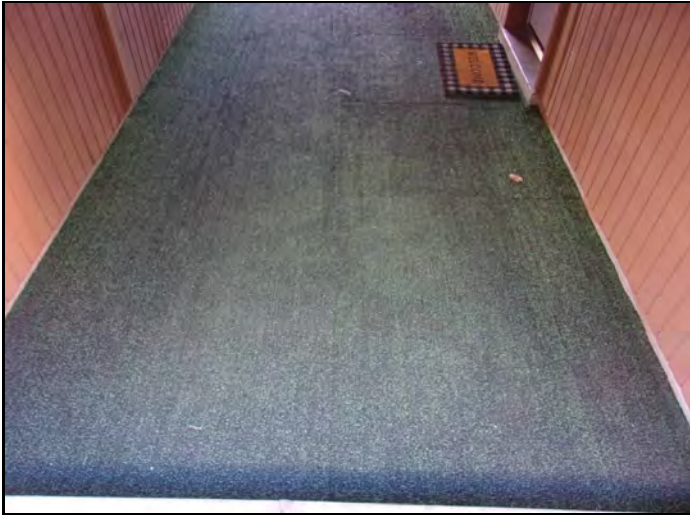
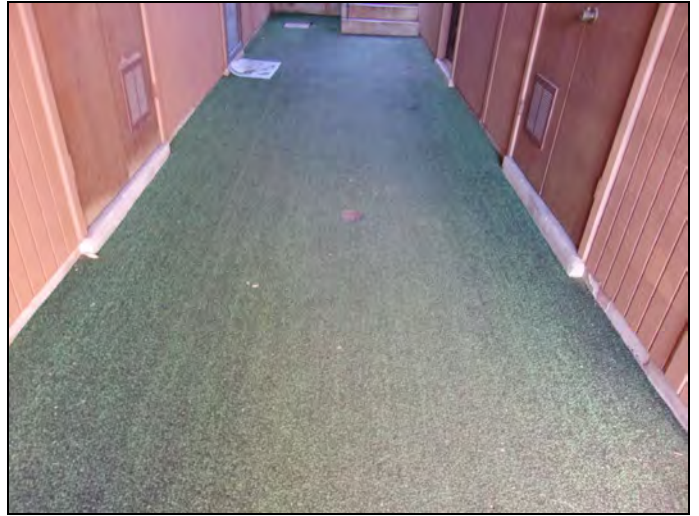
Comp #: 605 Indoor/Outdoor Carpet - Replace

The indoor/outdoor carpeting is in fair to poor condition. We recommend funding to replace this component approximately every 8 - 10 years. Remaining life based on current condition.

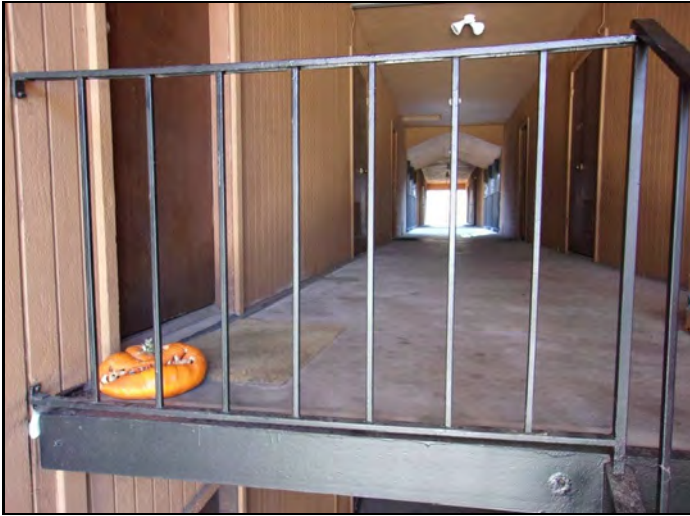
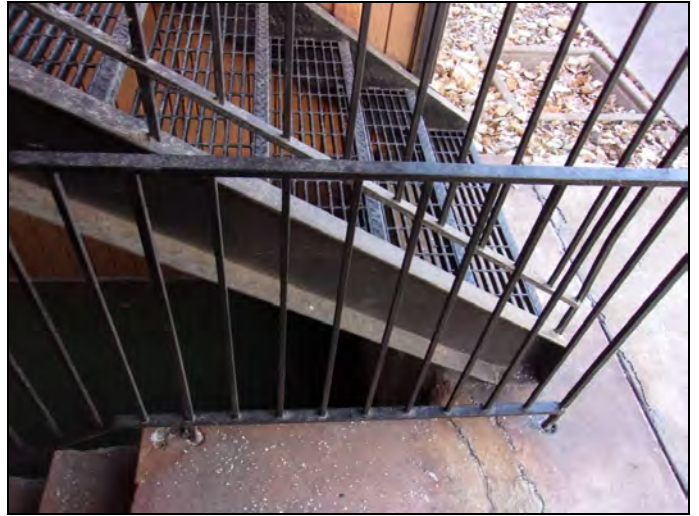
Comp #: 690 Metal Railing - Replace

The metal railing is in good to fair condition. We recommend funding to replace this component approximately every 40 - 50 years. Remaining life based on current age and condition.

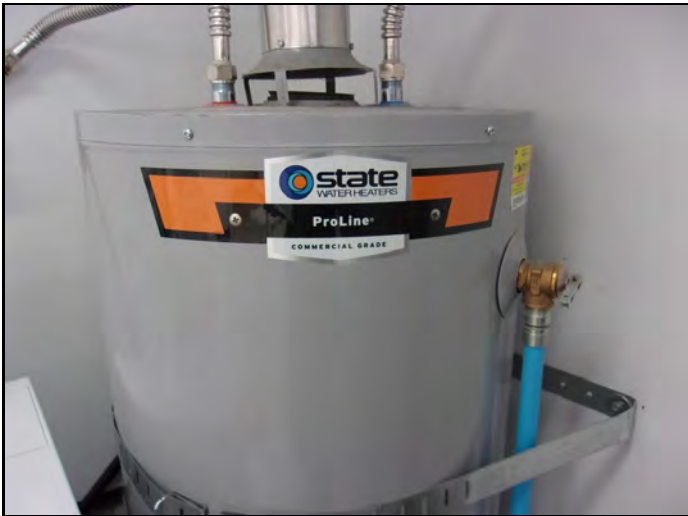
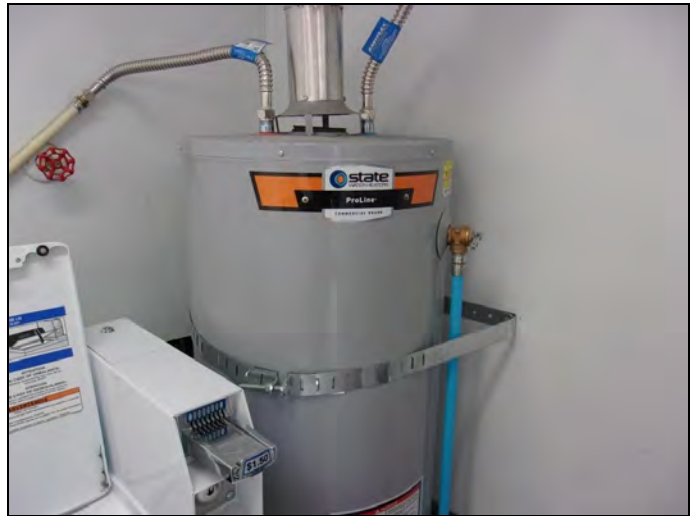
Comp #: 703 Water Heater - Replace

The water heater is in working condition. We recommend funding to replace this component approximately every 12 years. Remaining life based on current age.

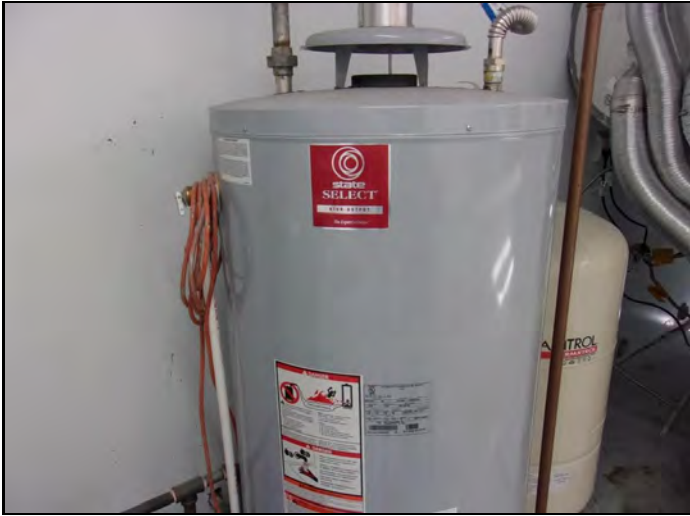
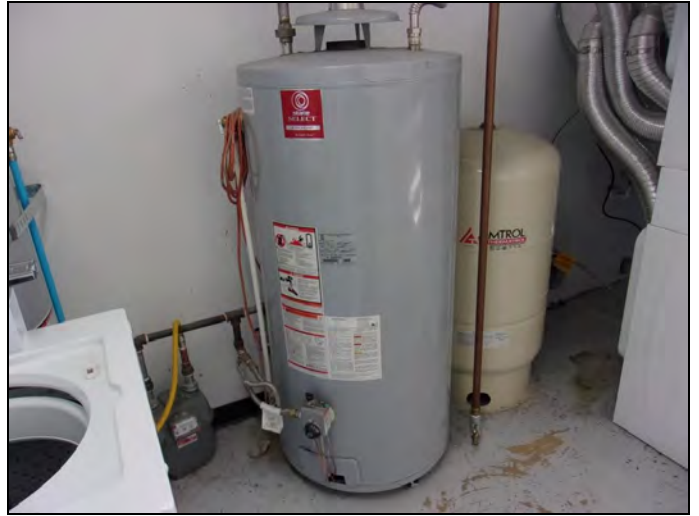
Comp #: 703 Water Heater - Replace

The water heater is in working condition. We recommend funding to replace this component approximately every 12 years. Remaining life based on current age.

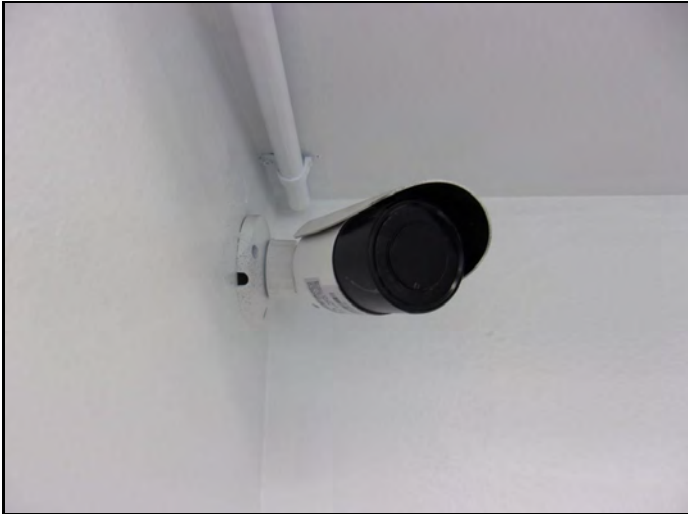
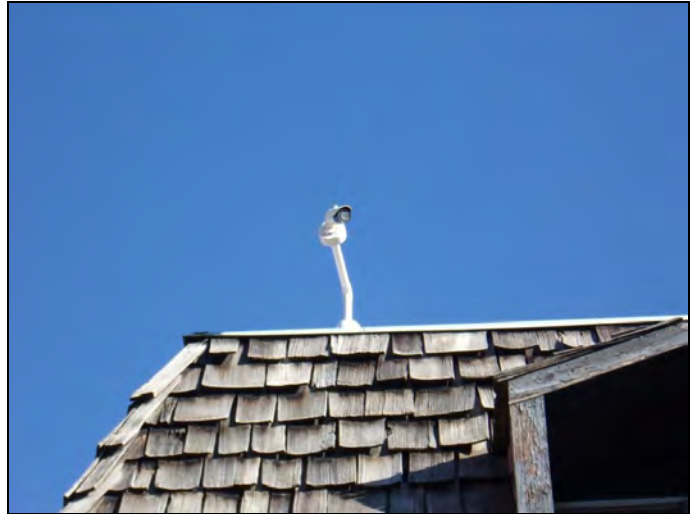
Comp #: 903 Security Camera System - Replace

The security camera system is in working condition. We recommend funding to replace this component approximately every 10 - 12 years. Remaining life based on current age.

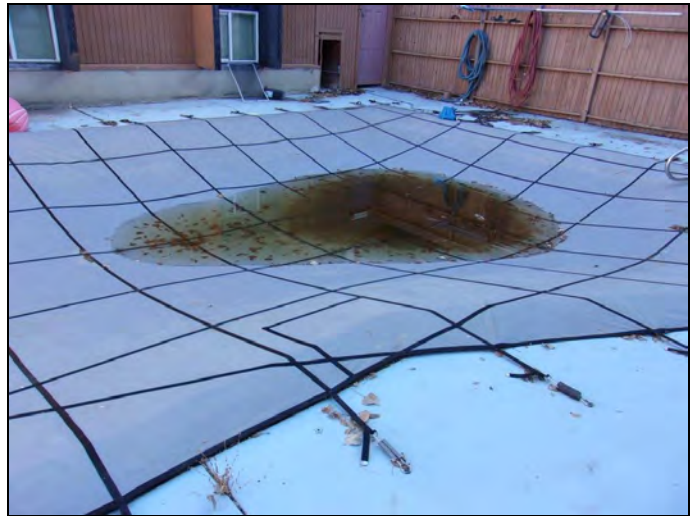
Comp #: 1101 Pool - Resurface

Research with the client reveals this component is being resurfaced in 2021. We recommend funding to resurface this component every 10 - 12 years. Remaining life based on current age.

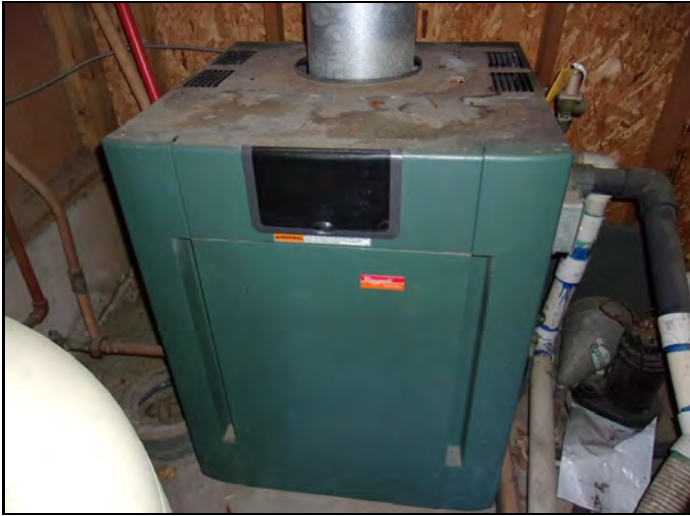
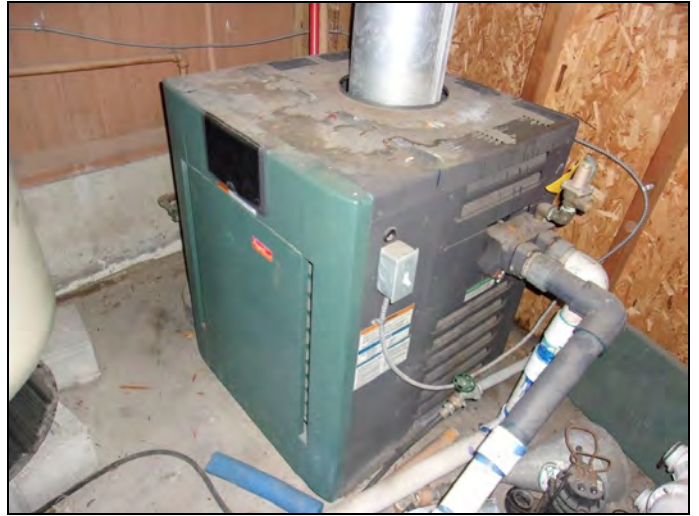
Comp #: 1104 Pool Heater - Replace

The pool heater is in working condition. We recommend funding to replace this component approximately every 12 years. Remaining life based on current age.

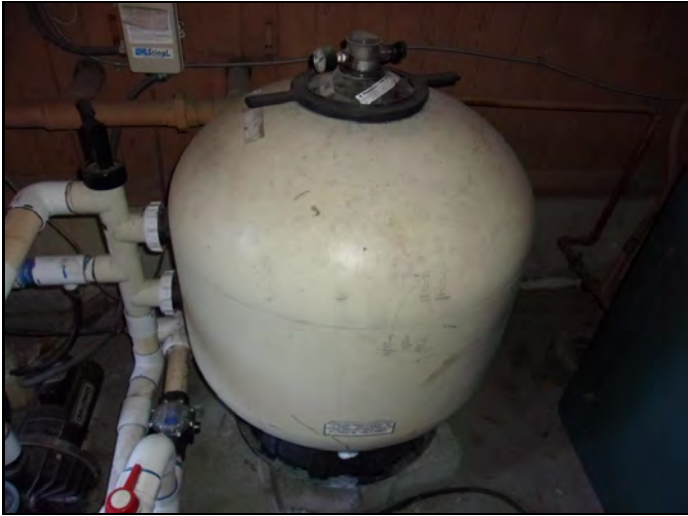
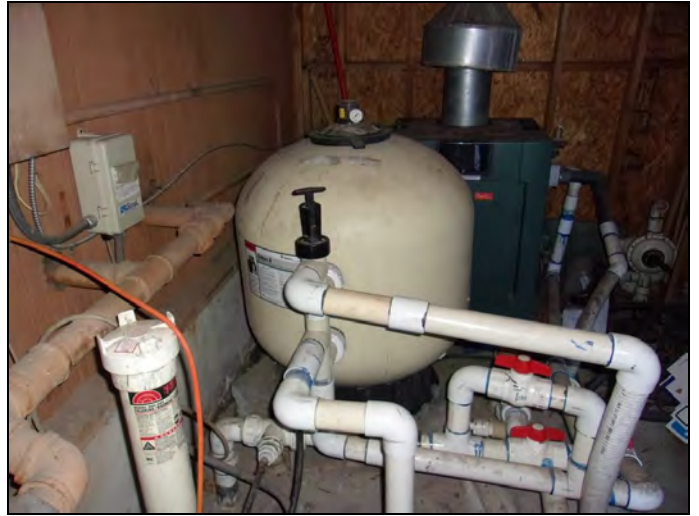
Comp #: 1107 Pool Filter - Replace

The pool filter is in working condition. We recommend funding to replace this component approximately every 12 - 15 years. Remaining life based on current age.

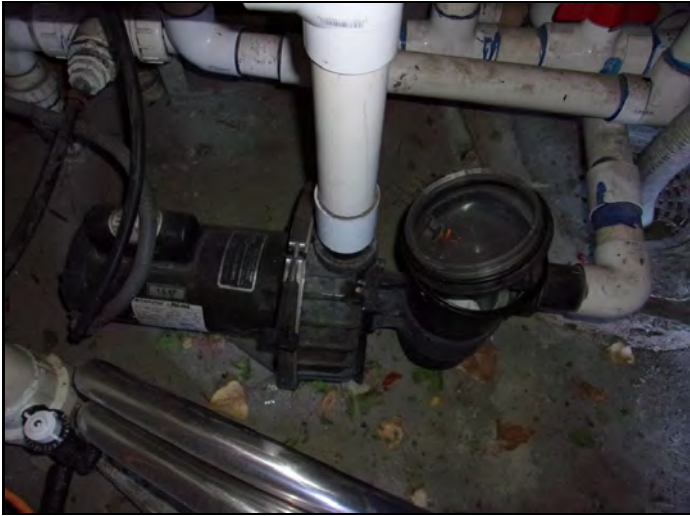
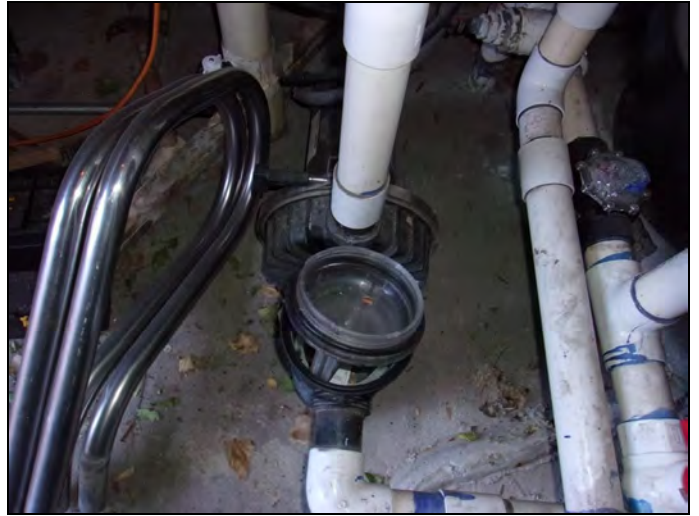
Comp #: 1110 Pool Pump - Replace

Research with the client reveals this component is being replaced in 2021. We recommend funding to replace this component approximately every 8 - 10 years. Remaining life based on current age.

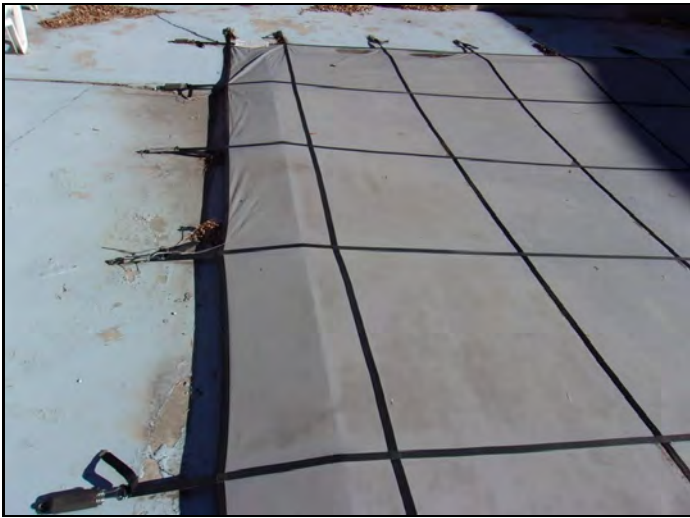
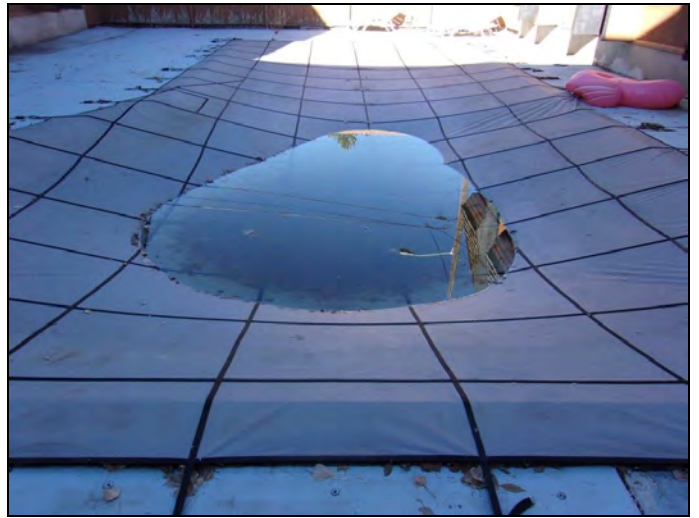
Comp #: 1112 Pool Cover - Replace

The pool cover appears to be in good condition. We recommend funding to replace this component approximately every 10 years. Remaining life based on current age.

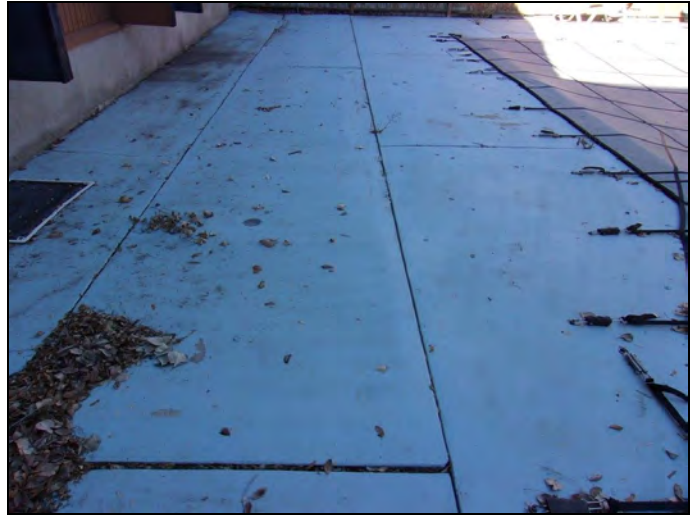
Comp #: 1116 Pool Deck - Repaint

The pool deck painted surfaces are in poor condition. We recommend funding to repaint this component approximately every 8 years. Remaining life based on current condition.

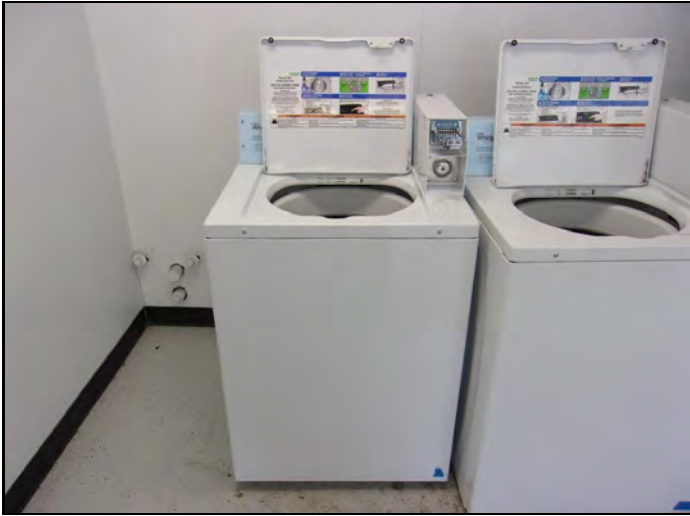
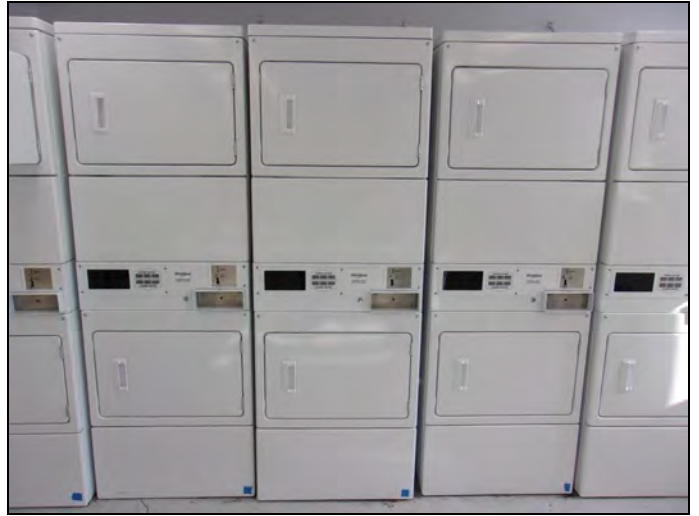
Comp #: 1401 Laundry Equipment - Replace

The laundry equipment is in working condition. We recommend replacing this component approximately every 10 - 15 years. Remaining life based on current age.

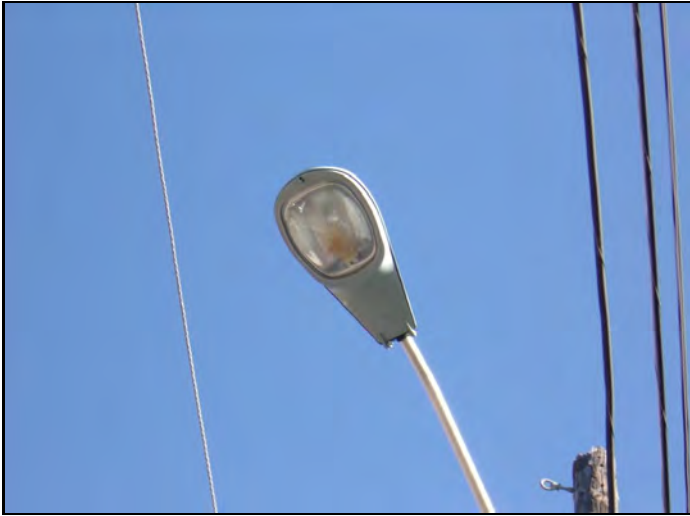
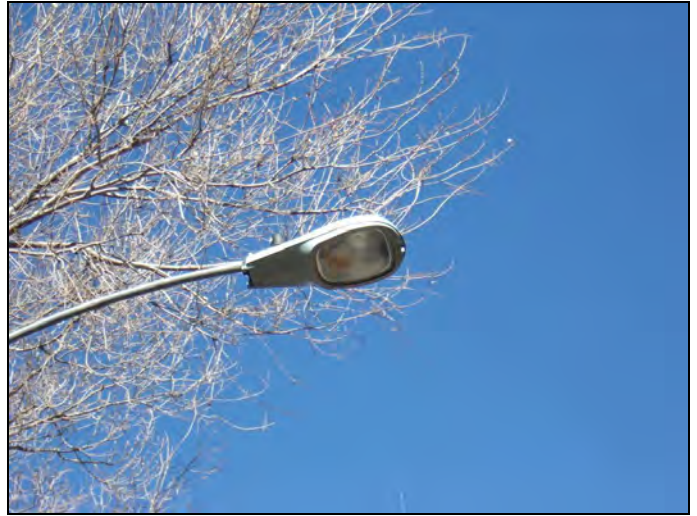
Comp #: 1609 Street Light Fixtures - Replace

The street light fixtures are in good condition. No expectation to replace the light poles. Paint poles as necessary as an operating expense. We recommend funding to replace this component approximately every 20 years. Remaining life based on current age and condition.

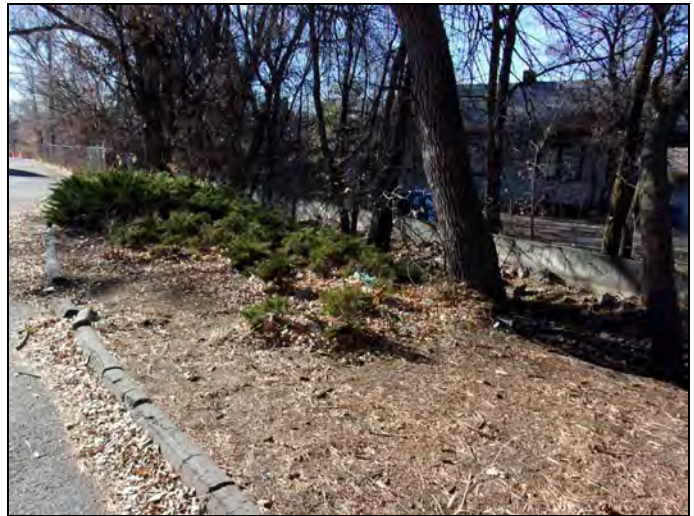
Comp #: 1812 Landscaping & Irrigation System - Renovate

The landscaping and irrigation system are in good to fair condition. We recommend funding for an allowance to renovate the landscaping and irrigation system approximately every 20 years. Remaining life based on current age.
