Legacy Beach HOA

Level 1 Reserve Study

Report Period – 01/01/2026 – 12/31/2026

Type of Study	Full Study
Date of Property Inspection	1/7/2025
Prepared By	Dale Gifford
Analysis Method	Cash Flow
Funding Goal	Full Funding

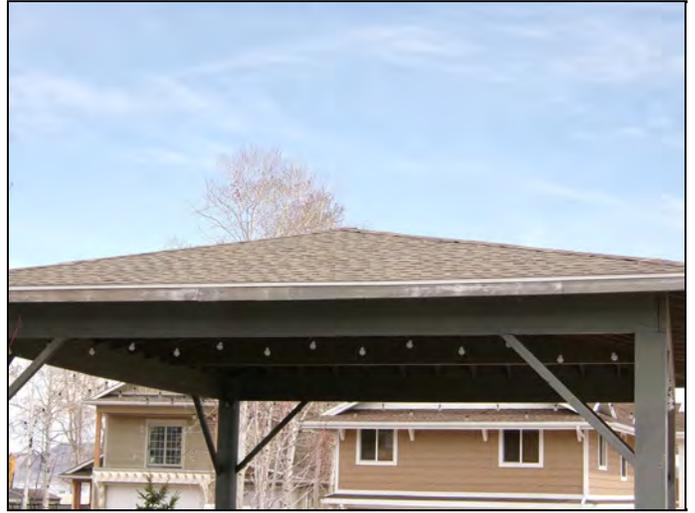
Comp #: 105 East Building Roofs - Replace

The roof appears to be in good condition. We recommend funding to replace this component approximately every 20 - 25 years. Remaining life based on current age.
