# Aspen Ridges (Clubhouse)

## Level 1 Reserve Study

**Report Period – 01/01/2027 – 12/31/2027**

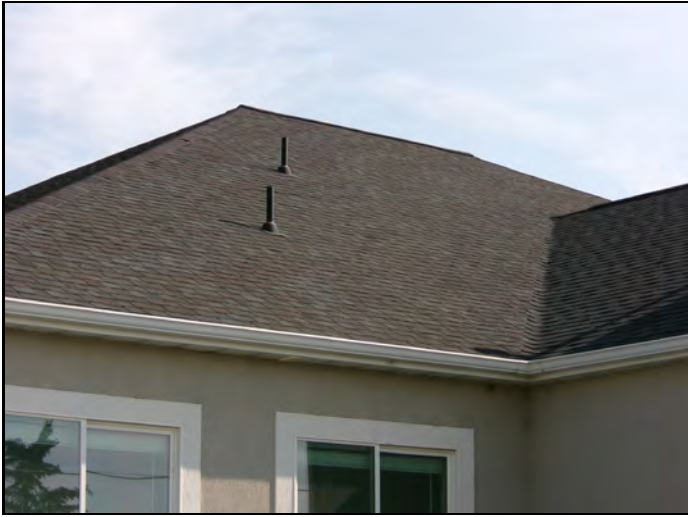
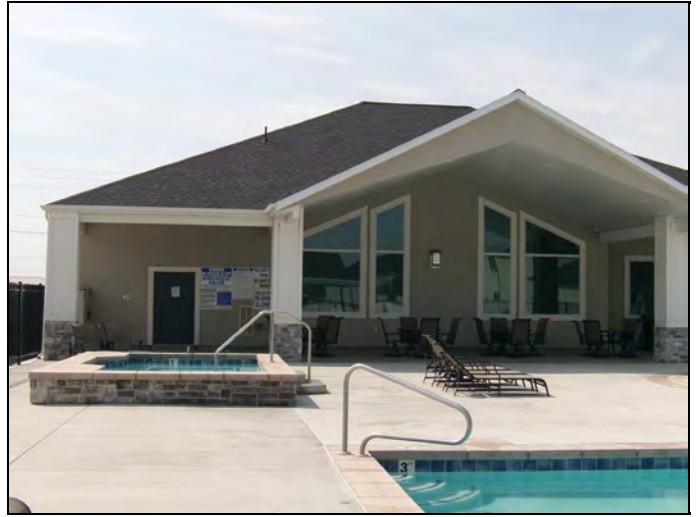
Comp #: 105    Roofs - Replace

*Location:*            **Building Roofs**

*Quantity:*           **Approx. 5,980 SF**

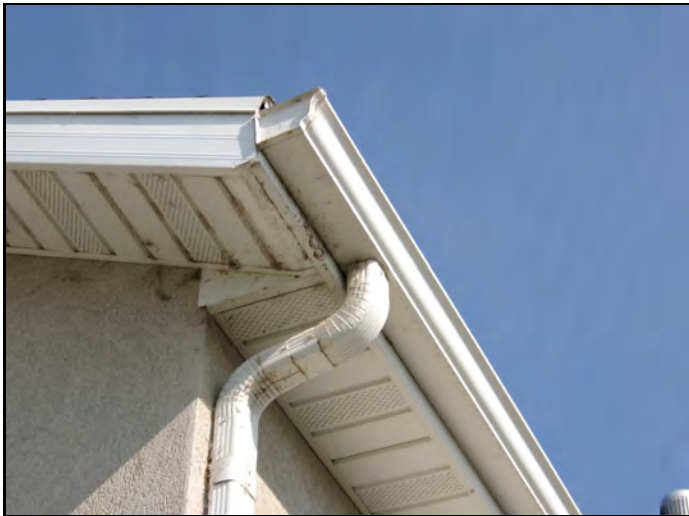
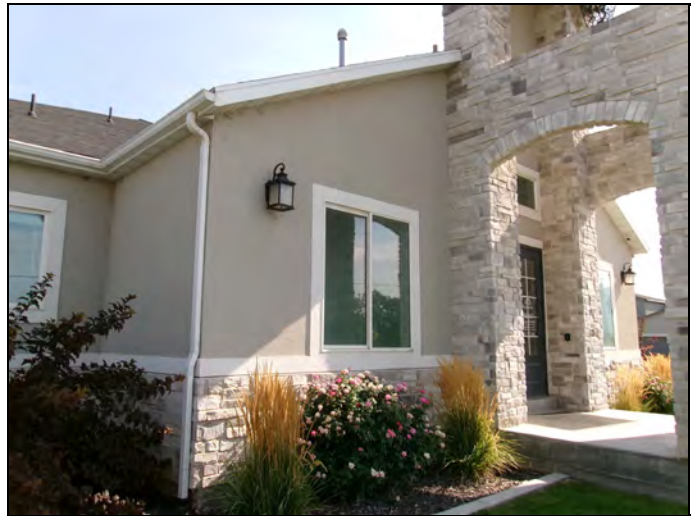
Comp #: 120 Rain Gutters/Downspouts - Replace

*Location:* **Building Exteriors**

*Quantity:* **Approx. 385 LF**

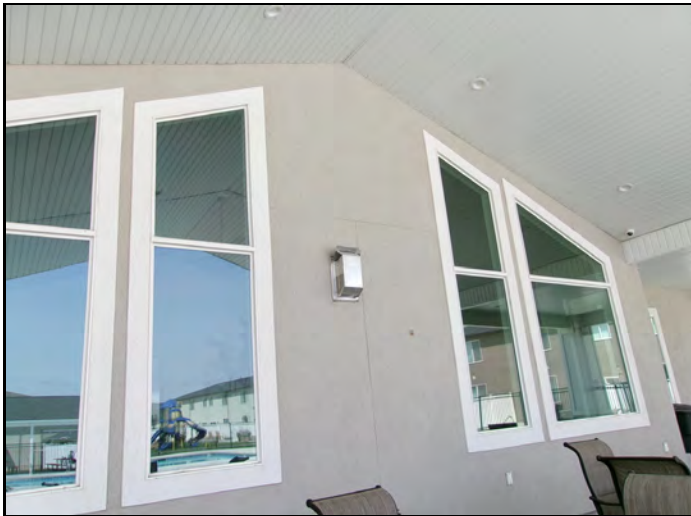
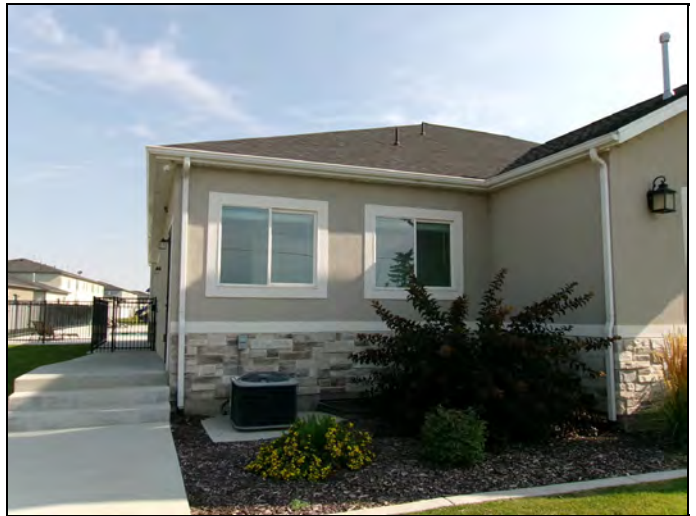
Comp #: 201 Stucco Surfaces - Repair/Repaint

*Location:* **Building Exteriors**

*Quantity:* **Approx. 4,650 SF**

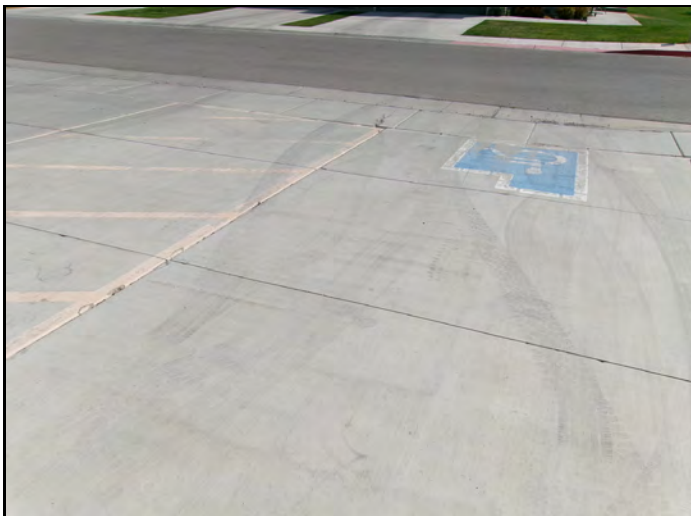
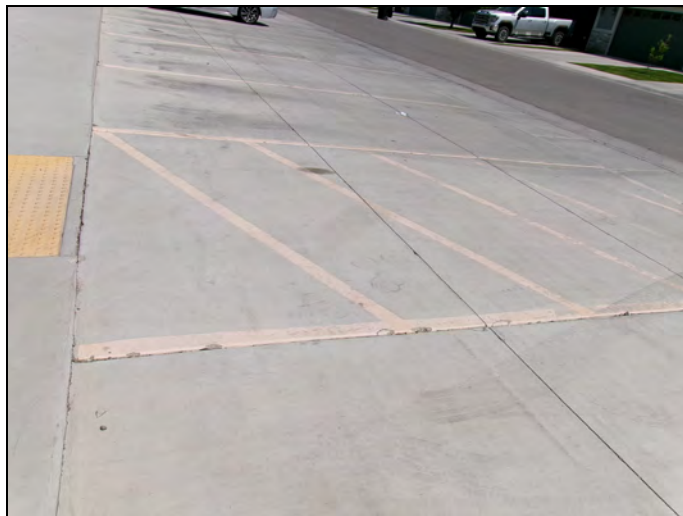
Comp #: 403 Concrete - Partial Repair/Replace

*Location:* Clubhouse Parking

*Quantity:* Minimal SF

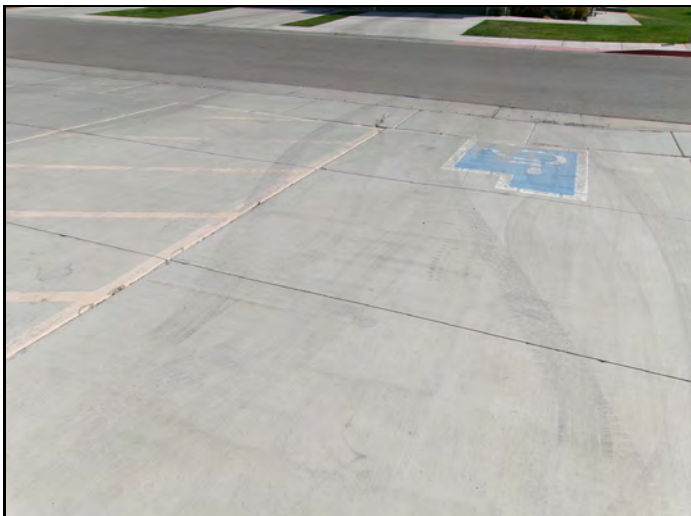
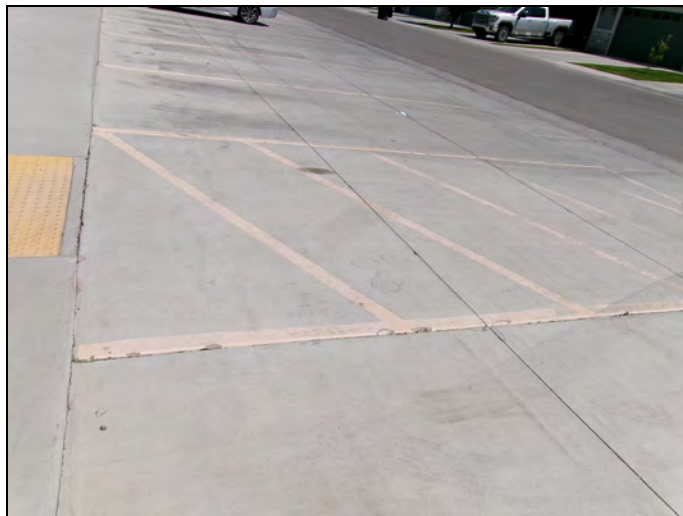
Comp #: 490 Concrete Parking - Replace

*Location:* Clubhouse Parking

*Quantity:* Approx. 3,690 SF

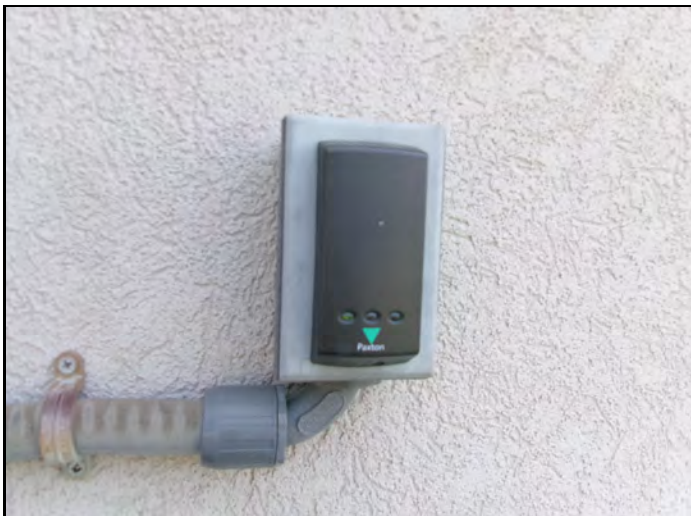
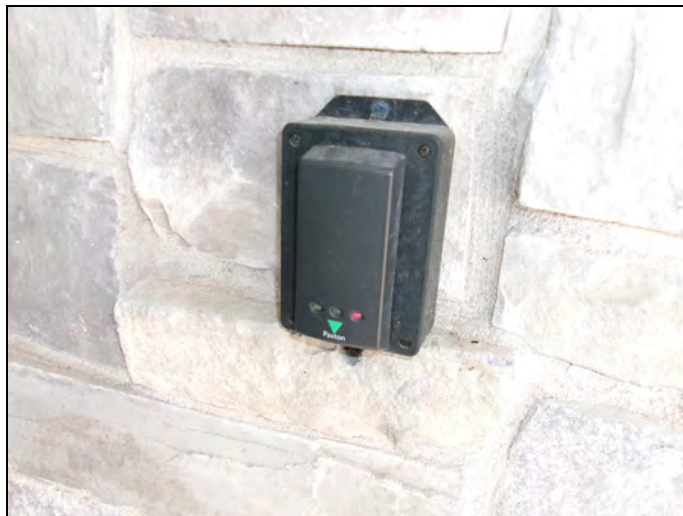
Comp #: 508 Access Control System - Replace

*Location:* Clubhouse Exteriors

*Quantity:* (1) System

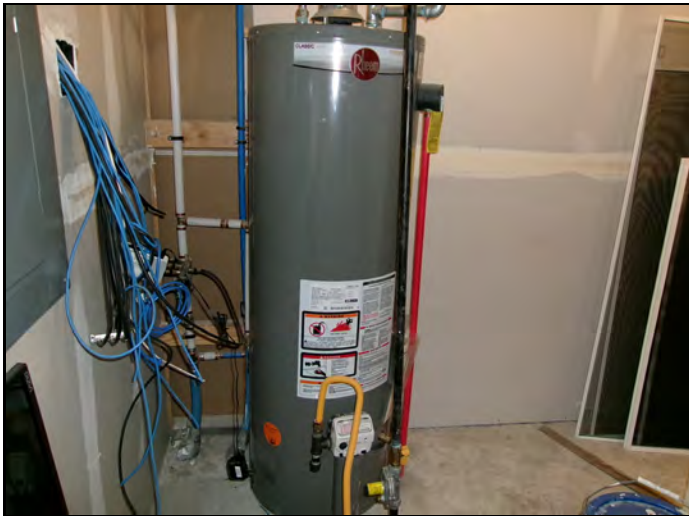
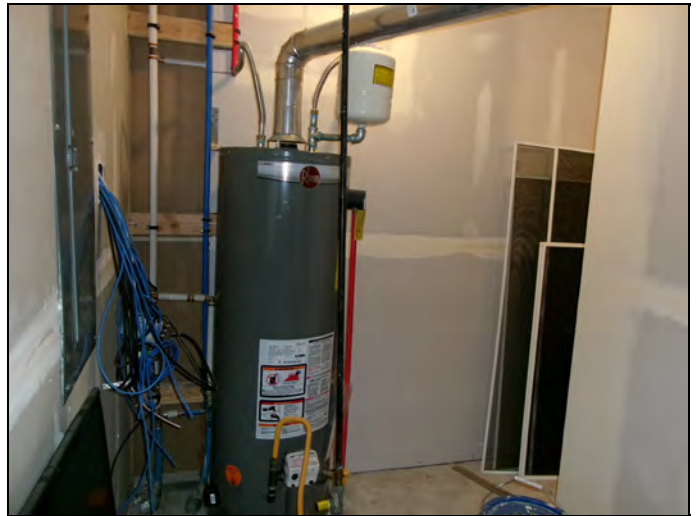
Comp #: 703 Water Heater - Replace

*Location:* Clubhouse Interior

*Quantity:* (1) Water Heater

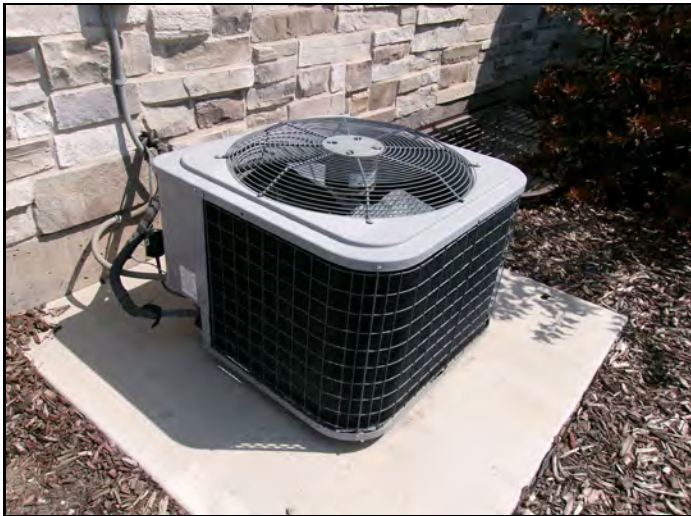
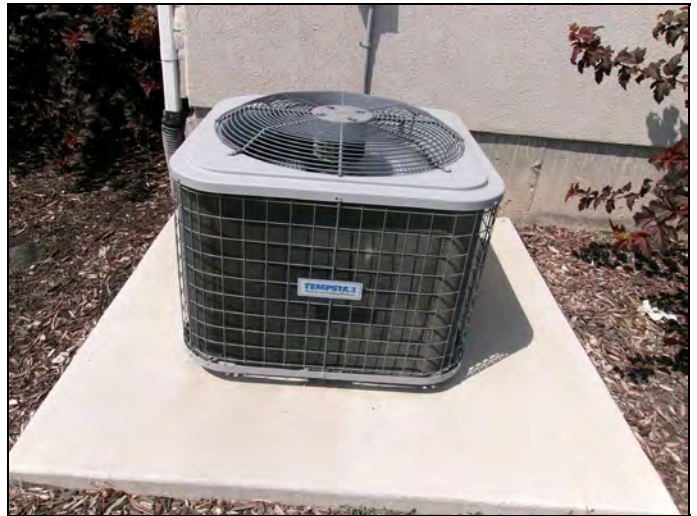
Comp #: 705 HVAC Condensers - Replace

*Location:* Clubhouse Exterior

*Quantity:* (2) Condensers

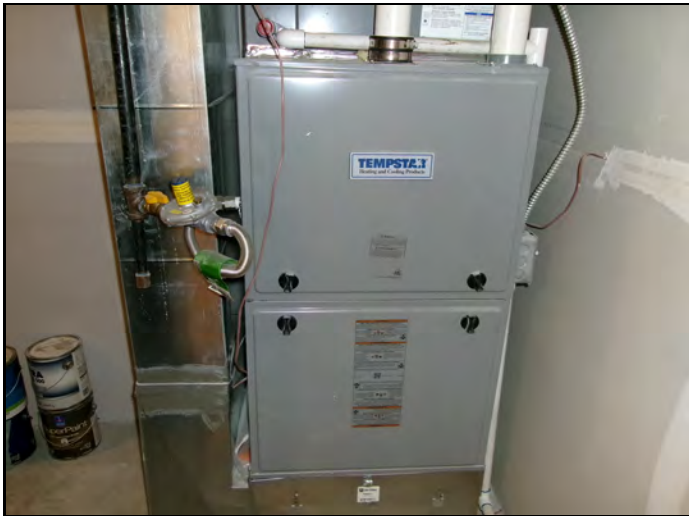
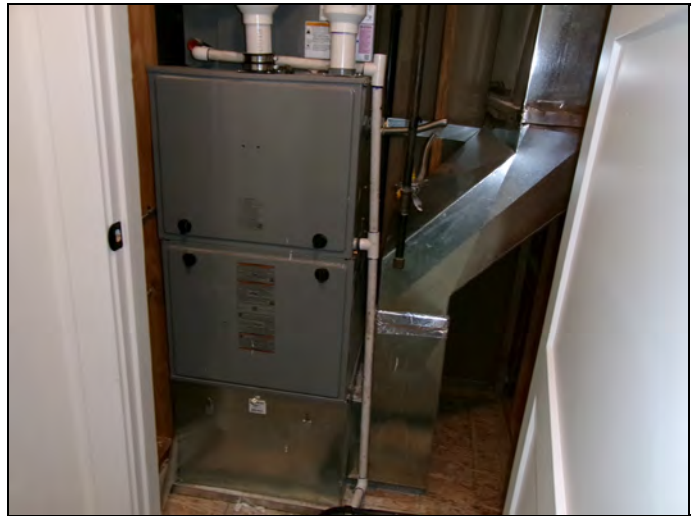
Comp #: 706 HVAC Furnaces - Replace

*Location:* Clubhouse Interior

*Quantity:* (2) Furnaces

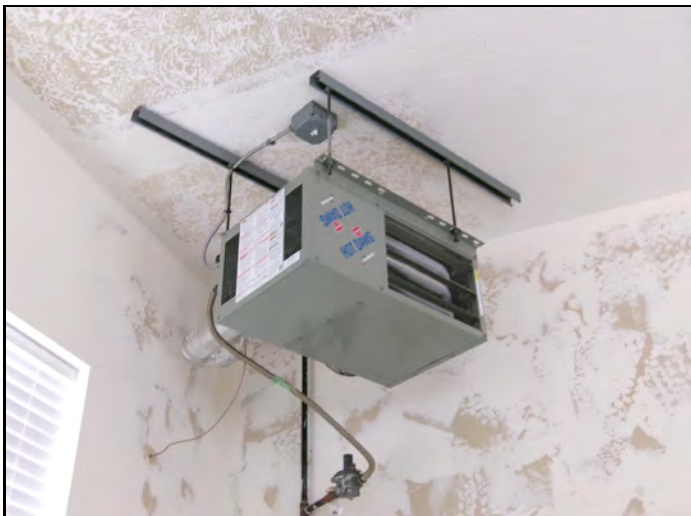
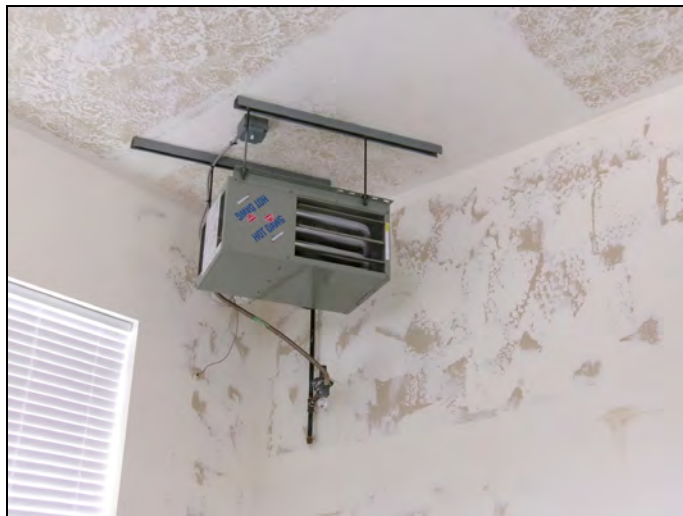
Comp #: 717 Suspended Heater - Replace

*Location:* **Pool Equipment Room**

*Quantity:* **(1) Heater**

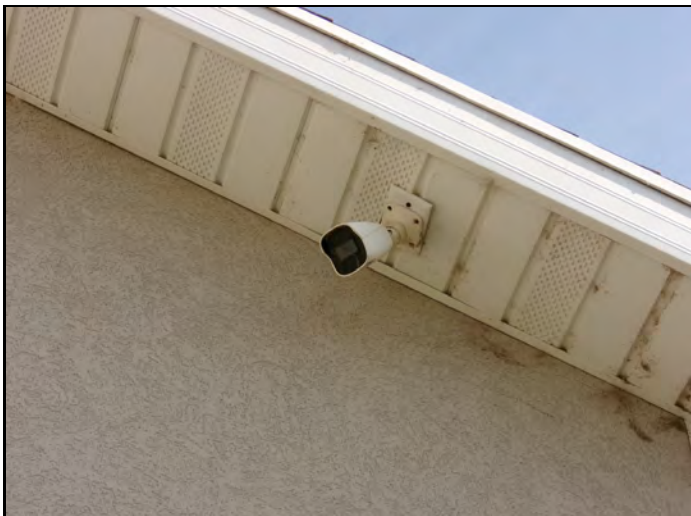
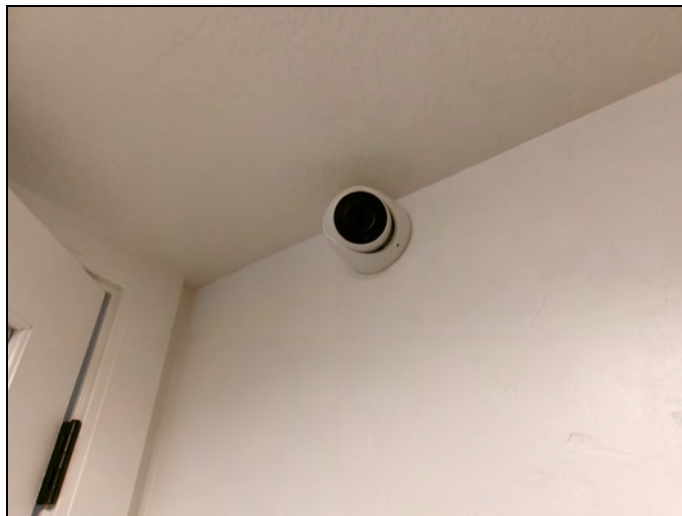
Comp #: 903 Security Camera System - Replace

*Location:* Clubhouse

*Quantity:* (1) System

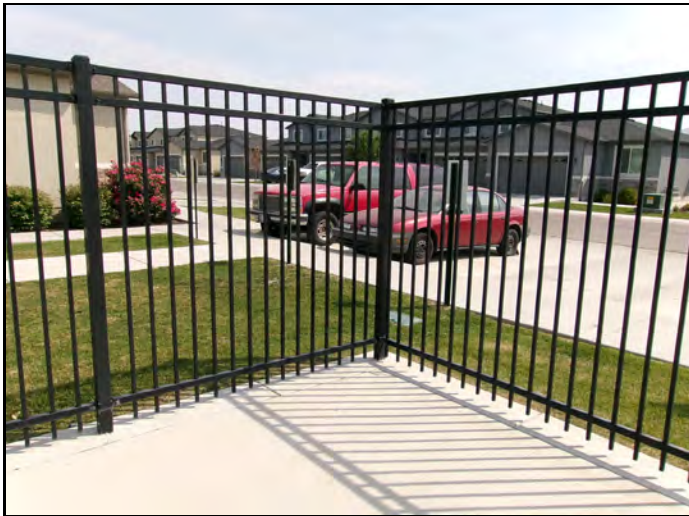
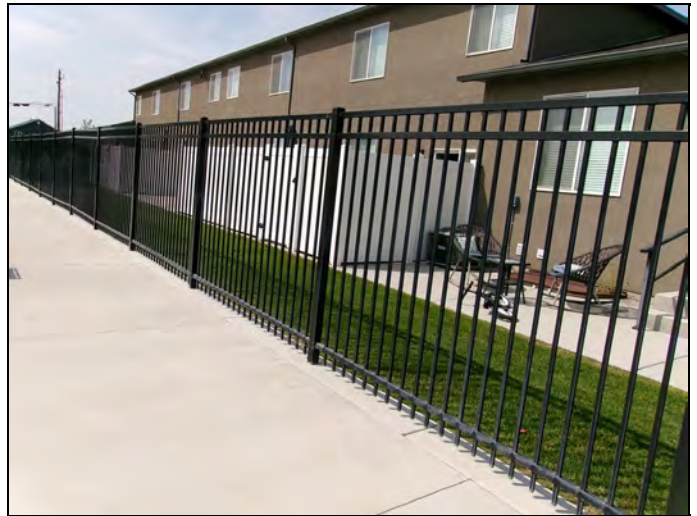
Comp #: 1002 Metal Pool Fencing - Replace

*Location:* **Pool Area**

*Quantity:* **Approx. 305 LF**

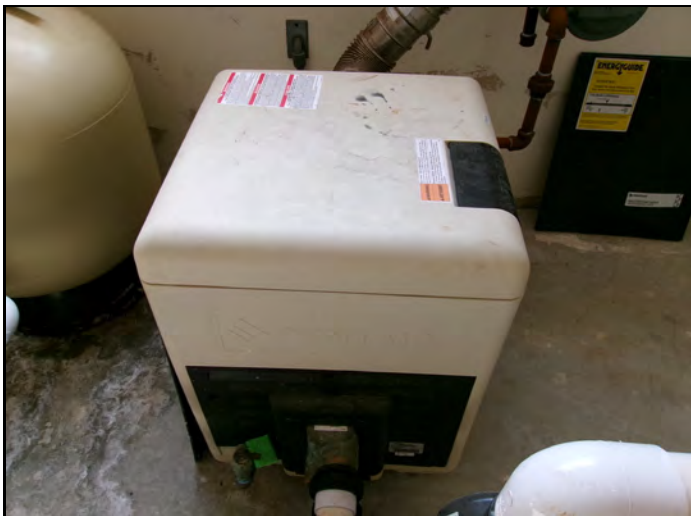
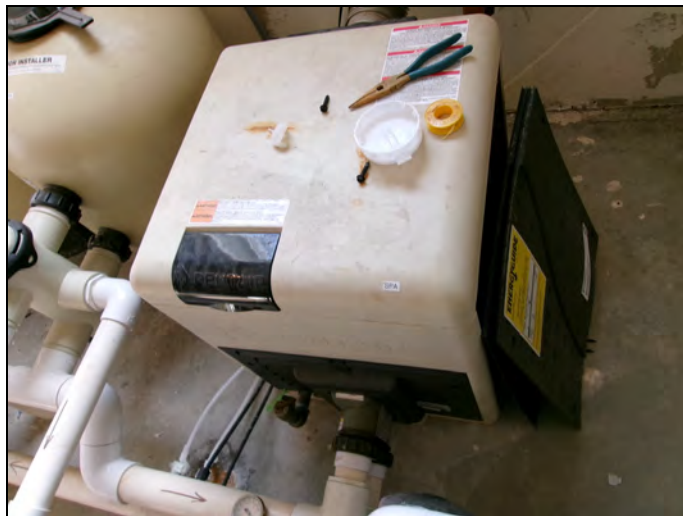
## Comp #: 1104 Pools & Spa Heaters - Replace

*Location:* **Pool Equipment Room**

*Quantity:* **(3) Heaters**

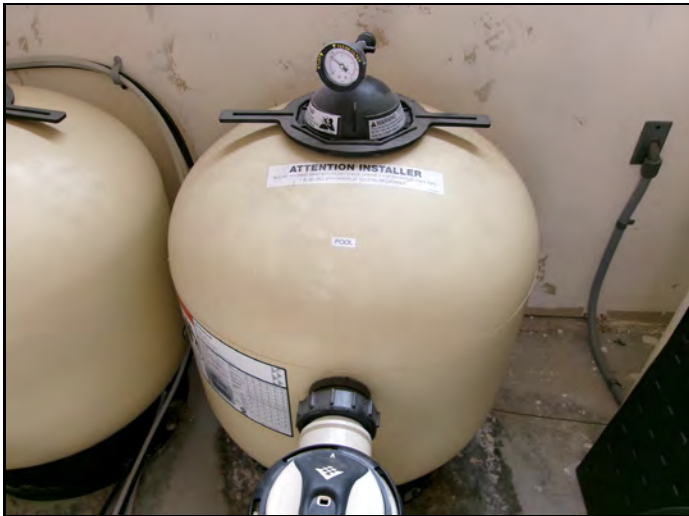
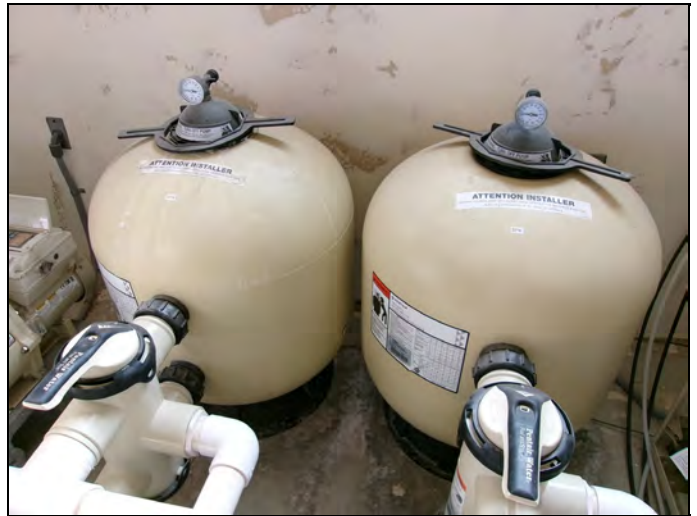
## Comp #: 1107 Pools & Spa Filters - Replace

*Location:* **Pool Equipment Room**

*Quantity:* **(6) Filters**

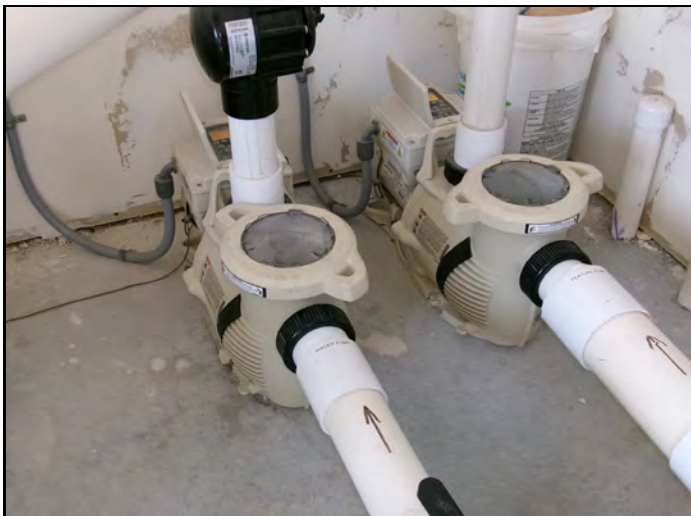
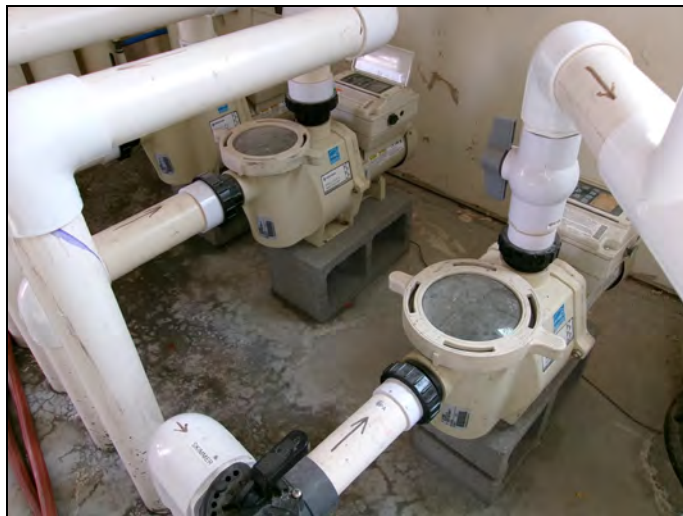
## Comp #: 1110 Pools & Spa Pumps - Replace

*Location:* **Pool Equipment Room**

*Quantity:* **(6) Pumps**

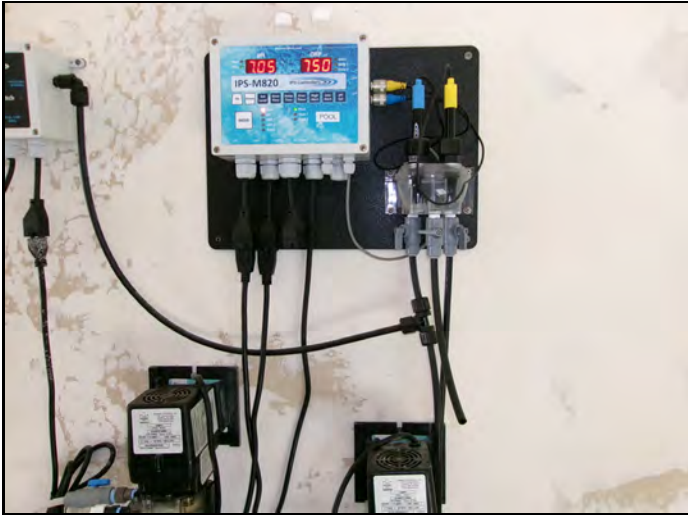
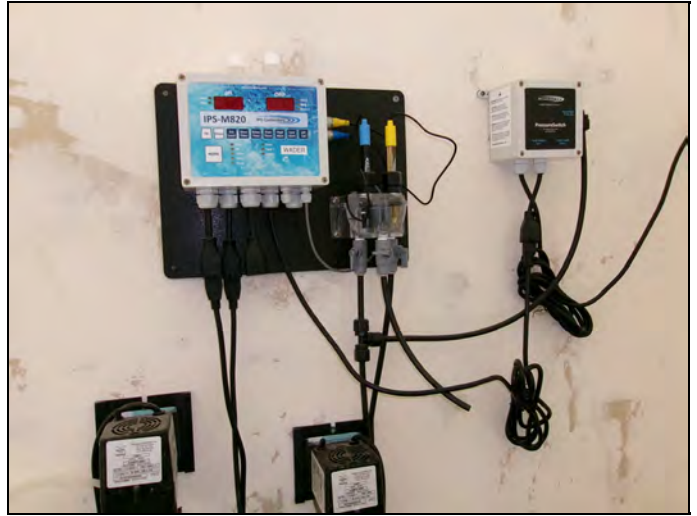
Comp #: 1111 Pools & Spa Chemical Systems - Replace

*Location:* Pool Equipment Room

*Quantity:* (3) Systems

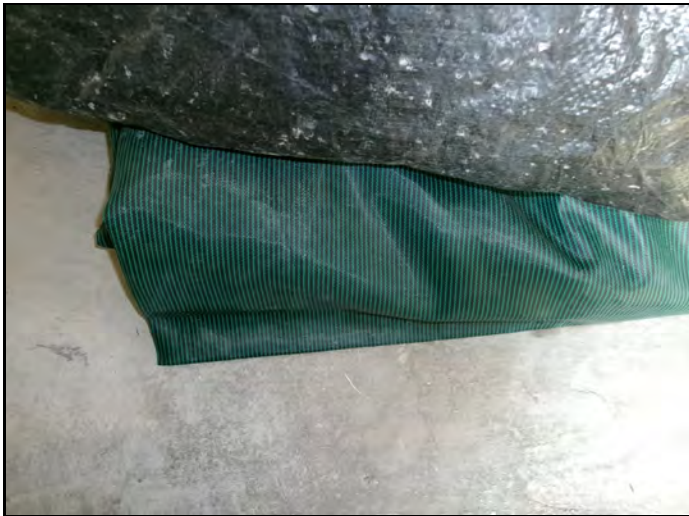
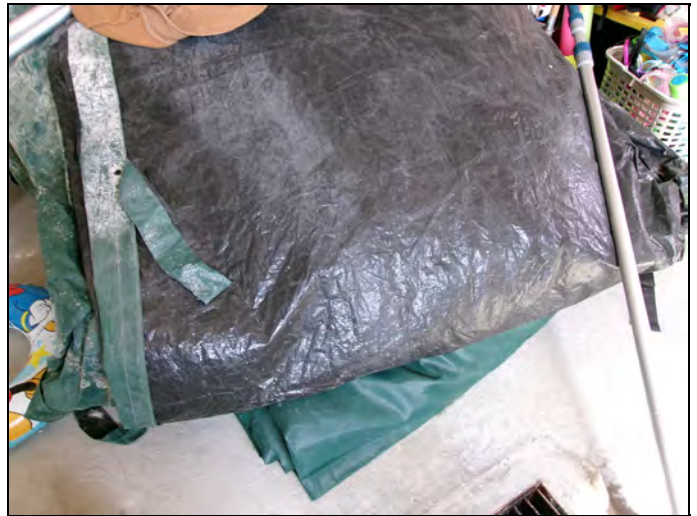
Comp #: 1112 Pools & Spa Covers - Replace

*Location:* **Pool Equipment Room**

*Quantity:* **(3) Covers**

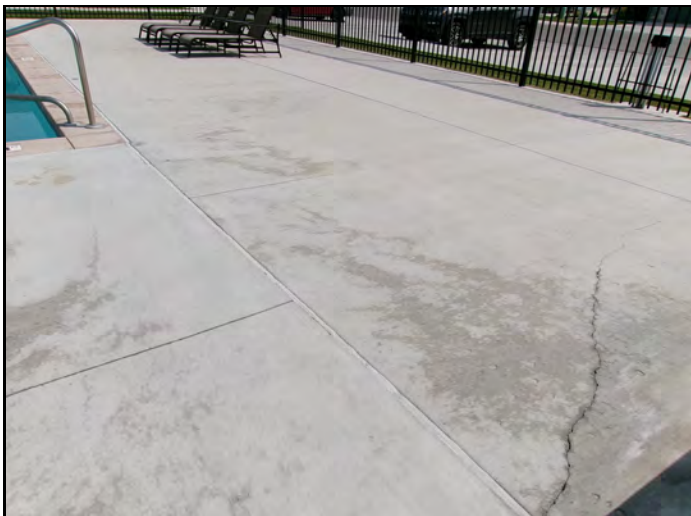
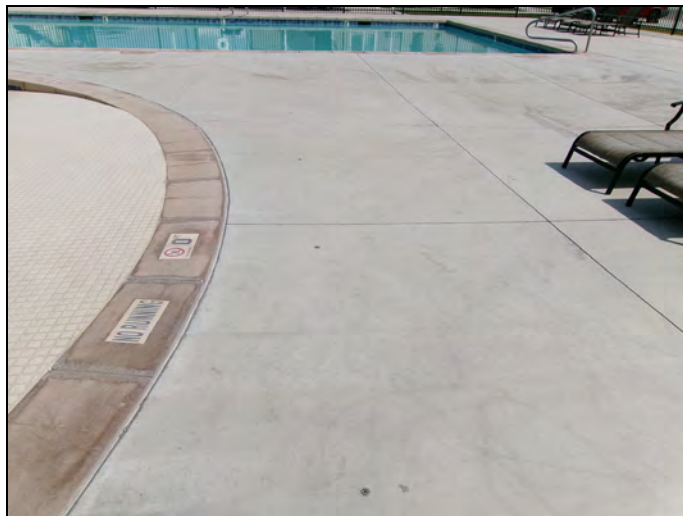
## Comp #: 1116 Pool Deck - Replace

*Location:* **Pool Area**

*Quantity:* **Approx. 6,000 SF**

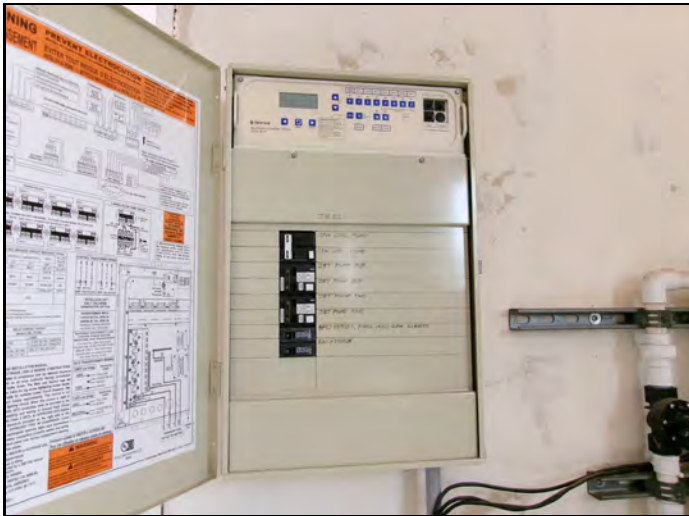
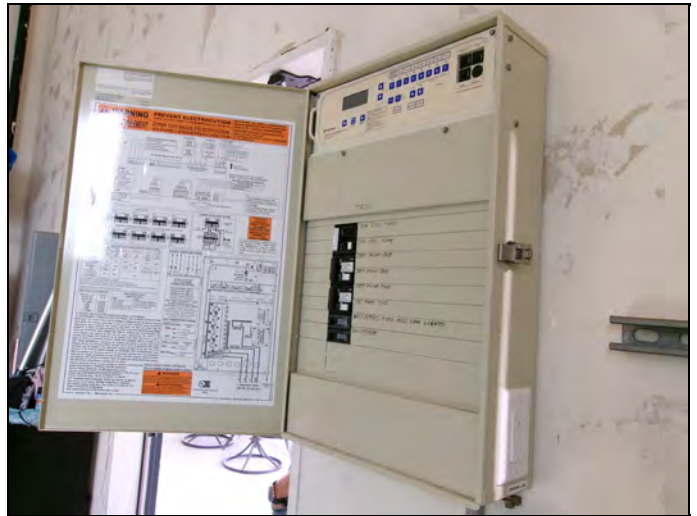
## Comp #: 1117 Pools & Spa Control System - Replace

*Location:* **Pool Equipment Room**

*Quantity:* **(1) System**

The pool and spa control system appears to be in working condition. We recommend funding to replace this system approximately every 12 - 15 years. Remaining life based on current age.

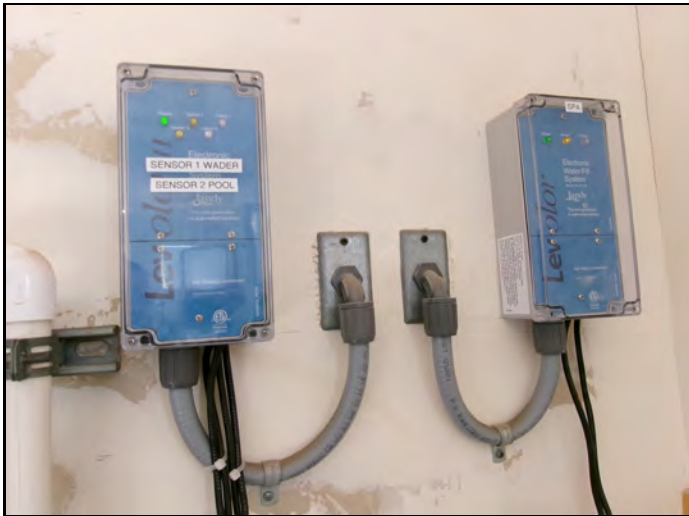
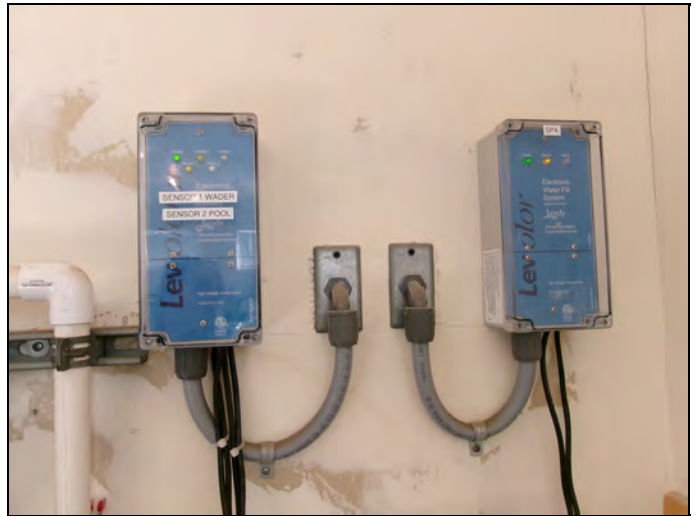
## Comp #: 1118 Pools & Spa Water Level Controllers - Replace

*Location:* **Pool Equipment Room**

*Quantity:* **(2) Controllers**

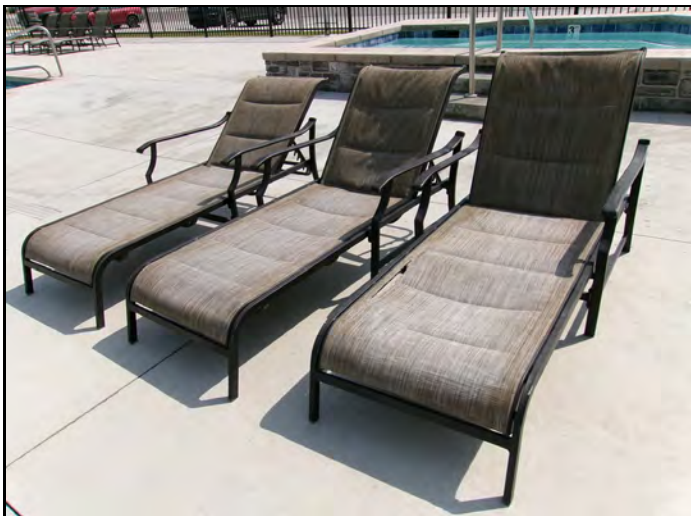
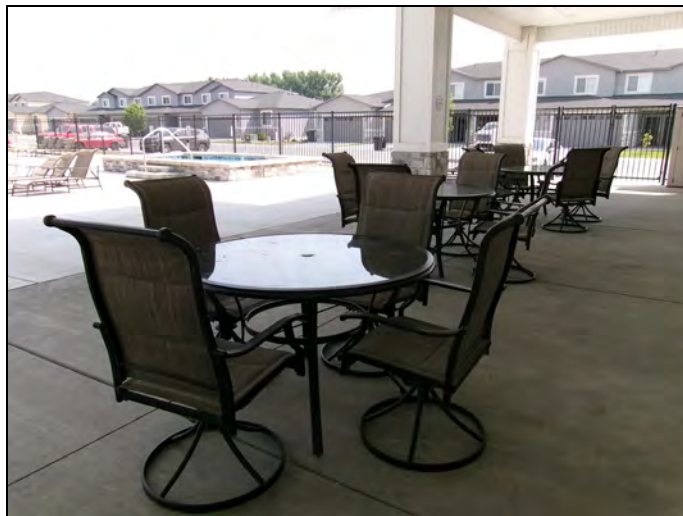
## Comp #: 1121 Pool Furniture - Replace

*Location:* **Pool Area**

*Quantity:* **(40) Pieces**

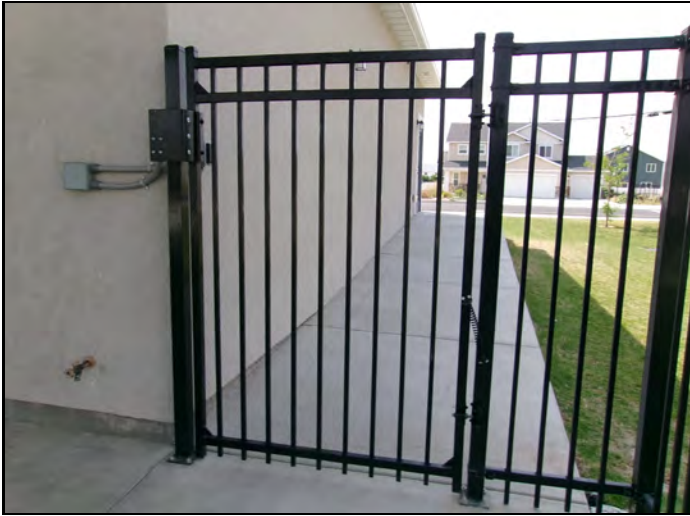
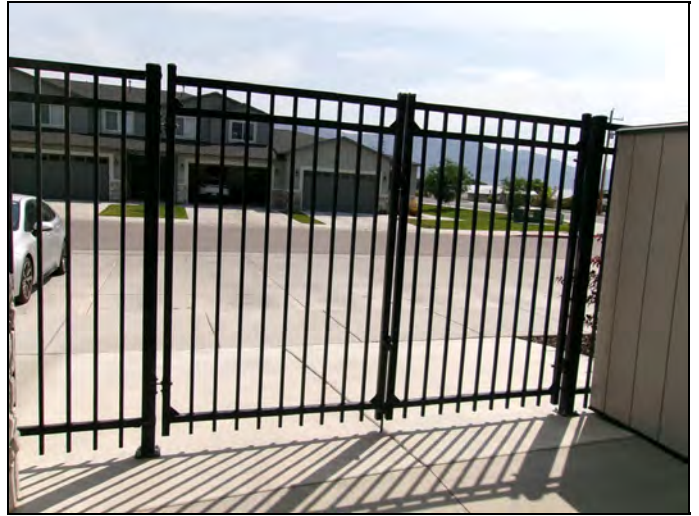
Comp #: 1190 Pool Gates - Replace

*Location:* **Pool Area**

*Quantity:* **(3) Gates**

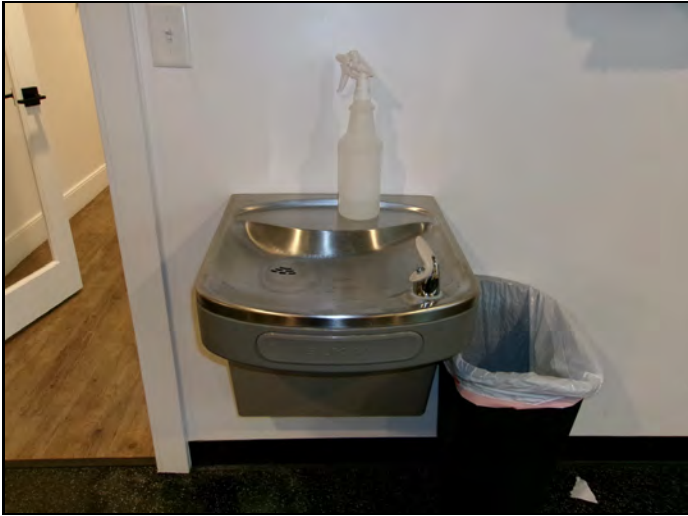
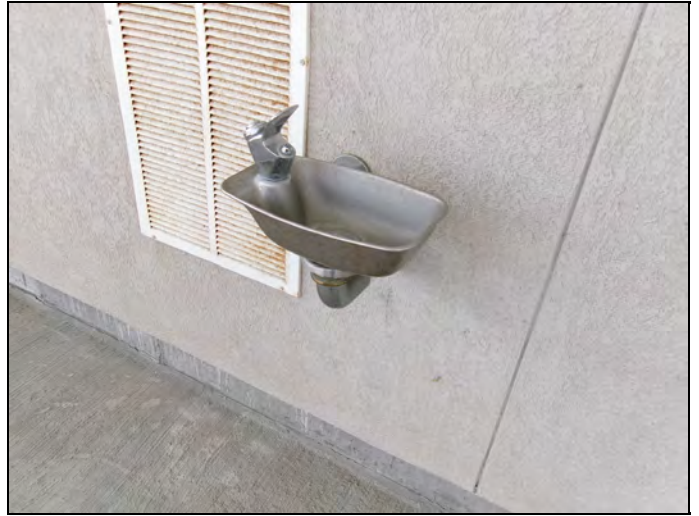
Comp #: 1304 Drinking Fountains - Replace

*Location:* **Common Area**

*Quantity:* **(2) Fountains**

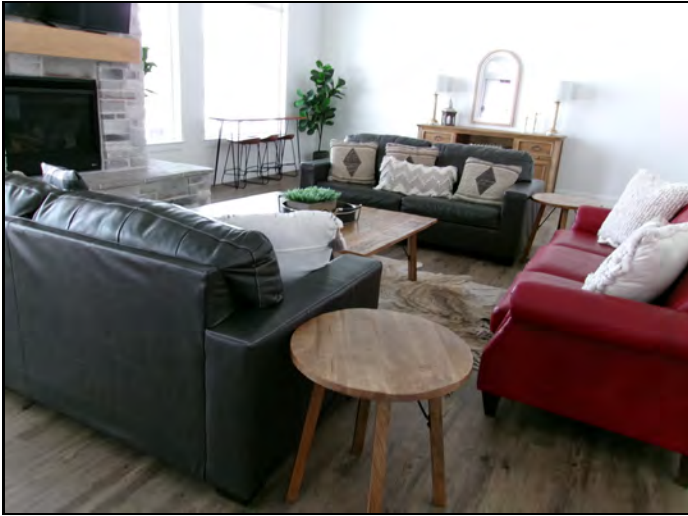
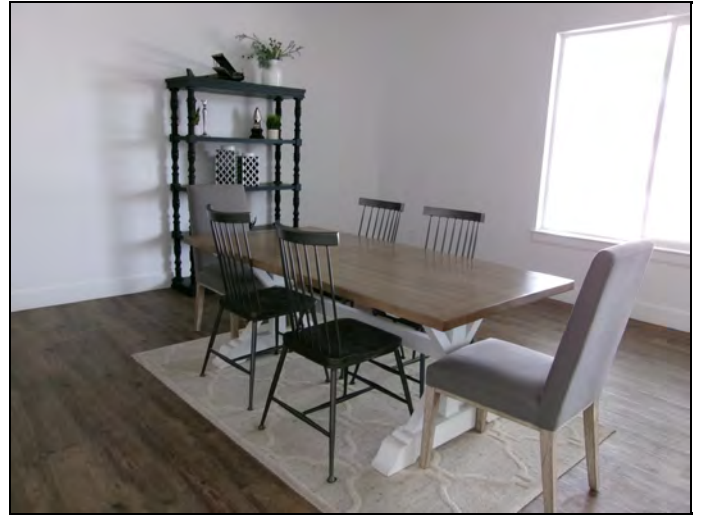
Comp #: 1405 Furniture - Replace

*Location:* Clubhouse Interior

*Quantity:* Assorted Pieces

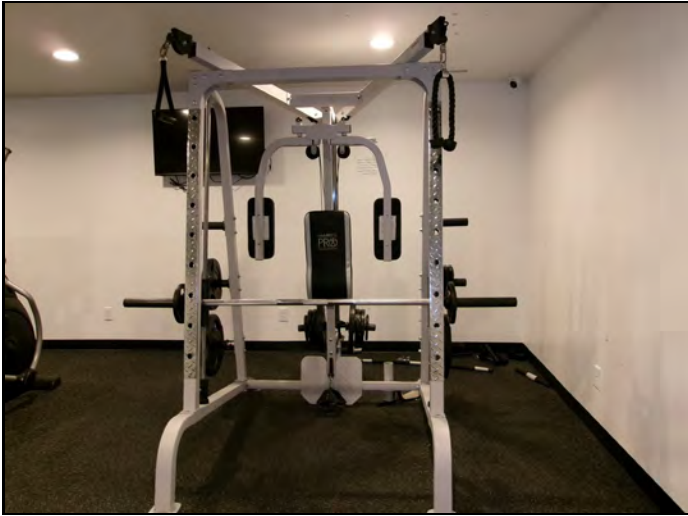
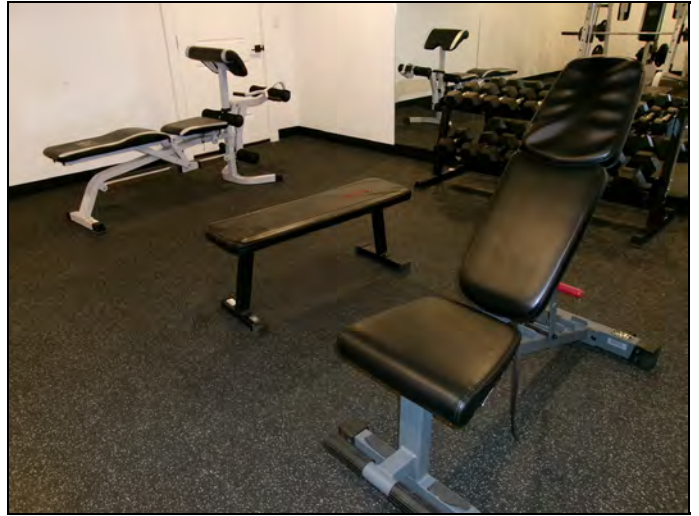
Comp #: 1406 Fitness Equipment - Replace

*Location:* Clubhouse Interior

*Quantity:* (5) Pieces

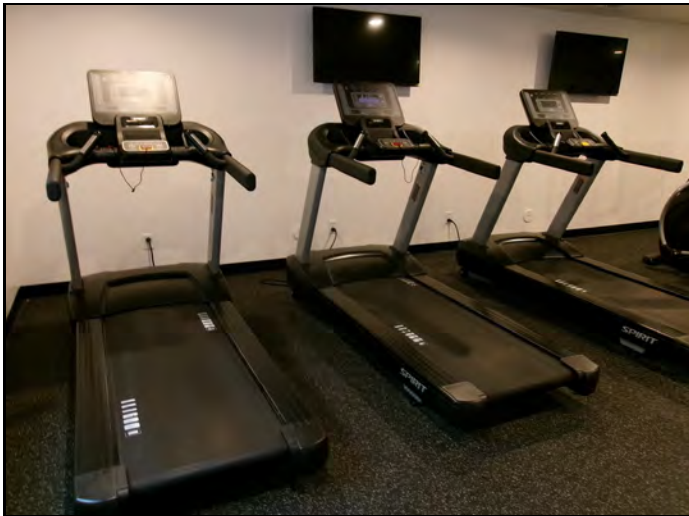
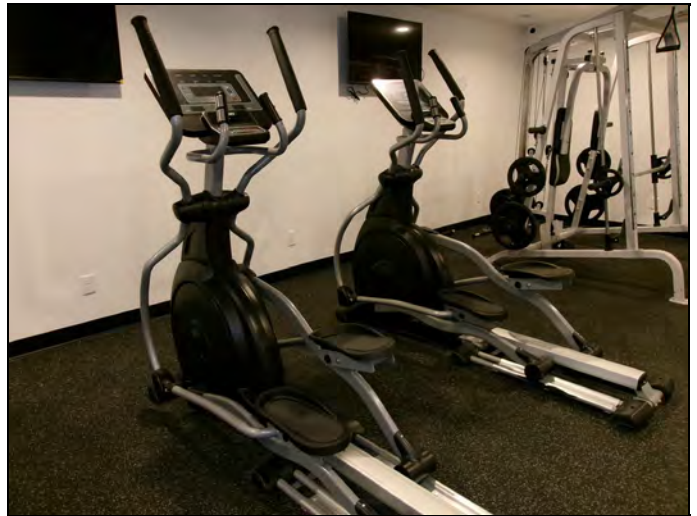
Comp #: 1407 Cardio Equipment - Replace

*Location:* Clubhouse Interior

*Quantity:* (6) Pieces

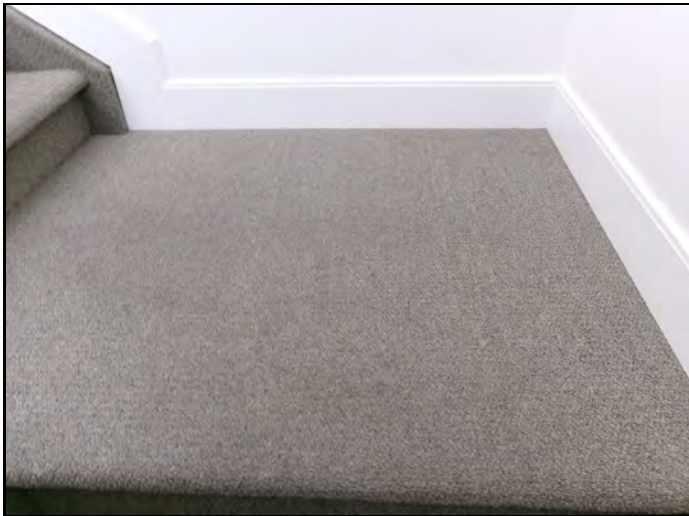
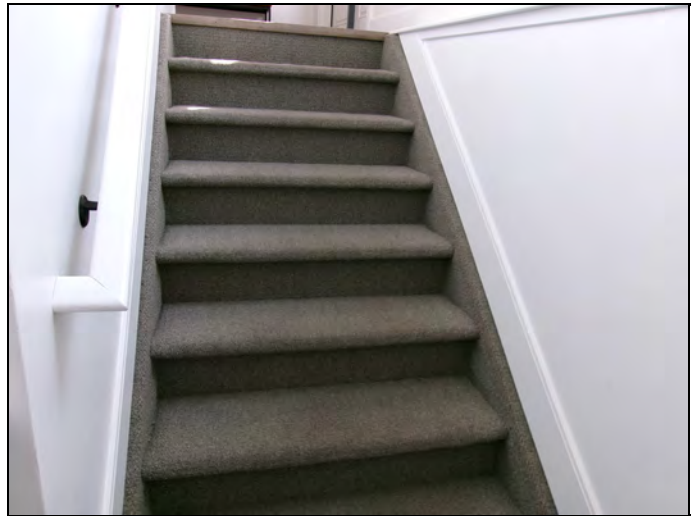
Comp #: 1501 Carpeting - Replace

*Location:* **Clubhouse Interior**

*Quantity:* **Approx. 200 SF**

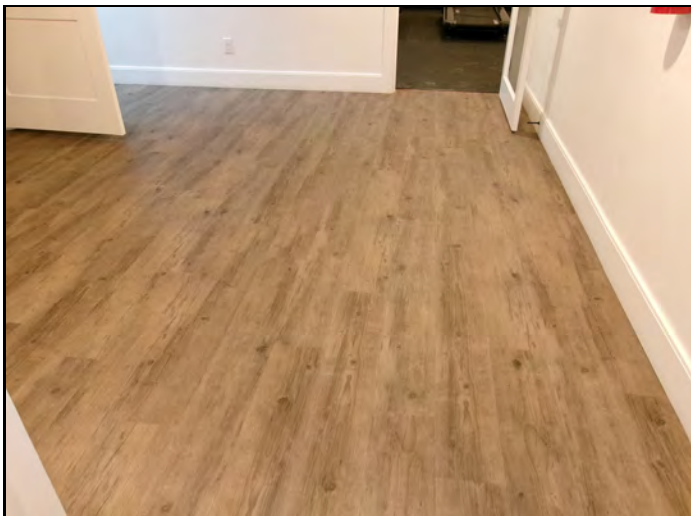
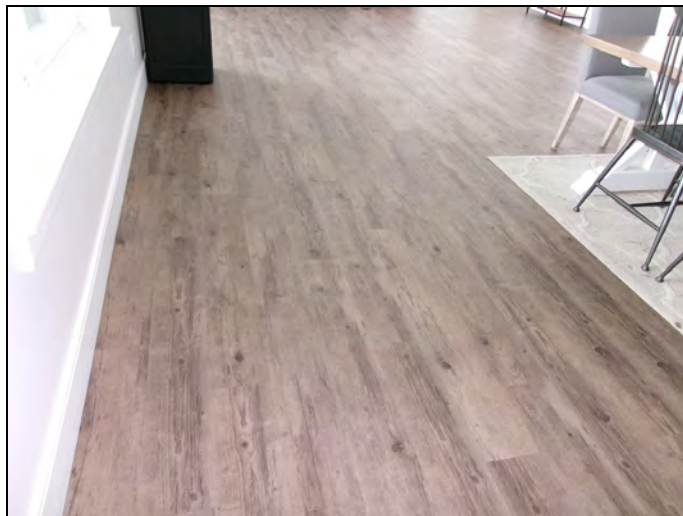
## Comp #: 1502 LVP Flooring - Replace

*Location:* **Clubhouse Interior**

*Quantity:* **Approx. 1,935 SF**

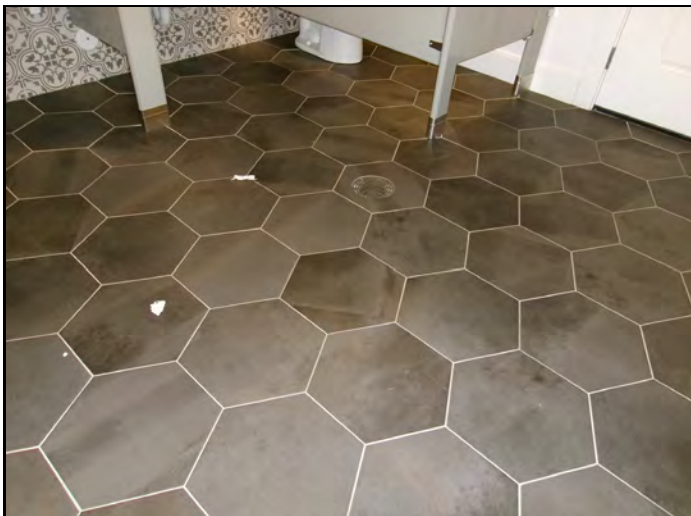
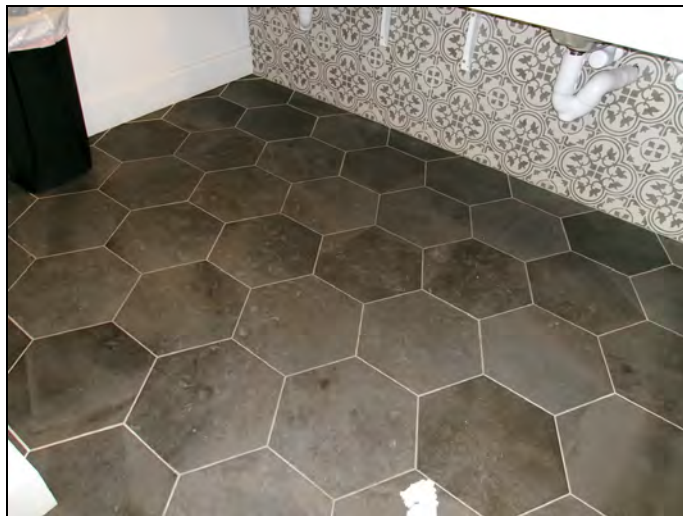
## Comp #: 1503 Tile Flooring - Replace

*Location:* **Clubhouse Interior**

*Quantity:* **Approx. 580 SF**

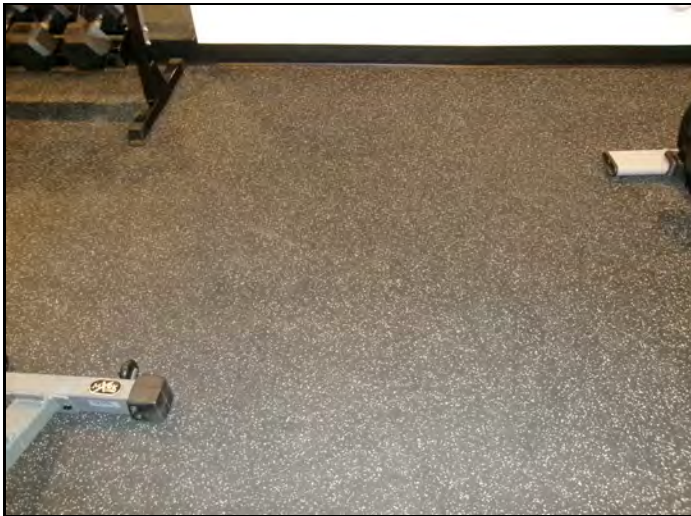
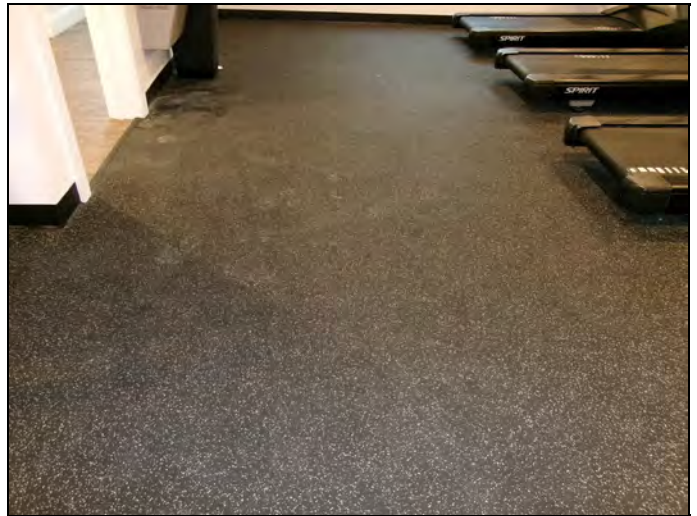
Comp #: 1590 Fitness Room Flooring - Replace

*Location:* Clubhouse Interior

*Quantity:* Approx. 805 SF

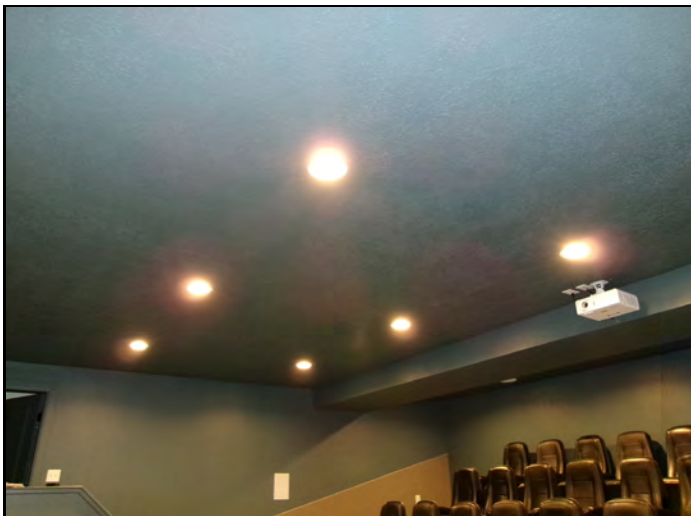
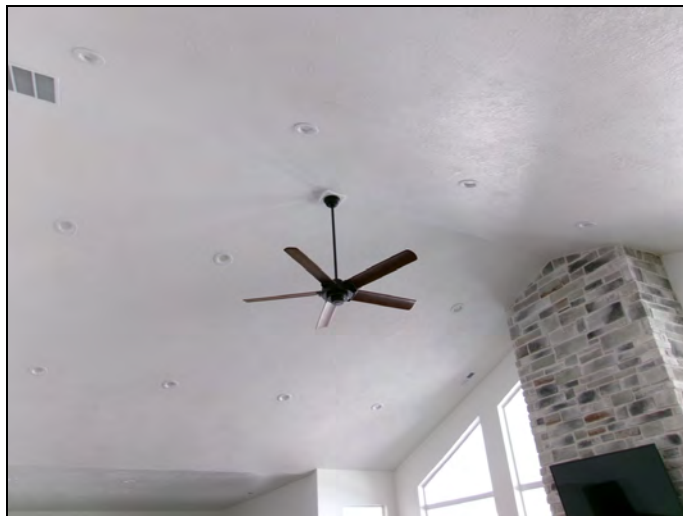
Comp #: 1601 Interior Light Fixtures - Replace

*Location:* Clubhouse Interior

*Quantity:* (81) Fixtures
