# Aspen Ridges (Clubhouse)

## Level 1 Reserve Study

**Report Period – 01/01/2027 – 12/31/2027**

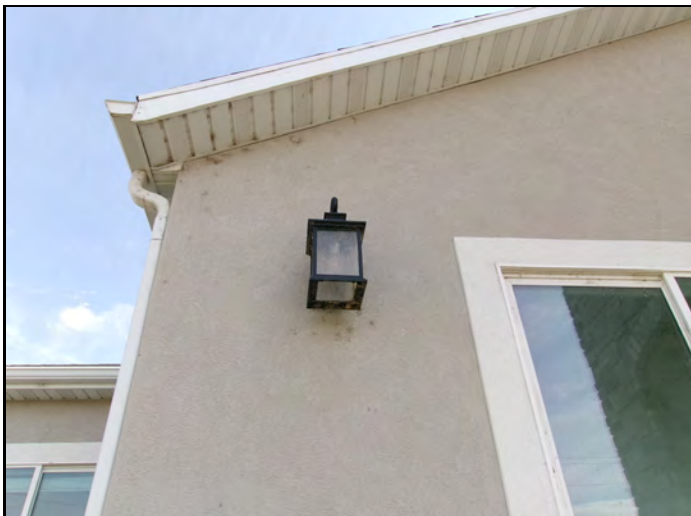
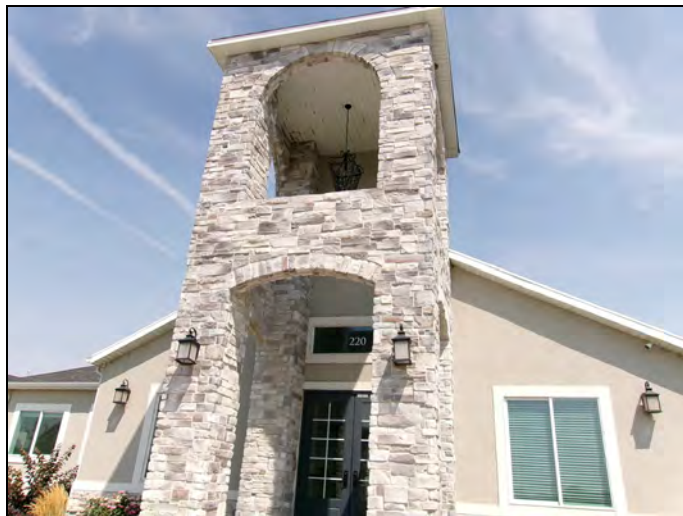
Comp #: 1602 Exterior Light Fixtures - Replace

*Location:* **Building Exteriors**

*Quantity:* **(31) Fixtures**

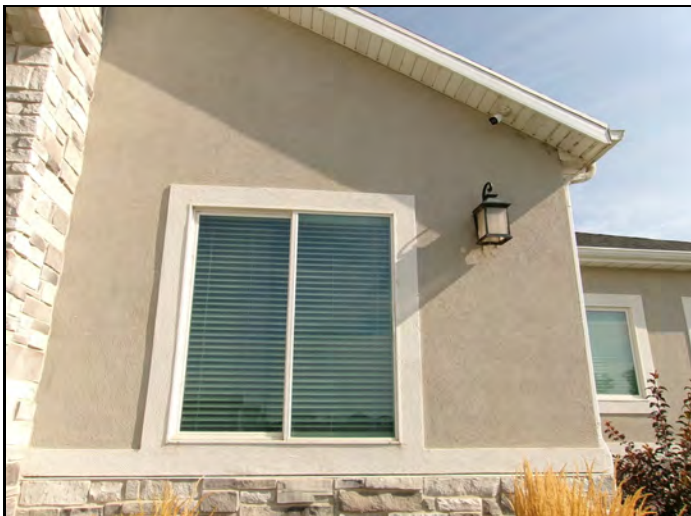
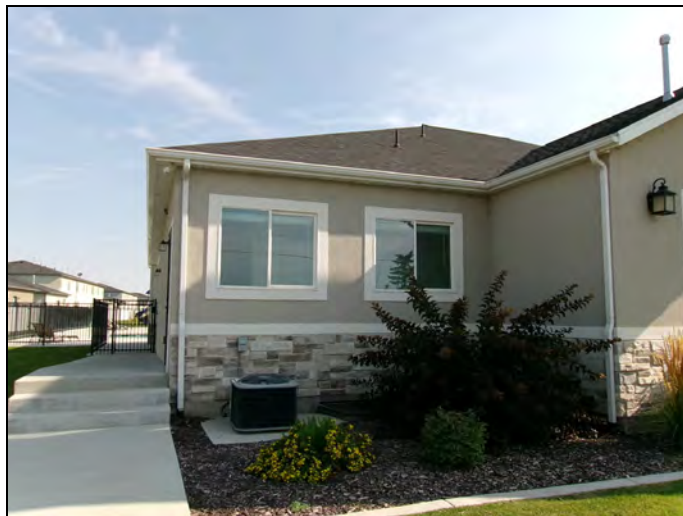
## Comp #: 2303 Windows - Replace

*Location:* Clubhouse Exterior

*Quantity:* (20) Windows

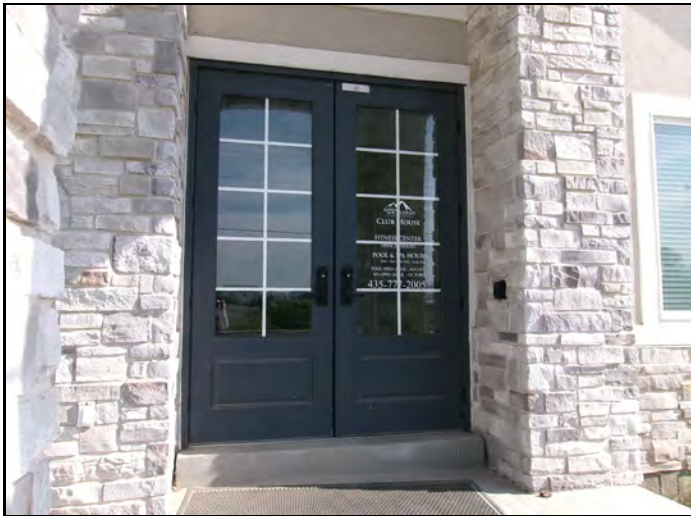
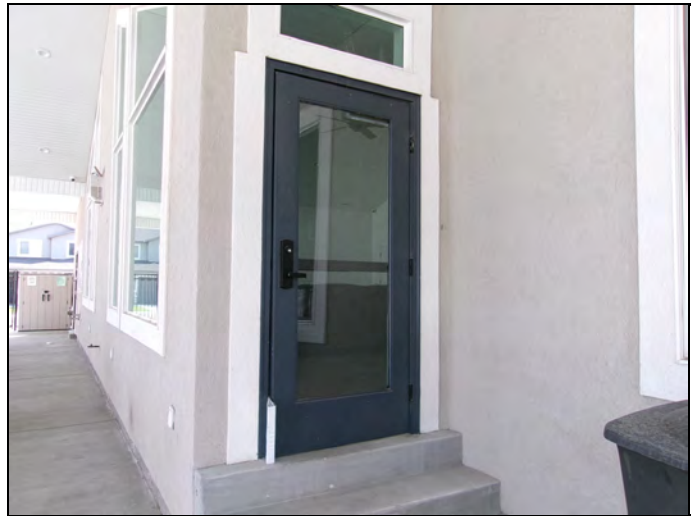
## Comp #: 2304 Exterior Doors - Replace

*Location:* Clubhouse Exterior

*Quantity:* (5) Doors
