Cedar Creek #1

Level 1 Reserve Study

Report Period – 01/01/2022 – 12/31/2022

Executive Summary – Cedar Creek #1 - ID # 18798

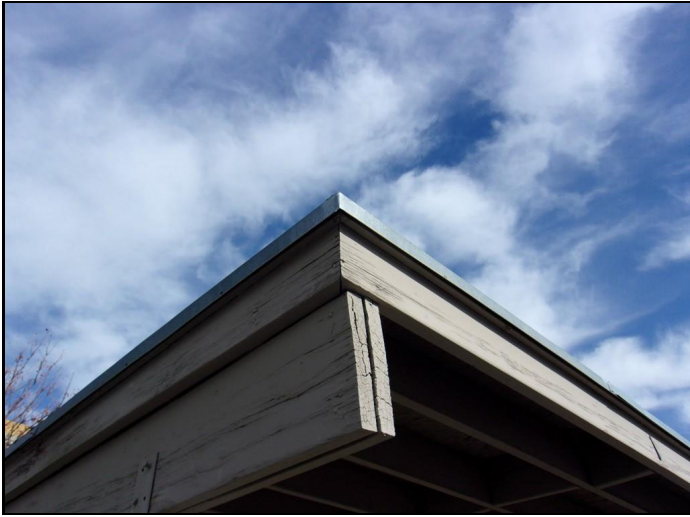
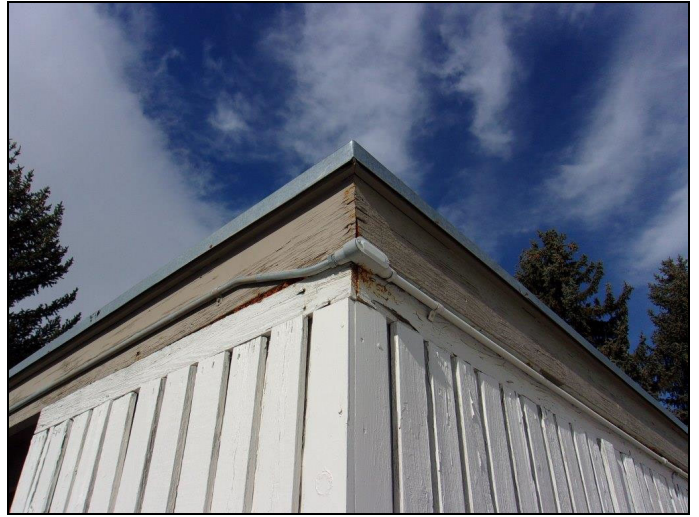
Comp #: 104 Carport Roofs - Replace

Unable to inspect this component at the time of the site visit. We recommend funding to replace this component approximately every 20 - 25 years. Remaining life based on current age.

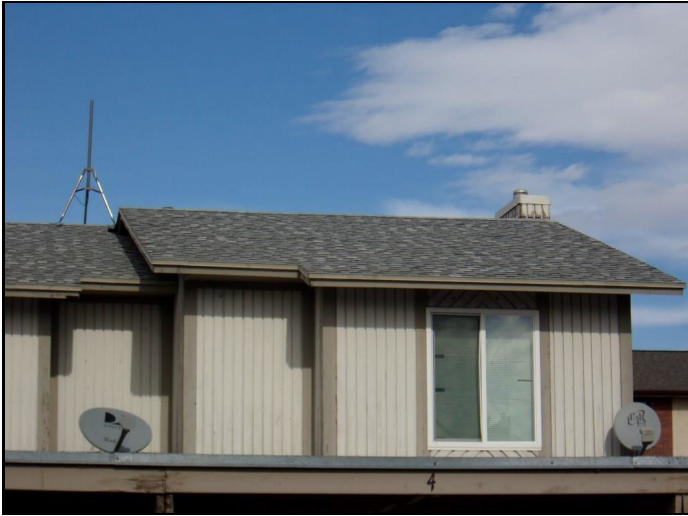
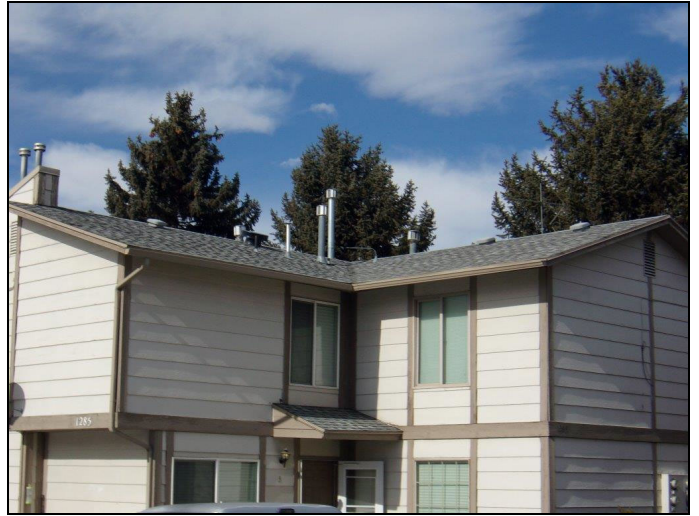
Comp #: 105 Roofs - Replace

The roofs are in good condition. We recommend funding to replace this component approximately every 20 - 25 years. Remaining life based on current age.

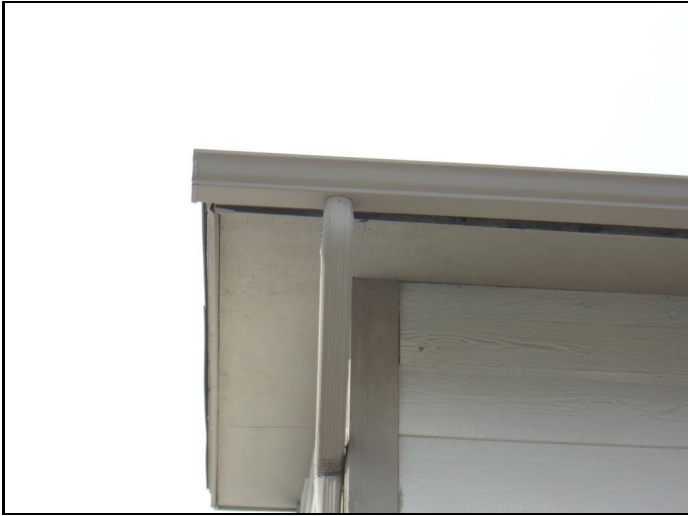
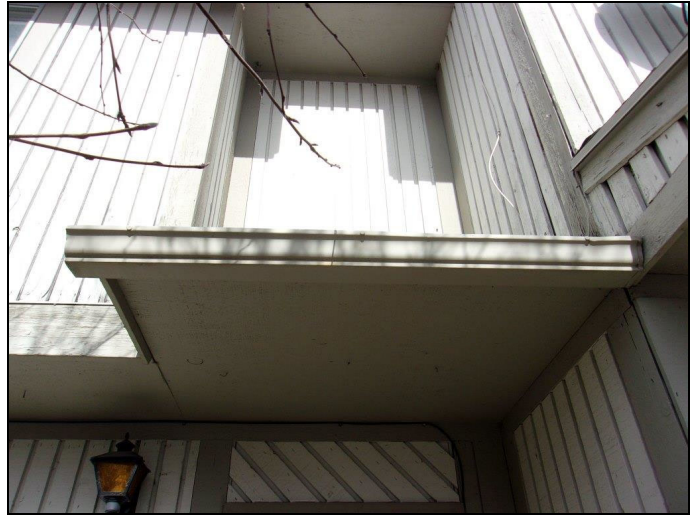
Comp #: 120 Rain Gutters/Downspouts - Replace

The rain gutters and downspouts are in good condition. We recommend funding to replace this component approximately every 25 - 30 years. Remaining life based on current age.

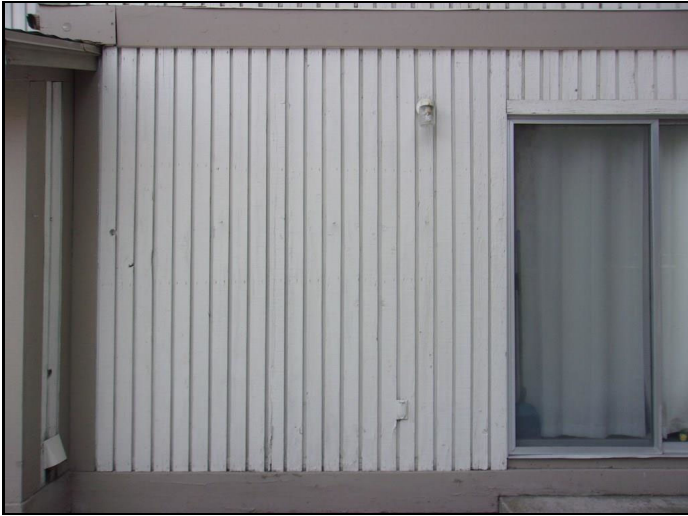
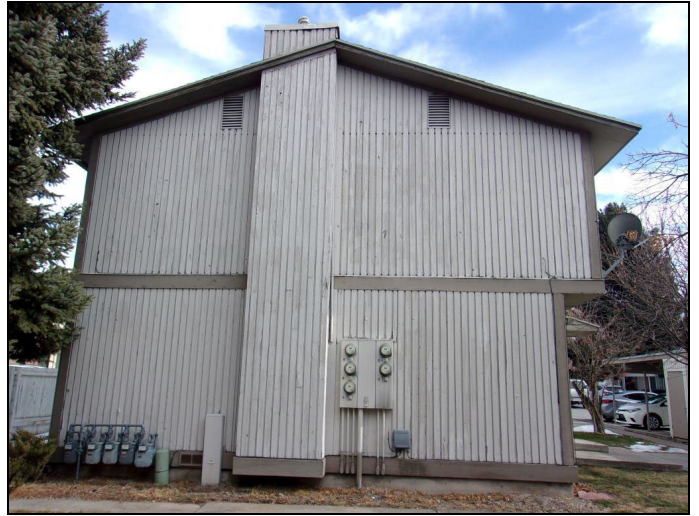
Comp #: 215 Siding - Repair/Repaint

The siding painted surfaces are in poor condition. We recommend funding to repair/repaint this component approximately every 6 - 8 years. Remaining life is based on current condition.

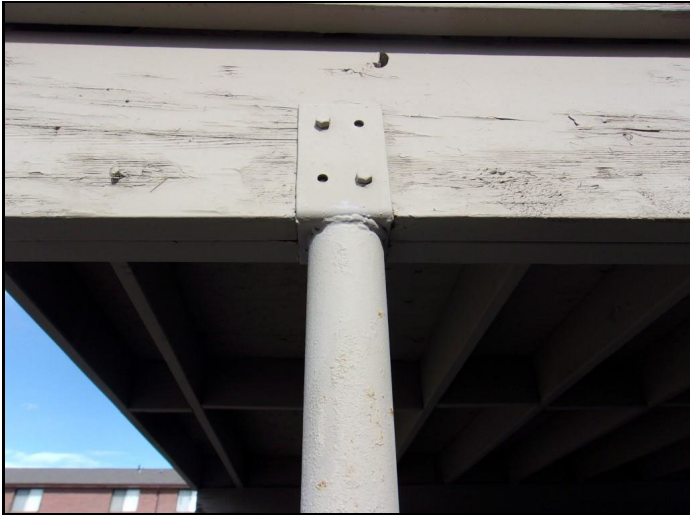
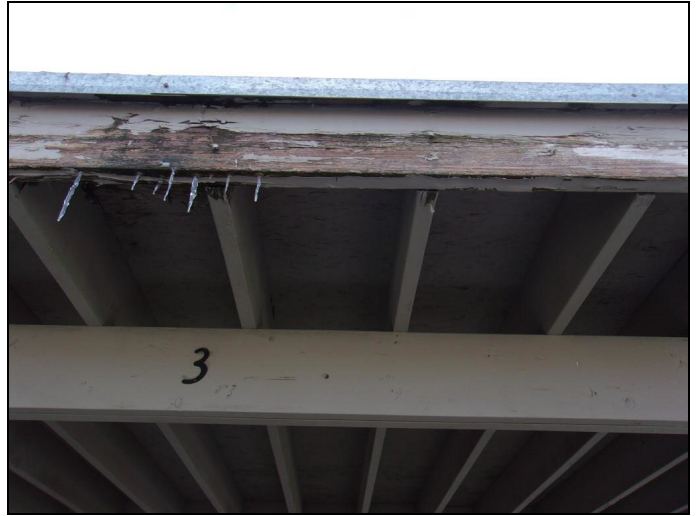
Comp #: 223 Carports - Repaint

The paint on the carport structure is in fair to poor condition. We recommend funding to repaint this component approximately every 8 - 10 years. Remaining life based on current condition.

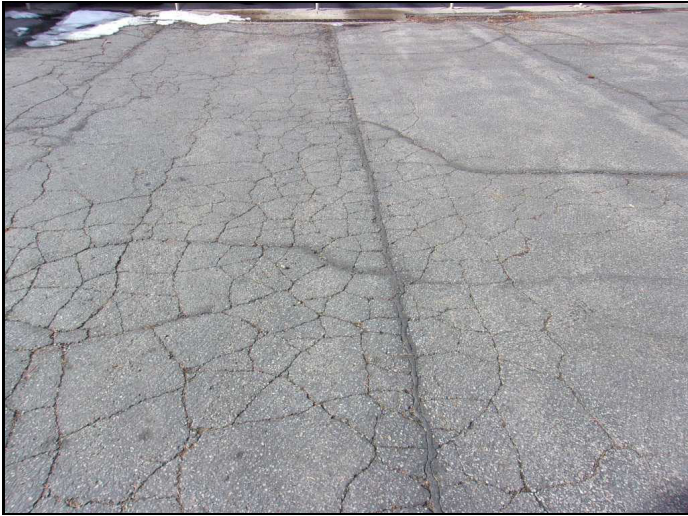
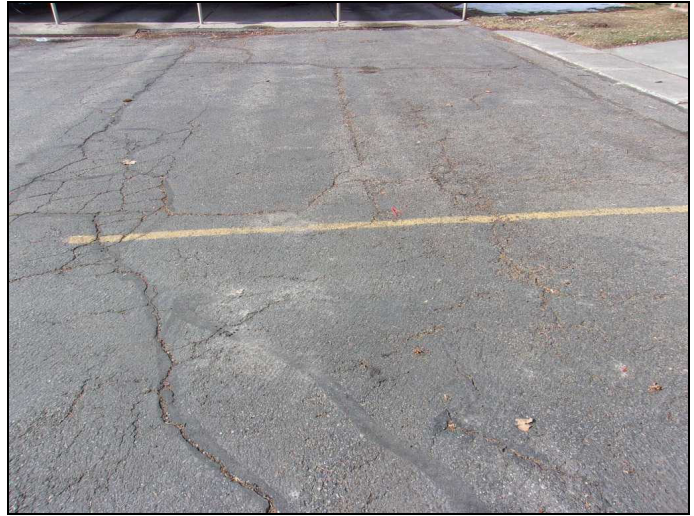
Comp #: 401 Asphalt - 1990's - Major Rehab

The asphalt surfaces are in fair to poor condition. This component is due for replacement in the near future. We recommend funding for a major rehab of this component approximately every 25 - 30 years. Remaining life based on current age.

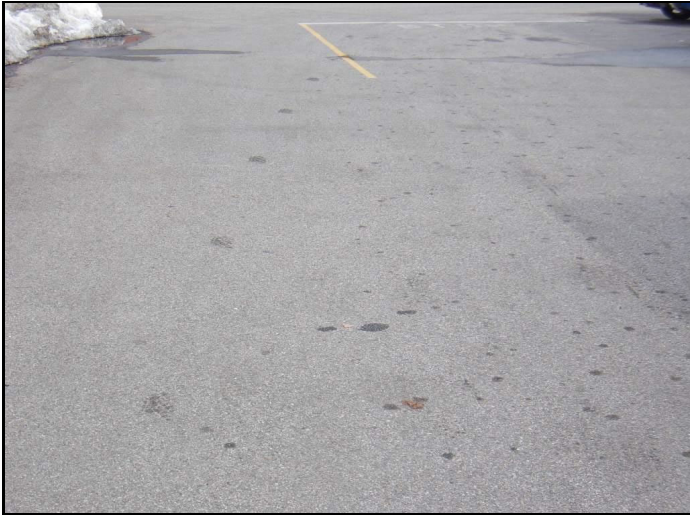
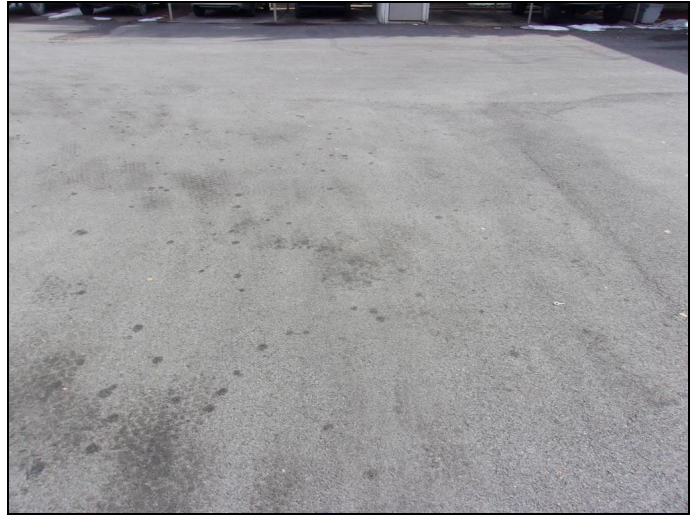
Comp #: 401 Asphalt - 2014 - Major Rehab

The asphalt surfaces are in good condition. We recommend funding for a major rehab of this component approximately every 25 - 30 years. Remaining life based on current age.

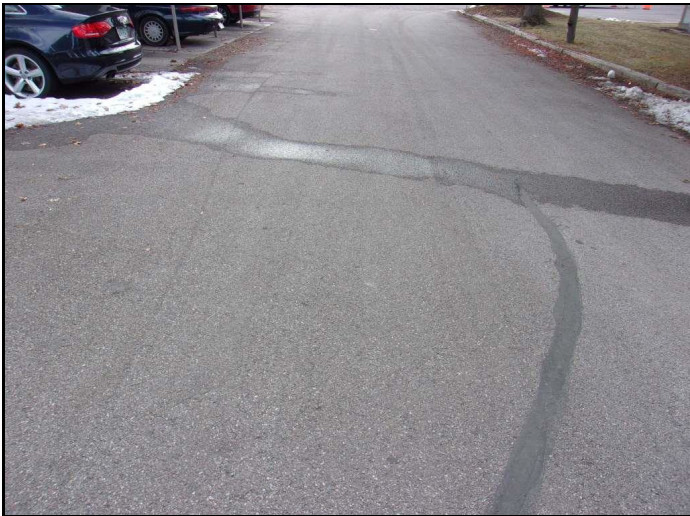
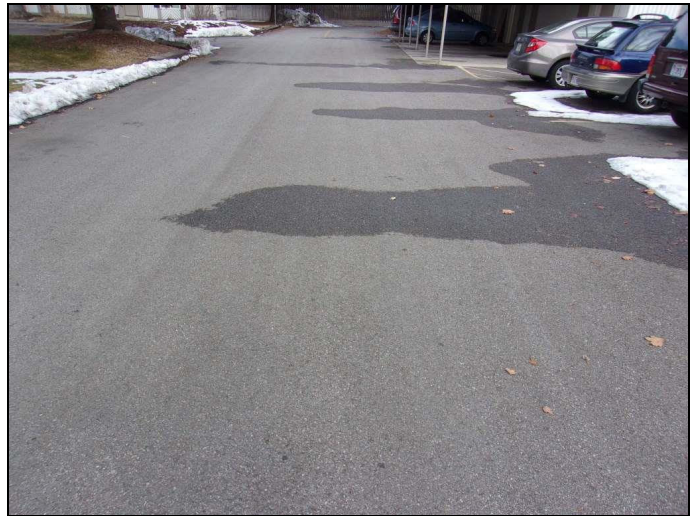
Comp #: 401 Asphalt - 2018 - Major Rehab

The asphalt surfaces are in good condition. We recommend funding for a major rehab of this component approximately every 25 - 30 years. Remaining life based on current age.

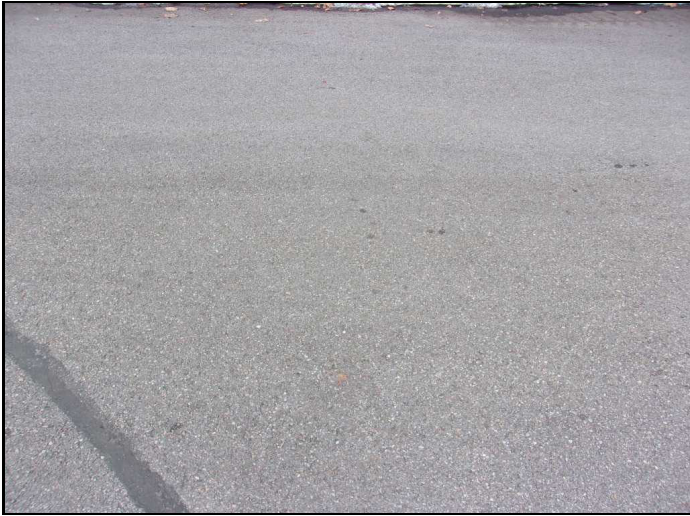
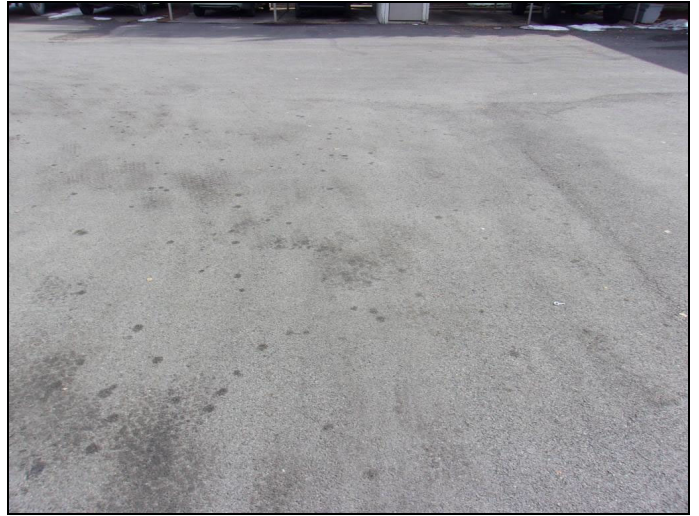
Comp #: 402 Asphalt - Seal Coat

The asphalt seal coat is in poor condition. We recommend funding to seal this component approximately every 3 - 5 years. Remaining life based on current condition.

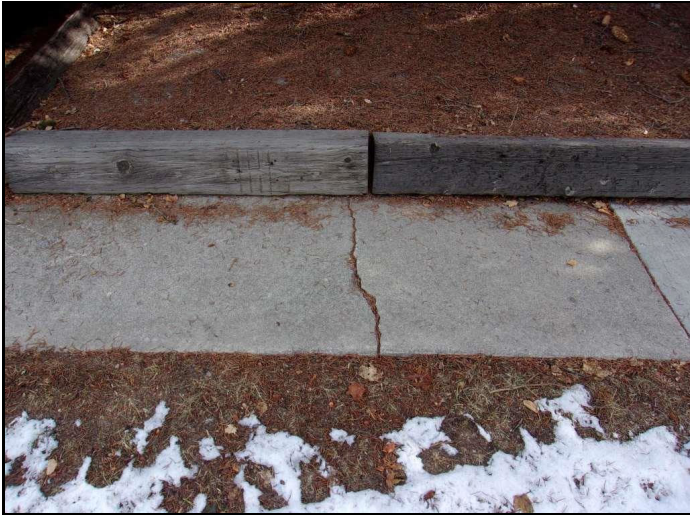
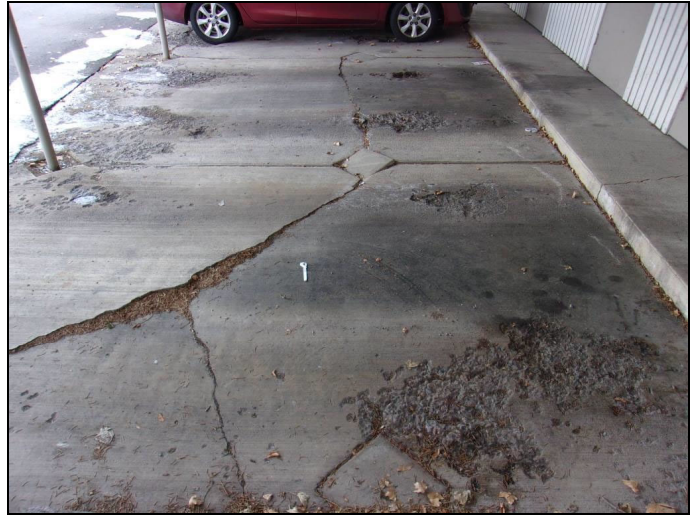
Comp #: 403 Concrete - Partial Repair/Replace

The concrete is in good to poor condition. This component has an extended useful life under normal conditions. We recommend funding to make repairs and partially replace this component approximately every 10 years. Remaining life based on current condition.

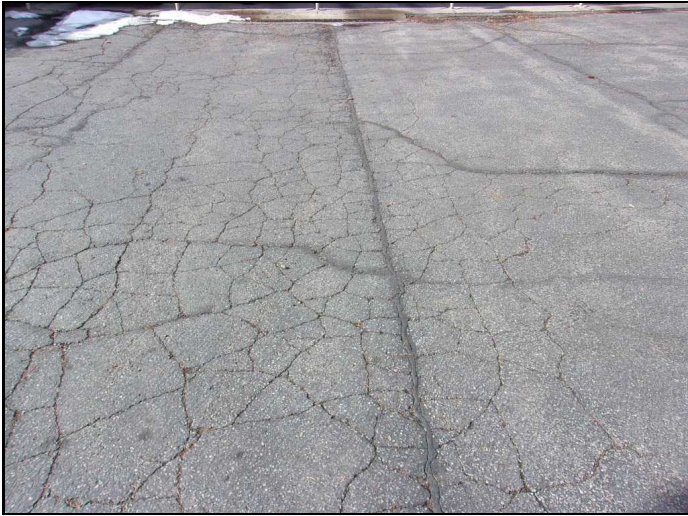
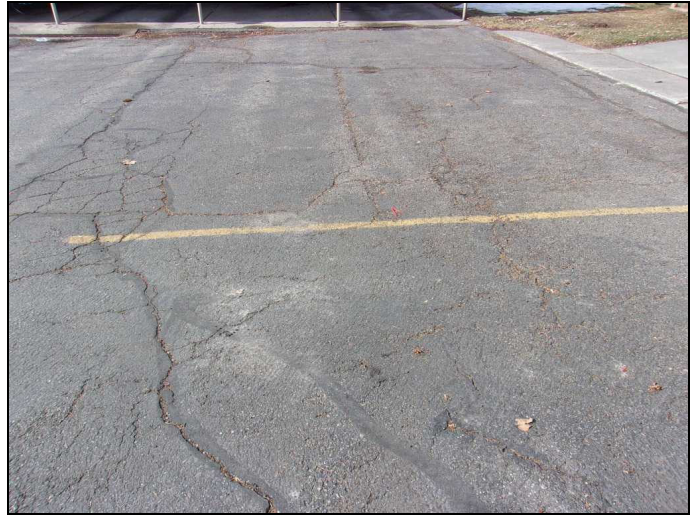
Comp #: 490 Asphalt - 1990's - Replace

The asphalt surfaces are in fair to poor condition. This component is due for replacement in the near future. This is a one-time project.

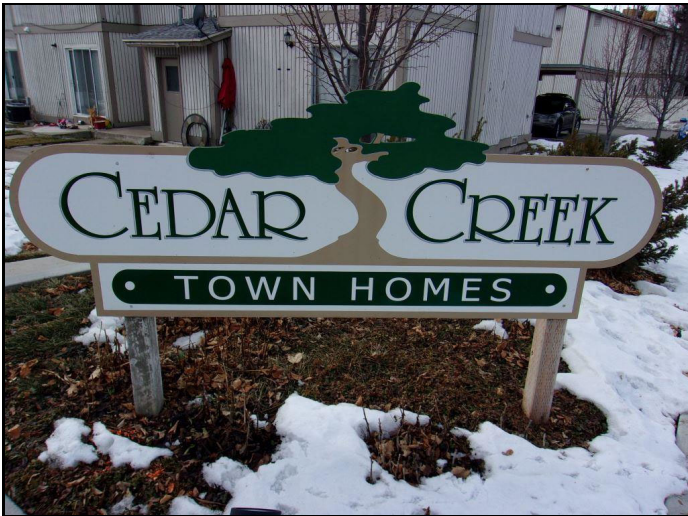
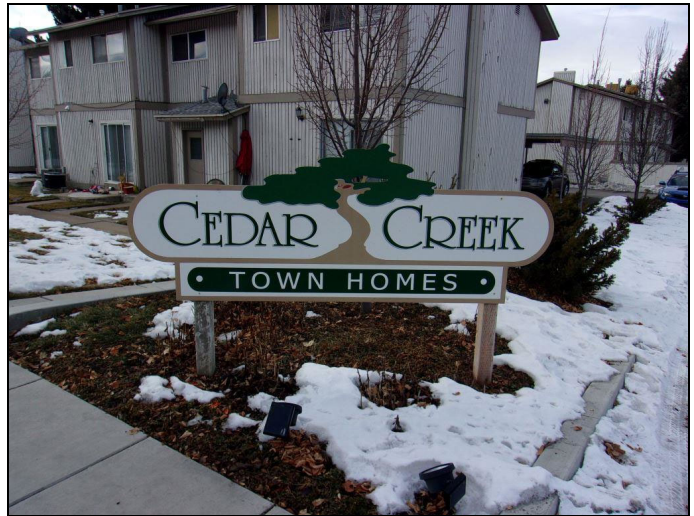
Comp #: 801 Community Sign - Replace

The community sign is in good condition. We recommend funding to refurbish this component approximately every 15 - 20 years. Remaining life is based on current age.

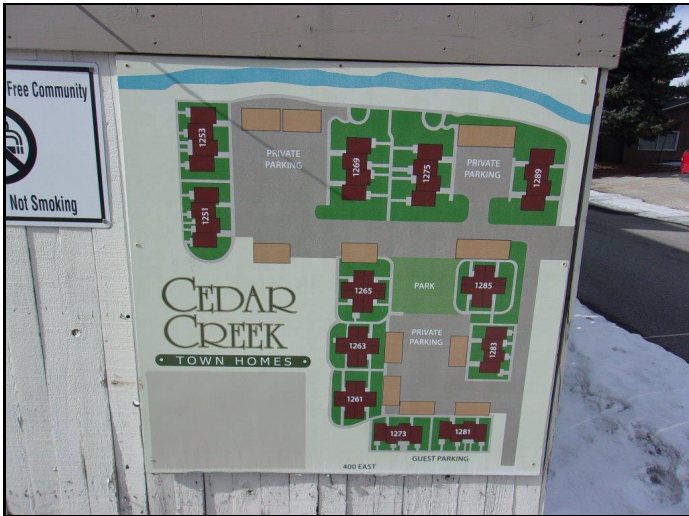
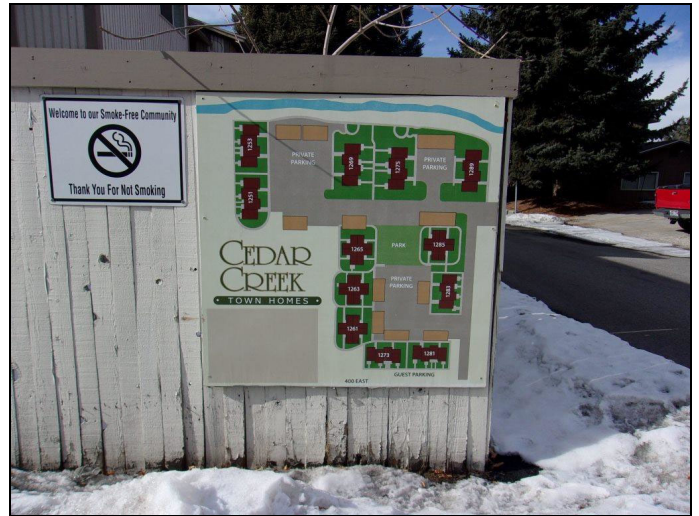
Comp #: 802 Community Map - Replace

Due to the minimal cost of this component, reserve funding is not appropriate. Replace as necessary as an operating expense.

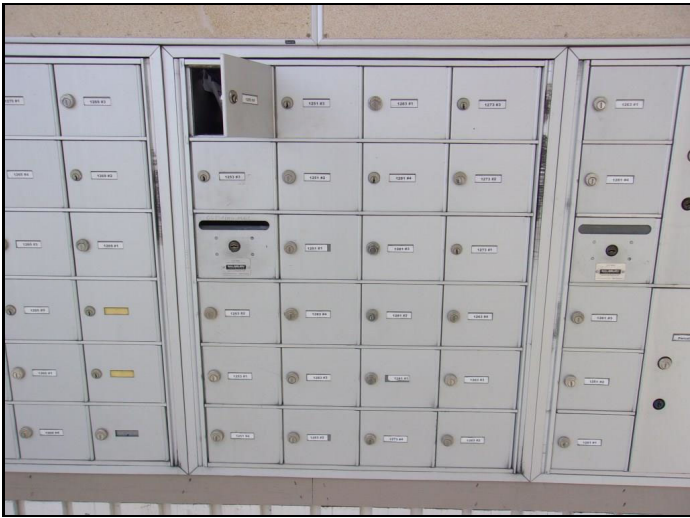
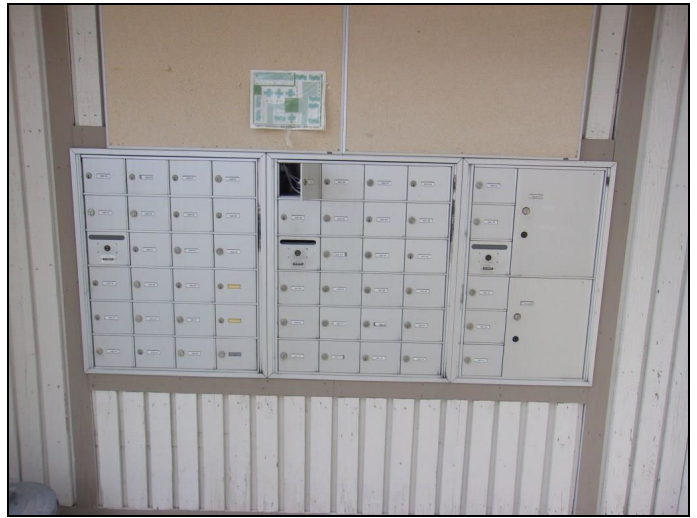
Comp #: 803 Mailboxes - Replace

The mailboxes are in fair condition. We recommend funding to replace this component approximately every 20 - 25 years. Remaining life based on current age.

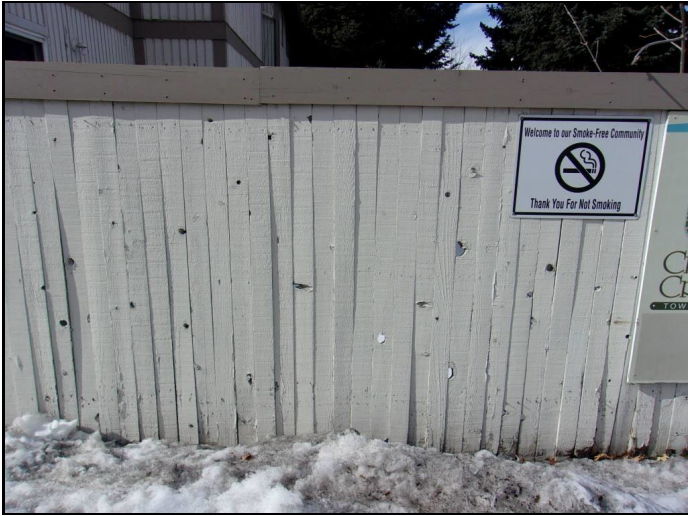
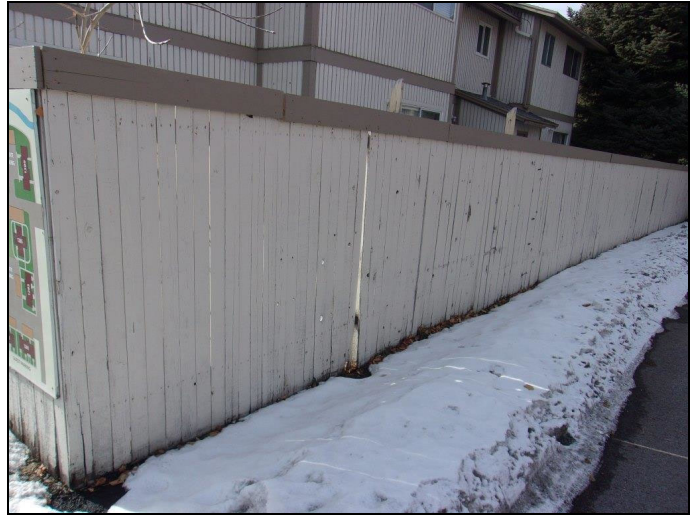
Comp #: 1001 Wood Fencing - Replace

The wood fencing is in fair to poor condition. We recommend funding to replace this component approximately every 25 - 30 years. Remaining life based on current condition.

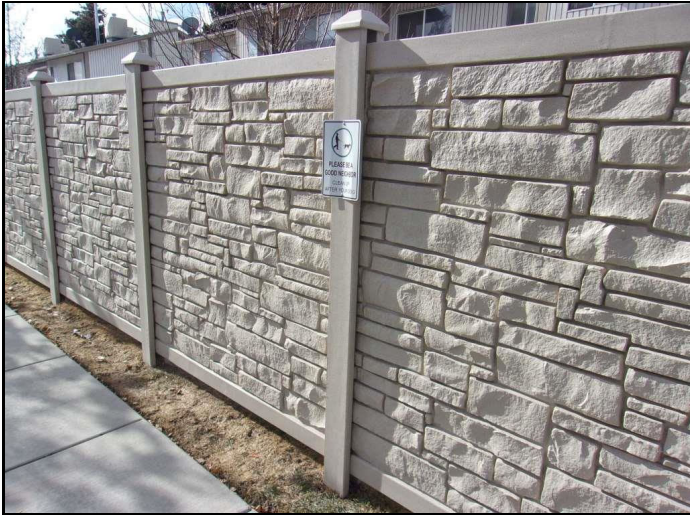
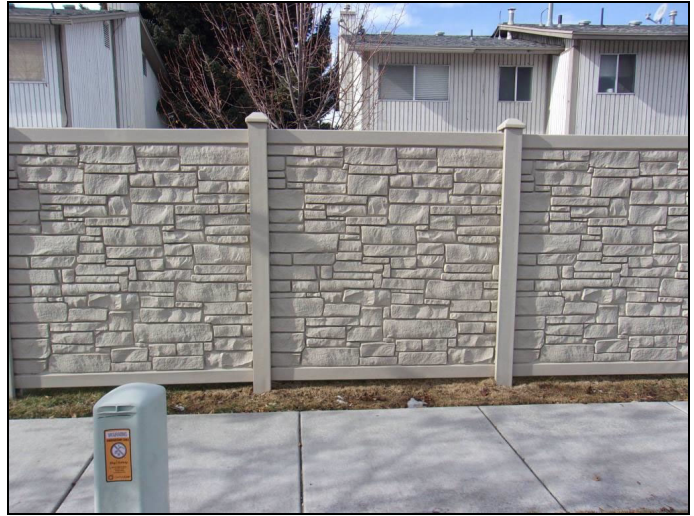
Comp #: 1008 SimTek Fencing - Replace

The SimTek fencing is in good condition. We recommend funding to replace this component approximately every 40 - 50 years. Remaining life based on current age.

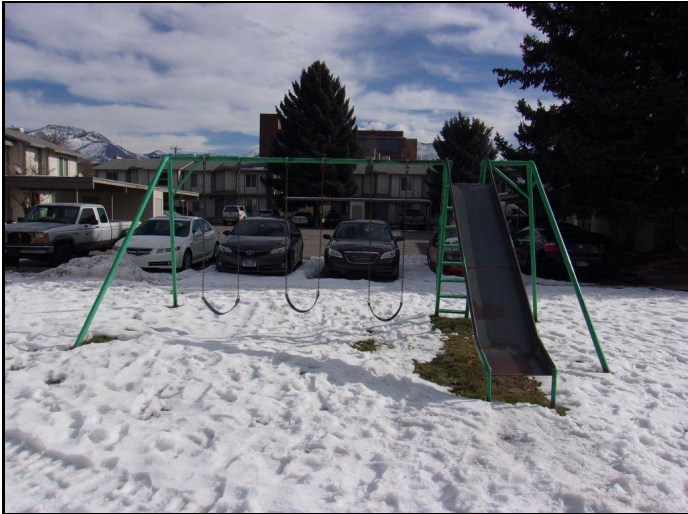
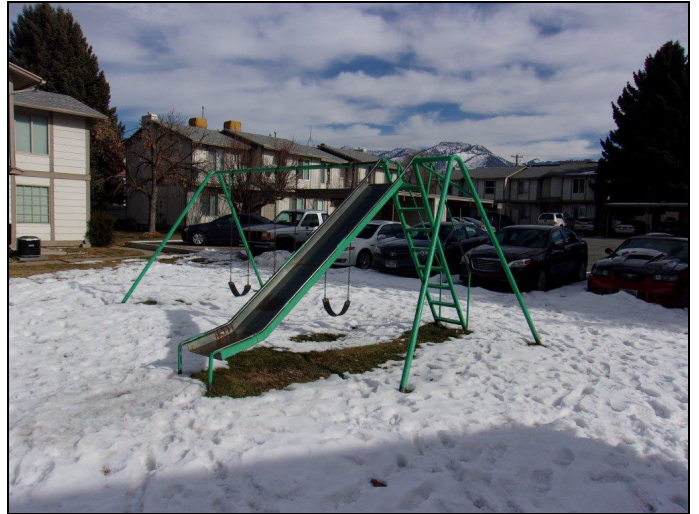
Comp #: 1301 Play Structure - Replace

The play structure is in fair condition. We recommend funding to replace this component approximately every 30 - 40 years. Remaining life based on current age.

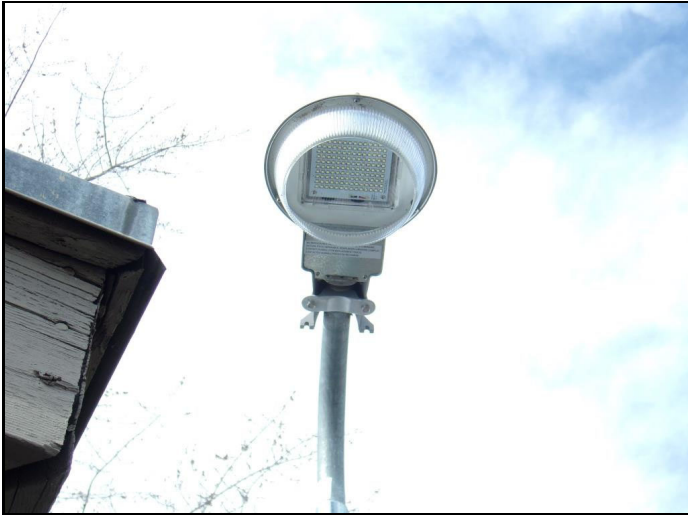
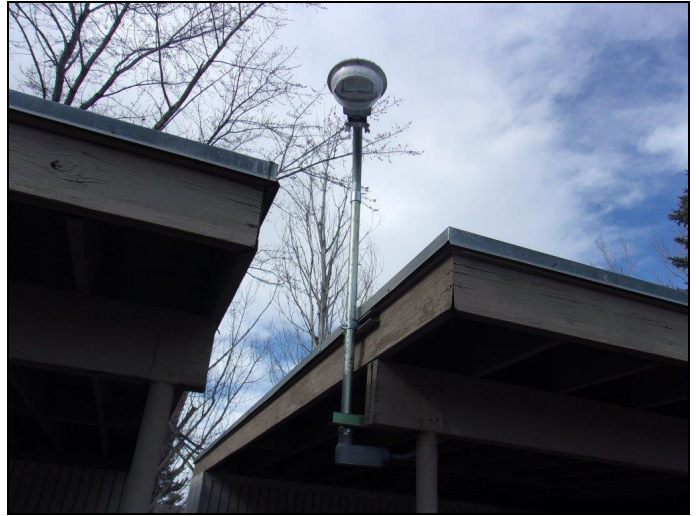
Comp #: 1609 Street Light Fixtures - New - Replace

The street light fixtures are in good condition. No expectation to replace the light poles. Paint poles as necessary as an operating expense. We recommend funding to replace this component approximately every 20 years. Remaining life based on current age.

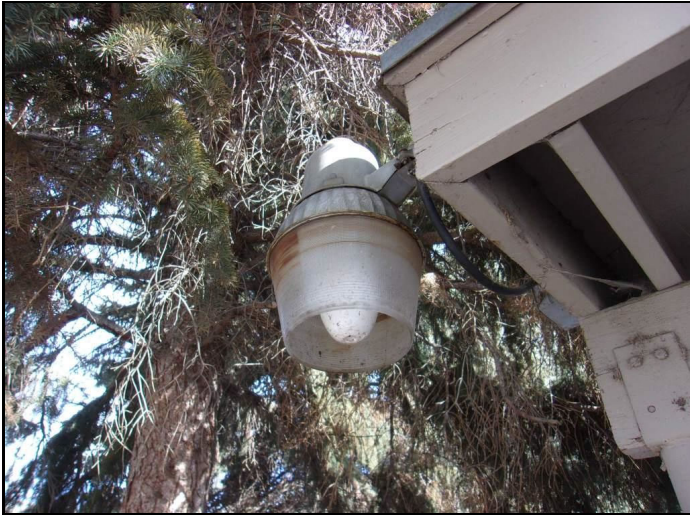
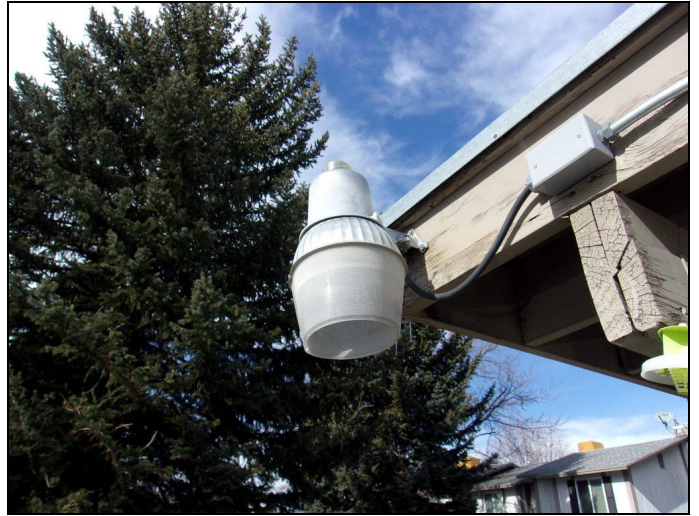
Comp #: 1609 Street Light Fixtures - Old - Replace

The street light fixtures are in fair condition. No expectation to replace the light poles. Paint poles as necessary as an operating expense. We recommend funding to replace this component approximately every 20 years. Remaining life based on current age and condition.

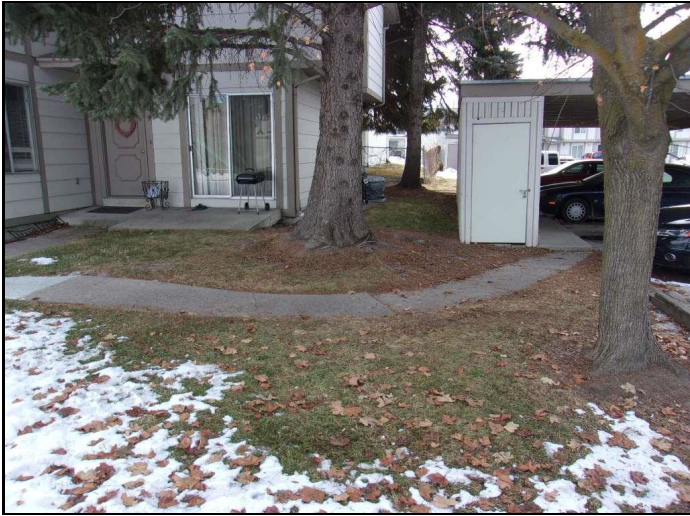
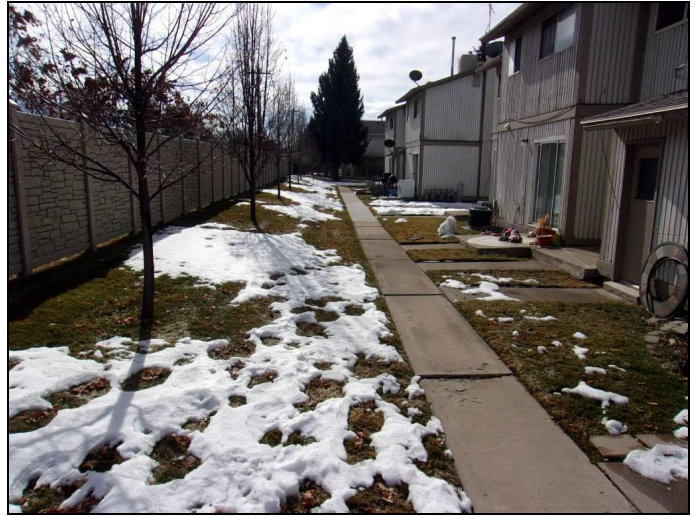
Comp #: 1812 Landscaping & Irrigation System - Renovate

The landscaping and irrigation system are in good to fair condition. We recommend funding for an allowance to renovate the landscaping and irrigation system approximately every 20 years. Remaining life based on current age.
