Highland Estates

Level 1 Reserve Study

Report Period – 01/01/2021 – 12/31/2021

Executive Summary – Highland Estates - ID # 18790

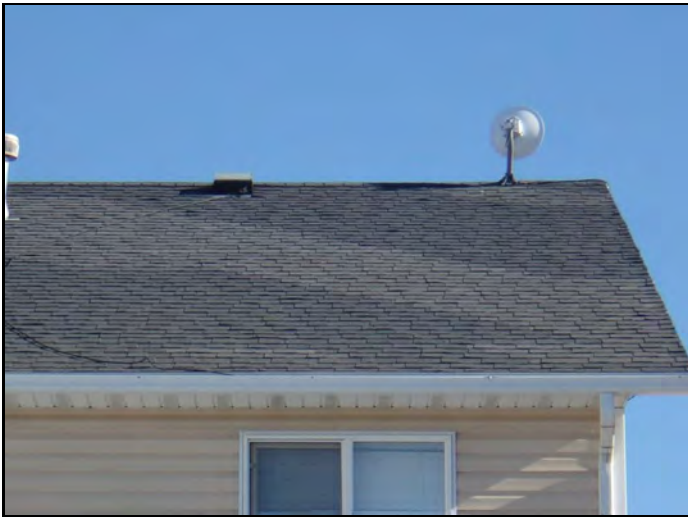
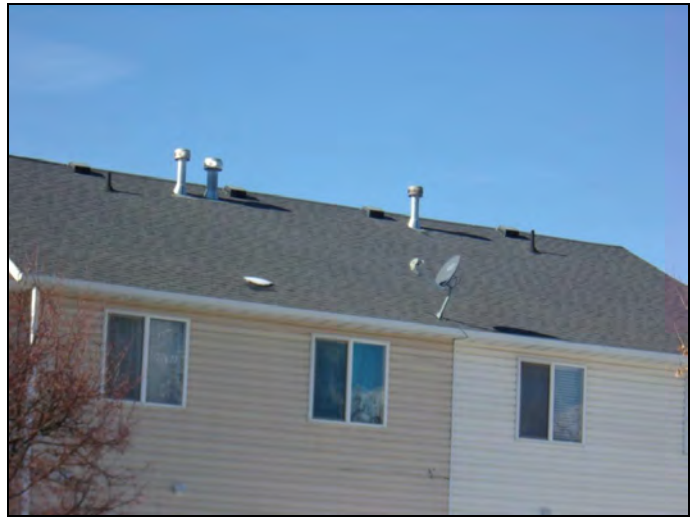
Comp #: 105 Roofs - Replace

Location: **Building Roofs**

Research with the client reveals this component will be replaced 2021 with funds from an insurance claim. We recommend funding to replace this component approximately every 20 - 25 years. Remaining life based on current age

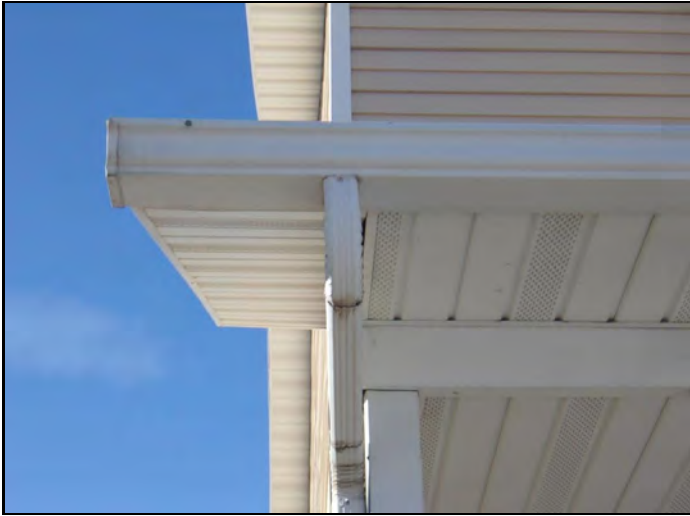
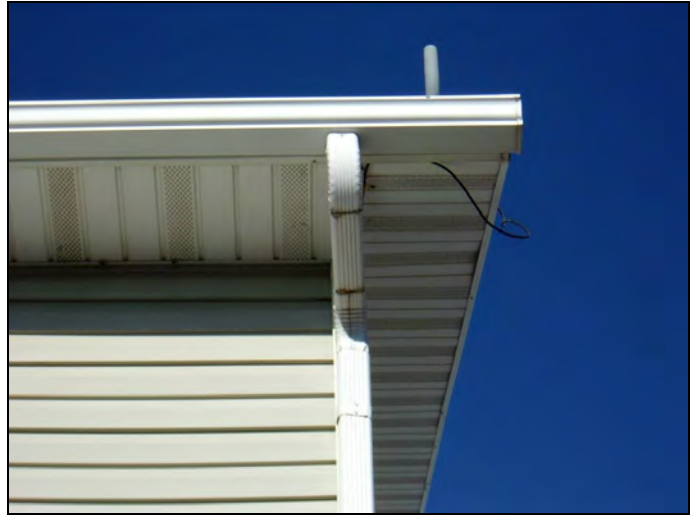
Comp #: 120 Rain Gutters/Downspouts - Replace

Location: **Building Exteriors**

The rain gutters and downspouts are in fair condition. We recommend funding to replace this component approximately every 25 - 30 years. Remaining life based on current age.

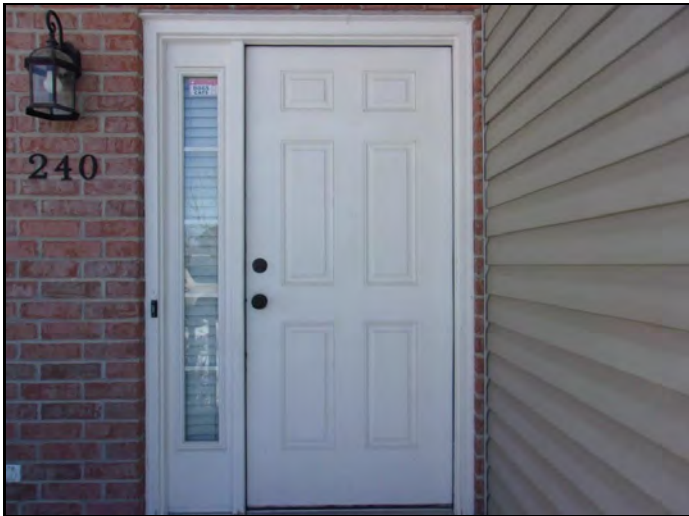
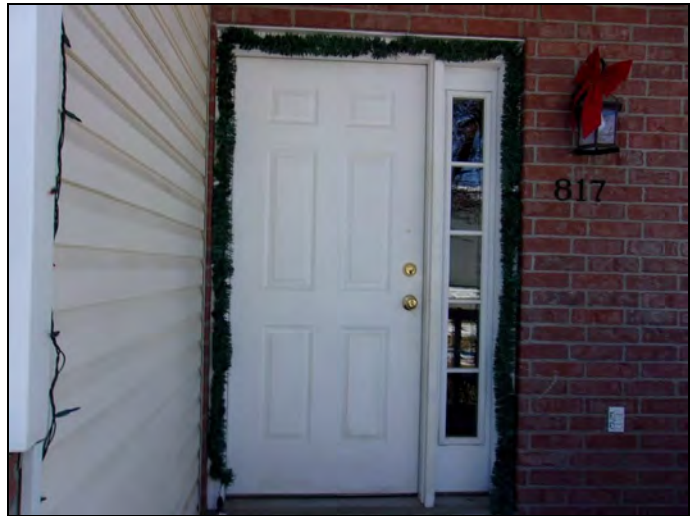
Comp #: 204 Front Doors - Repaint

Location: **Unit Entrances**

The painted door surfaces are in fair to poor condition. We recommend funding to repaint this component approximately every 6 - 8 years. Remaining life based on current age.

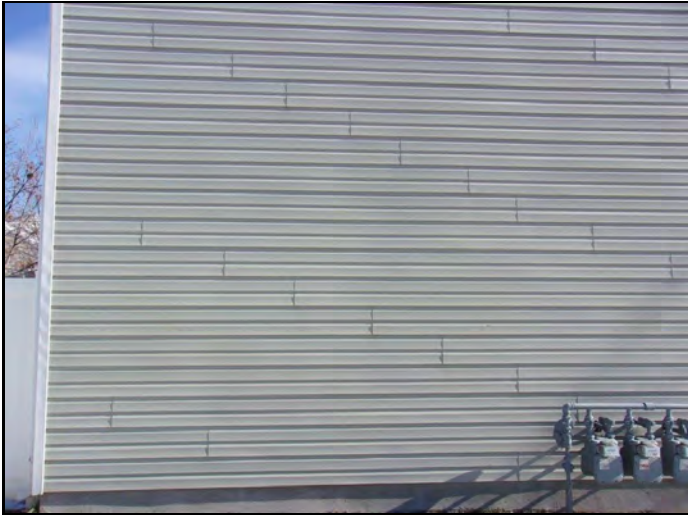
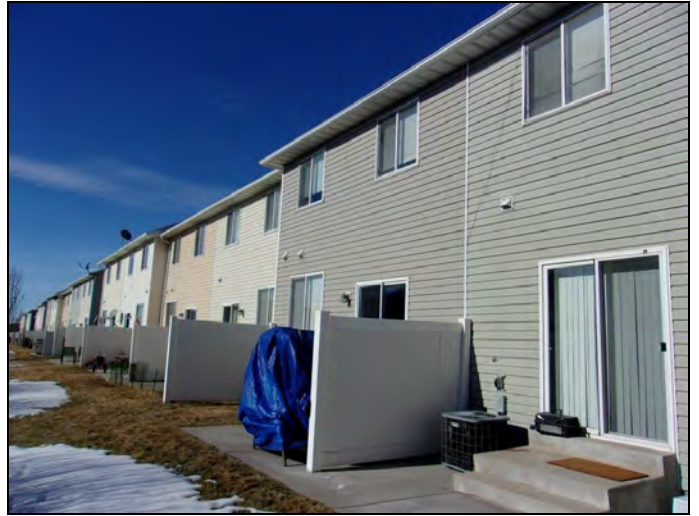
Comp #: 302 Vinyl Siding - Replace

Location: **Building Exteriors**

The vinyl siding is in good condition. We recommend funding to replace this component approximately every 40 - 50 years. Remaining life based on current age.

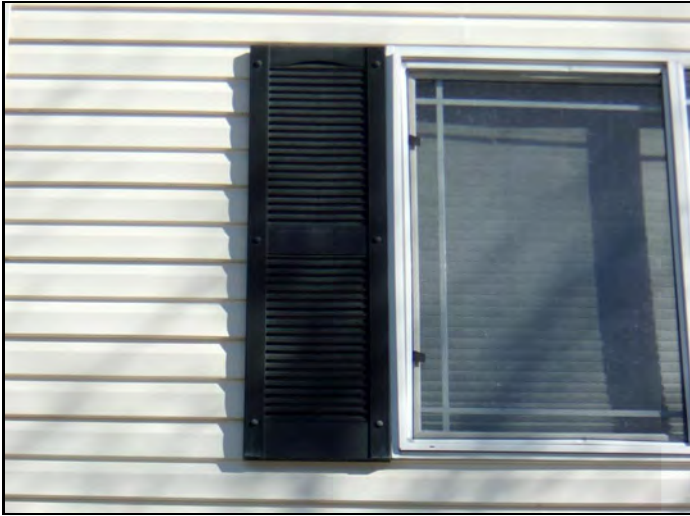
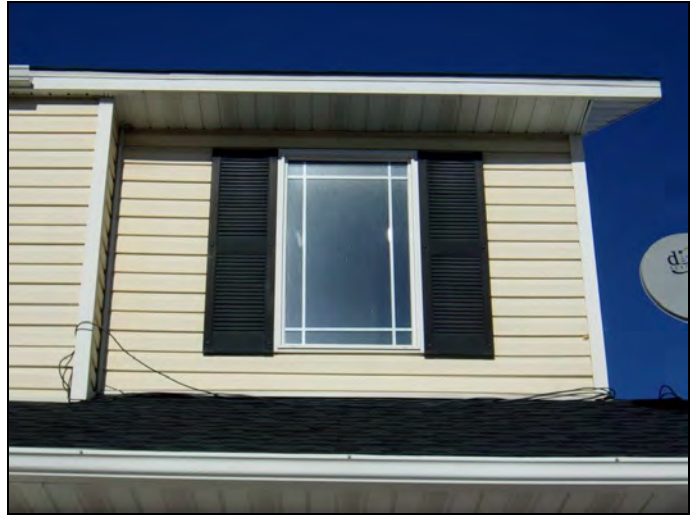
Comp #: 390 Vinyl Shutters - Replace

Location: **Building Exteriors**

The vinyl shutters are in fair condition. We recommend funding to replace this component approximately every 30 - 40 years. Remaining life based on current age.

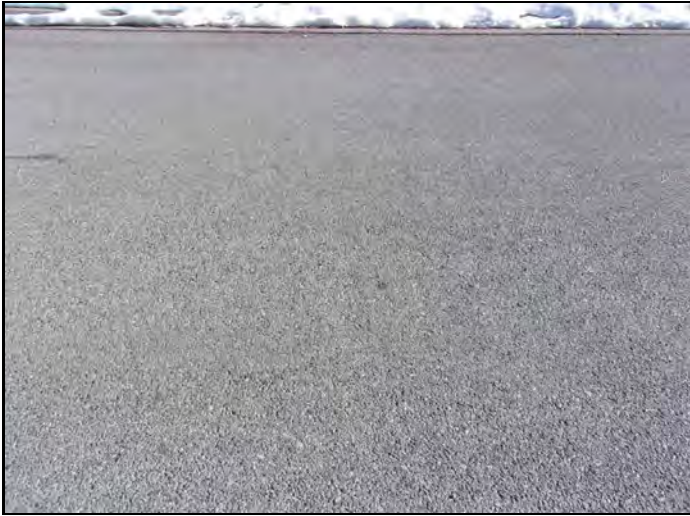
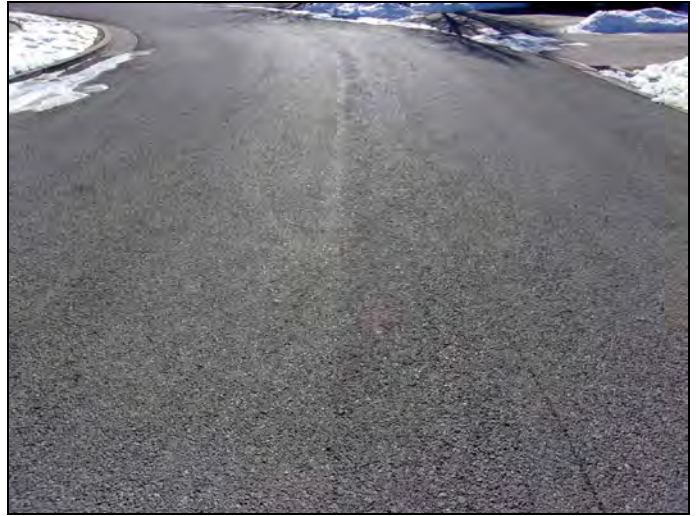
Comp #: 401 Asphalt - Major Rehab

Location: **Community Streets**

The asphalt surfaces are in good to fair condition. We recommend funding for a major rehab of this component approximately every 25 - 30 years. Remaining life based on current age.

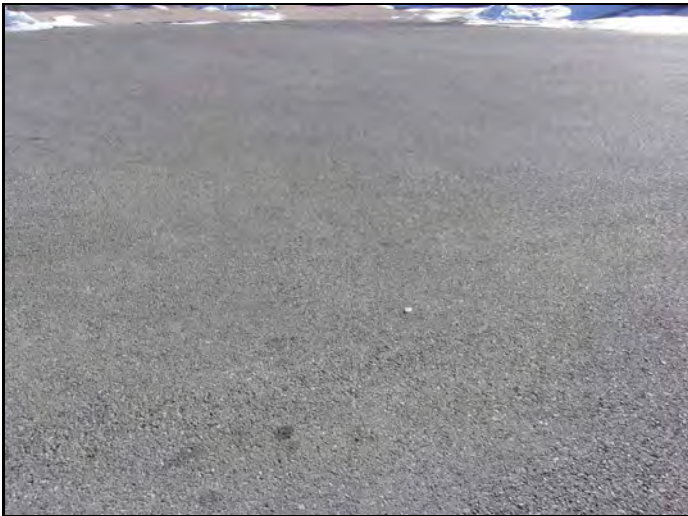
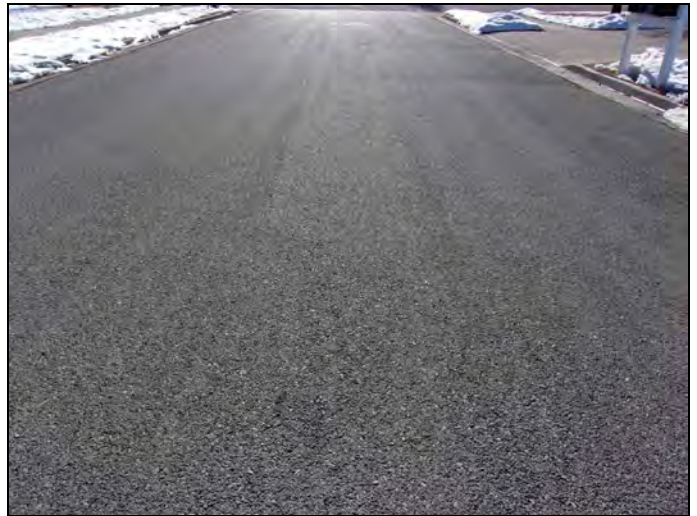
Comp #: 402 Asphalt - Seal Coat

Location: **Community Streets**

The asphalt seal coat is in poor condition. We recommend funding to seal this component approximately every 3 - 5 years. Remaining life based on current condition.

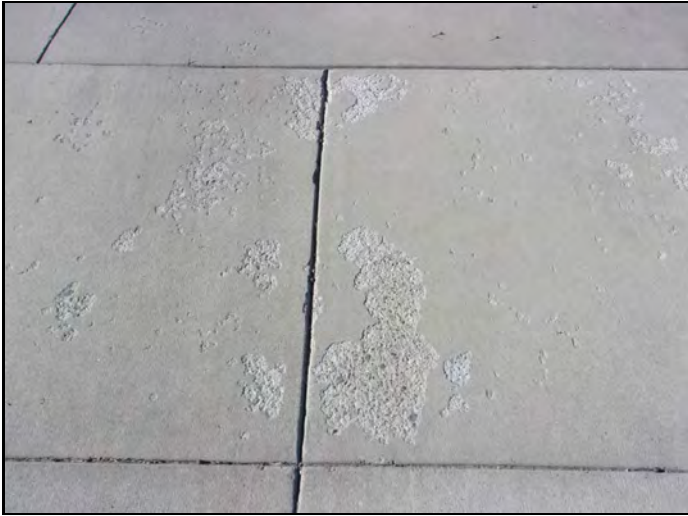
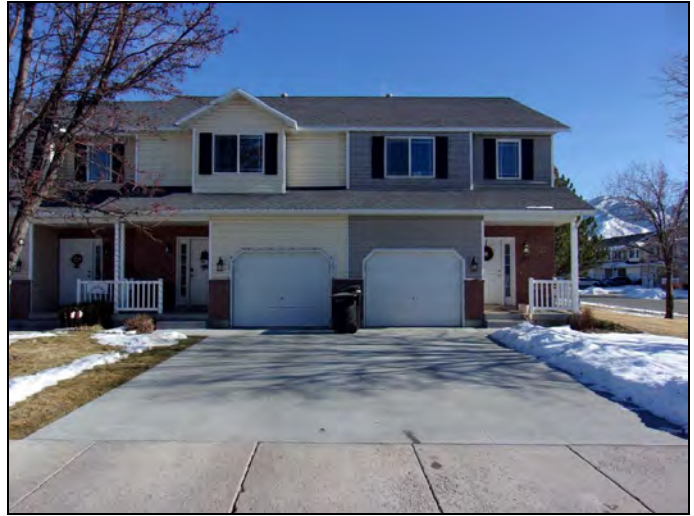
Comp #: 403 Concrete - Partial Repair/Replace

Location: **Curb/Gutter, Driveways, & Sidewalks**

Research with the client reveals they have lifting and crack fill to perform in the next few years. This component has an extended useful life under normal conditions. We recommend funding to make repairs and partially replace this component approximately every 10 years. Remaining life based on current age.

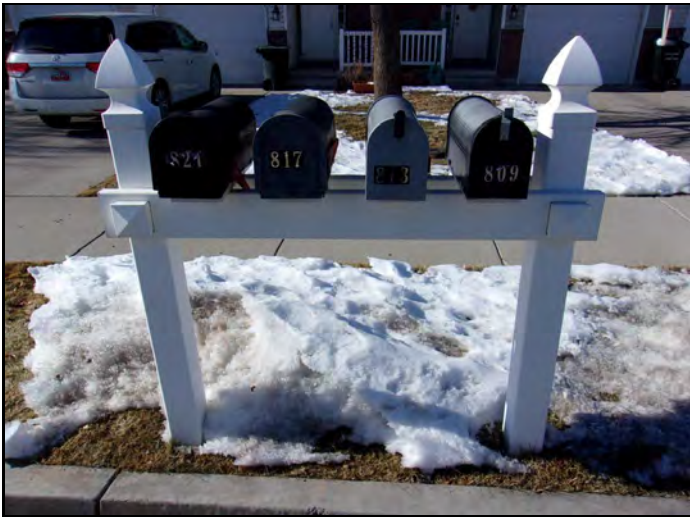
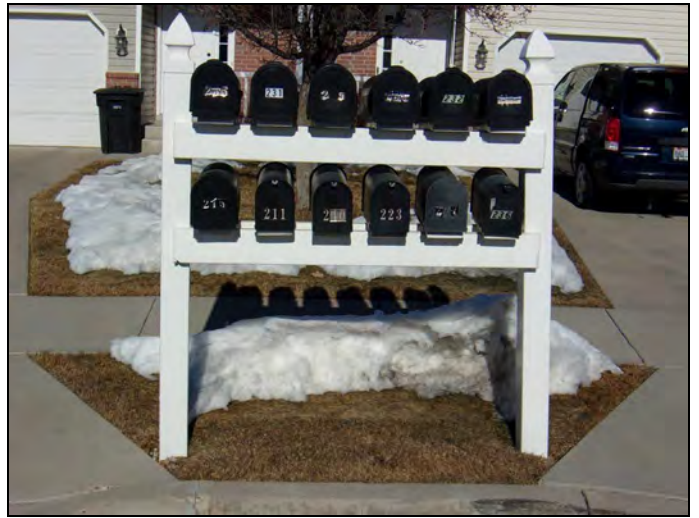
Comp #: 803 Mailboxes - Replace

Location: **Common Area**

Due to the minimal cost of replacing this component, reserve funding is not appropriate. Replace as necessary as an operating expense.

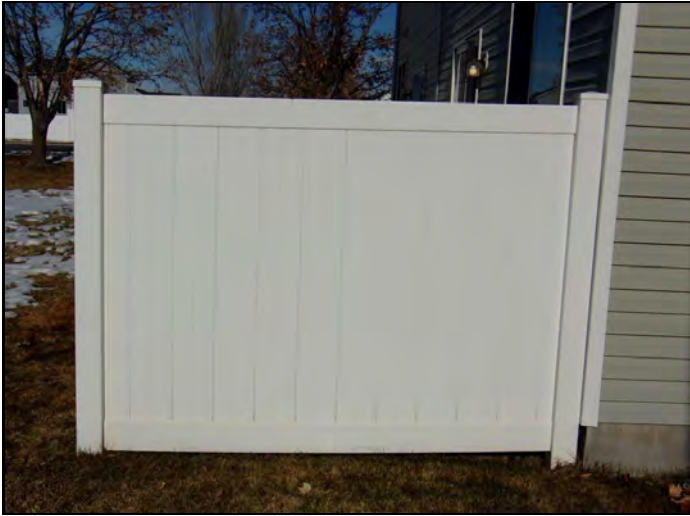
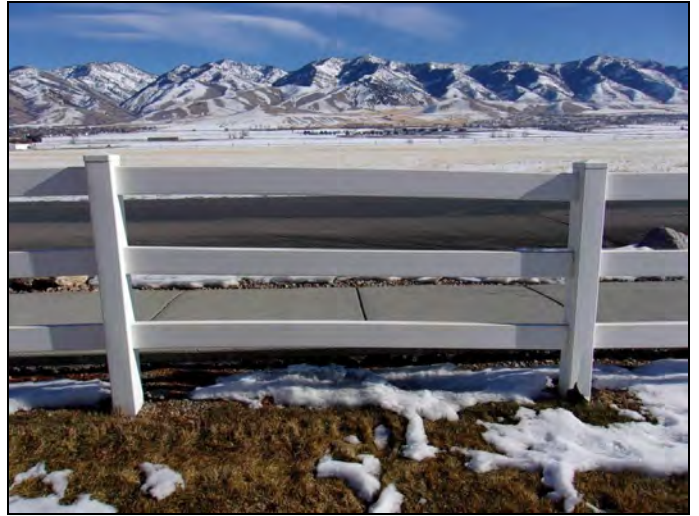
Comp #: 1008 Vinyl Fencing - Replace

Location: **Front Porch, Patio, & Perimeter**

The vinyl fencing is in good condition. We recommend funding to replace this component approximately every 25 - 30 years. Remaining life based on current age.

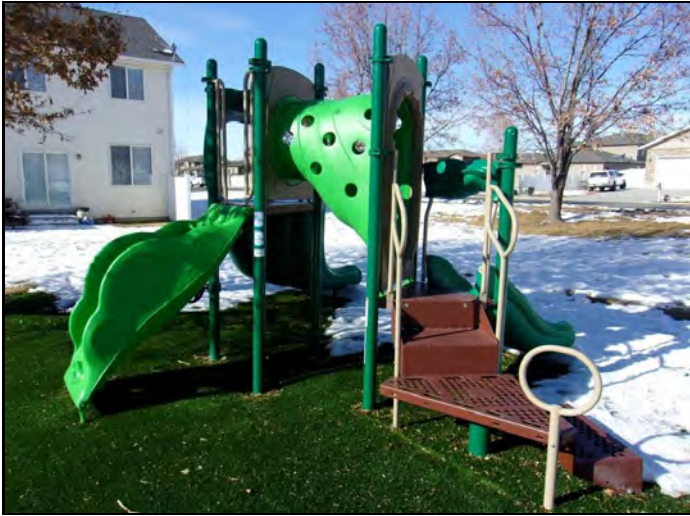
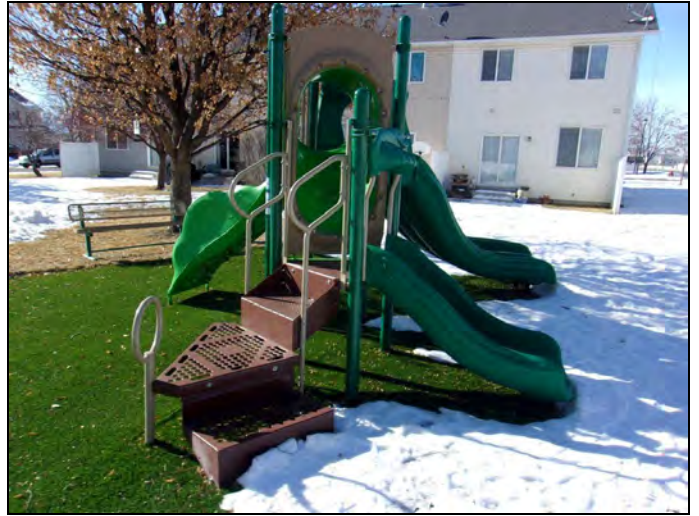
Comp #: 1301 Play Structure - Replace

Location: **Play Area**

The play structure is in good condition. We recommend funding to replace this component approximately every 20 - 25 years. Remaining life based on current age.

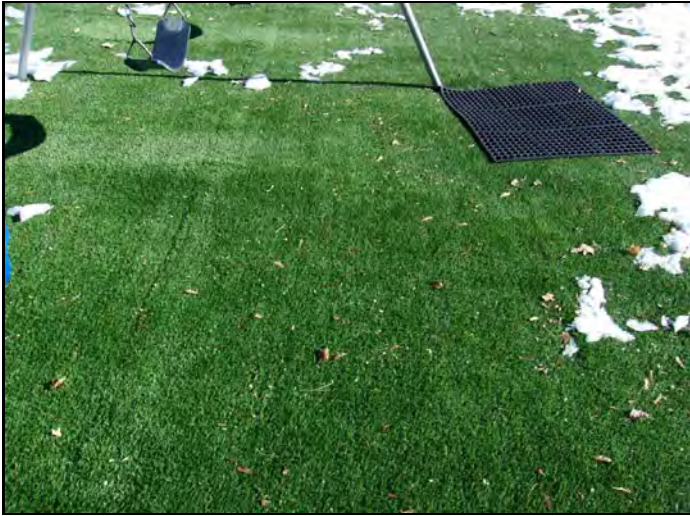
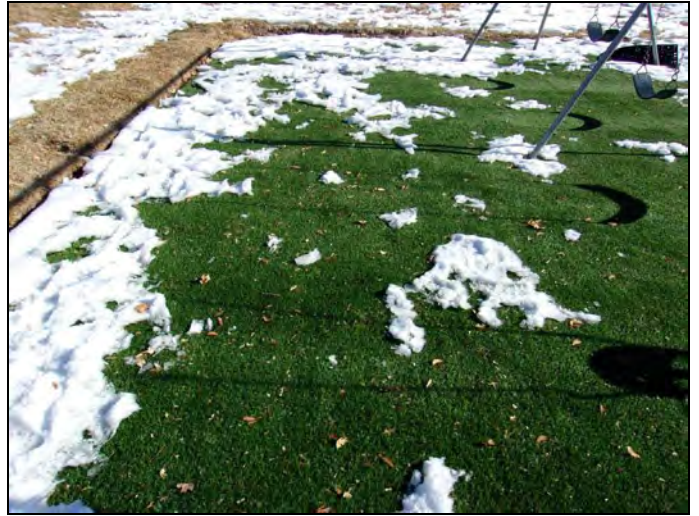
Comp #: 1303 Play Area Groundcover - Replace

Location: **Play Area**

The play area groundcover is in good condition. We recommend funding to replace this component approximately every 15 - 20 years. Remaining life is based on current age.

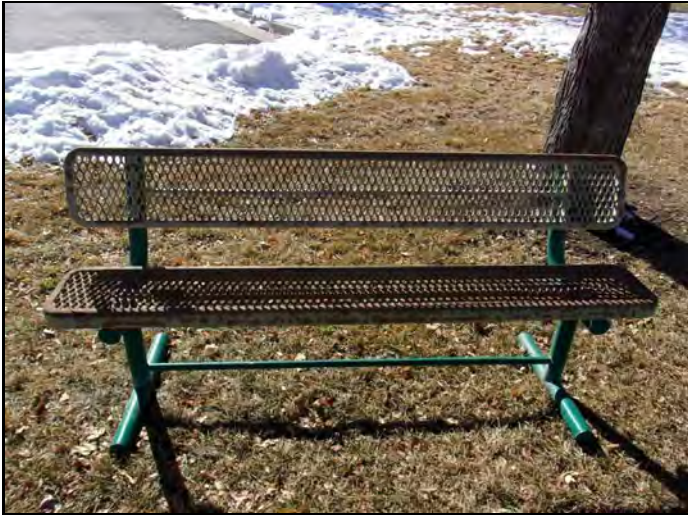
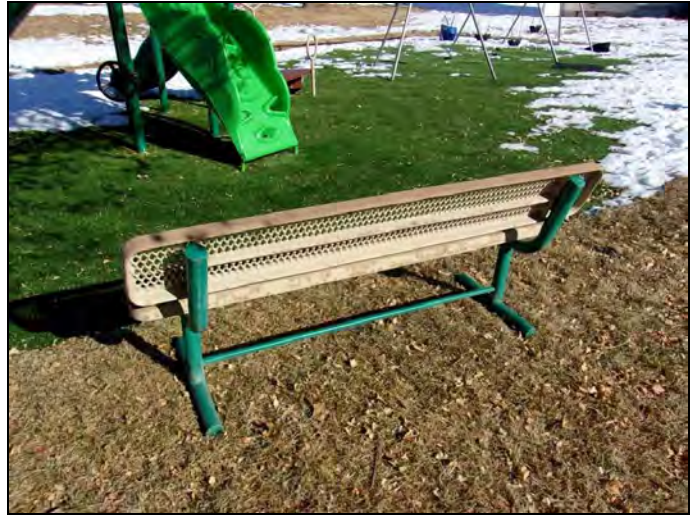
Comp #: 1307 Bench - Replace

Location: **Play Area**

Due to the minimal cost of replacing this component, reserve funding is not appropriate. Replace as necessary as an operating expense.

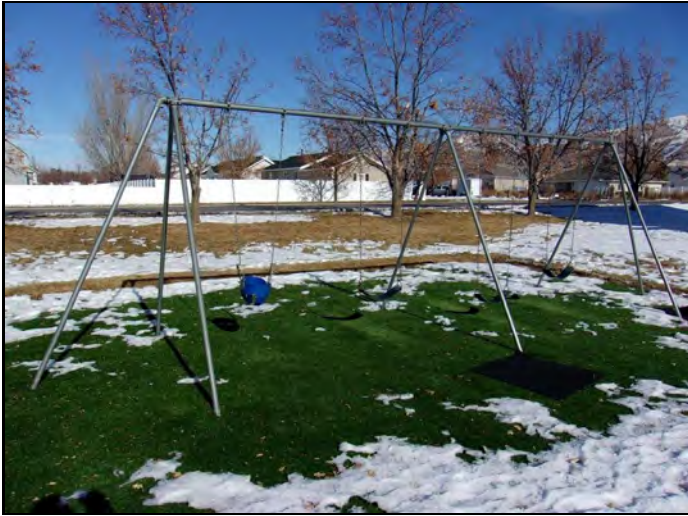
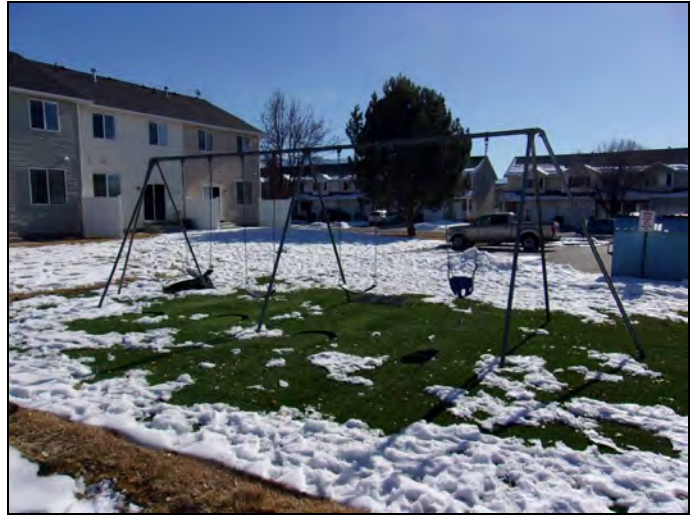
Comp #: 1390 Swing Set - Replace

Location: **Play Area**

The swing set is in fair condition. We recommend funding to replace this component approximately every 30 - 40 years. Remaining life based on current age.

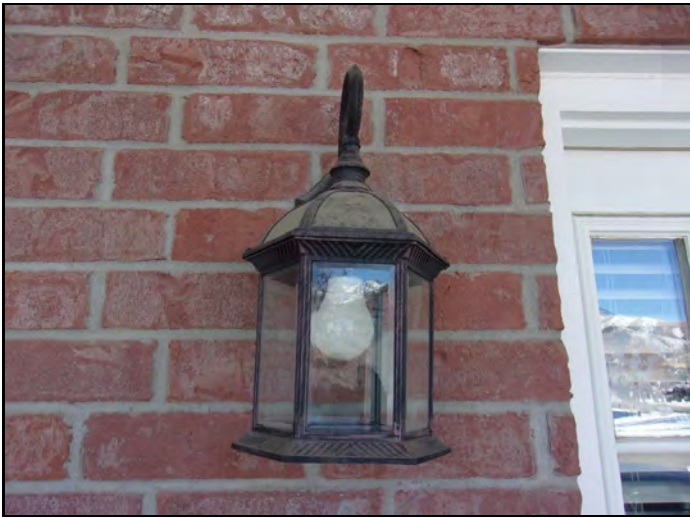
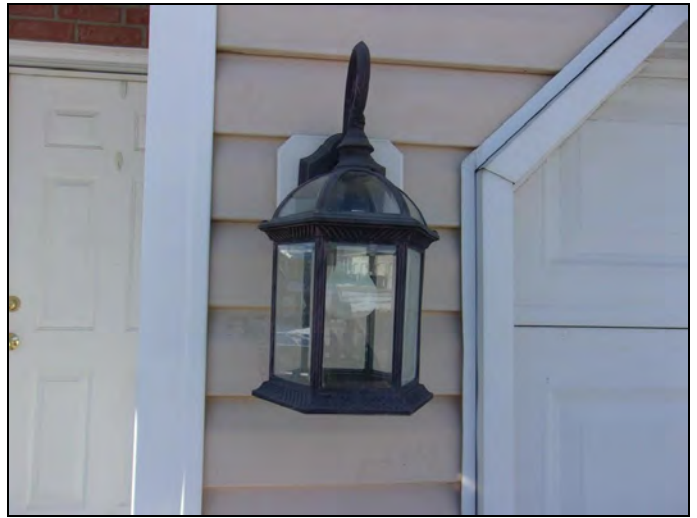
Comp #: 1602 Exterior Light Fixtures - Front - Replace

Location: **Building Exteriors**

The exterior light fixtures are in good condition. We recommend funding to replace this component approximately every 16 - 20 years. Remaining life based on current age.

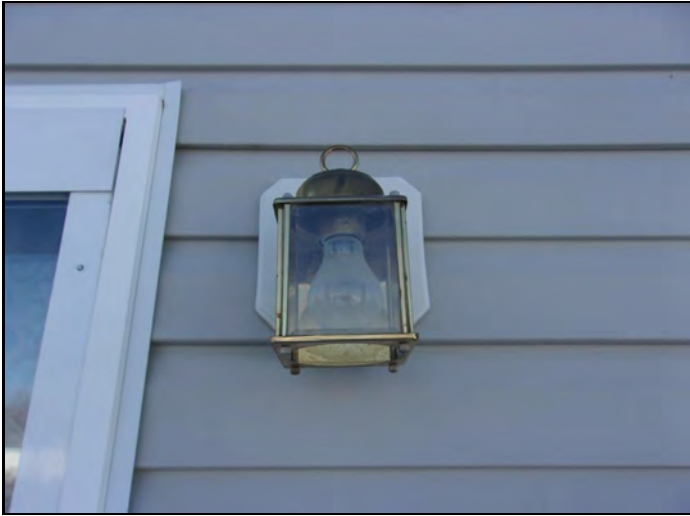
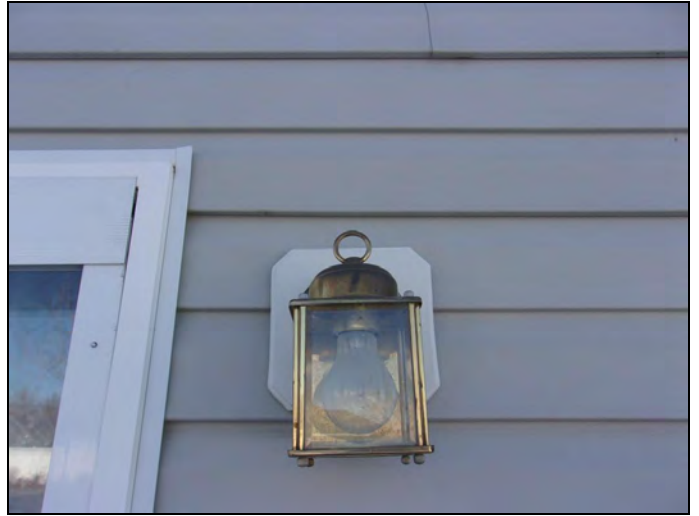
Comp #: 1602 Exterior Light Fixtures - Rear - Replace

Location: **Building Exteriors**

The exterior light fixtures are in fair to poor condition. We recommend funding to replace this component approximately every 16 - 20 years. Remaining life based on current age and condition.

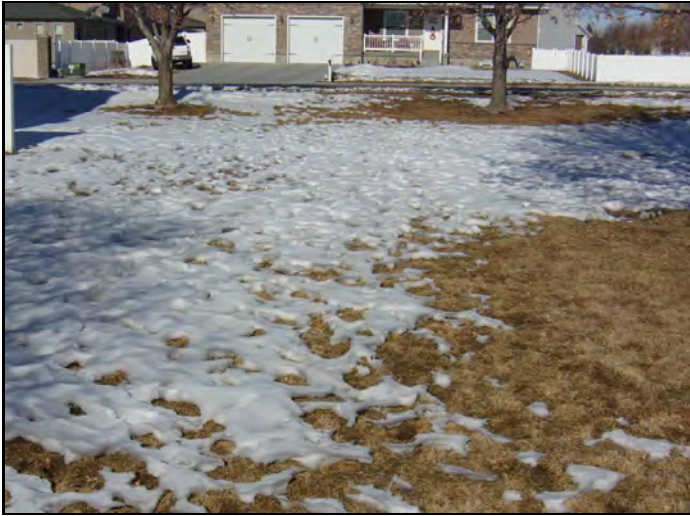
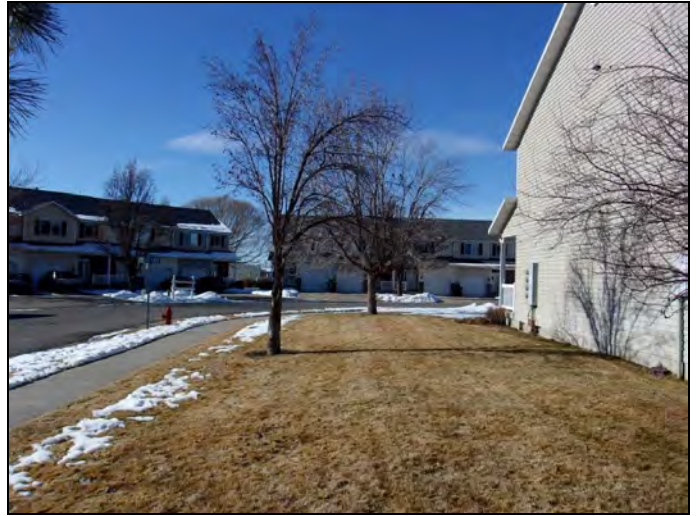
Comp #: 1812 Landscaping & Irrigation System - Renovate

Location: **Common Area**

The landscaping and irrigation system are in good to fair condition. We recommend funding for an allowance to renovate the landscaping and irrigation system approximately every 20 years. Remaining life based on current age and condition.
