North Logan Village

Level 1 Reserve Study

Report Period – 01/01/2024 – 12/31/2024

Client Reference Number	19054
Property Type	Mixed Use
Number of Units	61
Fiscal Year End	12/31

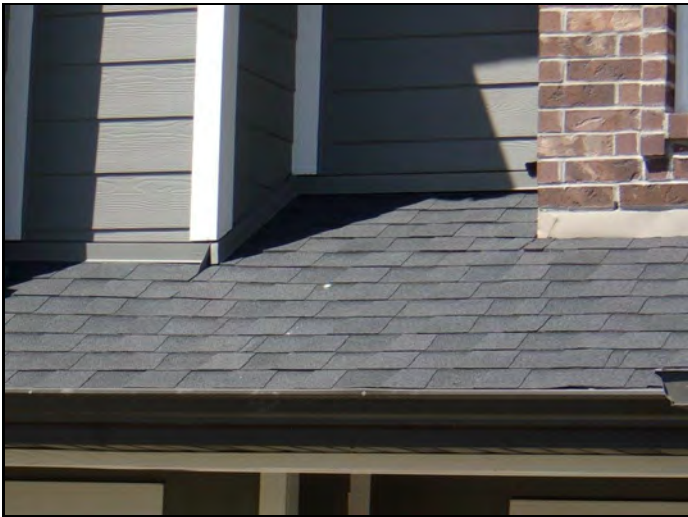
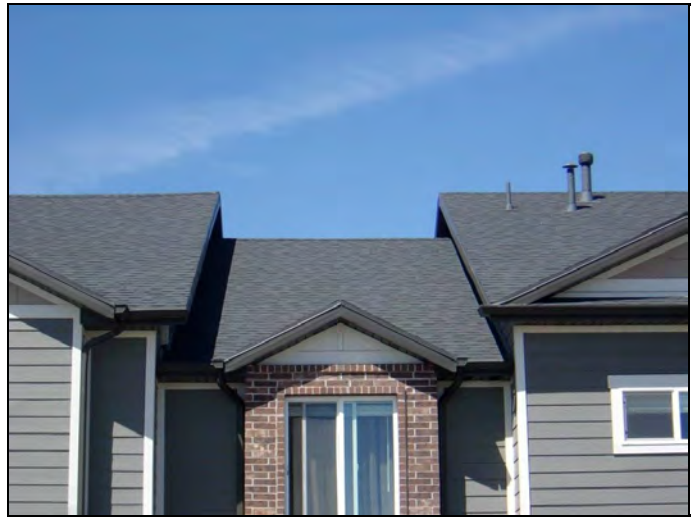
Comp #: 105 Roofs - Replace

Location: **Building Roofs**

Quantity: **Approx 78,195 Sq.ft.**

Life Expectancy: **25** *Remaining Life:* **22**

The roofs are in good condition. We recommend funding to replace this component approximately every 20 - 25 years. Remaining life based on current age.

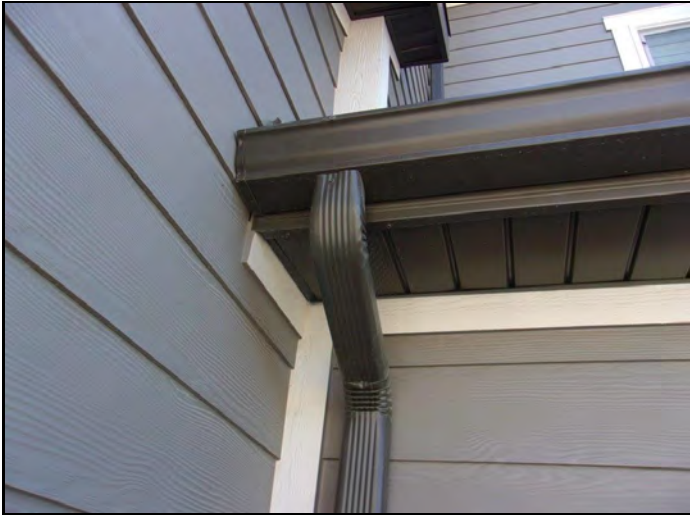
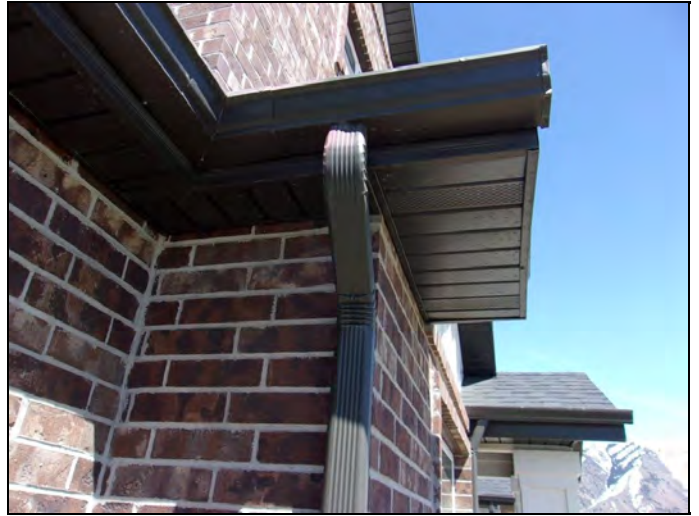
Comp #: 120 Rain Gutters/Downspouts - Replace

Location: **Building Exteriors**

Quantity: **Approx 7,551 Linear ft.**

Life Expectancy: **30** *Remaining Life:* **27**

The rain gutters and downspouts are in good condition. We recommend funding to replace this component approximately every 25 - 30 years. Remaining life based on current age.

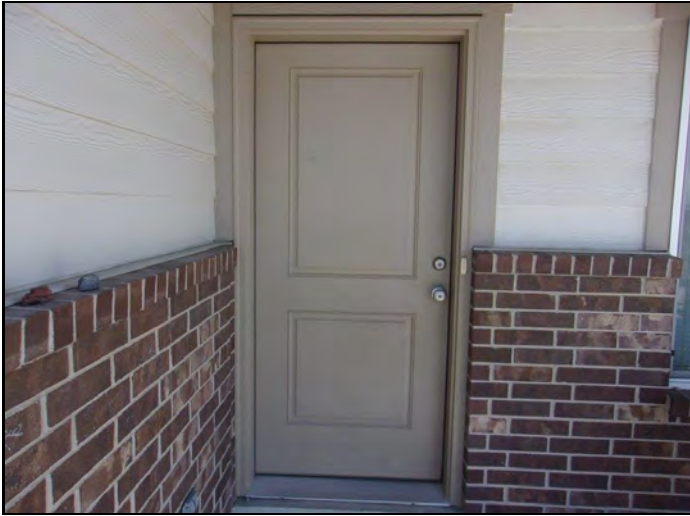
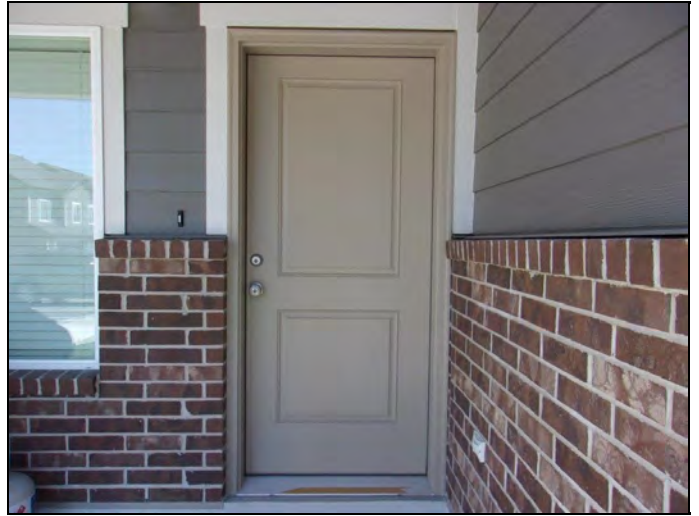
Comp #: 204 Front Doors - Repaint

Location: **Unit Entrances**

Quantity: **(61) Doors**

Research with the client reveals this component is not a responsibility of the association.

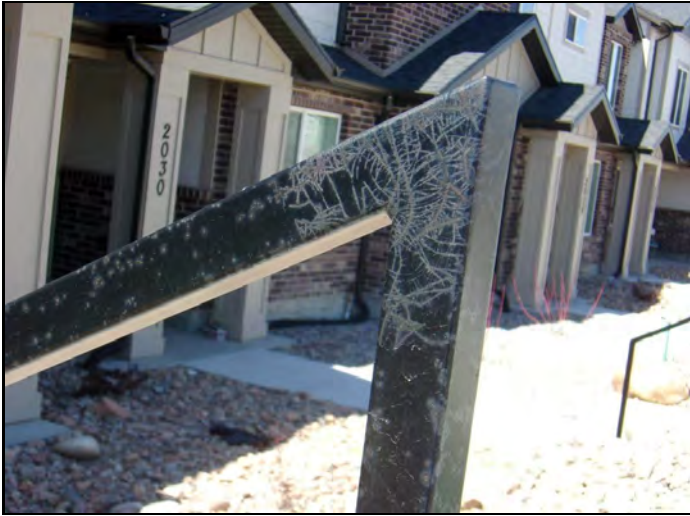
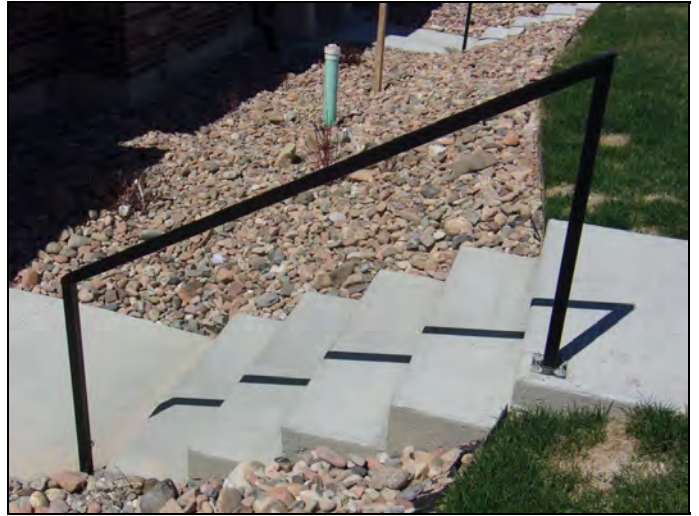
Comp #: 207 Metal Railing - Repaint

Location: **East Building Entrances**

Quantity: **Approx 80 Linear ft.**

Due to the minimal cost of repainting this component reserve funding is not appropriate. Repaint as necessary as an operating expense.

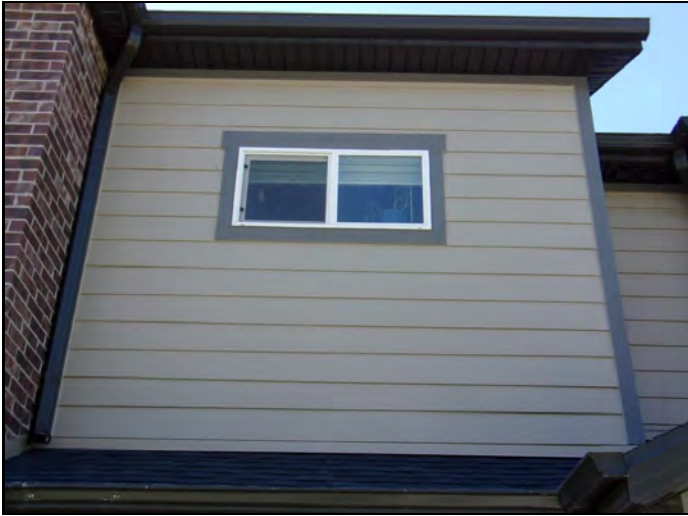
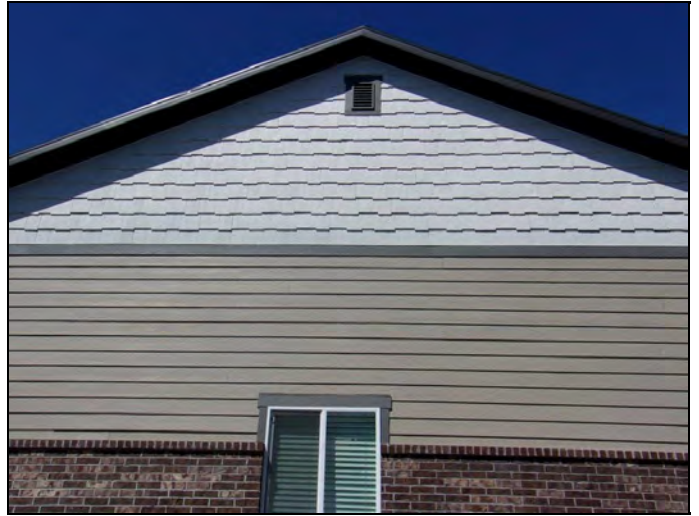
Comp #: 215 Siding - Repair/Repaint

Location: **Building Exteriors**

Quantity: **Approx 44,250 Sq.ft.**

Life Expectancy: **10** *Remaining Life:* **7**

The siding painted surfaces are in good condition. We recommend funding to repair/repaint this component approximately every 8 - 10 years. Remaining life is based on current age.

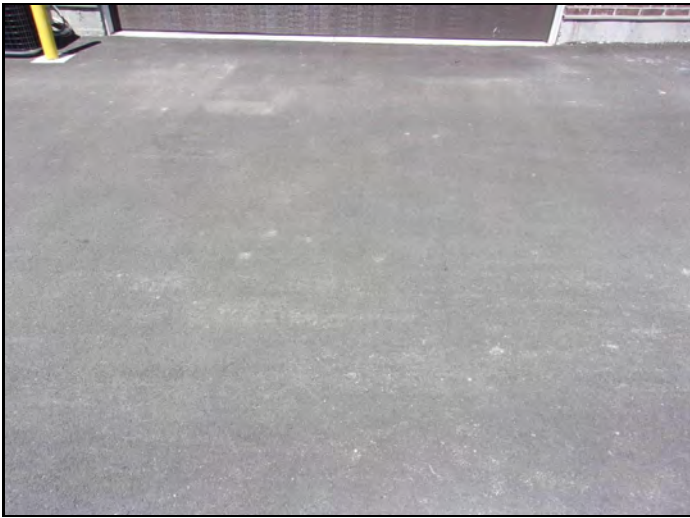
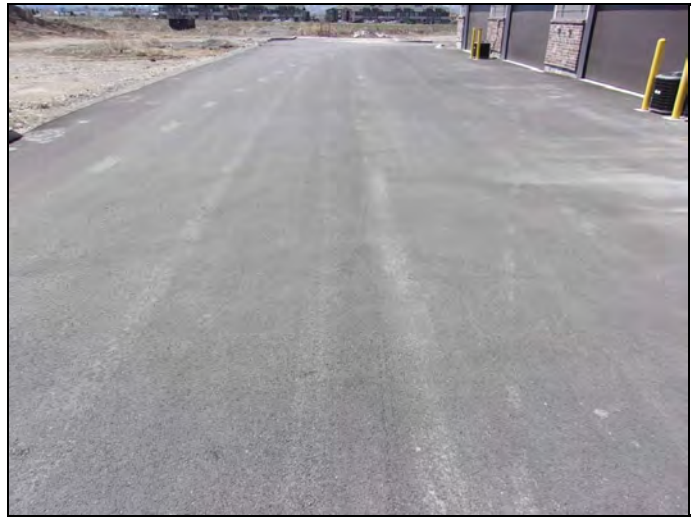
Comp #: 401 Asphalt - Major Rehab

Location: **Community Streets**

Quantity: **Approx 49,000 Sq.ft.**

Life Expectancy: **30** *Remaining Life:* **27**

The asphalt surfaces are in good condition. We recommend funding for a major rehab of this component approximately every 25 - 30 years. Remaining life based on current age.

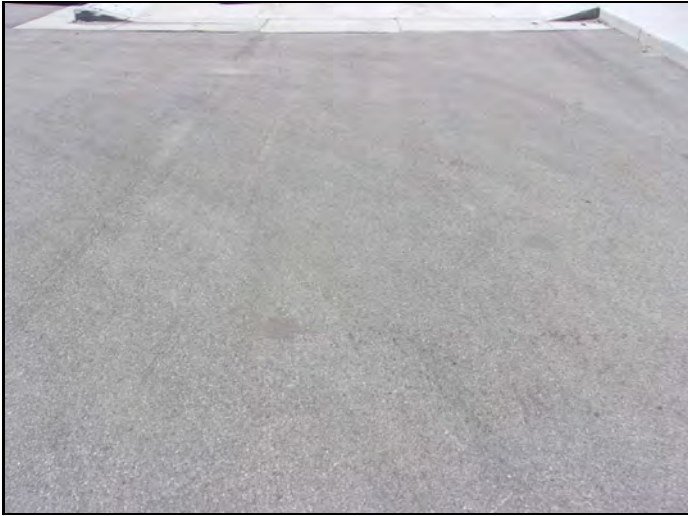
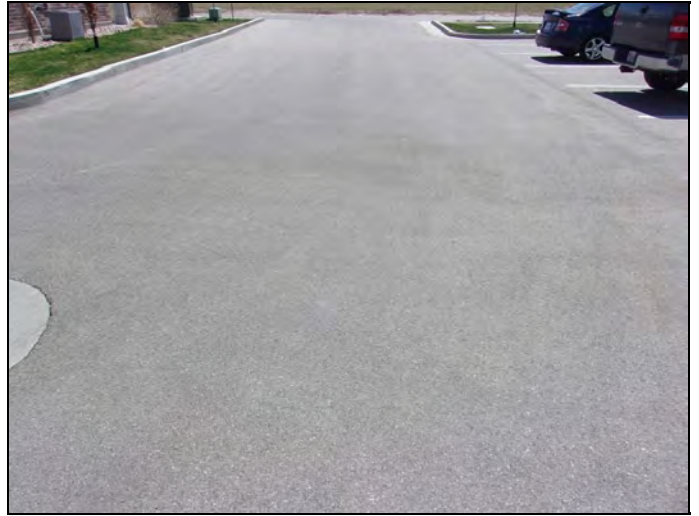
Comp #: 402 Asphalt - Seal Coat

Location: **Community Streets**

Quantity: **Approx 53,130 Sq.ft.**

The asphalt seal coat is in poor condition. We recommend funding to seal this component approximately every 3 - 5 years. Remaining life based on current condition.

Projects programmed to occur this fiscal year (FY2024) include asphalt seal coat (Comp# 402). We have programmed an estimated \$15,000 in reserve expenditures toward the completion of these projects. (See page 15)

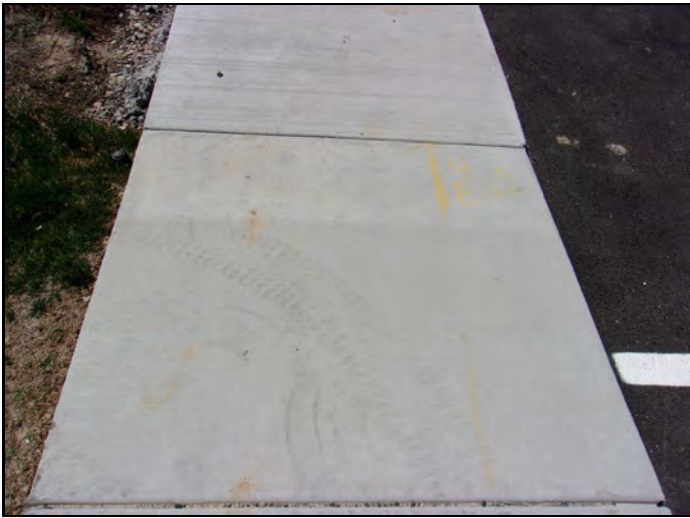
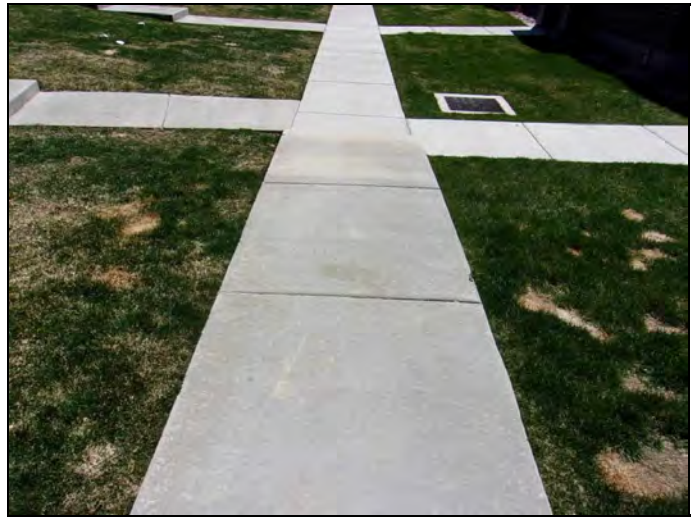
Comp #: 403 Concrete - Partial Repair/Replace

Location: **Common Area**

Quantity: **Minimal Sq.ft.**

The concrete is in good condition. This component has an extended useful life under normal conditions. We recommend funding to make repairs and partially replace this component approximately every 10 years. Remaining life based on current age.

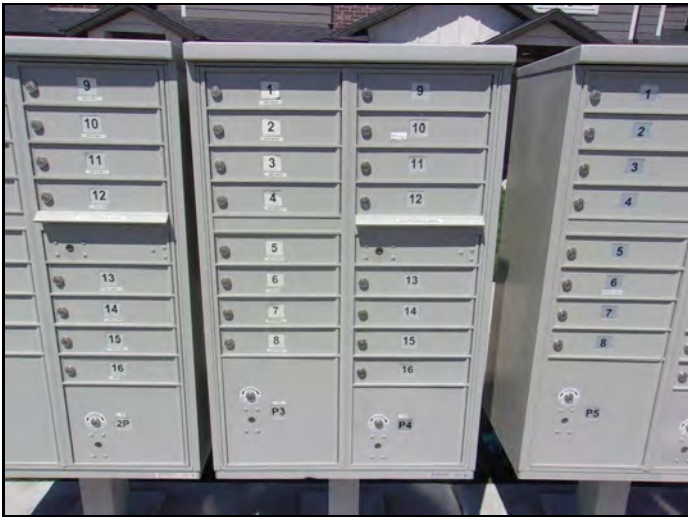
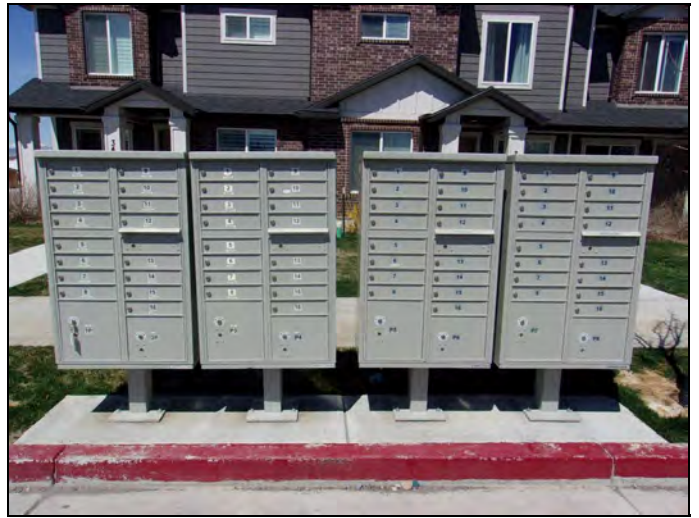
Comp #: 803 Mailboxes - Replace

Location: **Common Area**

Quantity: **(4) Clusters**

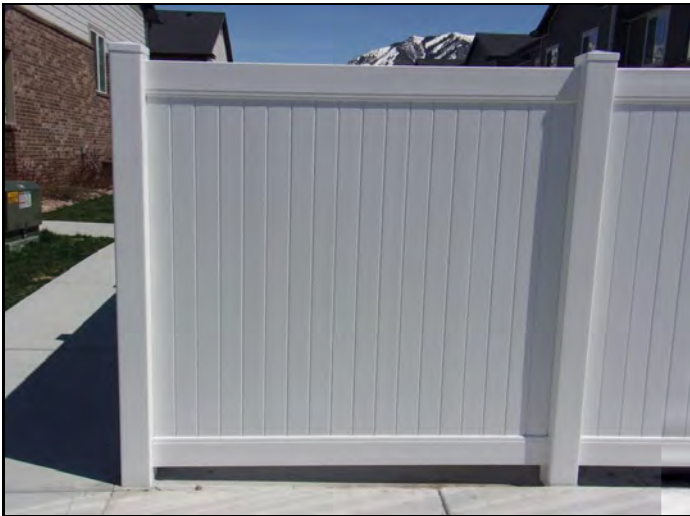
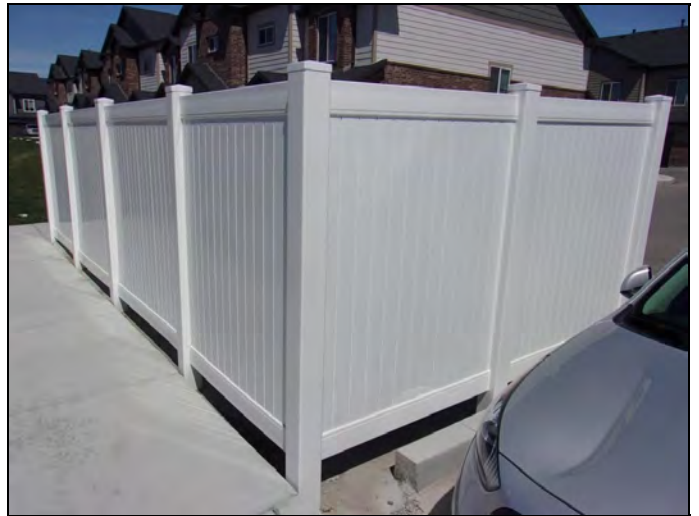
Comp #: 1010 Dumpster Enclosures - Replace

Location: **South Dumpster Well**

Quantity: **(1) Dumpster Enclosure**

The dumpster enclosure gates are in good condition. We recommend funding to replace this component approximately every 25 - 30 years. Remaining life based on current age.

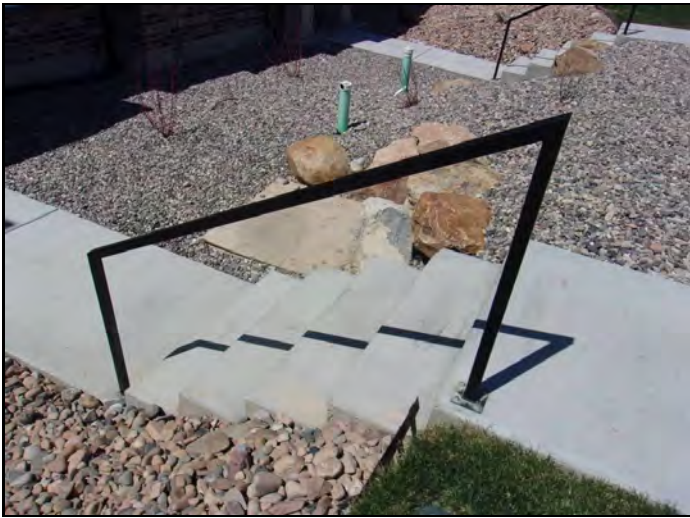
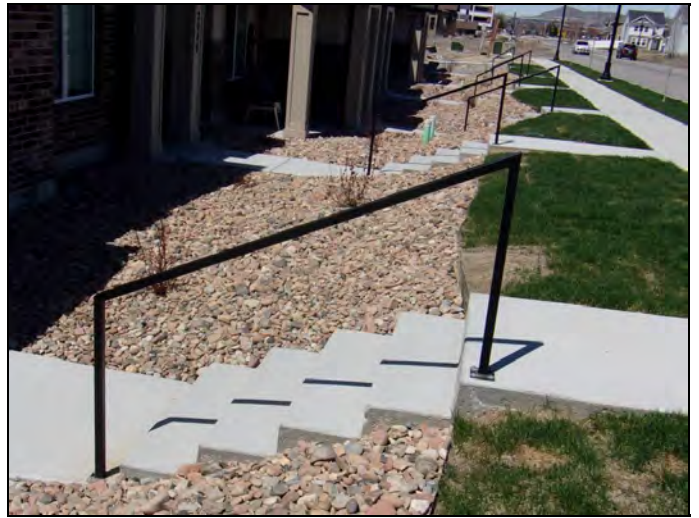
Comp #: 1090 Metal Railing - Replace

Location: **East Building Entrances**

Quantity: **Approx 80 Linear ft.**

The metal railing is in good condition. We recommend funding to replace this component approximately every 40 - 50 years. Remaining life based on current age.

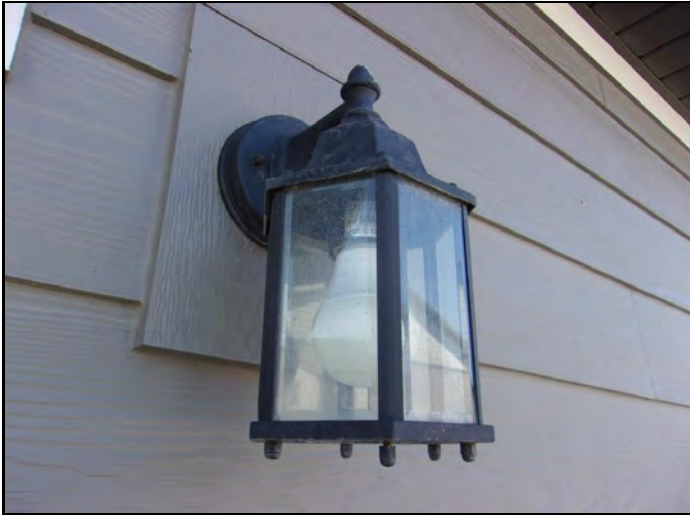
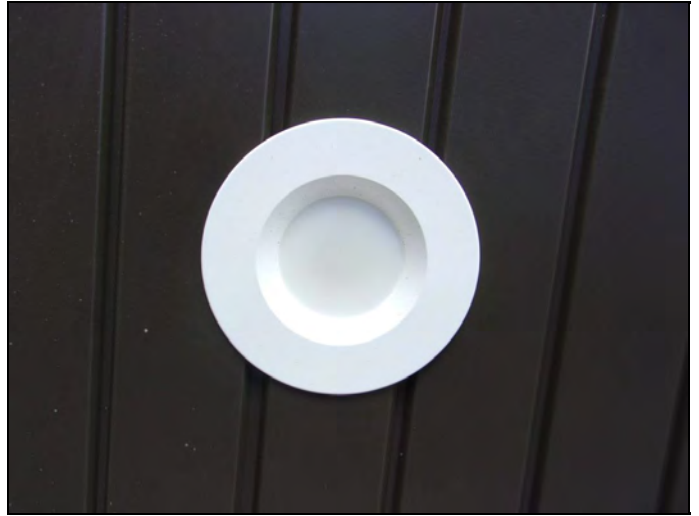
Comp #: 1602 Exterior Light Fixtures - Replace

Location: **Building Exteriors**

Quantity: **(201) Fixtures**

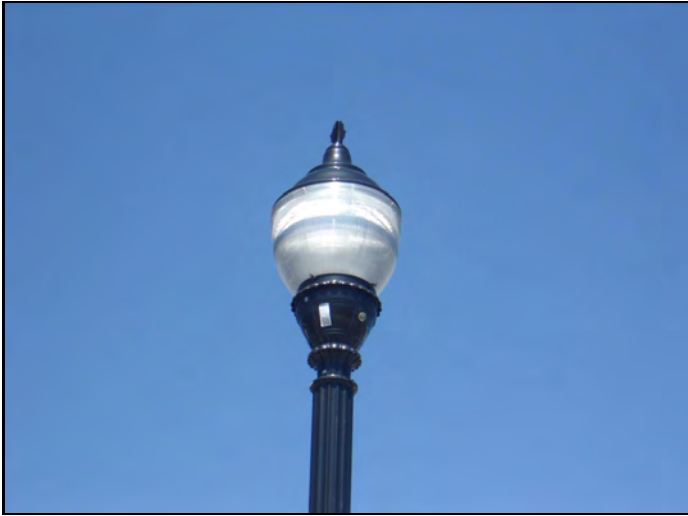
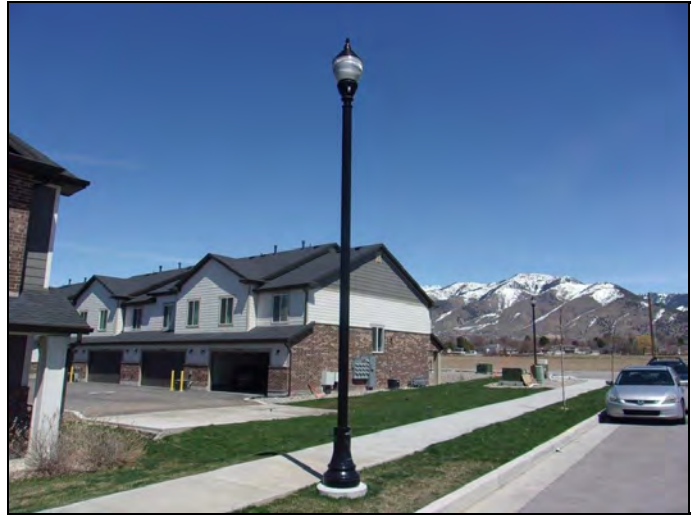
Comp #: 1609 Street Light Fixtures - Replace

Location: **Community Streets**

Quantity: **(10) Fixtures**

The street light fixtures are in good condition. No expectation to replace the light poles. Paint poles as necessary as an operating expense. We recommend funding to replace this component approximately every 20 years. Remaining life based on current age.

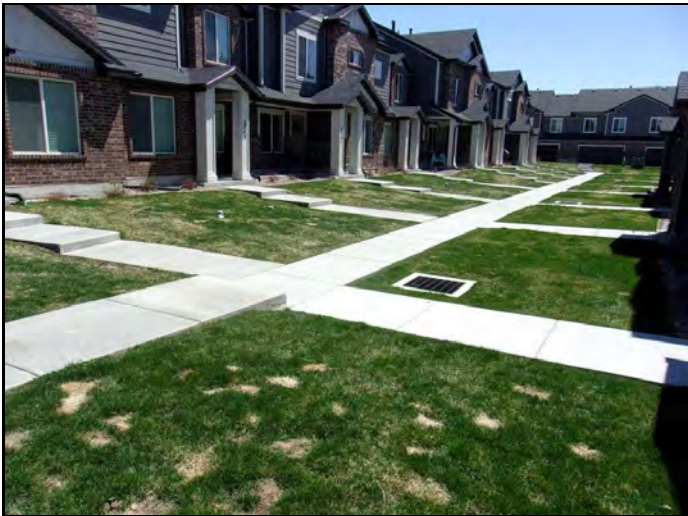
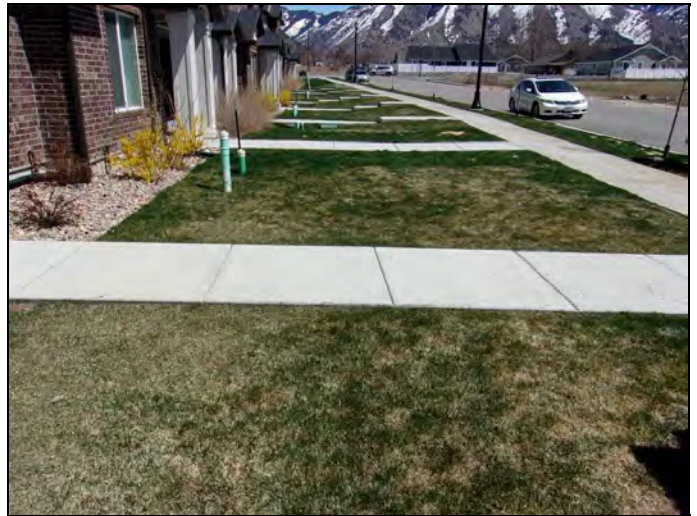
Comp #: 1812 Landscaping & Irrigation System - Renovate

Location: **Common Area**

Quantity: **Moderate Sq.ft.**

The landscaping and irrigation system are in good condition. We recommend funding for an allowance to renovate this component approximately every 20 years. Remaining life based on current age.
