Aspen Condominium

Level 1 Reserve Study

Client Reference Number	19162
Property Type	Townhouse
Number of Units	14
Fiscal Year End	12/31

Type of Study	Full Study
Date of Property Inspection	10/25/2023
Prepared By	Dale Gifford
Analysis Method	Cash Flow
Funding Goal	Full Funding

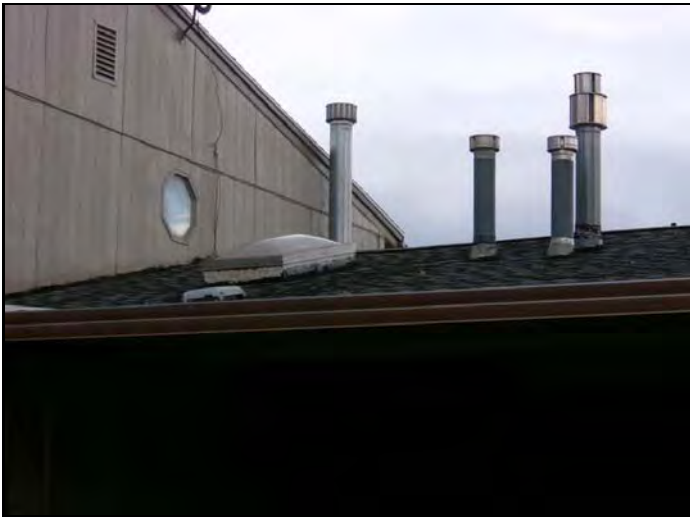
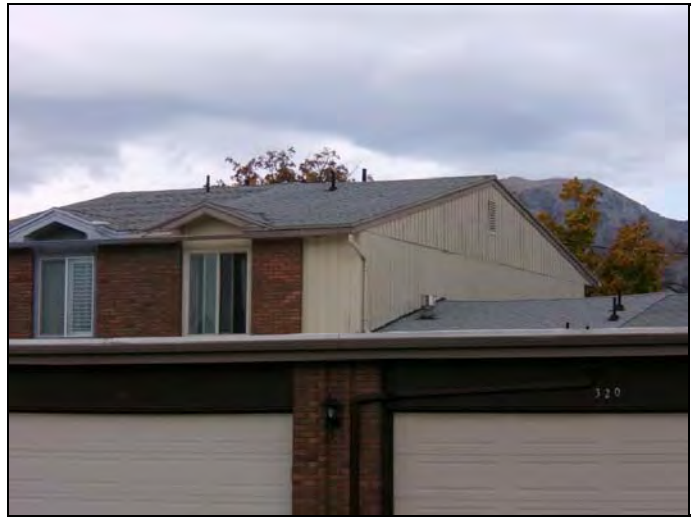
Comp #: 105 Roofs - Replace

Location: **Building Roofs**

We recommend consulting a roofing expert to assess the condition of the roofs and approximately how many years of life is left on each section. We recommend funding to replace this component approximately every 20 - 25 years. Remaining life based on current average age and condition.

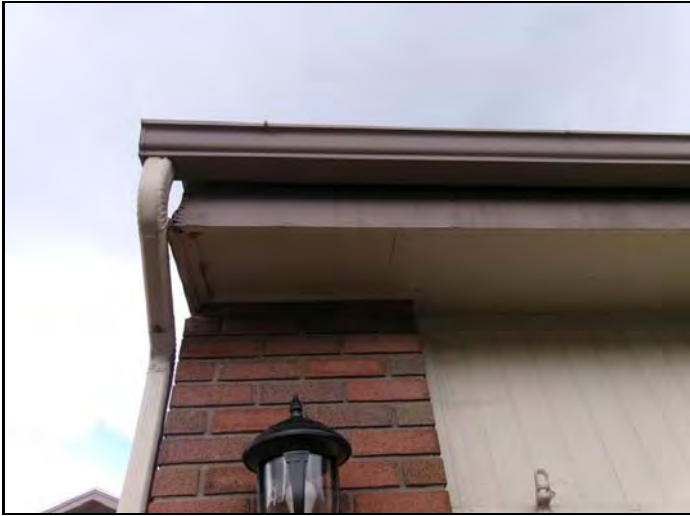
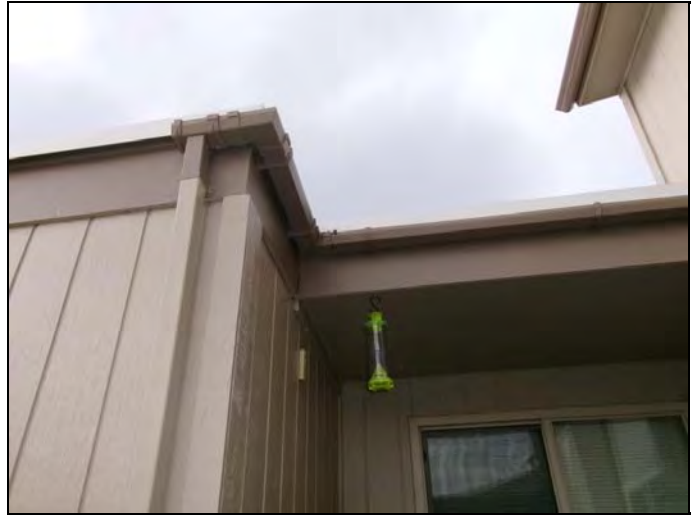
Comp #: 120 Rain Gutters/Downspouts - Replace

Location: **Building Exterior**

The rain gutters and downspouts are in fair condition. We recommend funding to replace this component approximately every 25 - 30 years. Remaining life based on current age and condition.

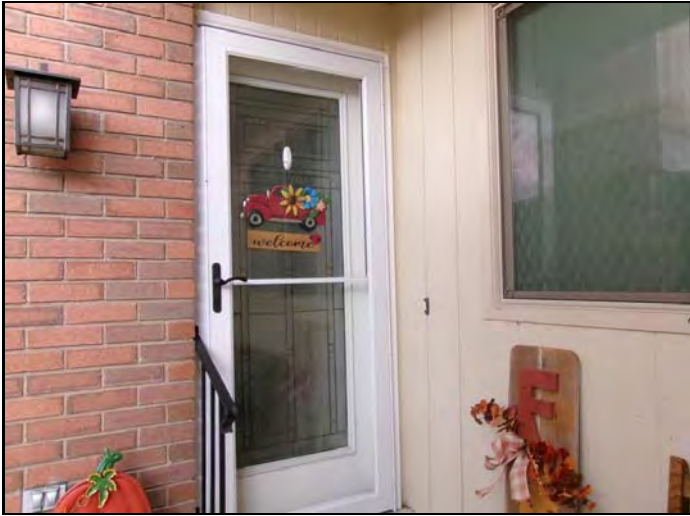
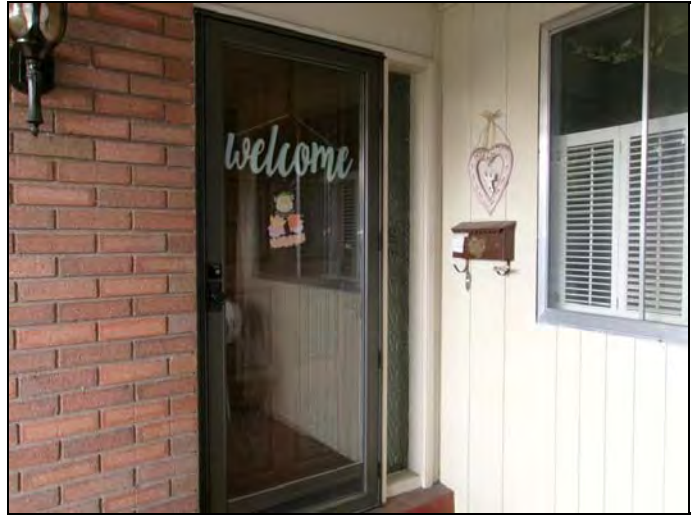
Comp #: 204 Front Doors - Repaint

Location: **Building Exterior**

The painted door surfaces are in good to fair condition. We recommend funding to repaint this component approximately every 8 - 10 years. Remaining life based on current age and condition.

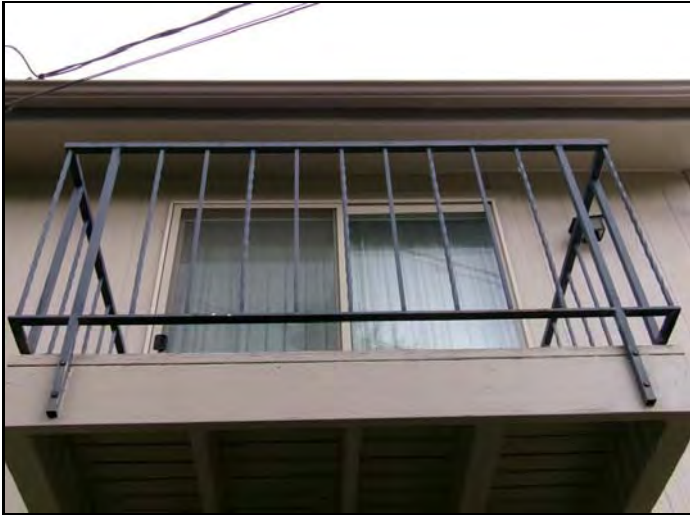
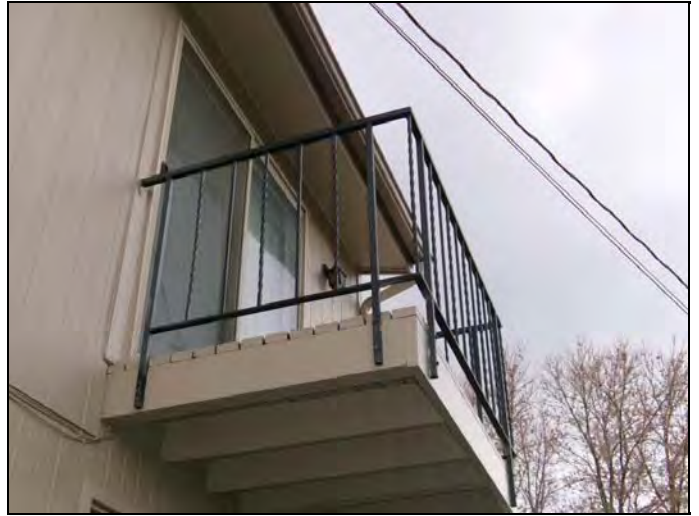
Comp #: 212 Balcony Railing - Repaint

Location: **Building Exterior**

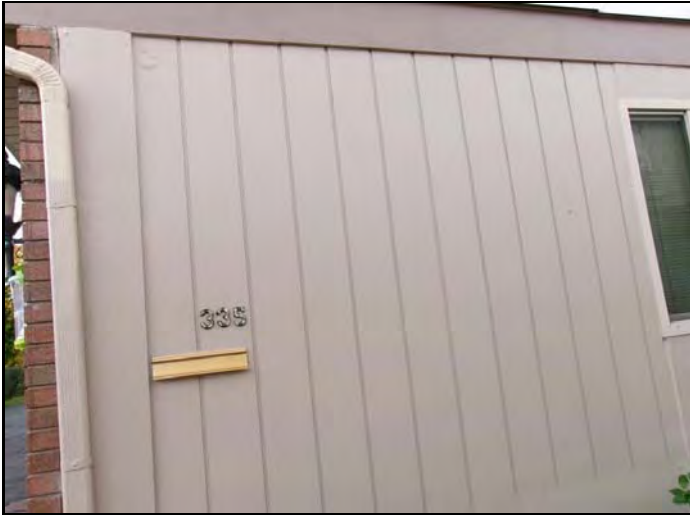
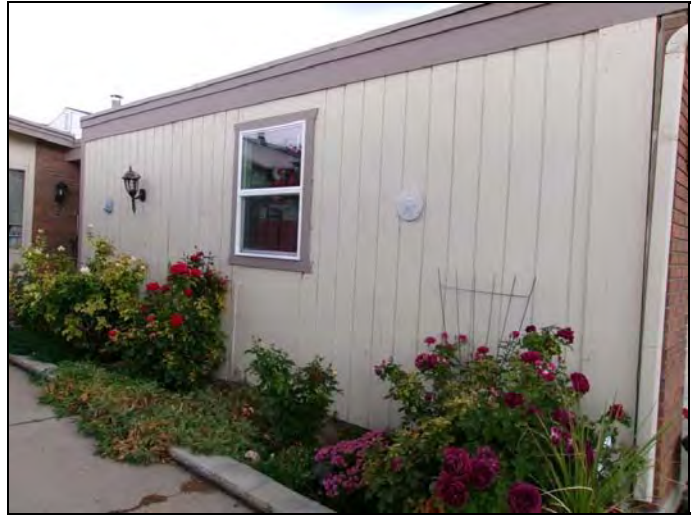
Comp #: 217 Building Exteriors - Repaint

Location: **Building Exterior**

The painted wood siding surfaces are in fair condition. We recommend funding to repair/repaint this component approximately every 8 - 10 years. Remaining life based on current age and condition.

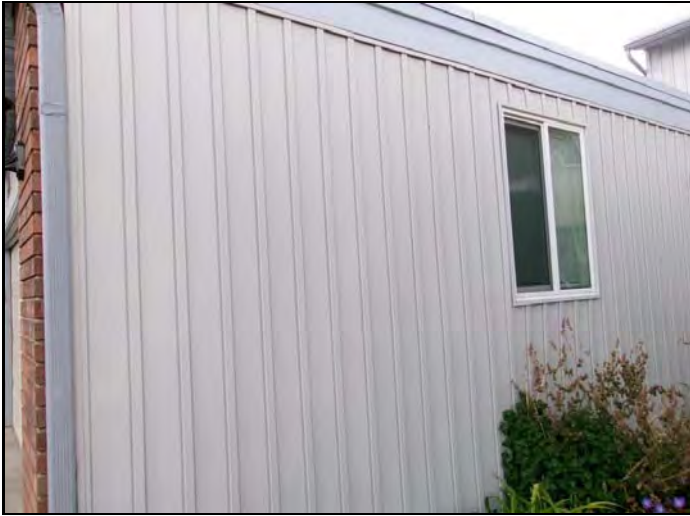
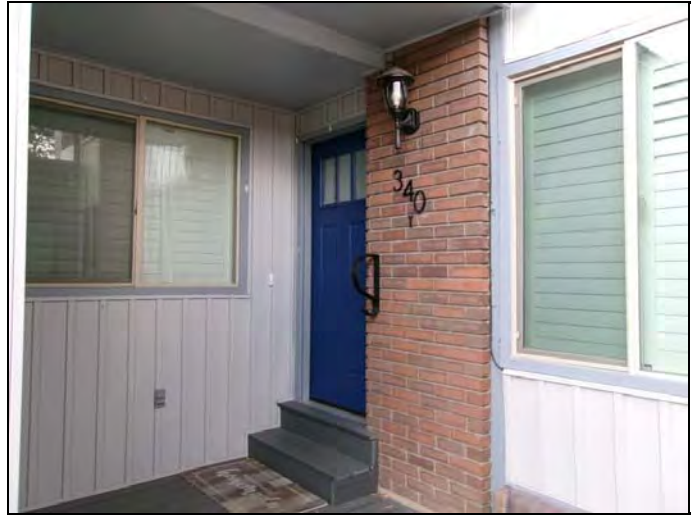
Comp #: 302 Vinyl Siding - Replace

Location: **Building Exterior**

The vinyl siding is in good condition. We recommend funding to replace this component approximately every 40 - 50 years. Remaining life based on current age and condition.

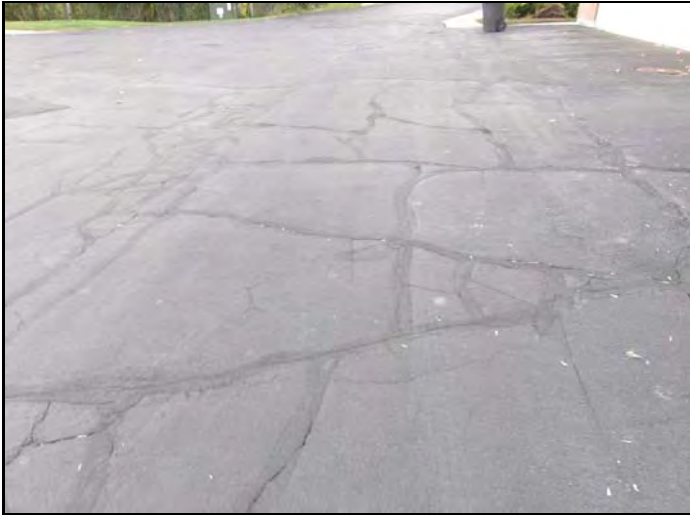
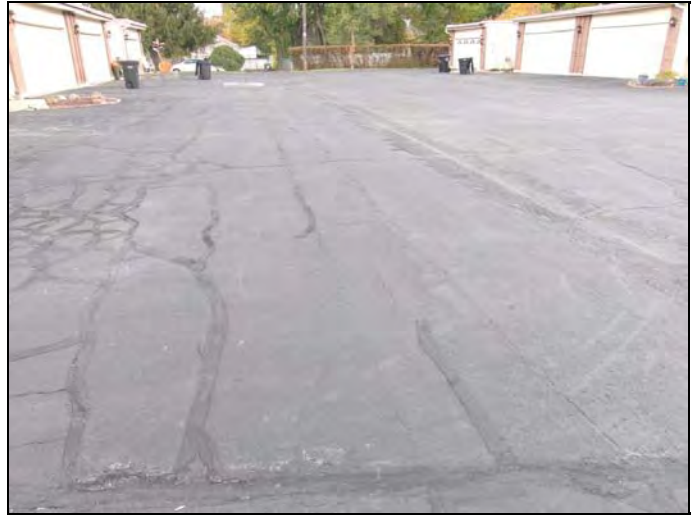
Comp #: 401 Asphalt - Major Rehab

Location: **Community Streets**

The asphalt surfaces are in fair condition. We recommend funding for a major rehab of this component approximately every 25 - 30 years. Remaining life based on current age and condition.

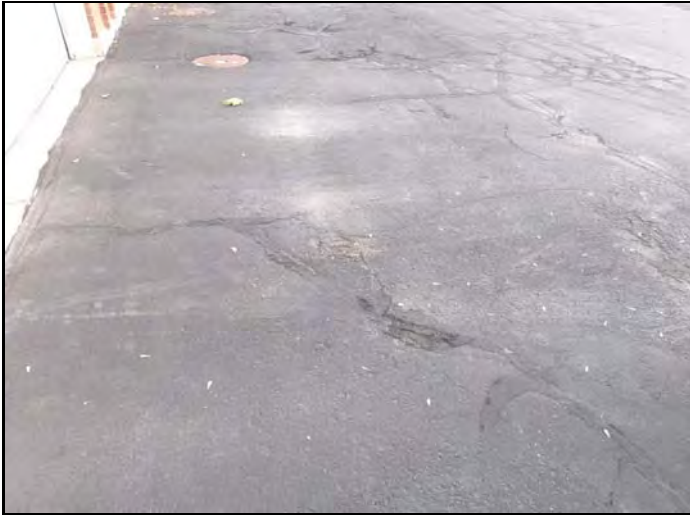
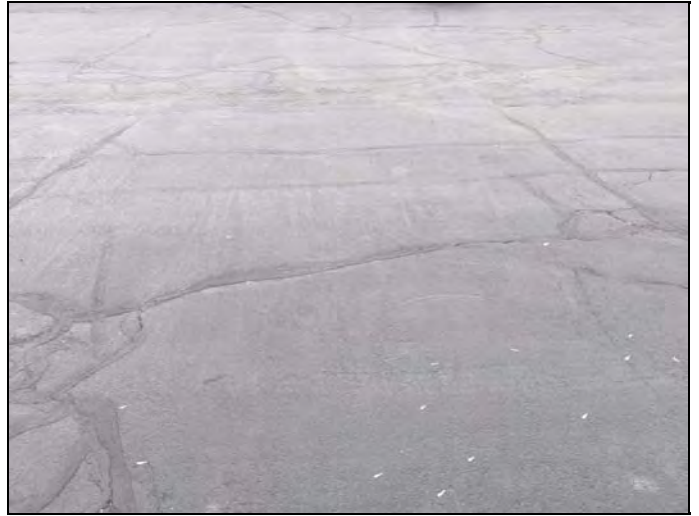
Comp #: 402 Asphalt - Seal Coat

Location: **Community Streets**

The asphalt seal coat is in fair condition. We recommend funding to seal this component approximately every 3 - 5 years. Remaining life based on current age.

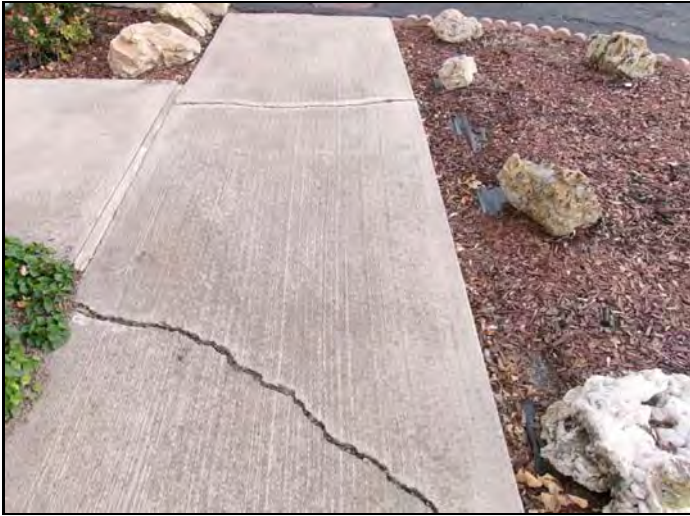
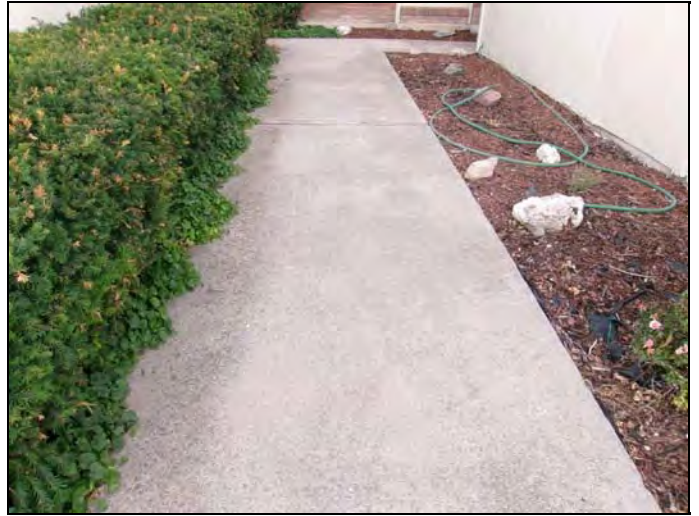
Comp #: 403 Concrete - Partial Repair/Replace

Location: **Common Area**

The concrete is in good to fair condition. This component has an extended useful life under normal conditions. We recommend funding to make repairs and partially replace this component approximately every 10 years. Remaining life based on current age.

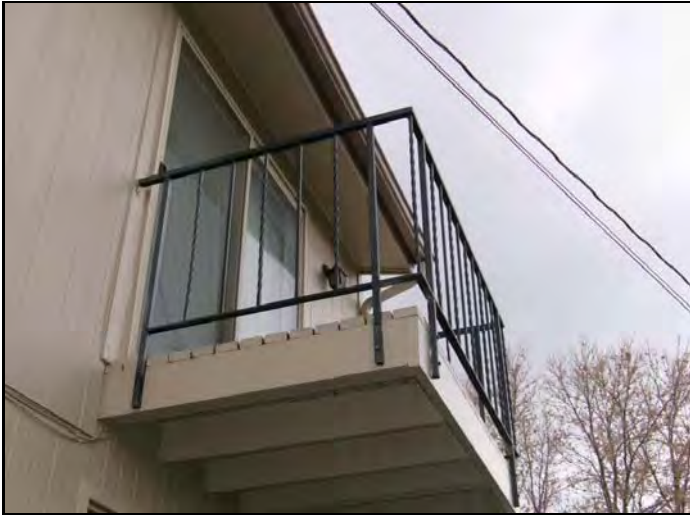
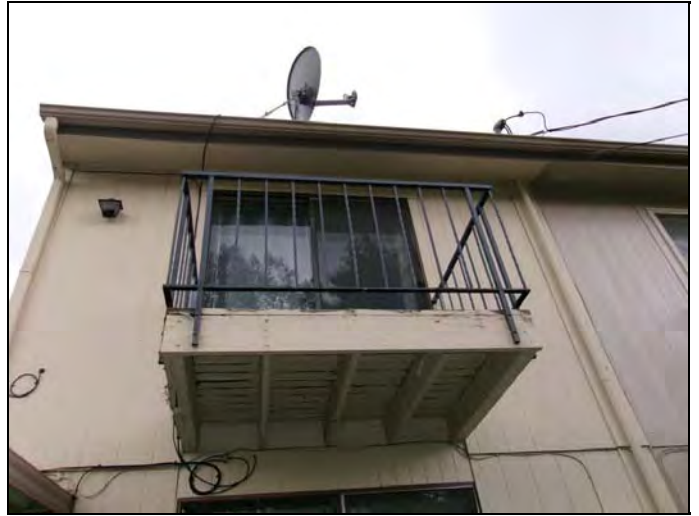
Comp #: 607 Balcony Decks - Replace

Location: **Building Exterior**

The decks are in fair condition. We recommend funding to replace this component every 20 - 30 years. Remaining life based on current age and condition.

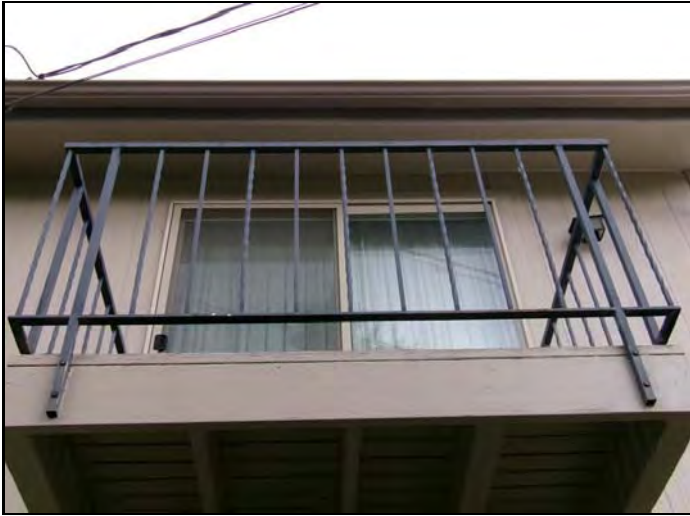
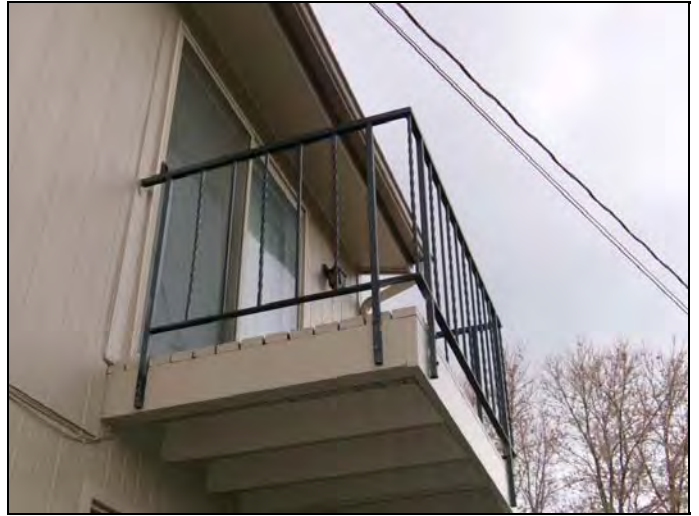
Comp #: 690 Balcony Railing - Replace

Location: **Building Exterior**

The deck railing is in fair condition. We recommend funding to replace this component approximately every 40 - 50 years. Remaining life based on current age and condition.

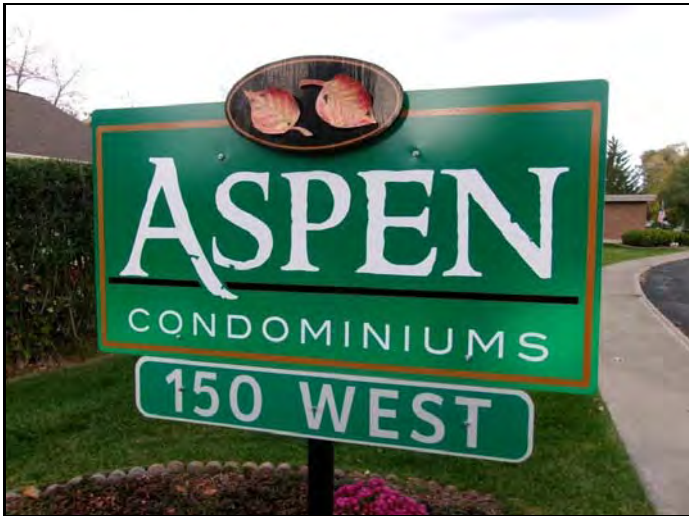
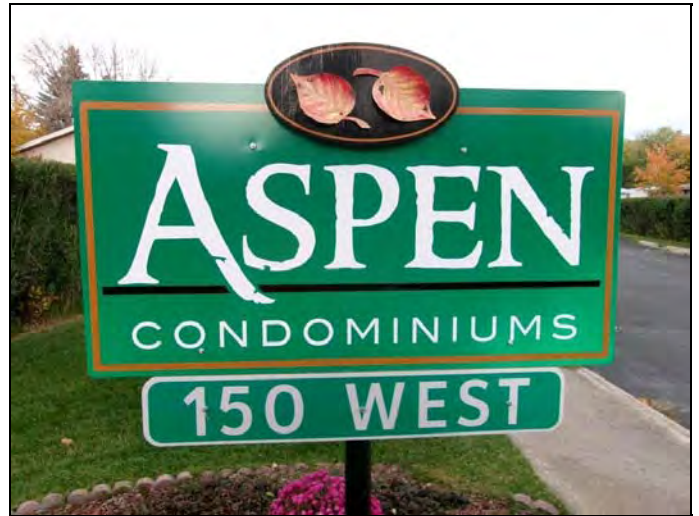
Comp #: 801 Monument Sign - Replace

Location: **Community Entrance**

Due to the minimal cost of replacing this component, reserve funding is not appropriate. Replace as necessary as an operating expense.

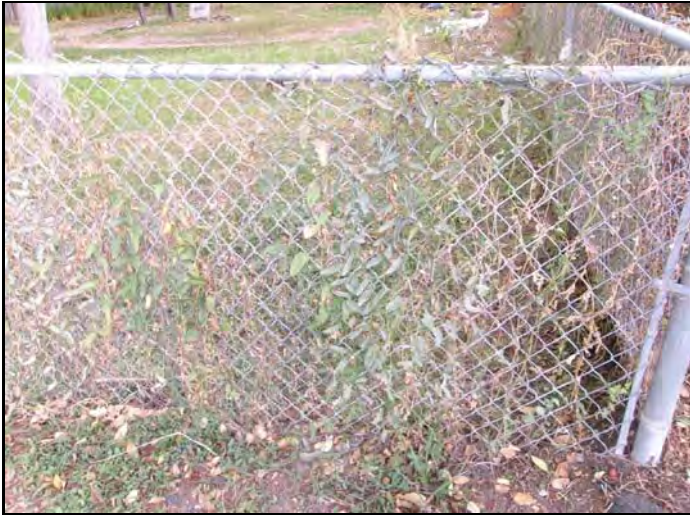
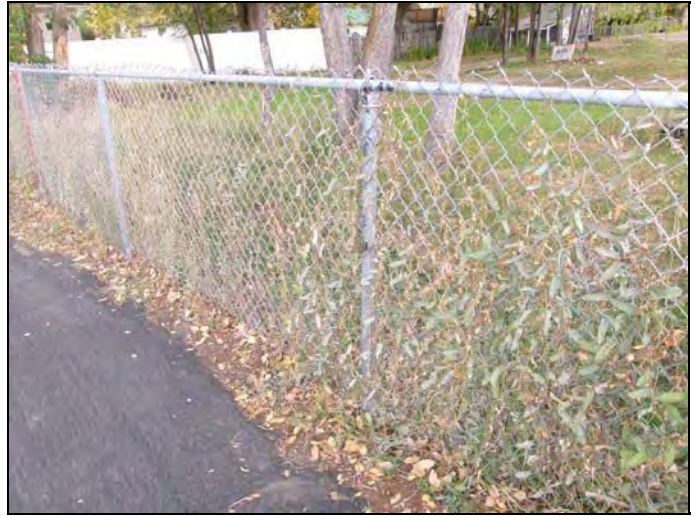
Comp #: 1003 Chain Link Fencing - Replace

Location: **Community Perimeter**

The chain link fencing is in fair condition. We recommend funding to replace this component approximately every 30 - 40 years. Remaining life based on current age and condition.

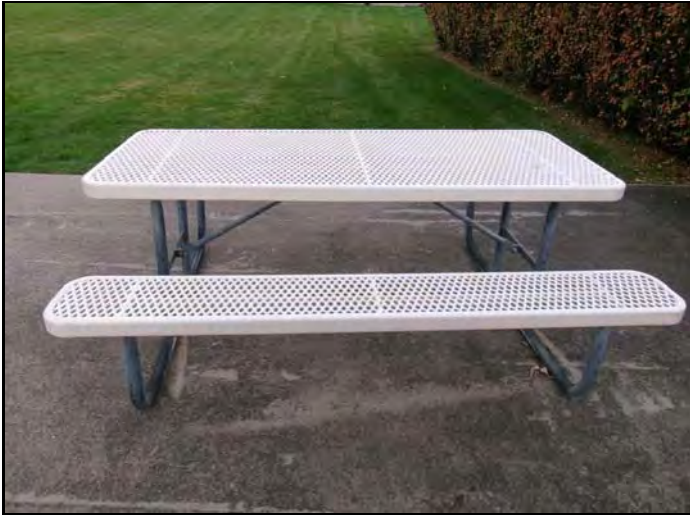
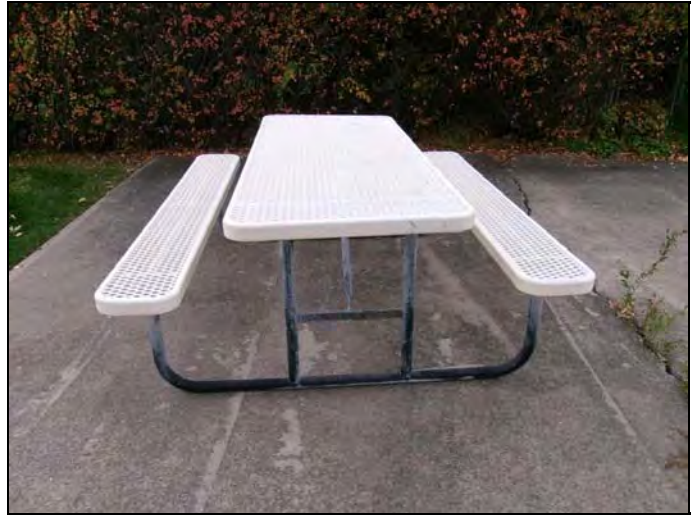
Comp #: 1306 Picnic Table - Replace

Location: **Common Area**

Due to the minimal cost of replacing this component, reserve funding is not appropriate. Replace as necessary as an operating expense.

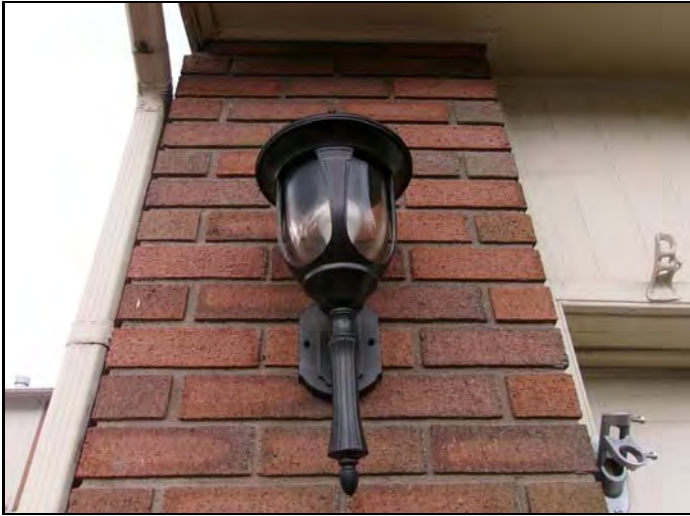
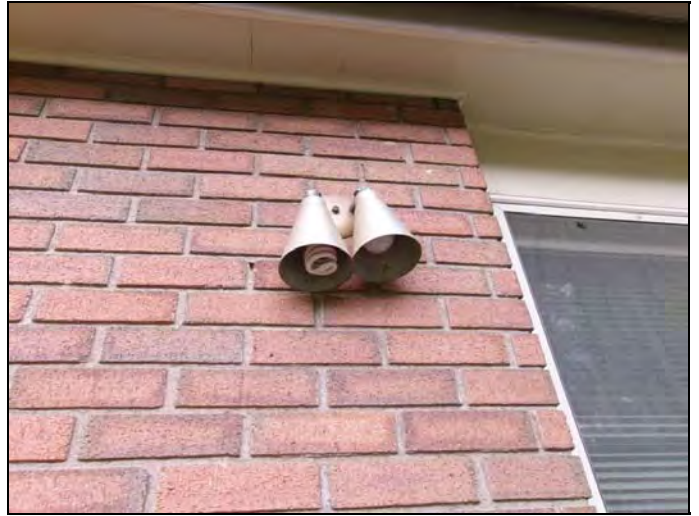
Comp #: 1602 Exterior Light Fixtures - Replace

Location: **Building Exteriors**

The exterior light fixtures are in fair to poor condition. We recommend funding to replace this component approximately every 16 - 20 years. Remaining life based on average age and condition.

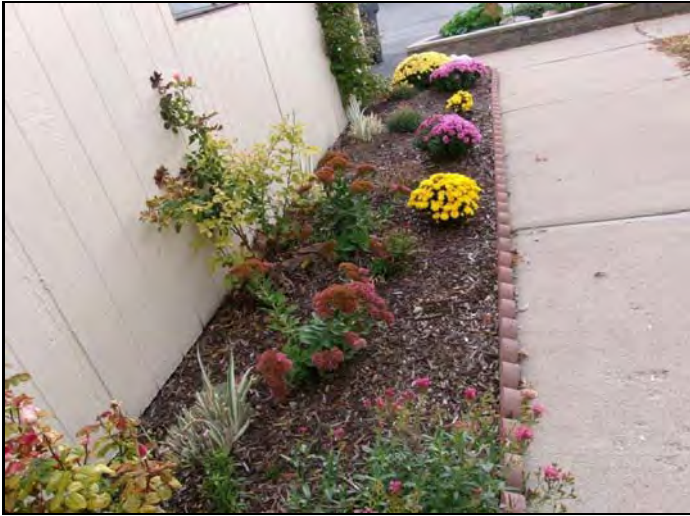
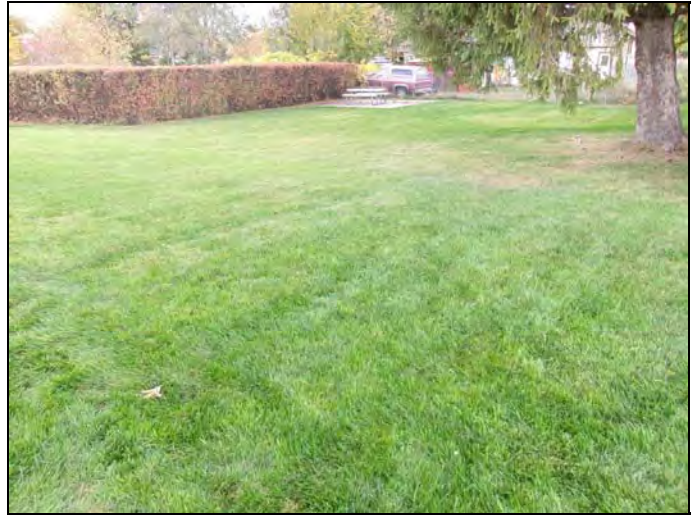
Comp #: 1812 Landscaping & Irrigation System - Renovate

Location: **Common Area**

The landscaping and irrigation system appear to be in good condition. We recommend funding for an allowance to renovate this component approximately every 20 years. Remaining life based on current age.
