# Yorkshire Village HOA

## Level 3 Reserve Study

**Report Period – 01/01/2024 – 12/31/2024**

# Executive Summary – Yorkshire Village HOA - ID # 18781

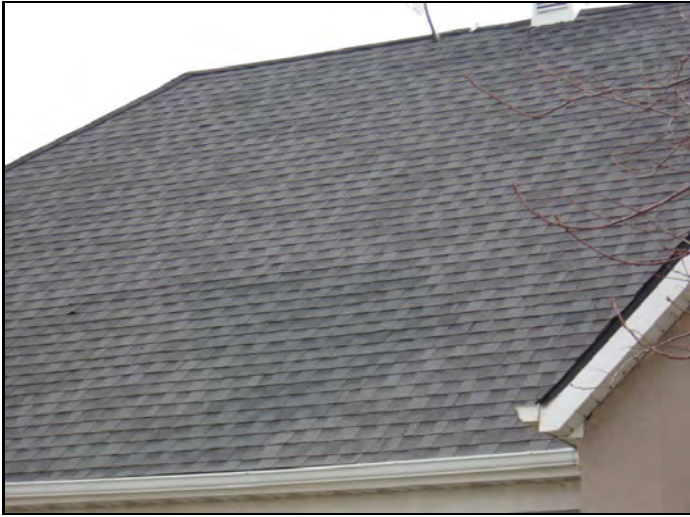
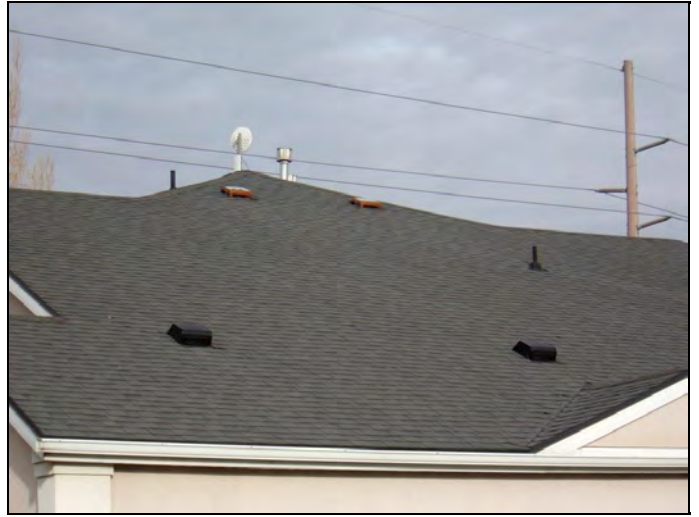
Comp #: 105    Roofs - Replace

The roofs are in good to poor condition. We recommend funding to replace this component approximately every 20 - 25 years. Remaining life based on average age.

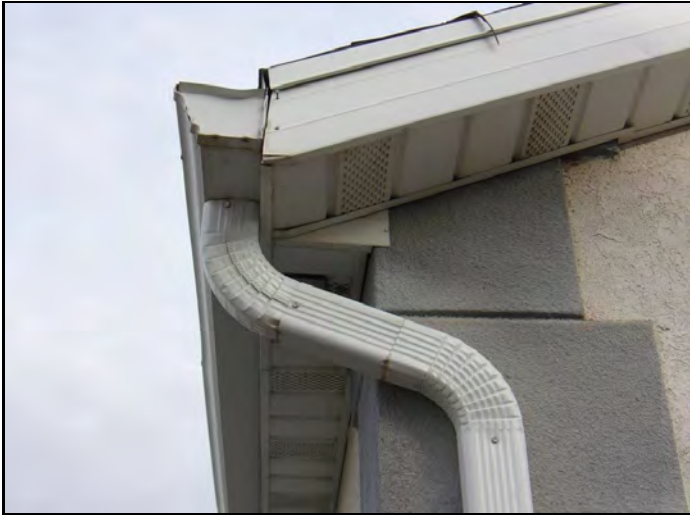
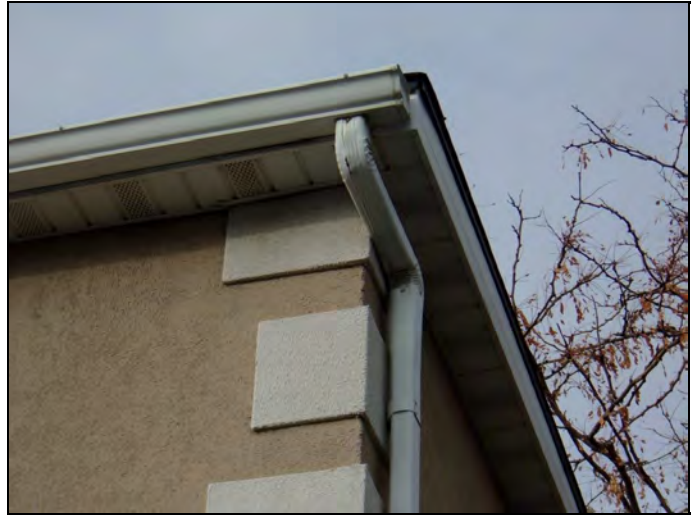
Comp #: 120 Rain Gutters/Downspouts - Replace

The rain gutters and downspouts are in good to fair condition. We recommend funding to replace this component approximately every 25 - 30 years. Remaining life based on average age.

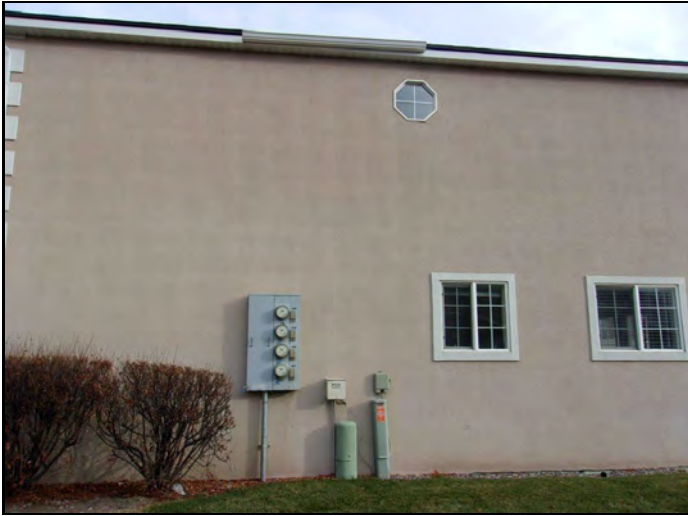
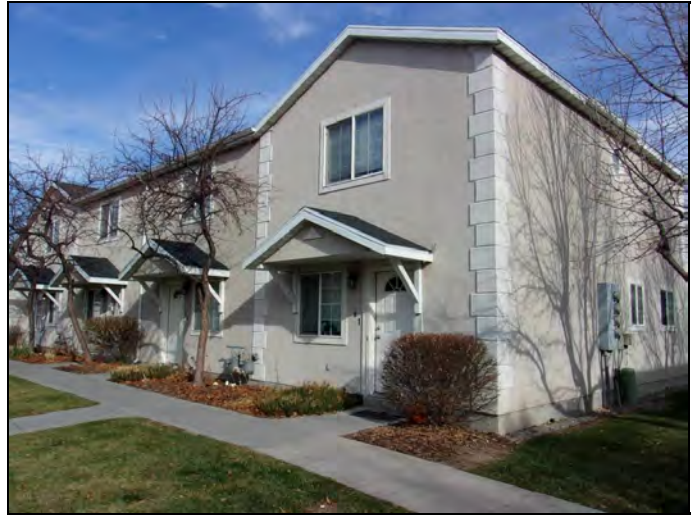
Comp #: 201 Stucco Surfaces - Partial Repair/Repaint

Research with the client reveals this component is partially repaired/repainted yearly.

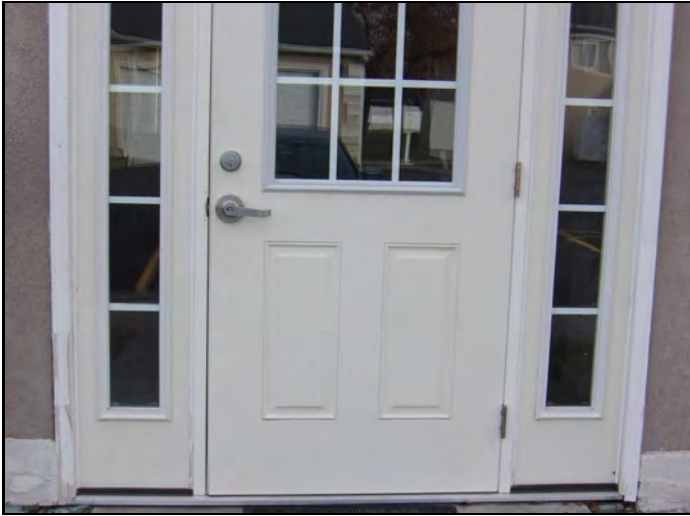
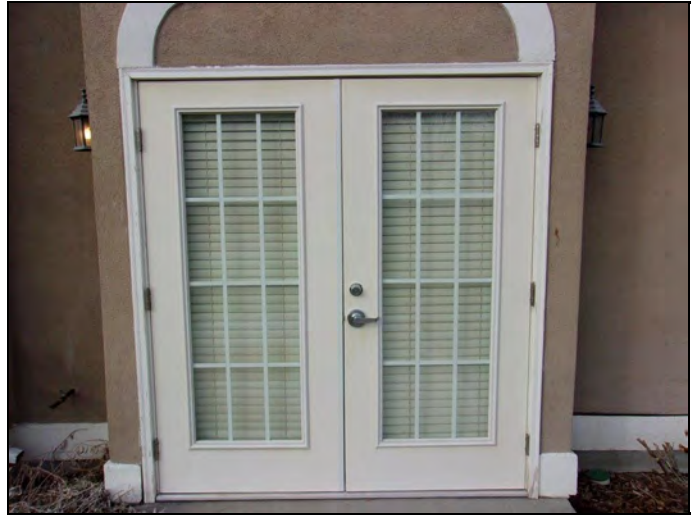
Comp #: 204 Clubhouse Doors - Repaint

The painted door surfaces are in fair to poor condition. We recommend funding to repaint this component approximately every 6 - 8 years. Remaining life based on current condition.

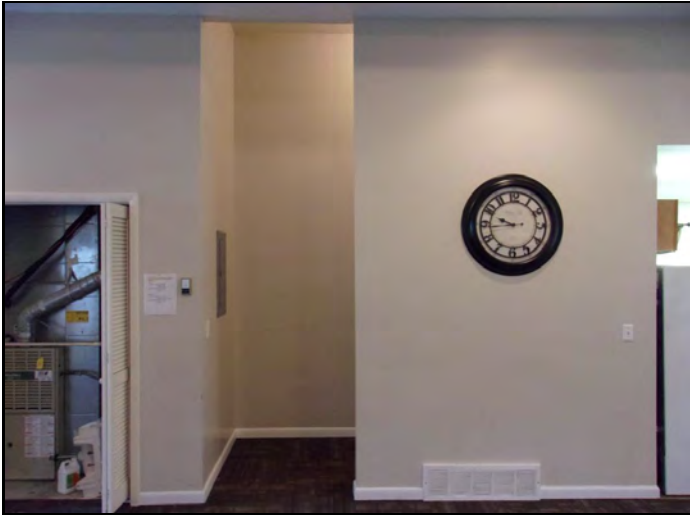
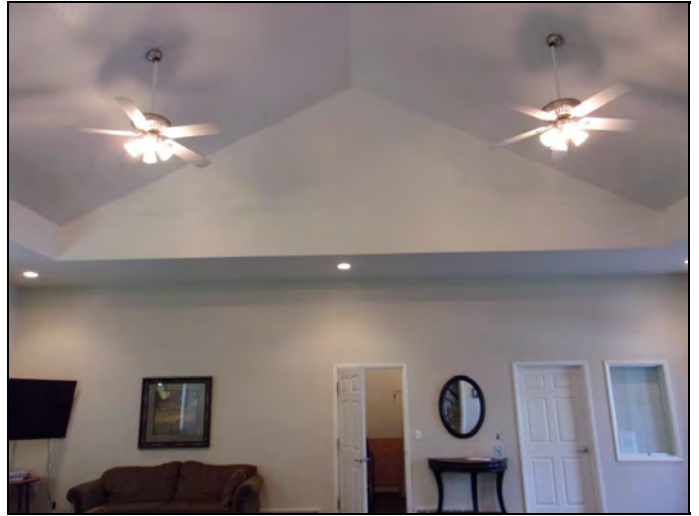
Comp #: 216 Interior Surfaces - Repaint

The interior painted surfaces are in good to fair condition. We recommend funding to repaint this component approximately every 10 years. Remaining life based on current condition.

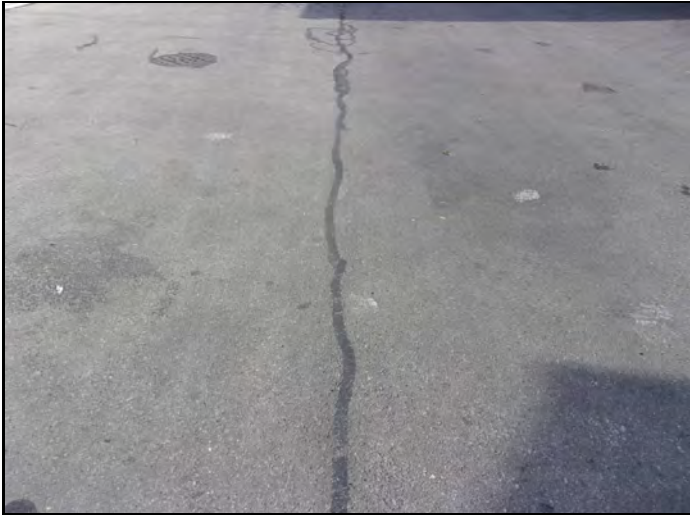
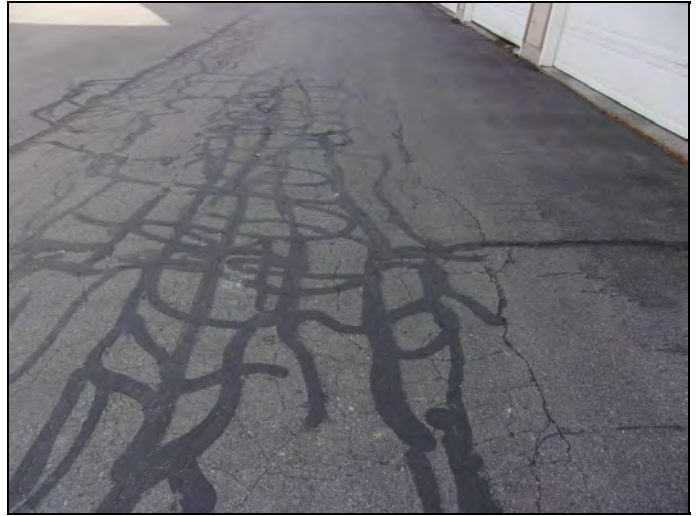
Comp #: 401 Asphalt - 2019 - Major Rehab

The asphalt surfaces are in good condition. We recommend funding for a major rehab of this component approximately every 25 - 30 years. Remaining life based on current age.

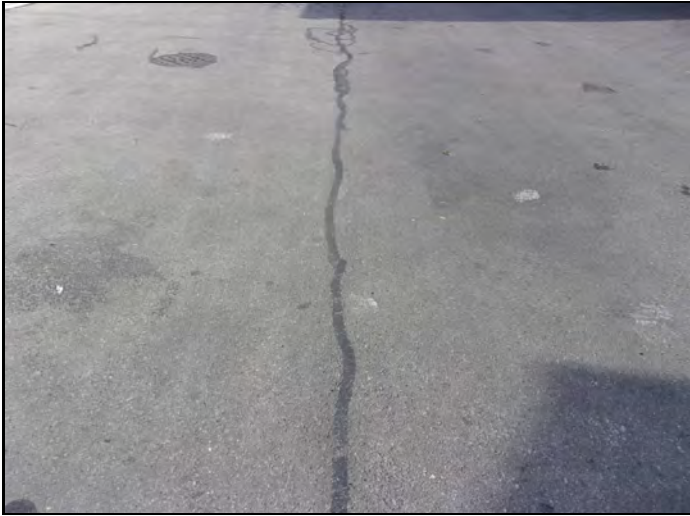
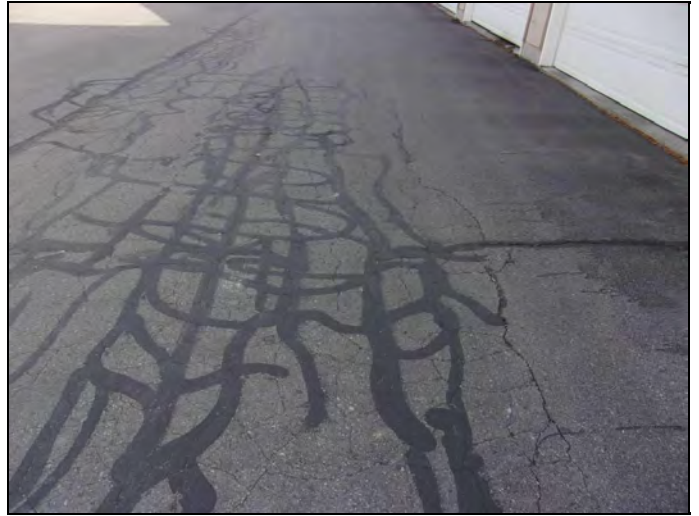
Comp #: 401 Asphalt - Major Rehab

The asphalt surfaces are in good to fair condition. We recommend funding for a major rehab of this component approximately every 25 - 30 years. Remaining life based on current age and condition.

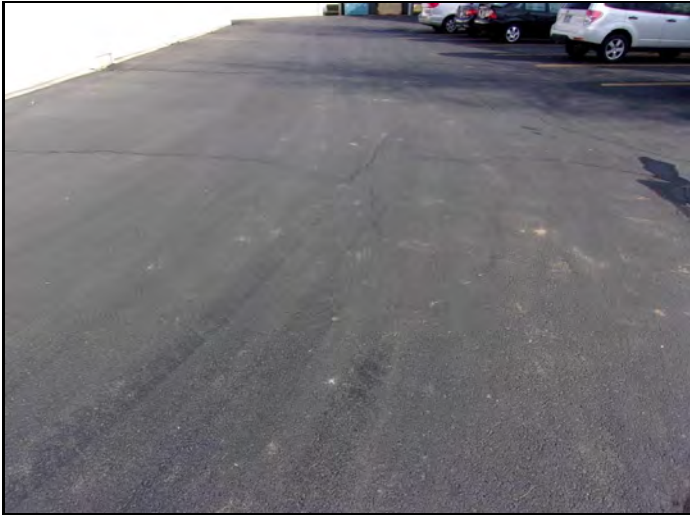
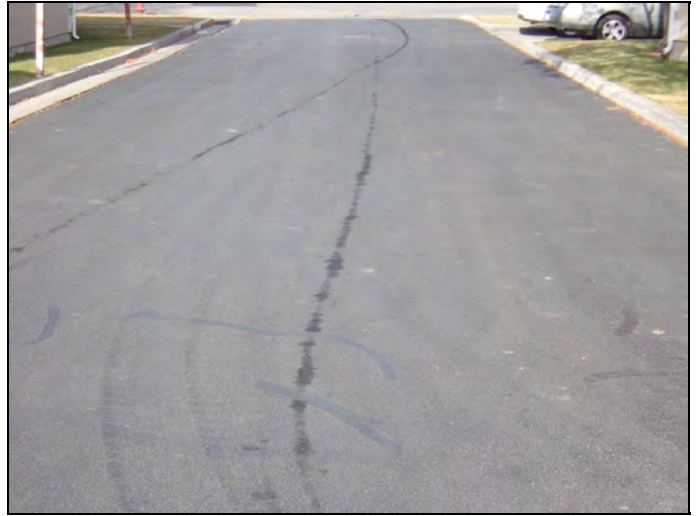
Comp #: 402 Asphalt - 2019 - Seal Coat

The asphalt seal coat is in good condition. We recommend funding to seal this component approximately every 3 - 5 years. Remaining life based on current age.

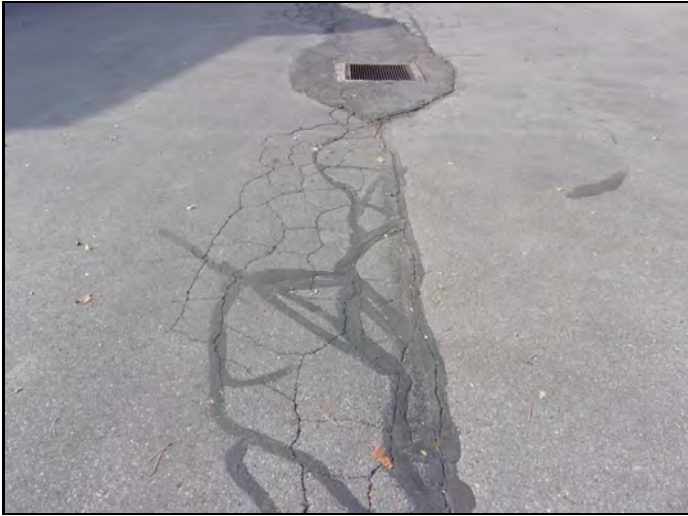
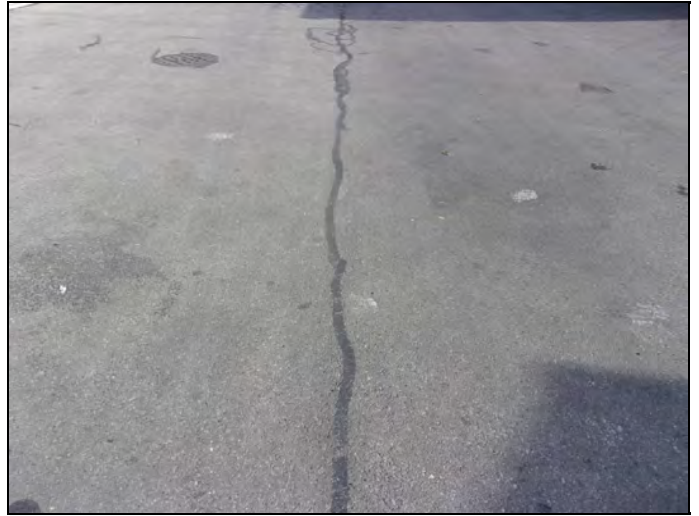
Comp #: 402 Asphalt - Seal Coat

The asphalt seal coat is in poor condition. We recommend funding to seal this component approximately every 3 - 5 years. Remaining life based on current condition.

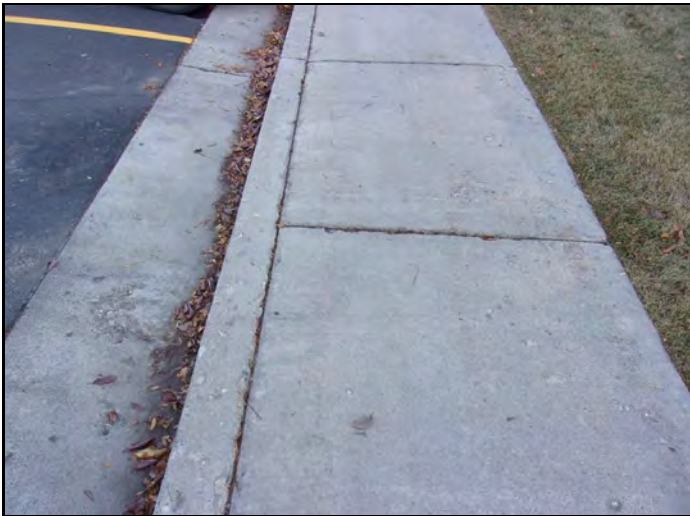
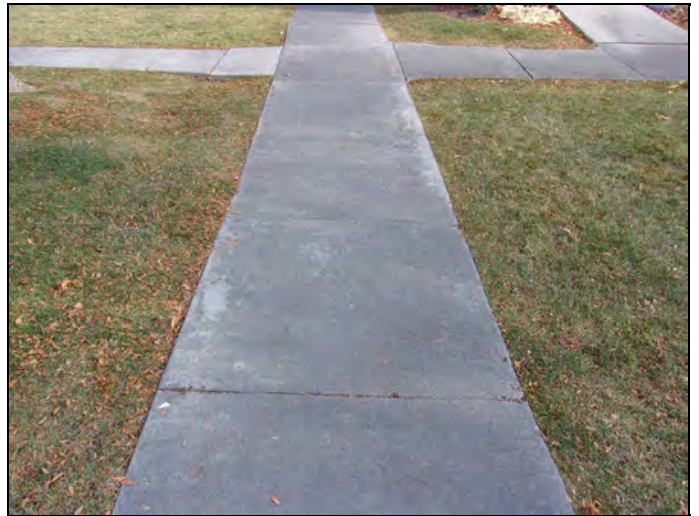
Comp #: 403 Concrete - Partial Repair/Replace

The concrete is generally in good to fair condition. This component has an extended useful life under normal conditions. We recommend funding to make repairs and partially replace this component approximately every 10 years. Remaining life based on current age.

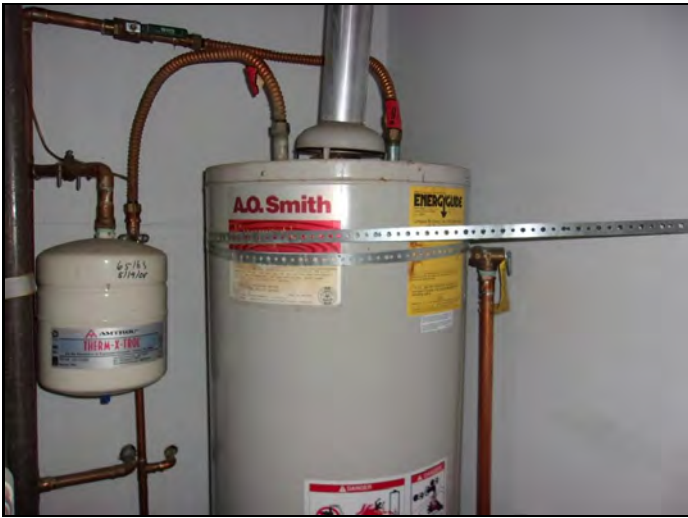
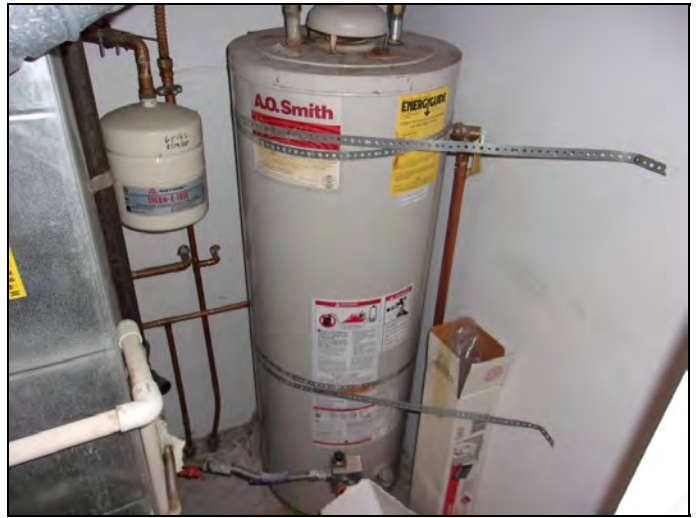
Comp #: 703 Water Heater - Replace

The water heater is in working condition. We recommend funding to replace this component approximately every 12 years. Remaining life based on current age.

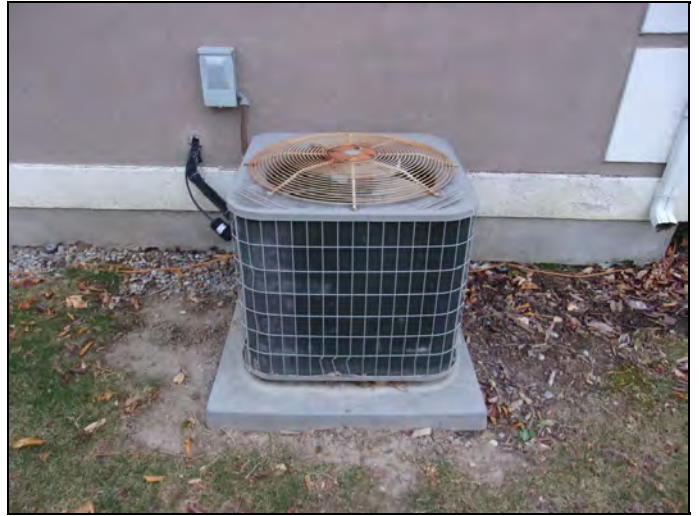
Comp #: 705 HVAC Condenser - Replace

The HVAC condenser is in working condition. We recommend replacing this component approximately every 20 years. Remaining life based on current age.

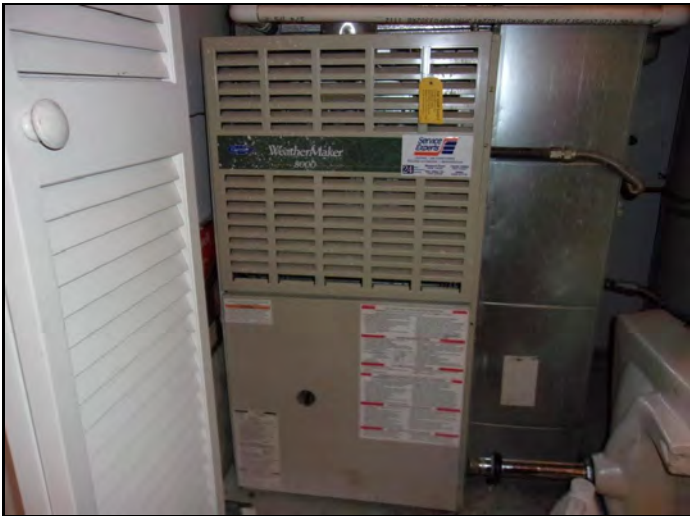
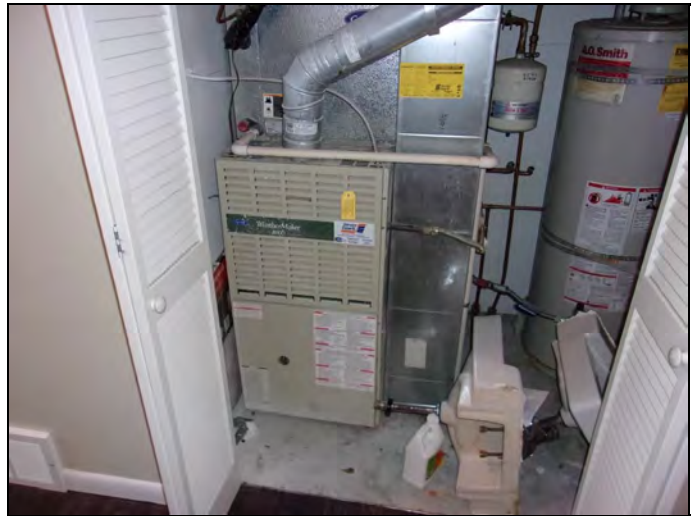
Comp #: 706 HVAC Furnace - Replace

The furnace is in working condition. We recommend funding to replace this component approximately every 20 years. Remaining life based on current age.

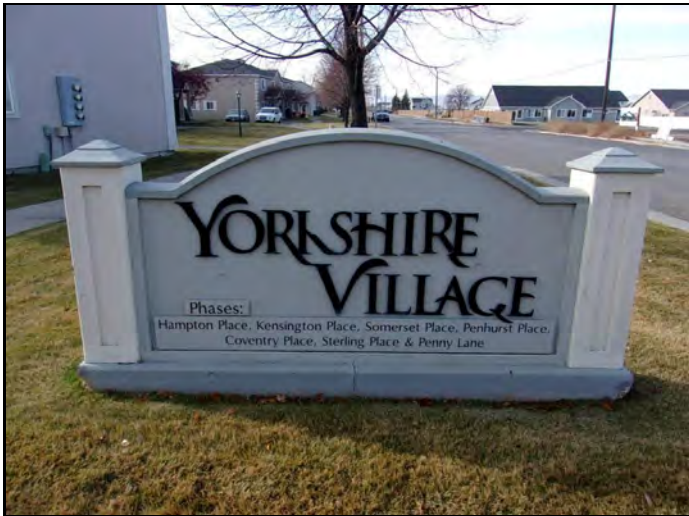
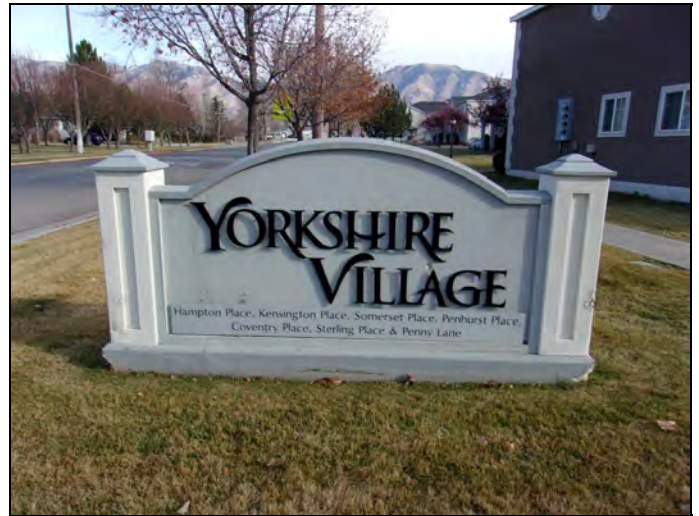
Comp #: 801 Monument Sign - Refurbish

The monument sign is in fair to poor condition. We recommend funding to refurbish this component approximately every 15 - 20 years. Remaining life is based on current age.

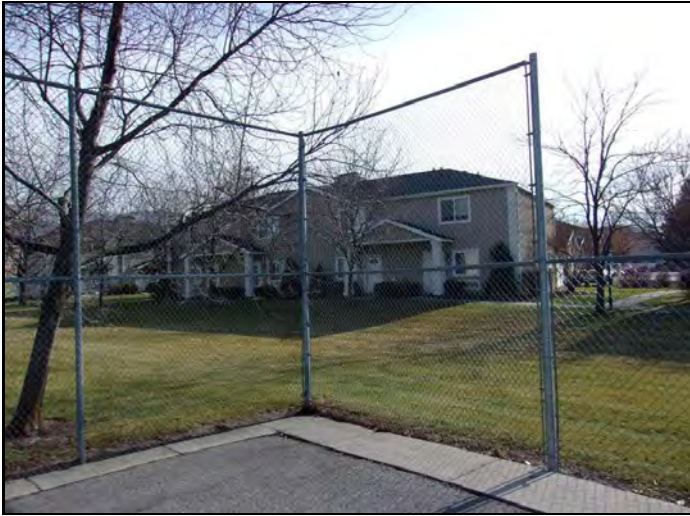
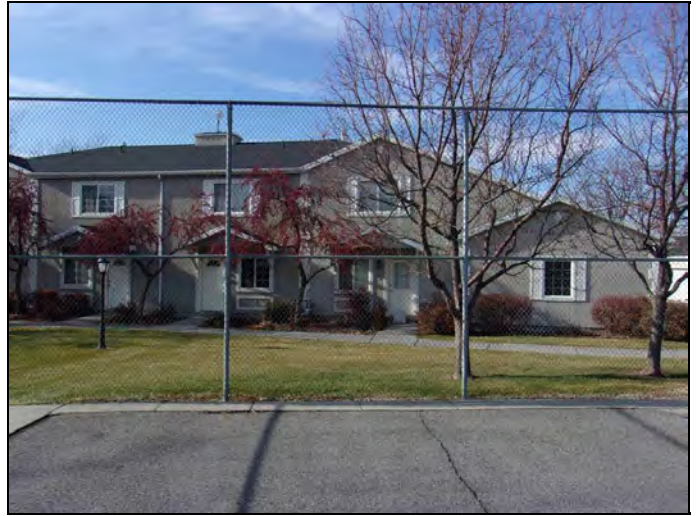
Comp #: 1003 Chain Link Fencing - Replace

The chain link fencing is in fair condition. We recommend funding to replace this component approximately every 30 - 40 years. Remaining life based on current age.

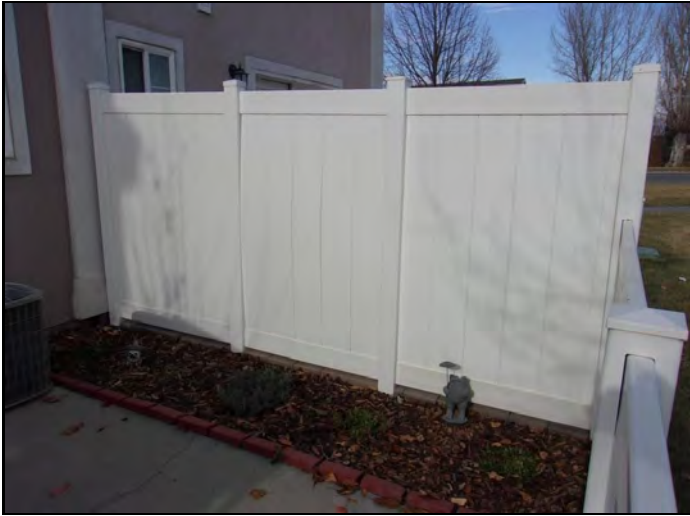
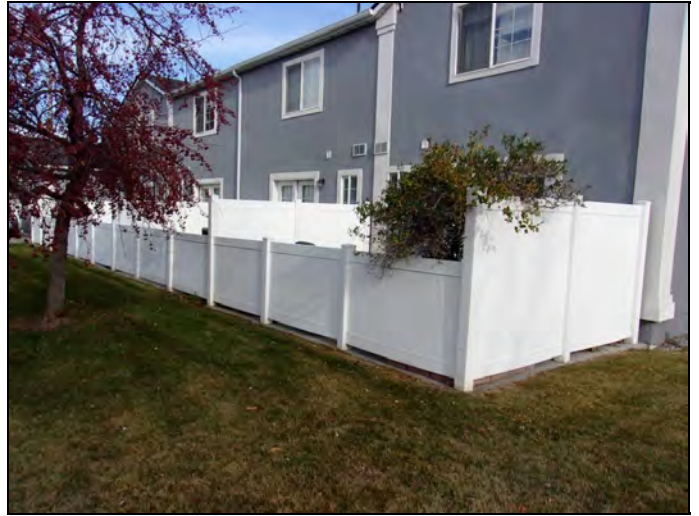
Comp #: 1008 Vinyl Fencing - Replace

The vinyl fencing is generally in good condition. We recommend funding to replace this component approximately every 25 - 30 years. Remaining life based on current age.

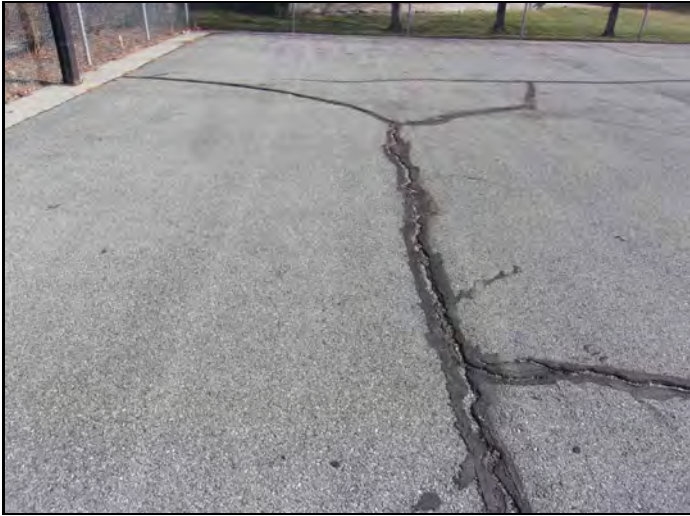
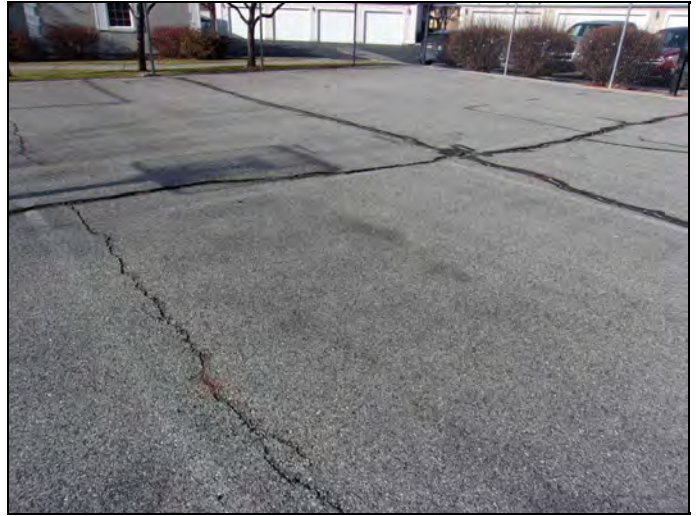
Comp #: 1201 Basketball/Tennis Court - Resurface

The court surface is in poor condition. We recommend funding to resurface this component approximately every 8 - 10 years. Remaining life based on current age.

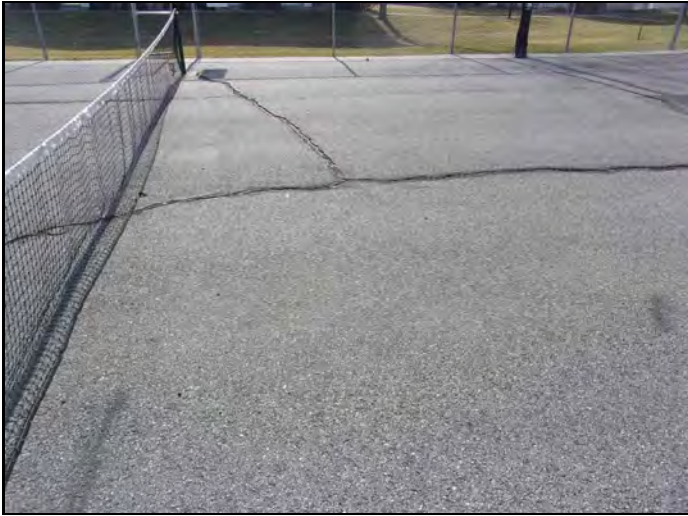
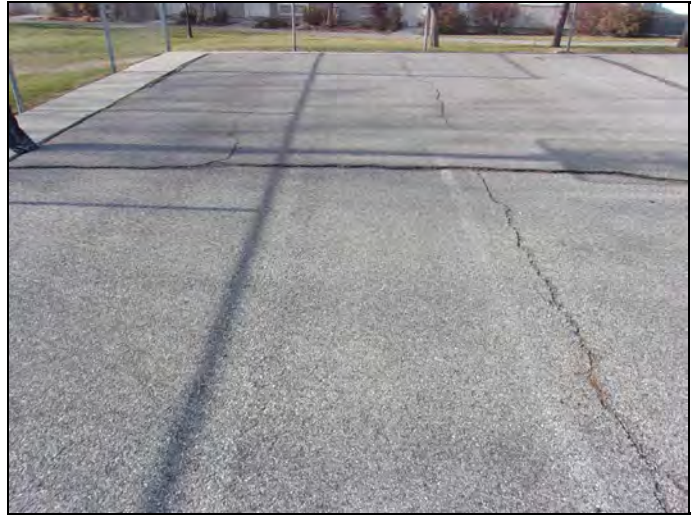
Comp #: 1203 Basketball/Tennis Court - Replace

The court is generally in fair condition. We recommend funding to replace this component approximately every 25 - 30 years. Remaining life based on current age.

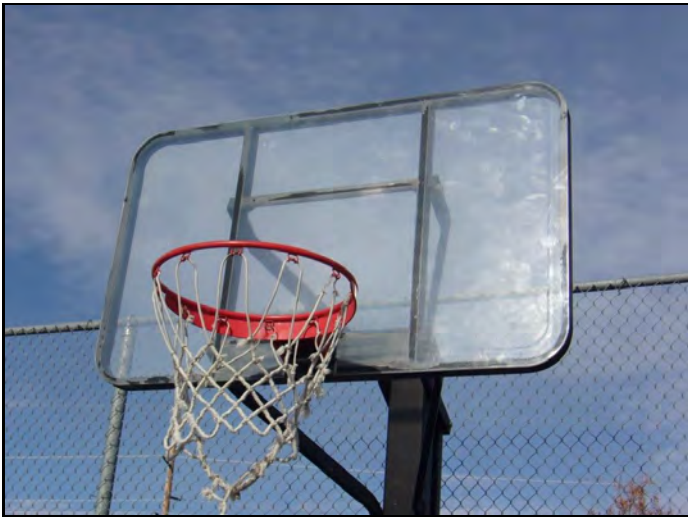
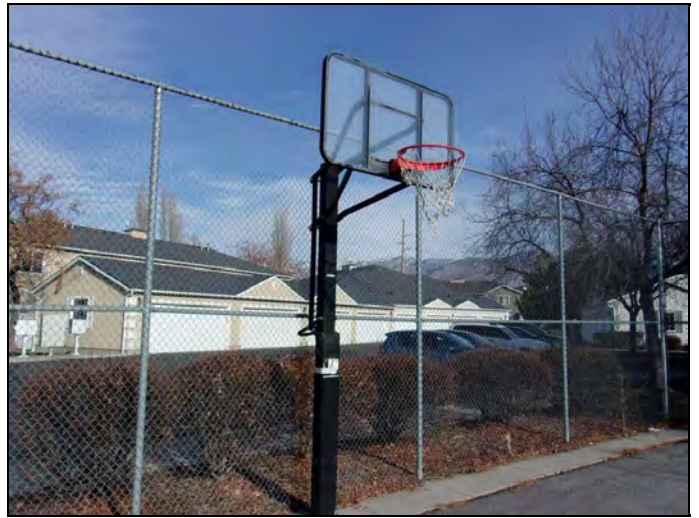
Comp #: 1207 Basketball Equipment - Replace

The basketball equipment is in fair condition. We recommend funding to replace this component approximately every 10 - 15 years. Remaining life is based on current condition.

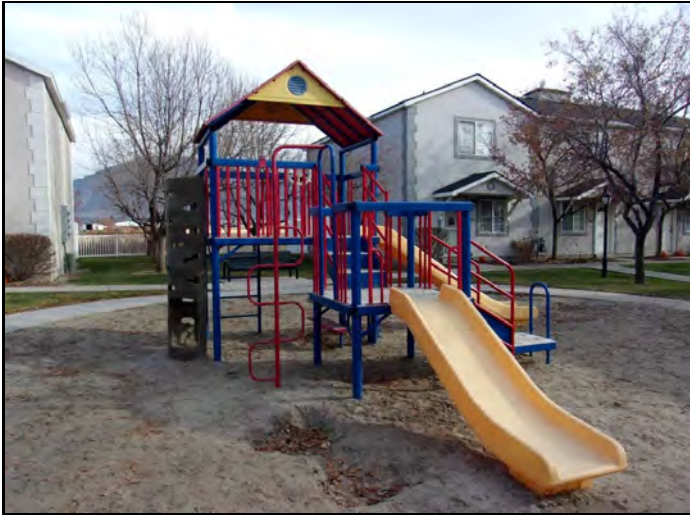
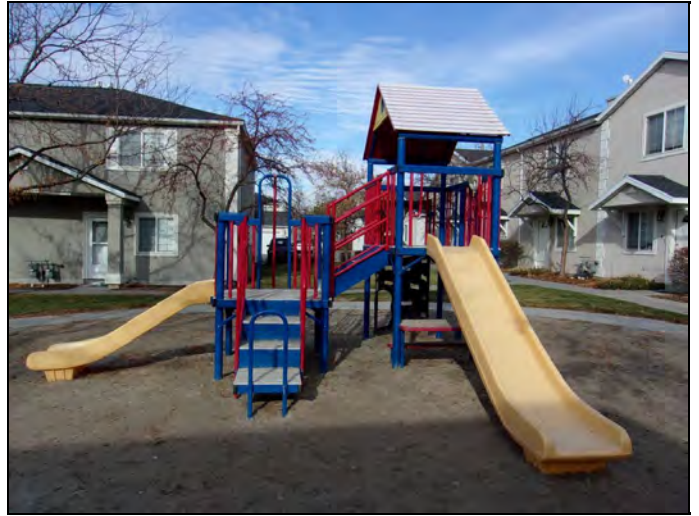
Comp #: 1301 Play Structures - Replace

The play structures are in good to fair condition. We recommend funding to replace this component approximately every 20 - 25 years. Remaining life based on current age.

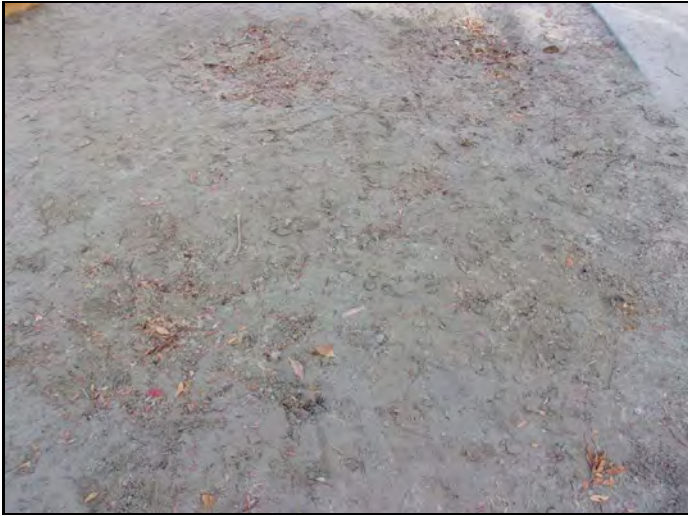
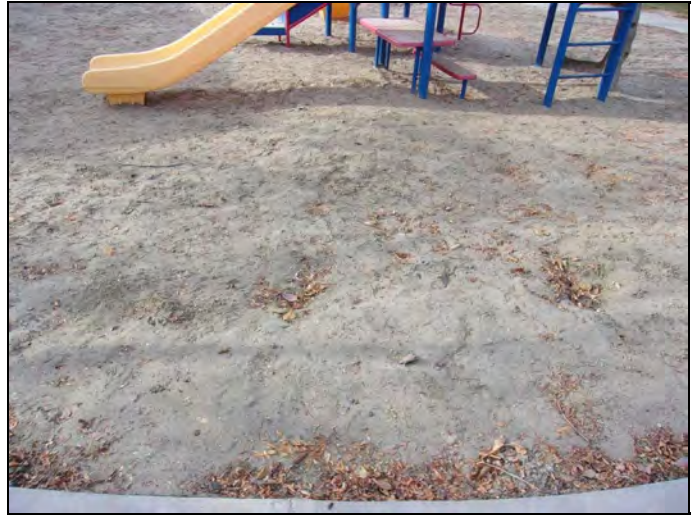
Comp #: 1303 Play Area Groundcover - Refill

The play area groundcover is in fair to poor condition. We recommend funding to refill this component approximately every 3 - 5 years. Remaining life is based on current condition.

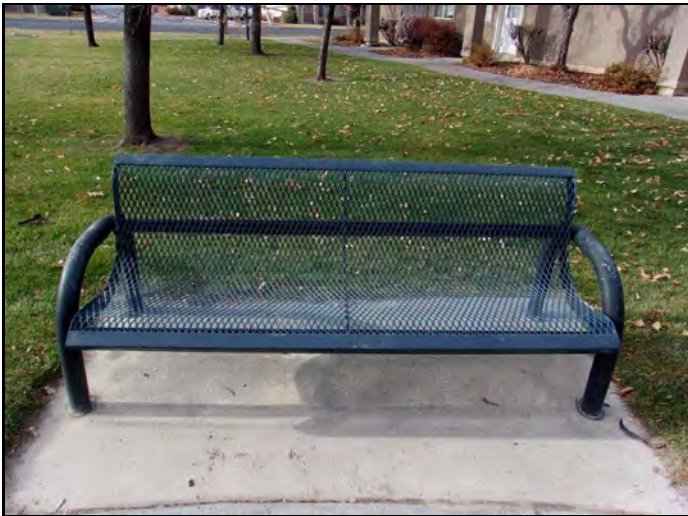
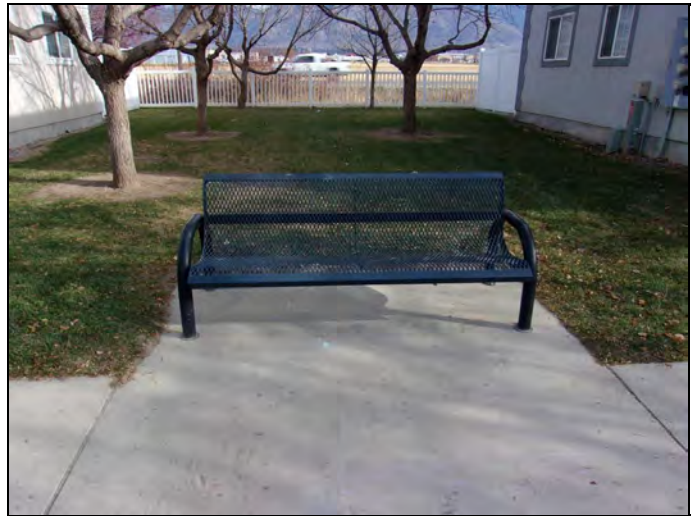
Comp #: 1307 Benches - Replace

The benches are in fair condition. We recommend funding to replace this component approximately every 10 - 15 years. Remaining life based on current condition.

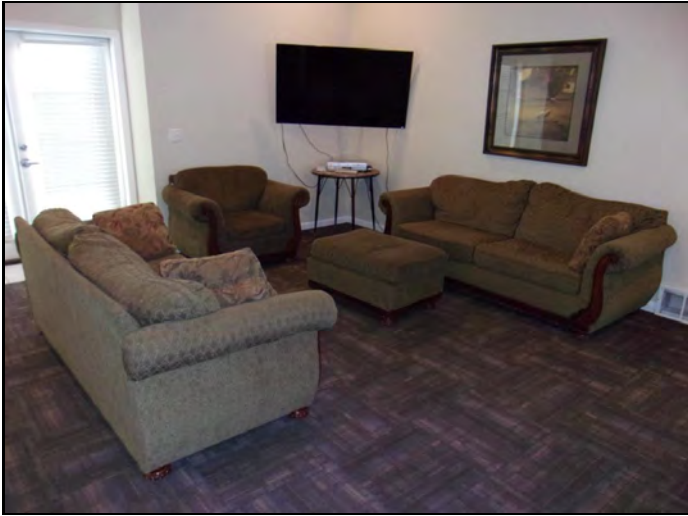
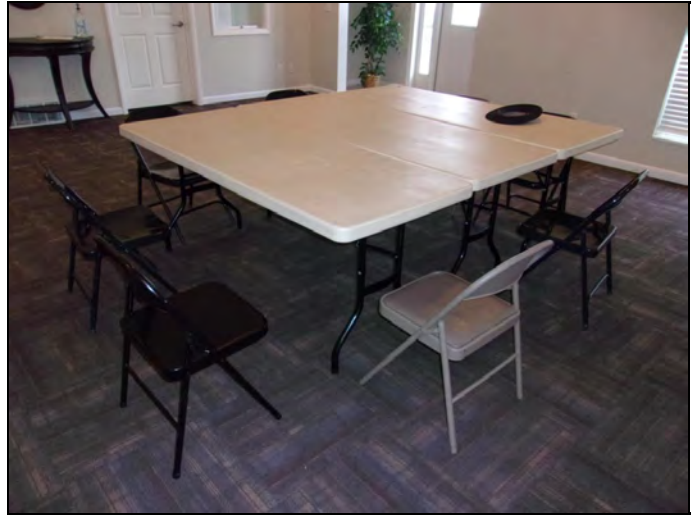
Comp #: 1405 Furniture - Replace

The furniture is generally in fair condition. We recommend funding an allowance to make replacements approximately every 10 years. Remaining life based on current age.

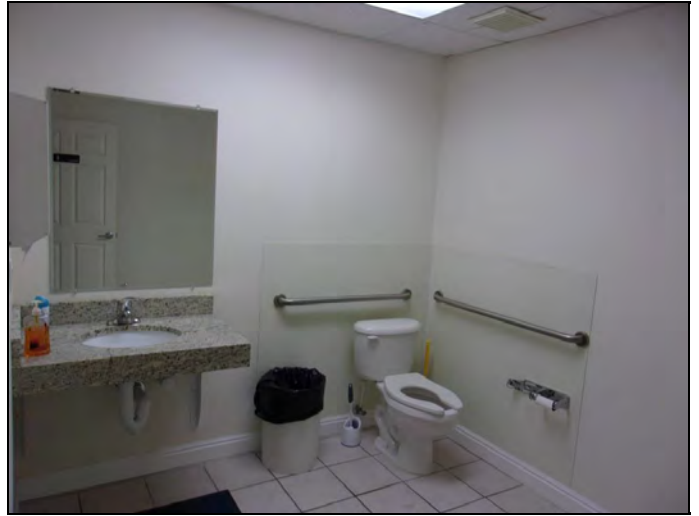
Comp #: 1413 Restrooms - Remodel

The restrooms are in good to fair condition. We recommend funding to remodel this component approximately every 20 years. Remaining life based on current age.

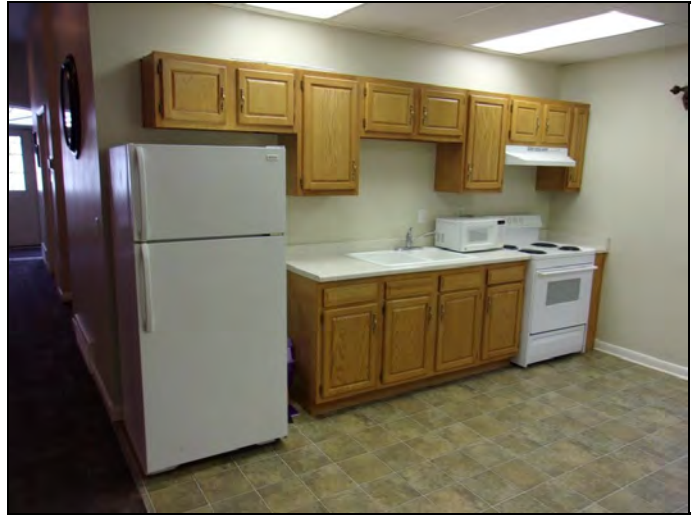
Comp #: 1417 Kitchen - Remodel

The kitchen is in fair condition. We recommend funding to remodel this component approximately every 20 years. Remaining life based on current age and condition.

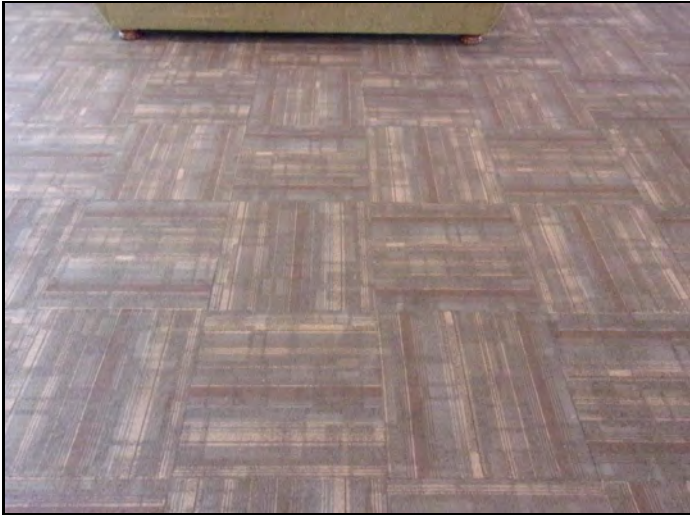
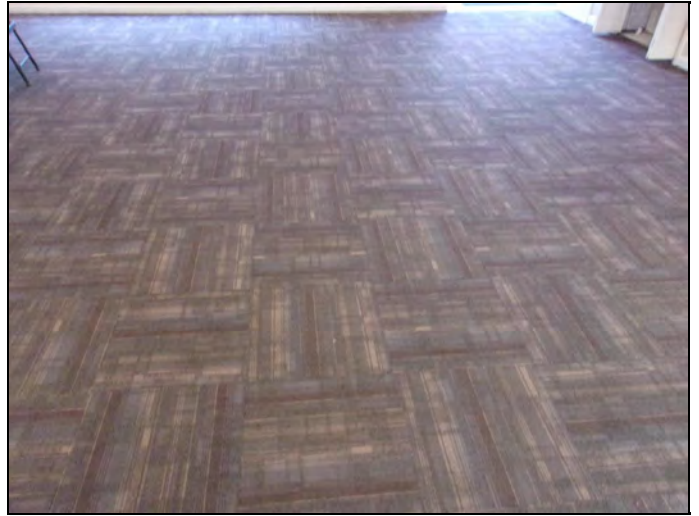
Comp #: 1501 Carpeting - Replace

The carpeting is in good to fair condition. We recommend funding to replace this component approximately every 8 - 10 years. Remaining life based on current age.

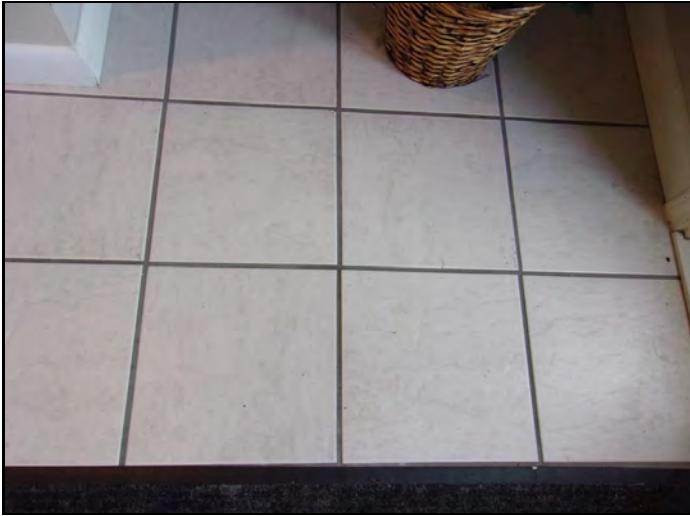
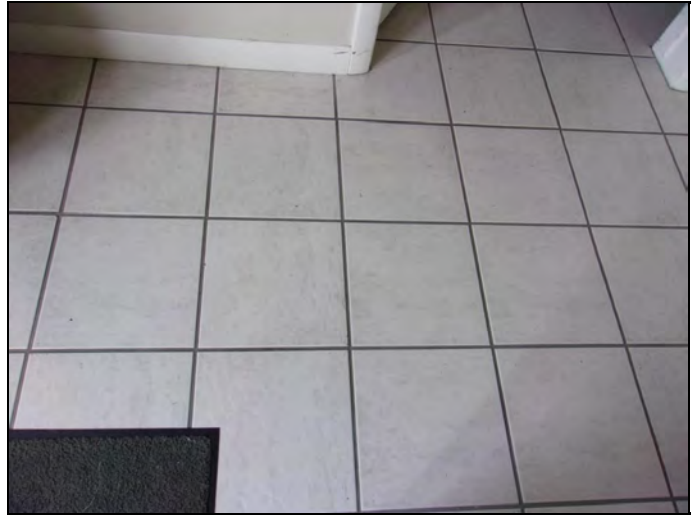
Comp #: 1503 Tile Flooring - Replace

The tile flooring is generally in good condition. We recommend funding to replace this component approximately every 30 years. Remaining life based on current age.

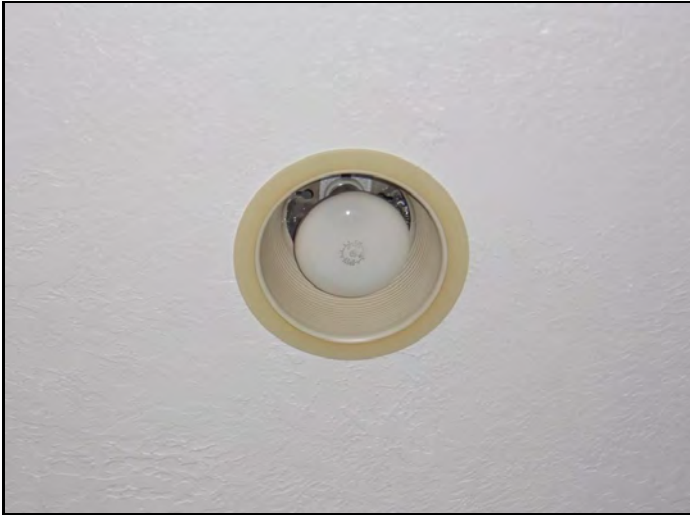
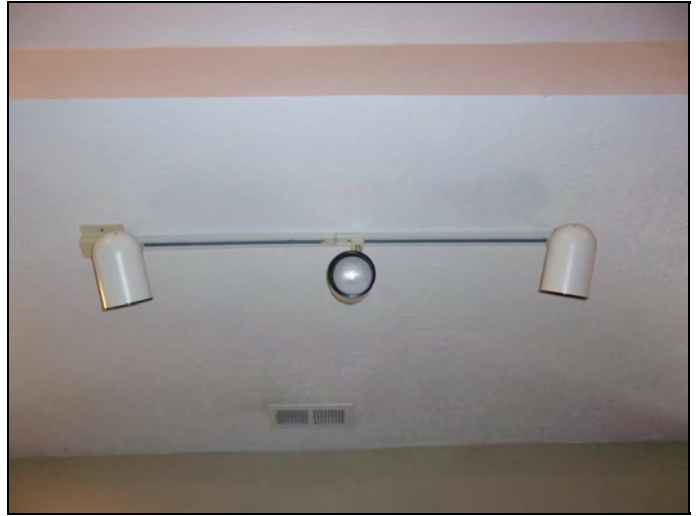
Comp #: 1601 Interior Light Fixtures - Replace

Research with the client reveals this component is being replaced as necessary as an operating expense.

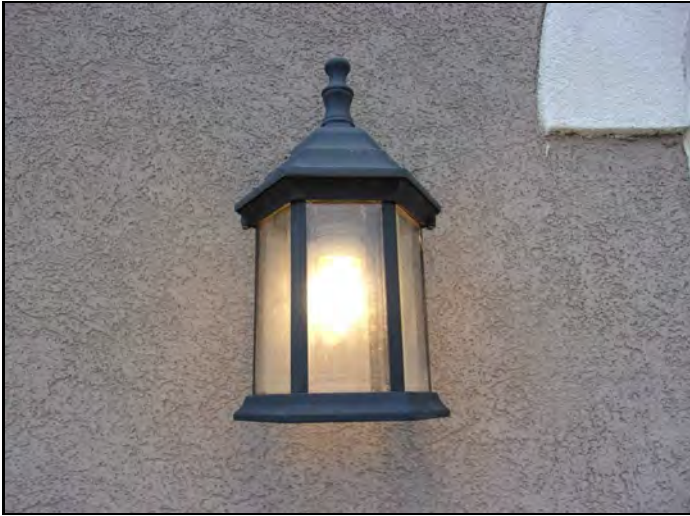
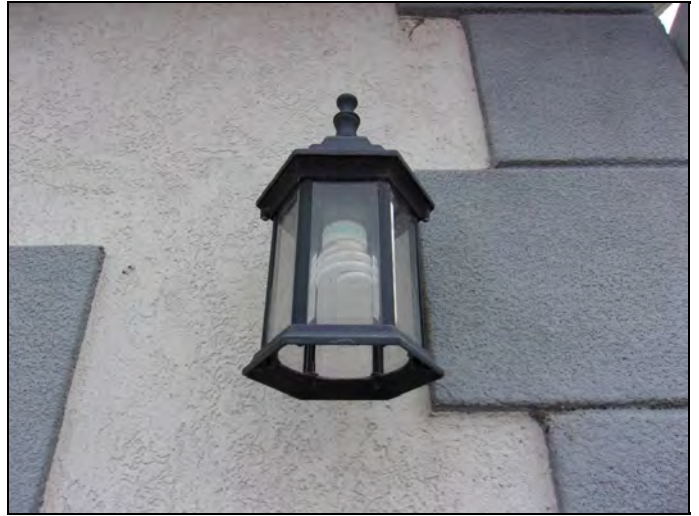
Comp #: 1602 Exterior Light Fixtures - Replace

Research with the client reveals this component is being replaced as necessary as an operating expense.

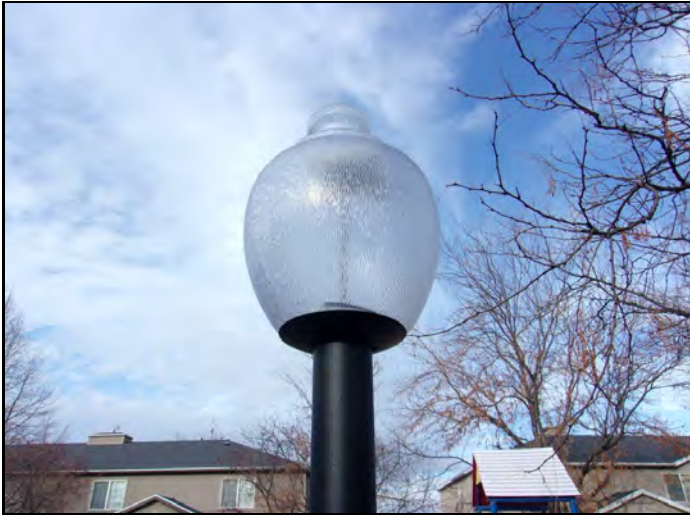
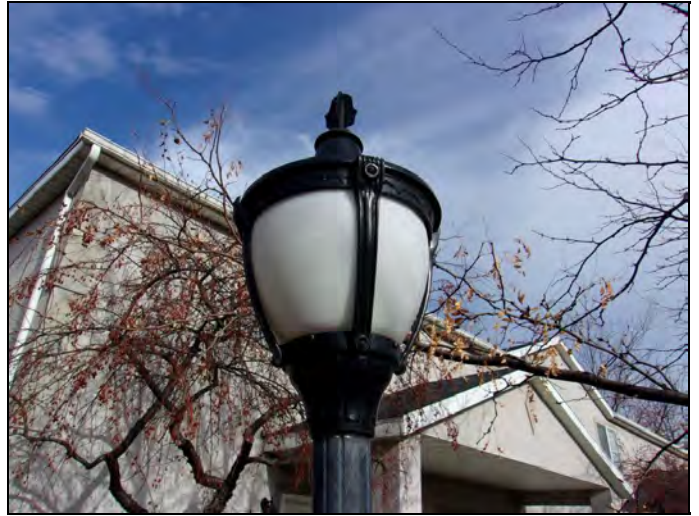
Comp #: 1604 Pole Lights - Replace

Research with the client reveals this component is being replaced as necessary as an operating expense.

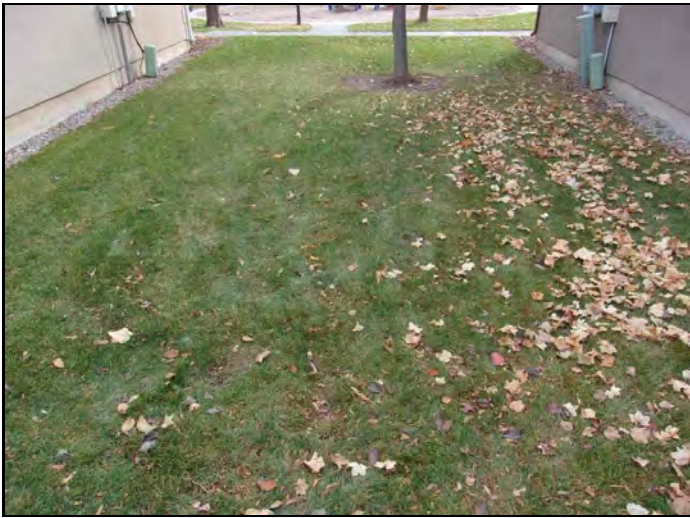
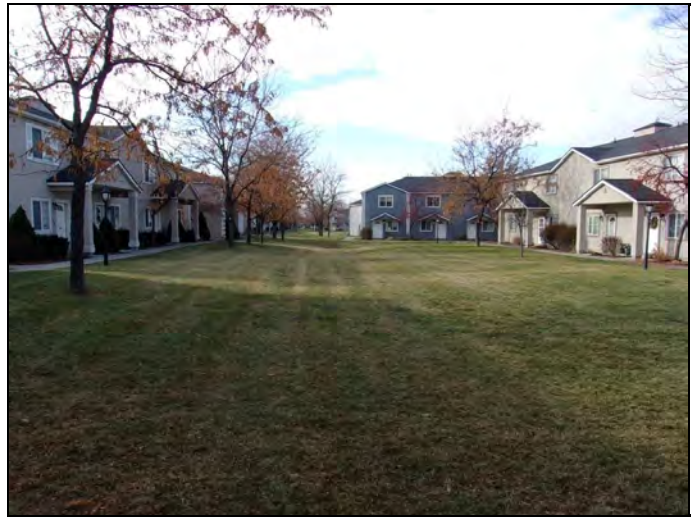
Comp #: 1812 Landscaping & Irrigation System - Renovate

The landscaping and irrigation system are in good to fair condition. We recommend funding for an allowance to renovate the landscaping and irrigation system approximately every 20 years. Remaining life based on current age.
