Northridge Townhomes

Level 1 Reserve Study

Executive Summary – Northridge Townhomes - ID # 18019

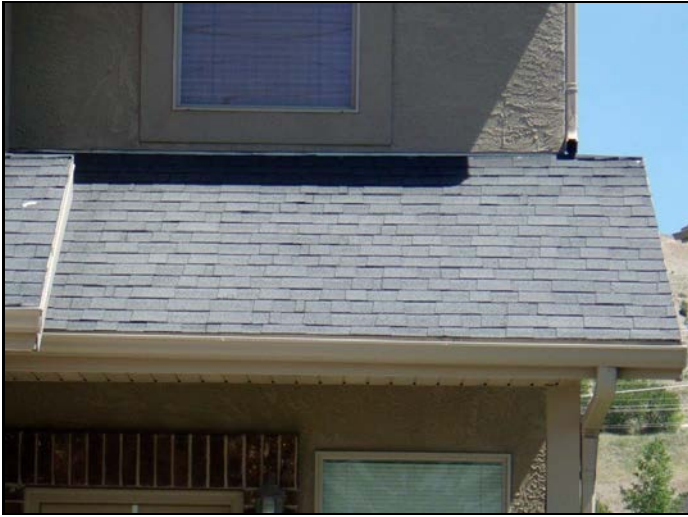
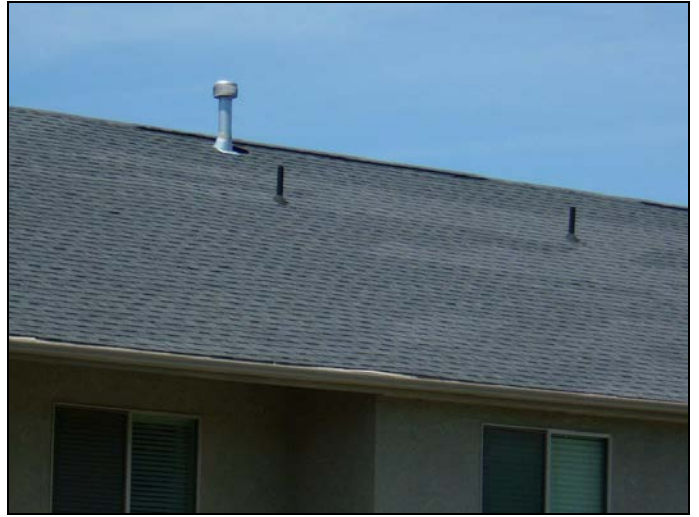
Comp #: 105 Roofs - Replace

Location: **Building Roofs**

The roofs are in good to fair condition. We recommend funding to replace this component approximately every 20 - 25 years. Remaining life based on current age.

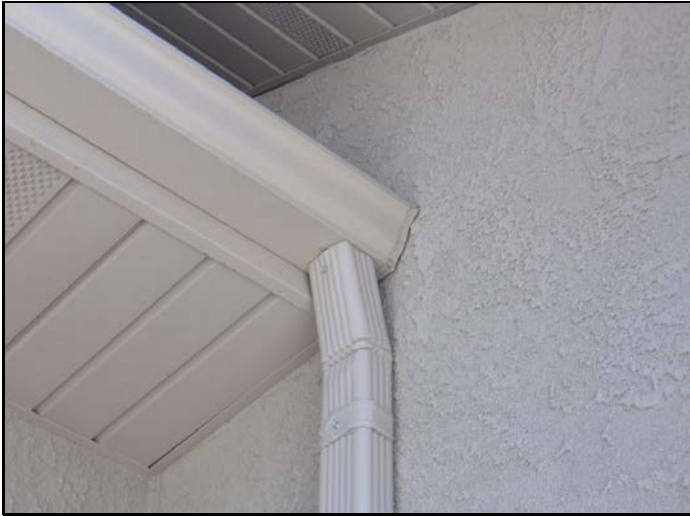
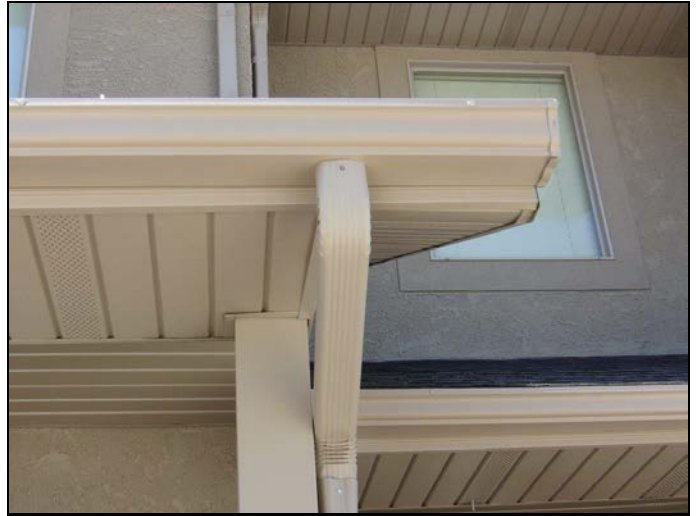
Comp #: 120 Rain Gutters/Downspouts - Replace

Location: **Building Exteriors**

The rain gutters and downspouts are in good condition. We recommend funding to replace this component approximately every 25 - 30 years. Remaining life based on current age.

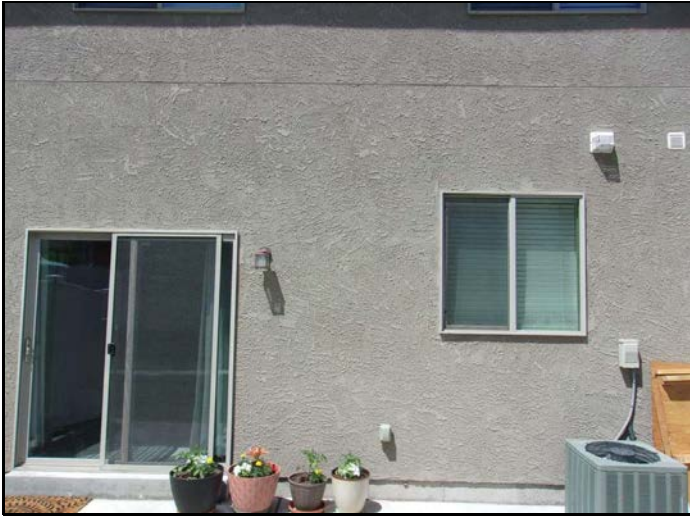
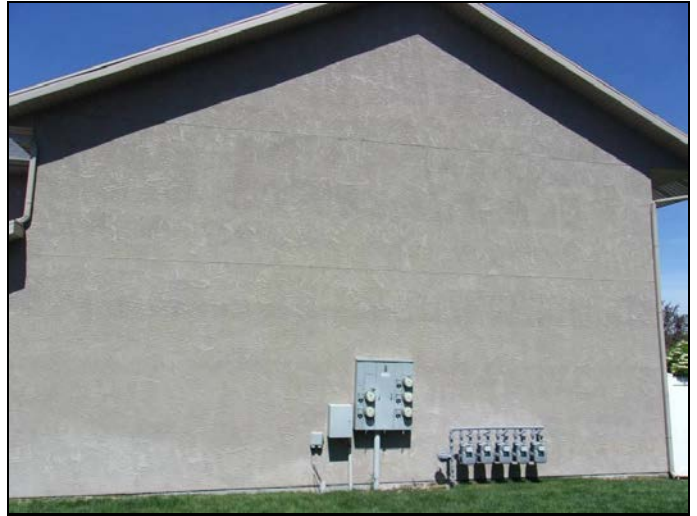
Comp #: 201 Stucco Surfaces - Repair/Repaint

Location: **Building Exteriors**

The stucco surfaces are generally in good to fair condition. We recommend funding to repair/repaint this component approximately every 12 - 15 years. Remaining life based on current age and condition.

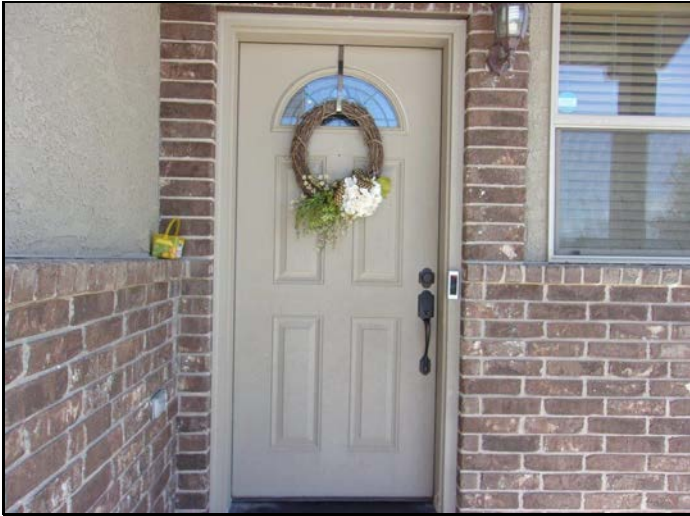
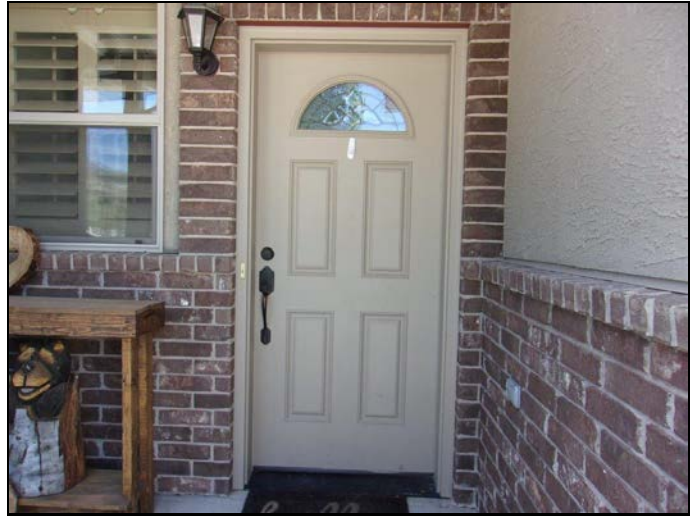
Comp #: 204 Front Doors - Repaint

Location: **Unit Entrances**

The painted door surfaces are in fair to poor condition. We recommend funding to repaint this component approximately every 8 - 10 years. Remaining life based on current age.

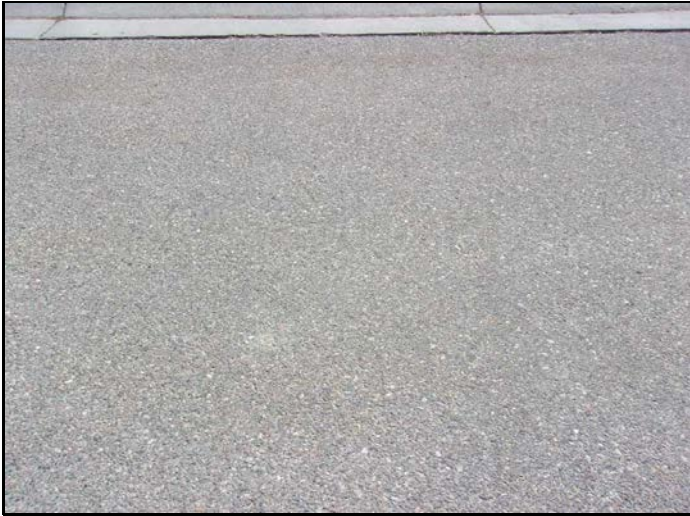
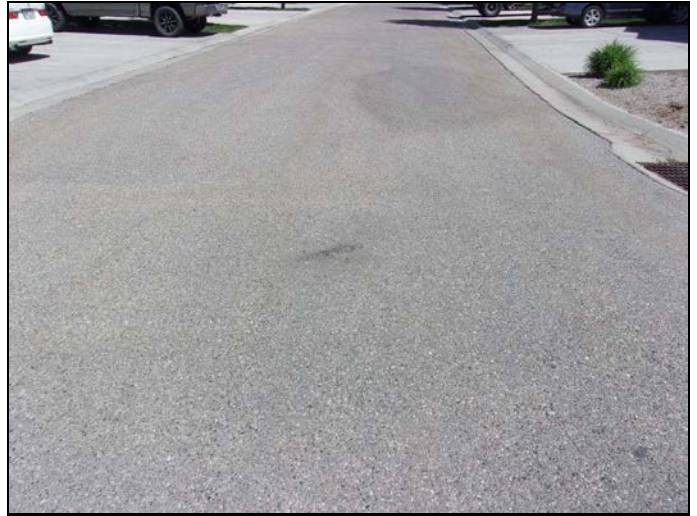
Comp #: 401 Asphalt - Major Rehab

Location: **Community Streets**

The asphalt surfaces are in good condition. We recommend funding for a major rehab of this component approximately every 25 - 30 years. Remaining life based on current age.

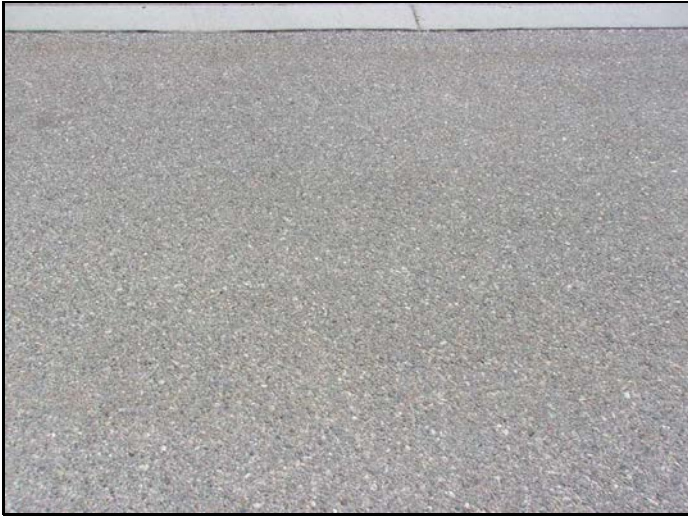
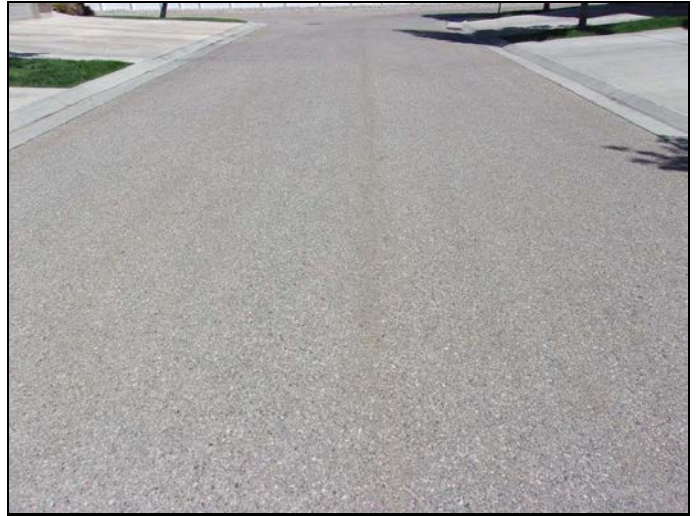
Comp #: 402 Asphalt - Seal Coat

Location: **Community Streets**

The asphalt seal coat is in poor condition. We recommend funding to seal this component approximately every 3 - 5 years. Remaining life based on current condition.

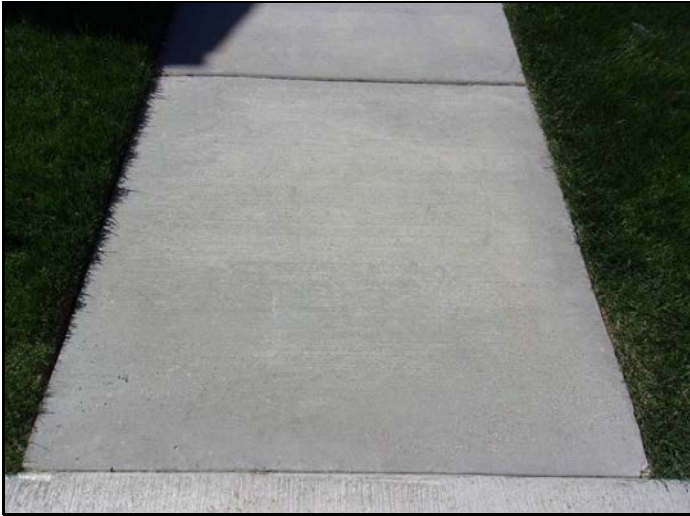
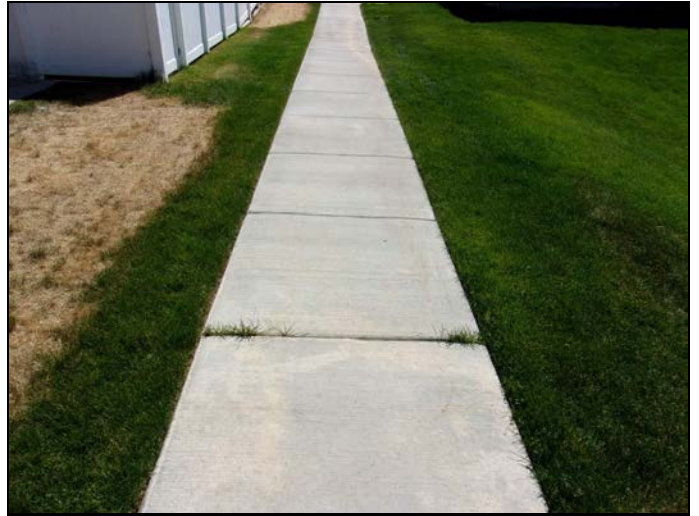
Comp #: 403 Concrete - Partial Repair/Replace

Location: **Common Area**

The concrete is generally in good condition. This component has an extended useful life under normal conditions. We recommend funding to make repairs and partially replace this component approximately every 10 years. Remaining life based on current age.

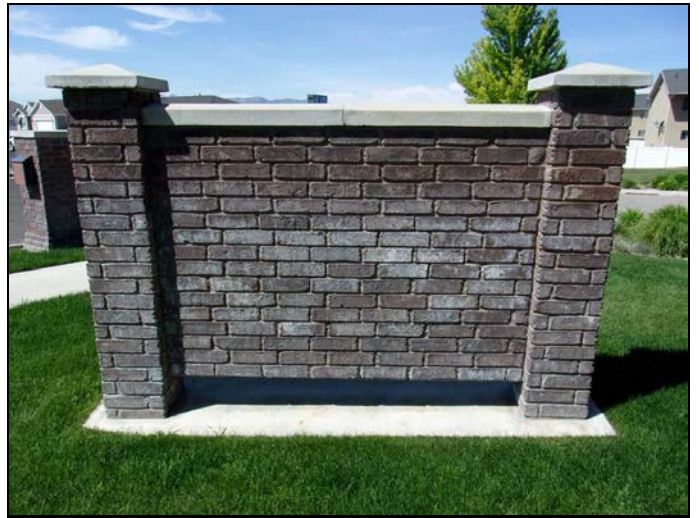
Comp #: 801 Monument Sign - Refurbish

Location: **West Community Entrance**

The monument sign is in good condition. We recommend funding to refurbish this component approximately every 15 - 20 years. Remaining life is based on current age.

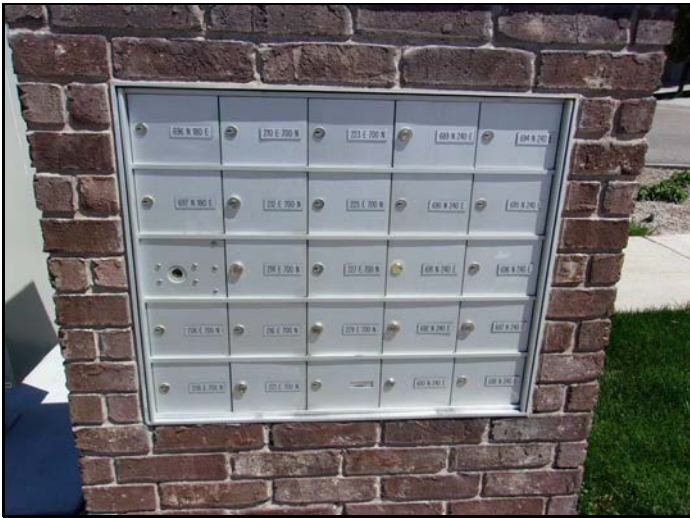
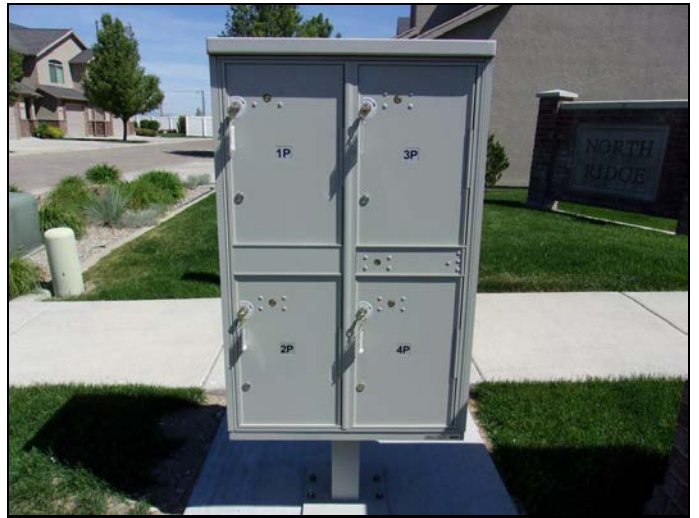
Comp #: 803 Mailboxes - Replace

Location: **Common Area**

The mailboxes are in good to fair condition. We recommend funding to replace this component approximately every 20 - 25 years. Remaining life based on current age.

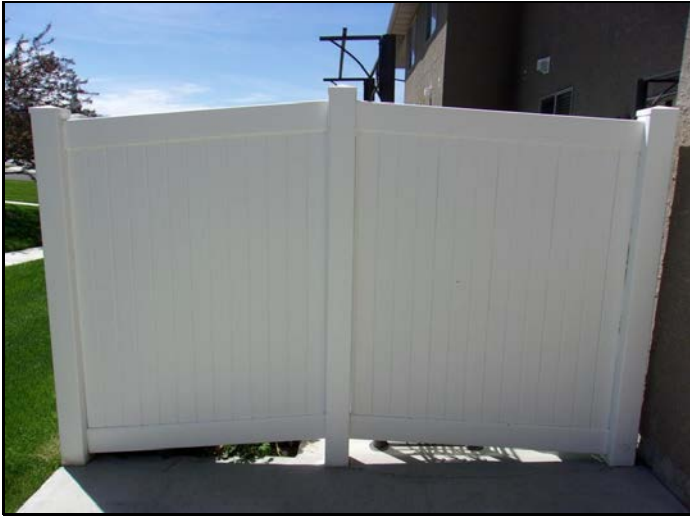
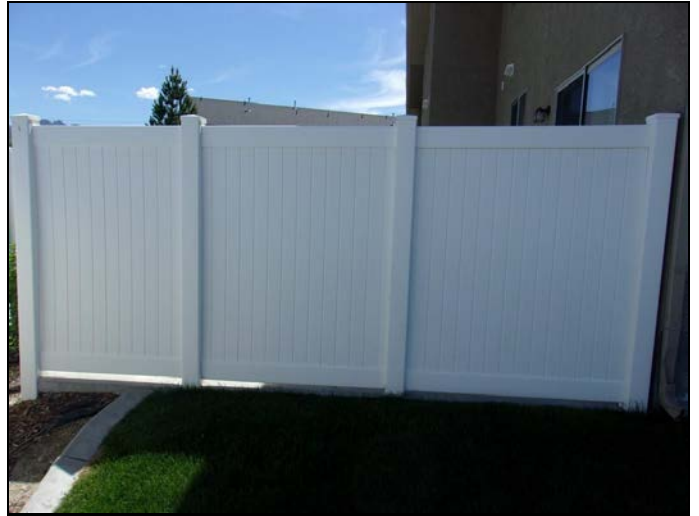
Comp #: 1008 Vinyl Fencing - Replace

Location: **Patio Privacy Screens**

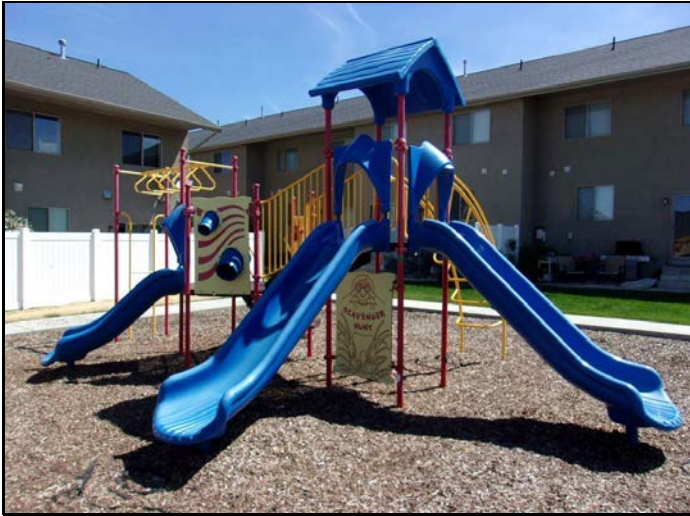
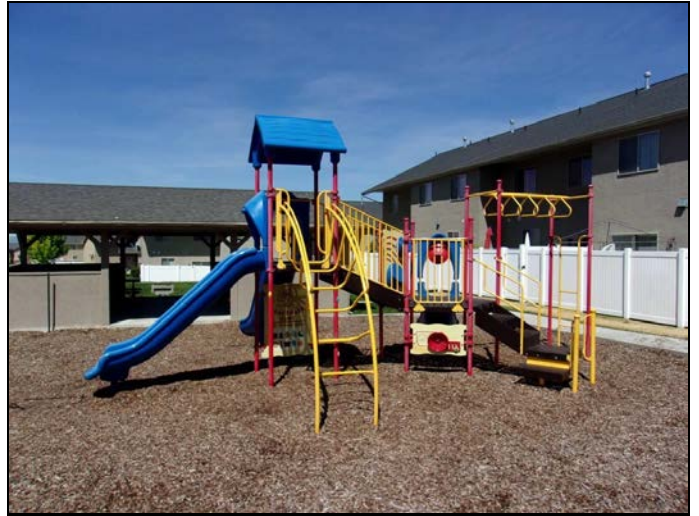
Comp #: 1301 Play Structure - Replace

Location: **Play Area**

The play structure is in good condition. We recommend funding to replace this component approximately every 20 - 25 years. Remaining life based on current age.

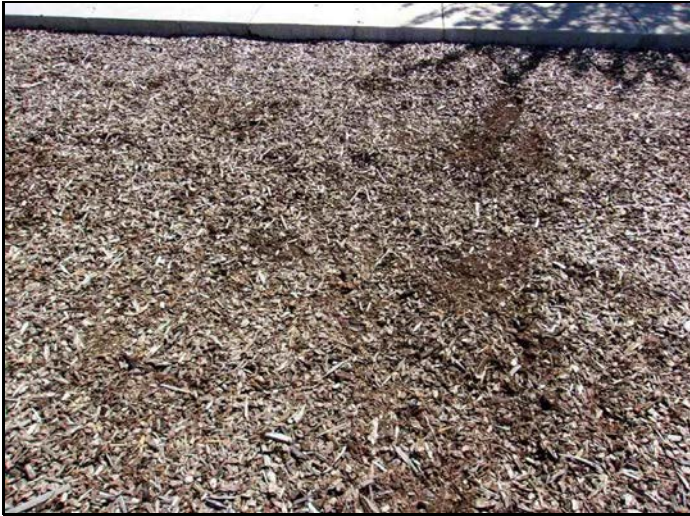
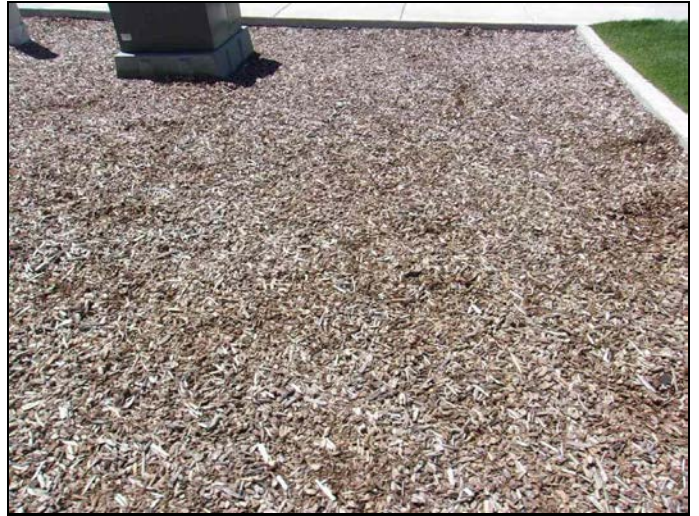
Comp #: 1303 Play Area Groundcover - Refill

Location: **Play Area**

The play area groundcover is in fair to poor condition. We recommend funding to refill this component approximately every 3 - 5 years. Remaining life is based on current condition.

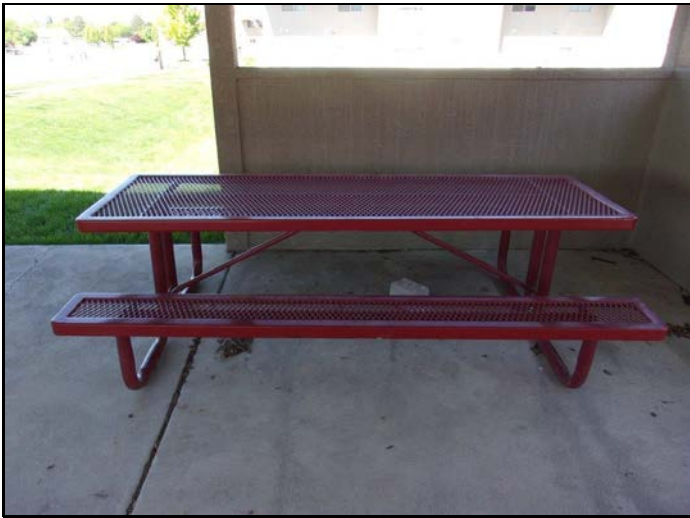
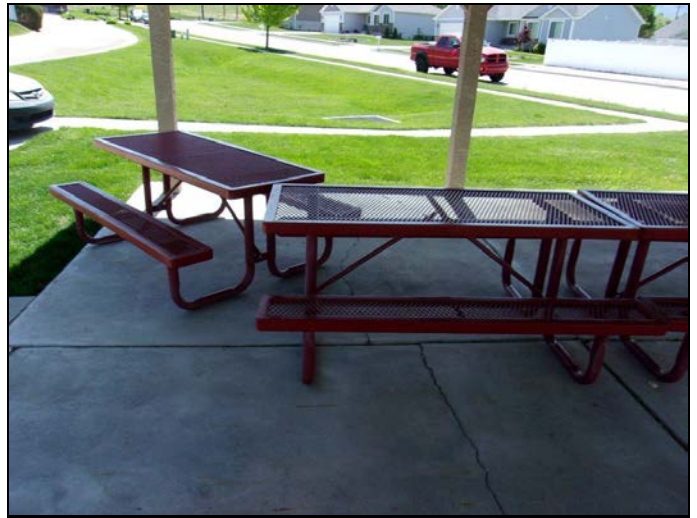
Comp #: 1306 Picnic Tables - Replace

Location: **Pavilions**

The picnic tables are in good to fair condition. We recommend funding to replace this component approximately every 10 - 15 years. Remaining life based on current age.

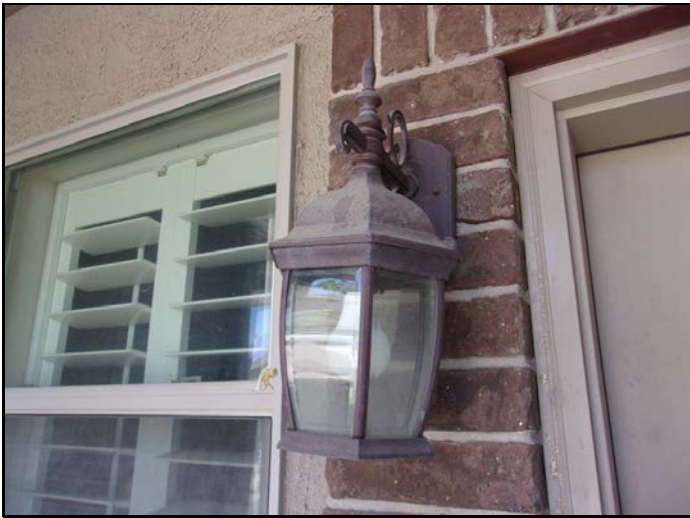
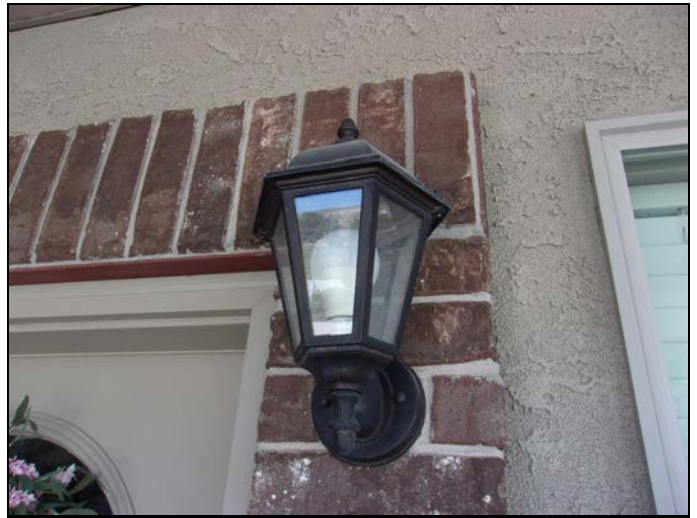
Comp #: 1602 Exterior Light Fixtures - Replace

Location: **Building Exteriors**

The exterior light fixtures are in good to fair condition. We recommend funding to replace this component approximately every 16 - 20 years. Remaining life based on current age.

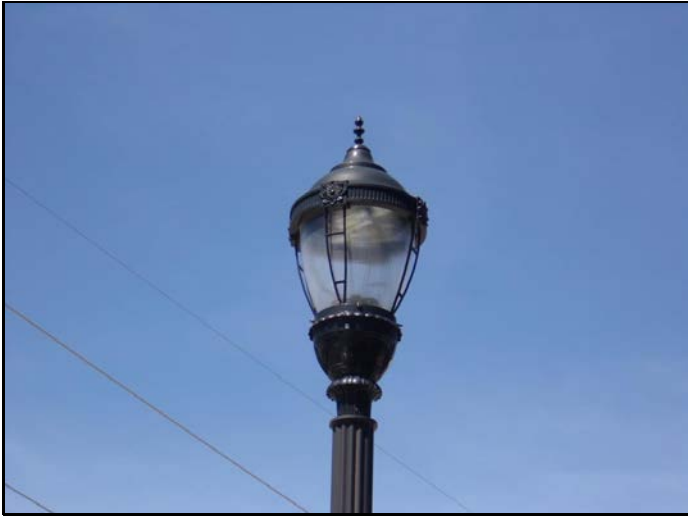
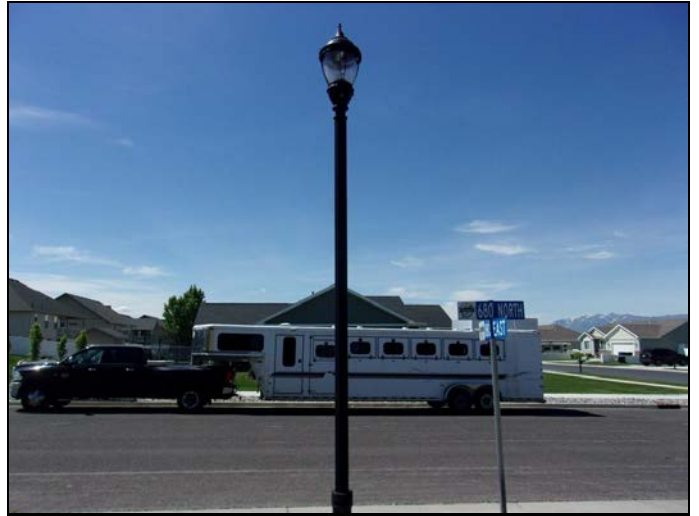
Comp #: 1609 Street Light Fixtures - Replace

Location: **Community Streets**

The street light fixtures are in good condition. No expectation to replace the light poles. Paint poles as necessary as an operating expense. We recommend funding to replace this component approximately every 20 years. Remaining life based on current age.

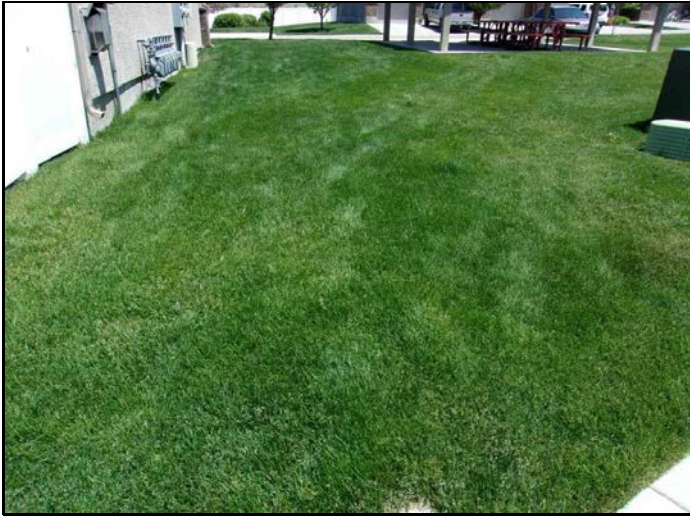
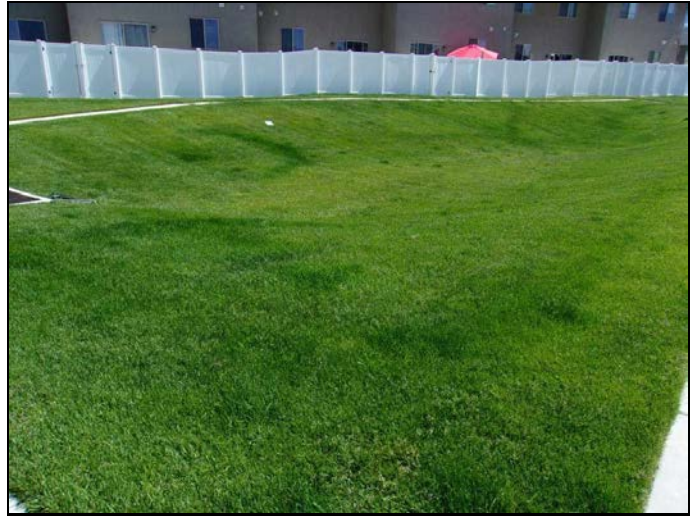
Comp #: 1812 Landscaping & Irrigation System - Renovate

Location: **Common Area**

The landscaping and irrigation system are in good to fair condition. We recommend funding for an allowance to renovate the landscaping and irrigation system approximately every 20 years. Remaining life based on current age.
