Mt. Aire Gardens

Level 3 Reserve Study

Client Reference Number	18782
Property Type	Condominium
Number of Units	52
Fiscal Year End	12/31

Type of Study	Update No Site Visit
Date of Property Inspection	N/A
Prepared By	Dale Gifford
Analysis Method	Cash Flow
Funding Goal	Full Funding

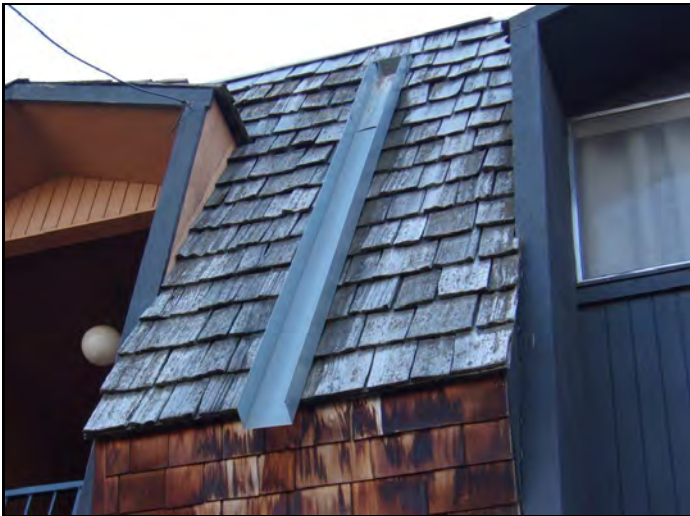
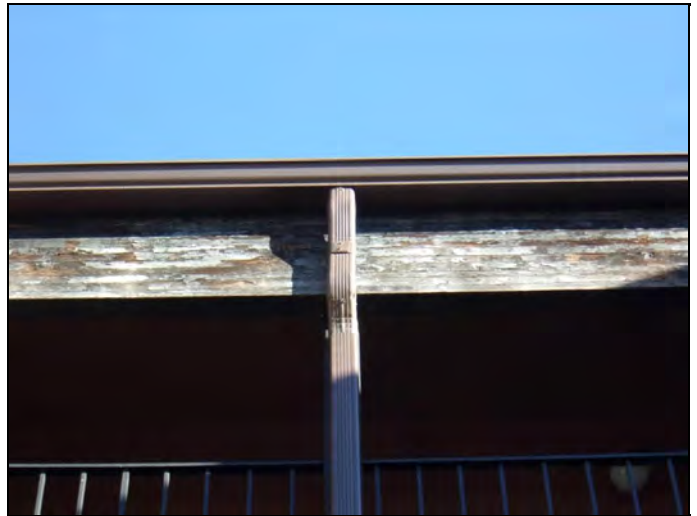
Comp #: 120 Rain Gutters/Downspouts - Replace

Location: **Building Exteriors**

Quantity: **Approx 440 LF**

The rain gutters and downspouts are in good to fair condition. We recommend funding to replace this component approximately every 25 - 30 years. Remaining life based on current age.

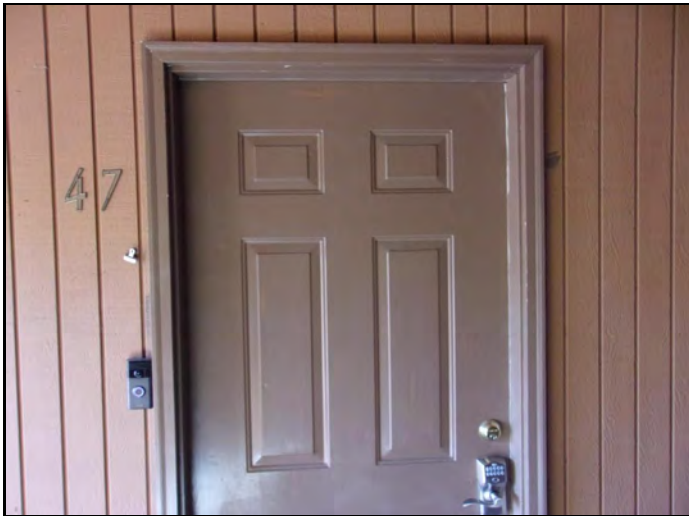
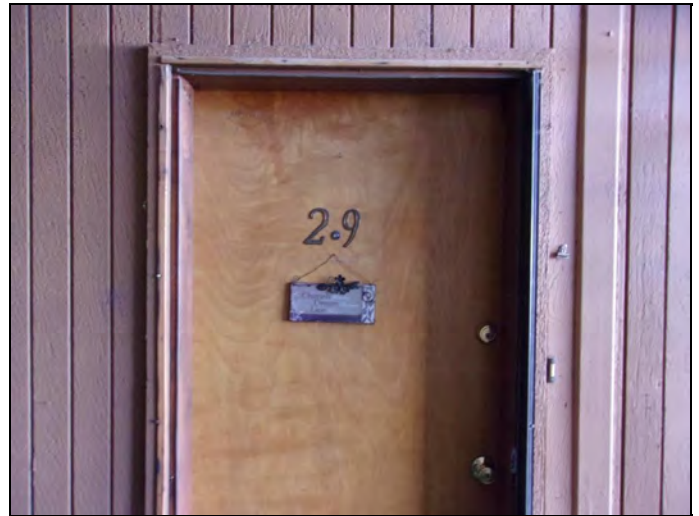
Comp #: 204 Doors - Repaint/Refinish

Location: **Building Exteriors**

Quantity: **(112) Doors**

The painted door surfaces are in fair to poor condition. We recommend funding to repaint this component approximately every 8 - 10 years. Remaining life based on current average condition.

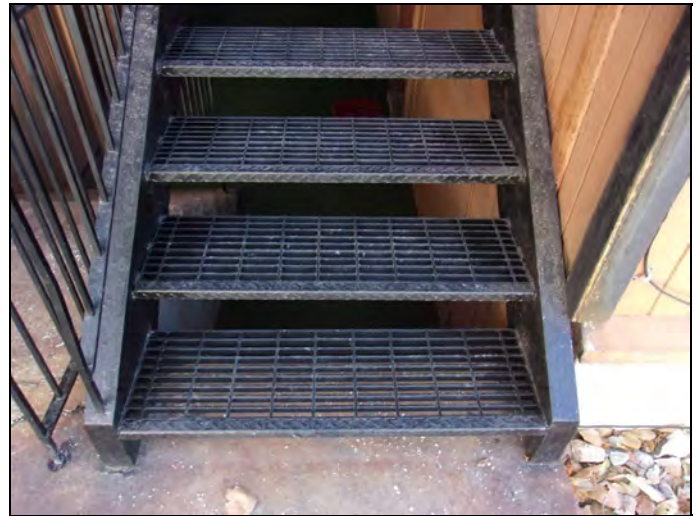
Comp #: 212 Metal Surfaces - Repaint

Location: **Breezeways & Stairwells**

Quantity: **(3) Buildings**

The painted metal surfaces are in good to fair condition. We recommend funding to paint this component approximately every 6 - 8 years. Remaining life based on current condition.

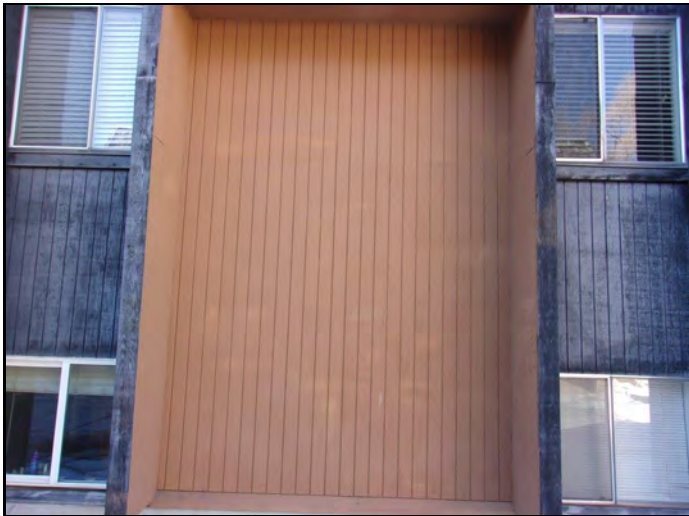
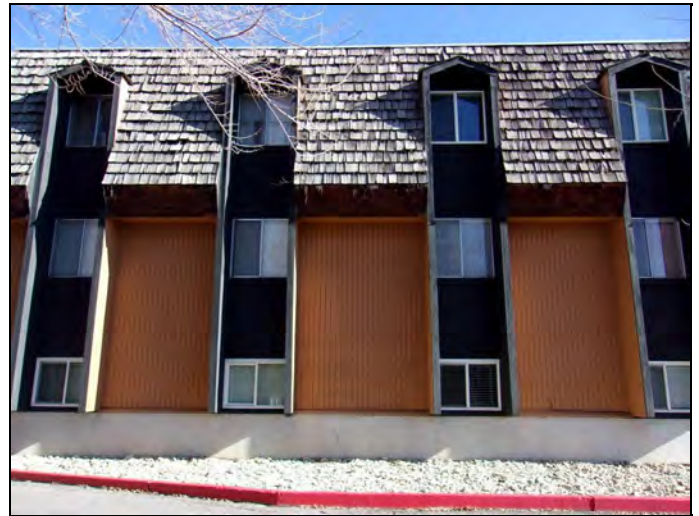
Comp #: 215 Building Exteriors & Fence - Repair/Repaint

Location: **Building Exteriors**

Quantity: **Approx 24,330 SF**

The painted surfaces are in fair to poor condition. We recommend funding to repair/repaint this component approximately every 8 - 10 years. Remaining life is based on current condition.

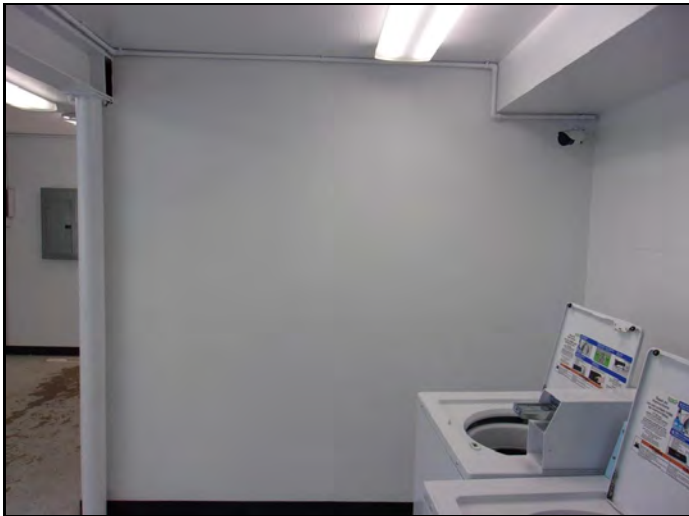
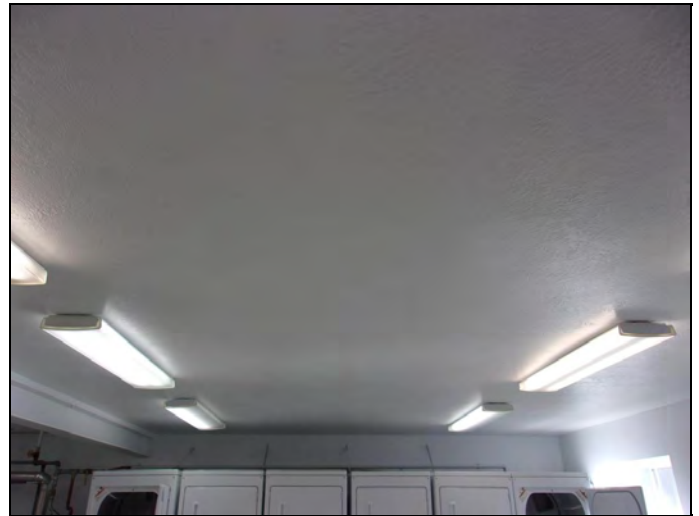
Comp #: 216 Laundry Room - Repaint

Location: **Laundry Room**

Quantity: **Approx 1,500 SF**

The painted surfaces are in good to fair condition. We recommend funding to repaint this component approximately every 8 - 10 years. Remaining life based on current age.

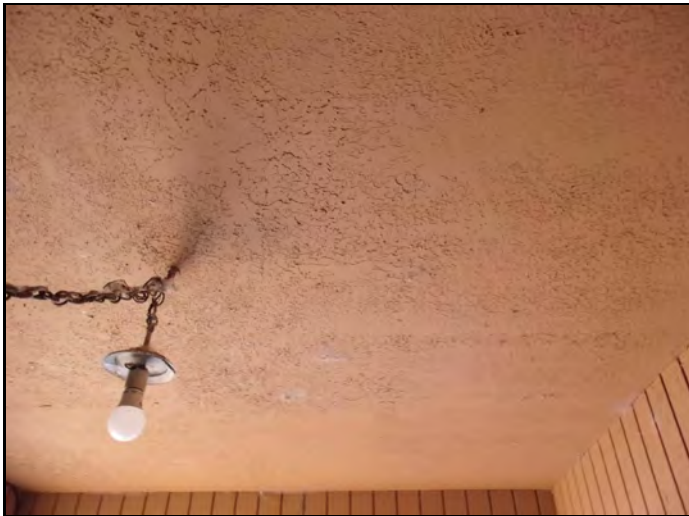
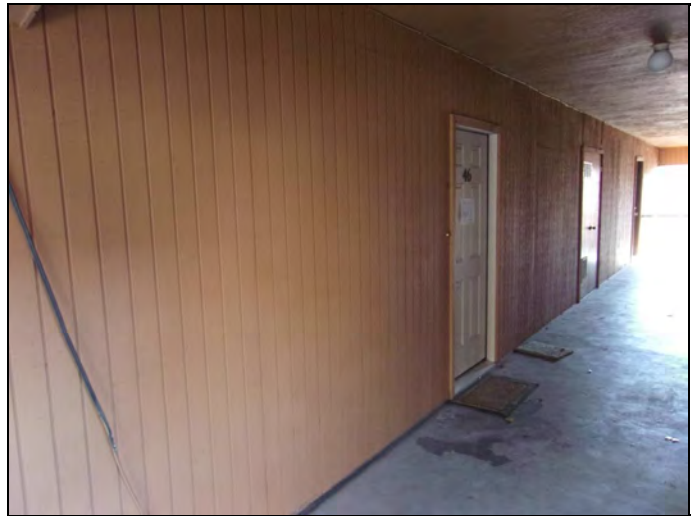
Comp #: 219 Breezeway Walls/Ceilings - Repair/Repaint

Location: **Building Breezeways**

Quantity: **Approx 15,400 SF**

The painted surfaces are in good to fair condition. We recommend funding to repair/repaint this component approximately every 8 - 10 years. Remaining life is based on current age.

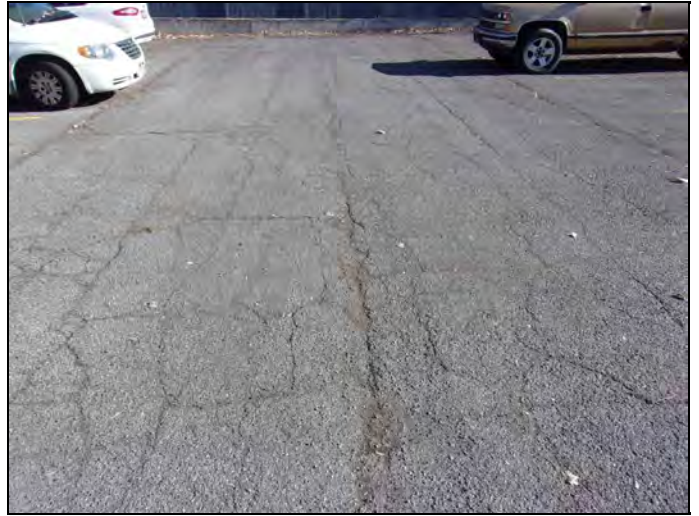
Comp #: 401 Asphalt - Major Rehab

Location: **Parking Lot**

Quantity: **Approx 43,000 SF**

The asphalt surfaces are in fair to poor condition. We recommend funding for a major rehab of this component approximately every 25 - 30 years. Remaining life based on current age and condition.

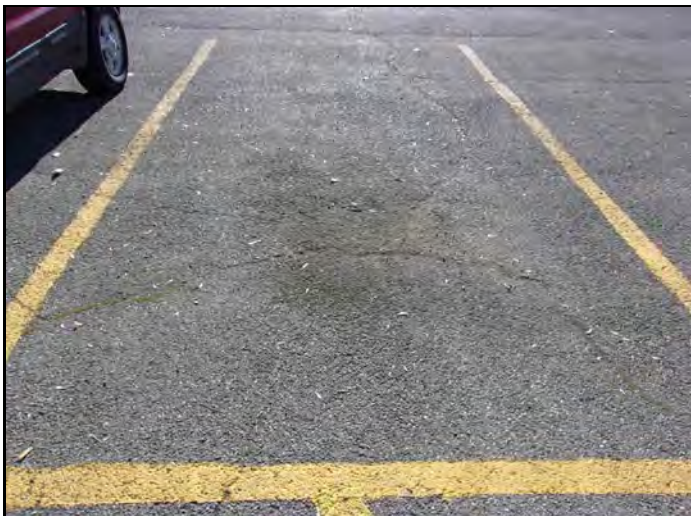
Comp #: 402 Asphalt - Seal Coat

Location: **Parking Lot**

Quantity: **Approx 43,000 SF**

Research with the client reveals this component will be completed in 2025. We recommend funding to seal this component approximately every 3 - 5 years. Remaining life based on current condition.

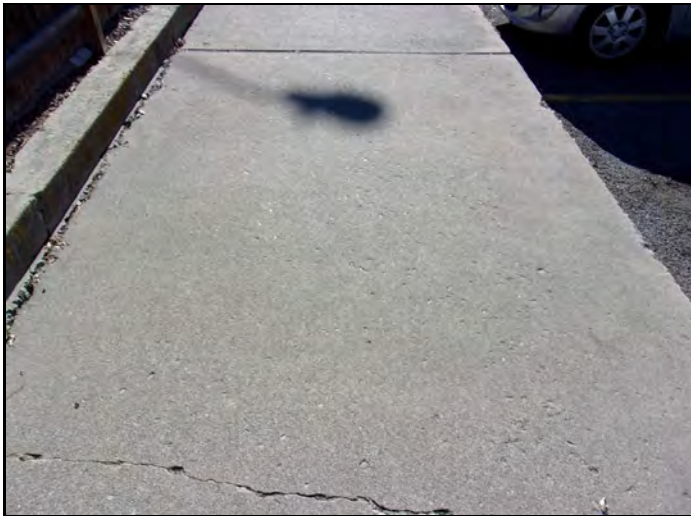
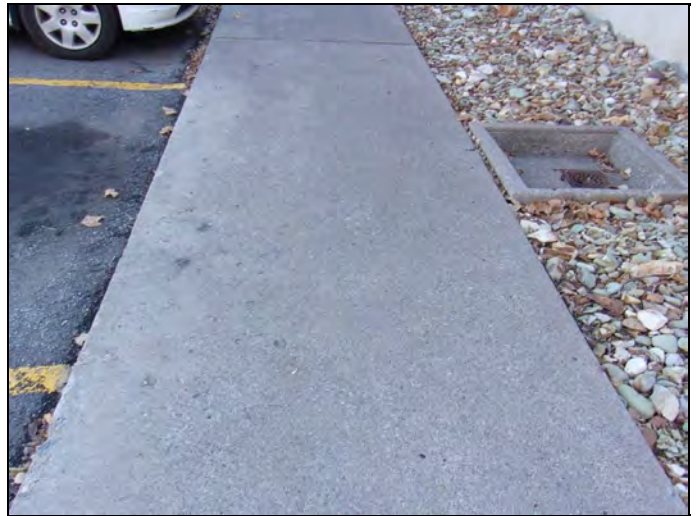
Comp #: 403 Concrete - Partial Repair/Replace

Location: Common Area

Quantity: Minimal SF

The concrete is generally in fair condition. This component has an extended useful life under normal conditions. We recommend funding to make repairs and partially replace this component approximately every 10 years. Remaining life based on current age.

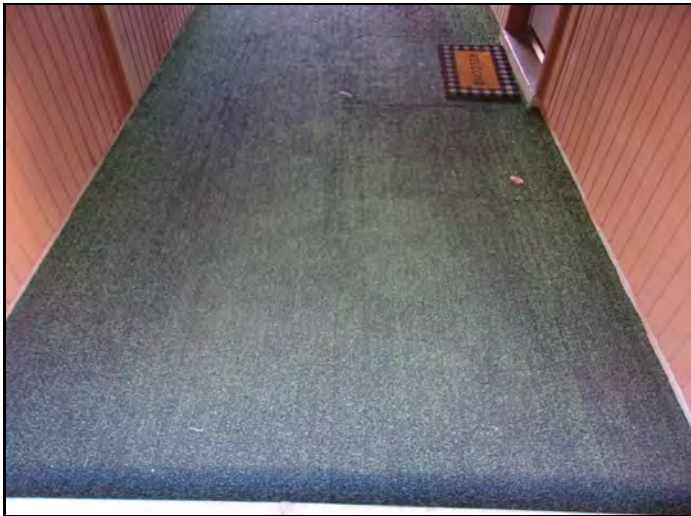
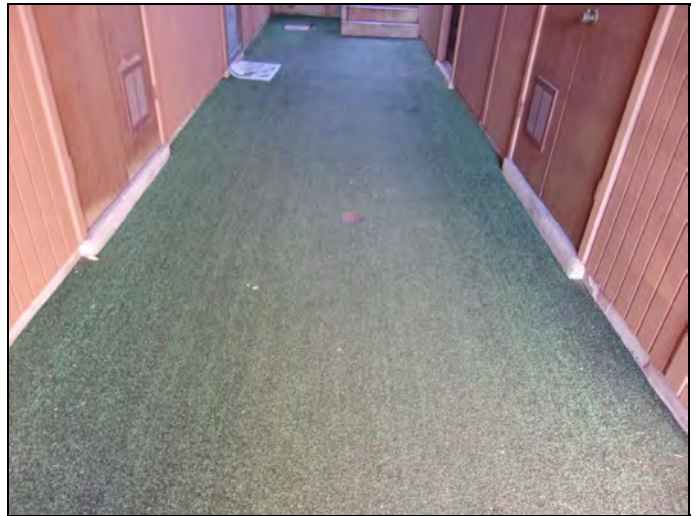
Comp #: 605 Indoor/Outdoor Carpet - Replace

Location: **Building Breezeways**

Quantity: **Approx 1,800 SF**

The indoor/outdoor carpeting is in fair to poor condition. We recommend funding to replace this component approximately every 8 - 10 years. Remaining life based on current condition.

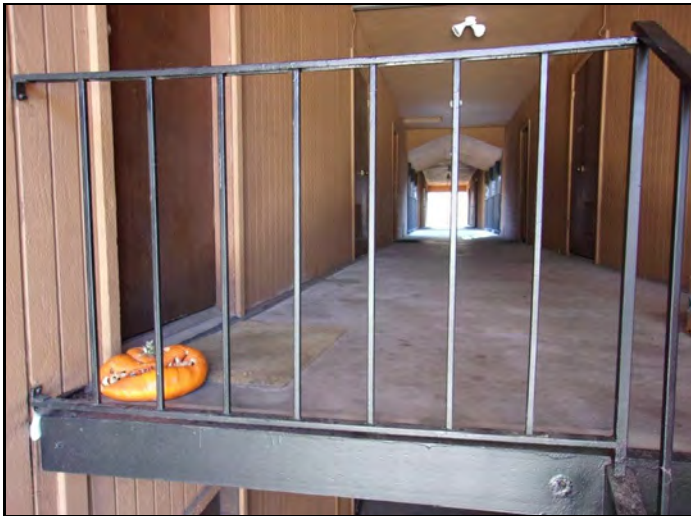
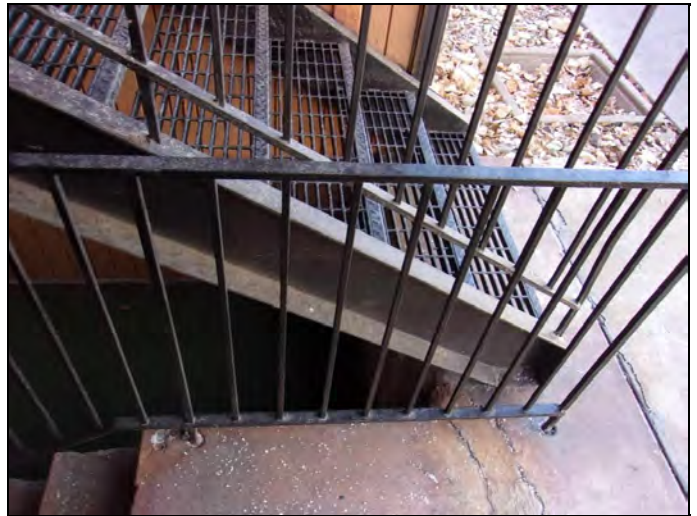
Comp #: 690 Metal Railing - Replace

Location: **Building Breezeways & Stairwells**

Quantity: **Approx 475 LF**

The metal railing is in good to fair condition. We recommend funding to replace this component approximately every 40 - 50 years. Remaining life based on current age and condition.

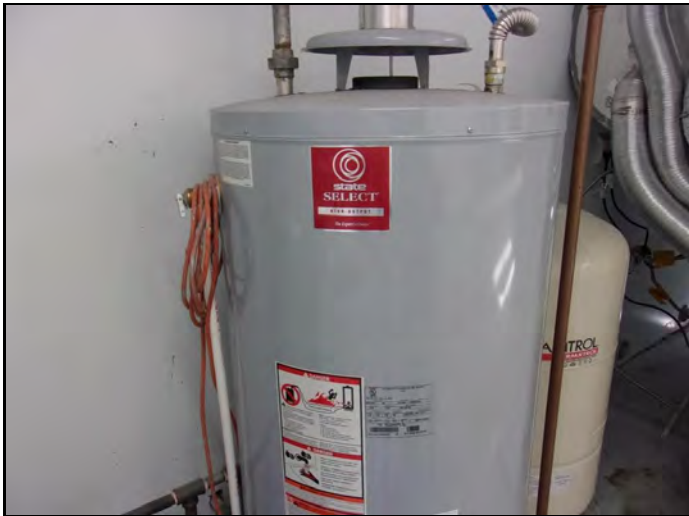
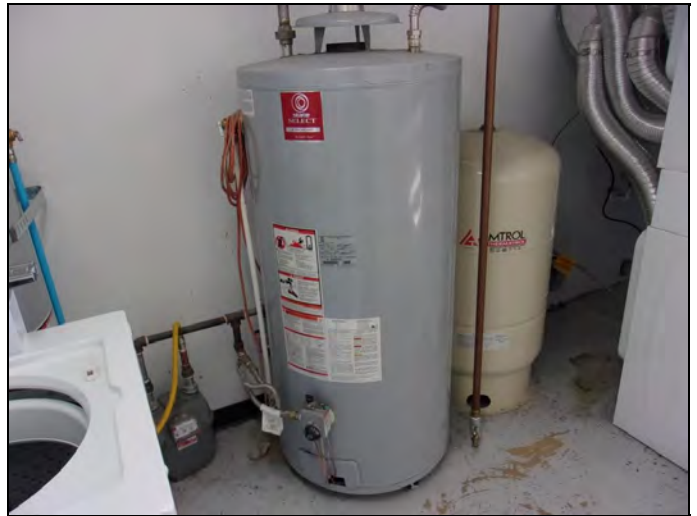
Comp #: 703 Water Heater - Replace

Location: **Laundry Room**

Quantity: **(1) Water Heater**

The water heater is in working condition. We recommend funding to replace this component approximately every 12 years. Remaining life based on current age.

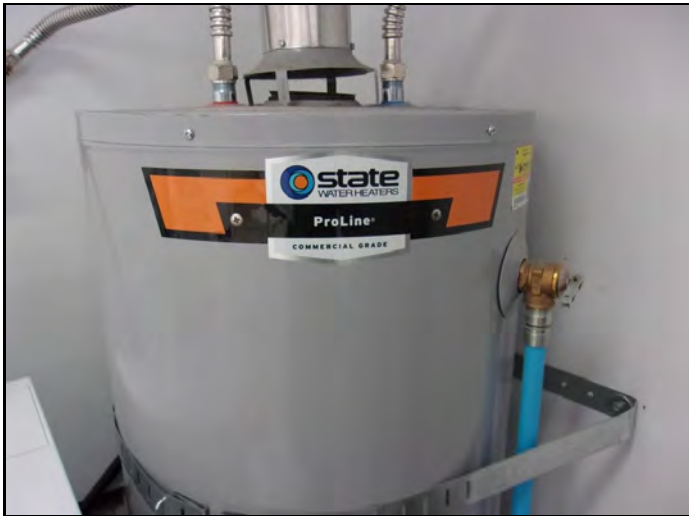
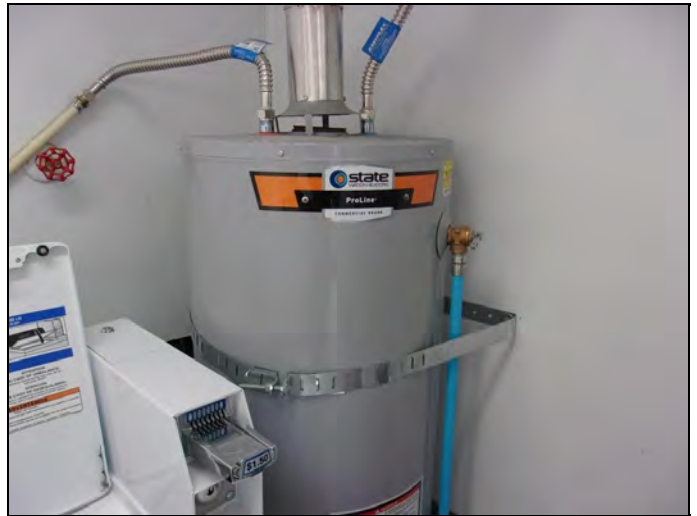
Comp #: 703 Water Heater - Replace

Location: Laundry Room

Quantity: (1) Water Heater

The water heater is in working condition. We recommend funding to replace this component approximately every 12 years. Remaining life based on current age.

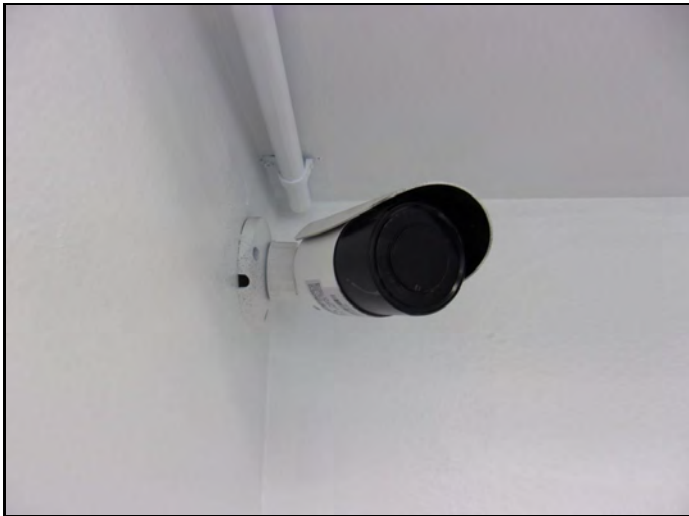
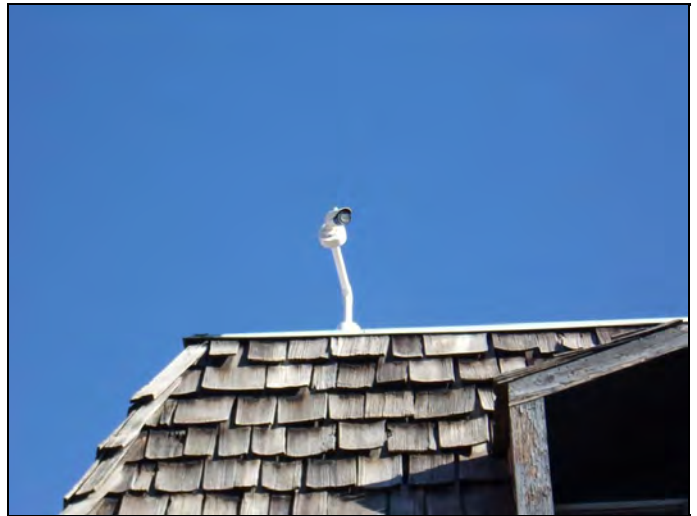
Comp #: 903 Security Camera System - Replace

Location: **Building Roofs, Laundry Area**

Quantity: **(1) System**

The security camera system is in working condition. We recommend funding to replace this component approximately every 10 - 12 years. Remaining life based on current age.

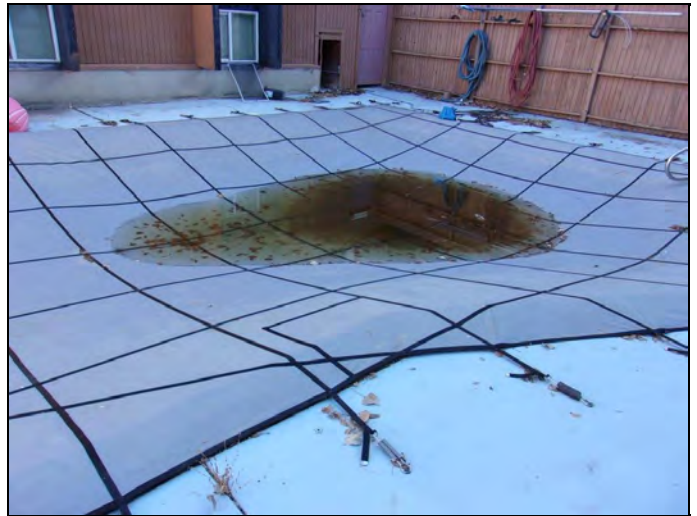
Comp #: 1101 Pool - Resurface

Location: **Pool Area**

Quantity: **(1) Pool**

Research with the client reveals this component is being resurfaced in 2021. We recommend funding to resurface this component every 10 - 12 years. Remaining life based on current age.

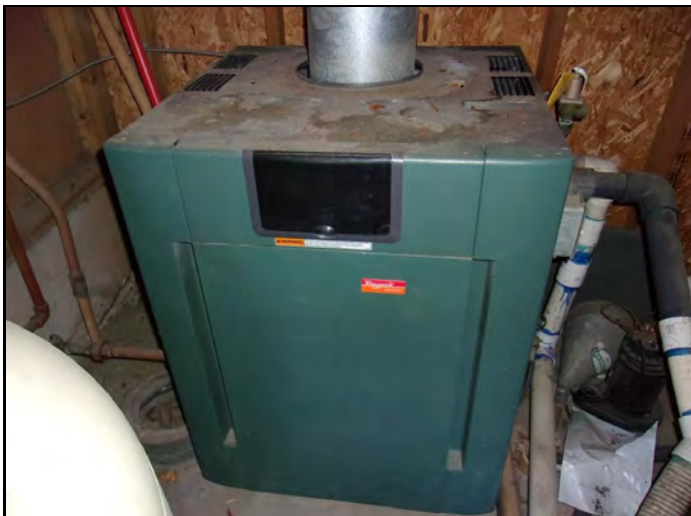
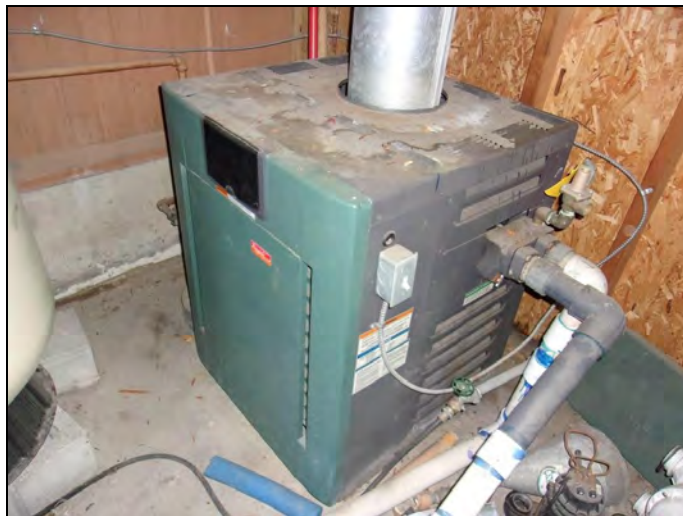
Comp #: 1104 Pool Heater - Replace

Location: **Pool Equipment Room**

Quantity: **(1) Heater**

The pool heater is in working condition. We recommend funding to replace this component approximately every 12 years. Remaining life based on current age.

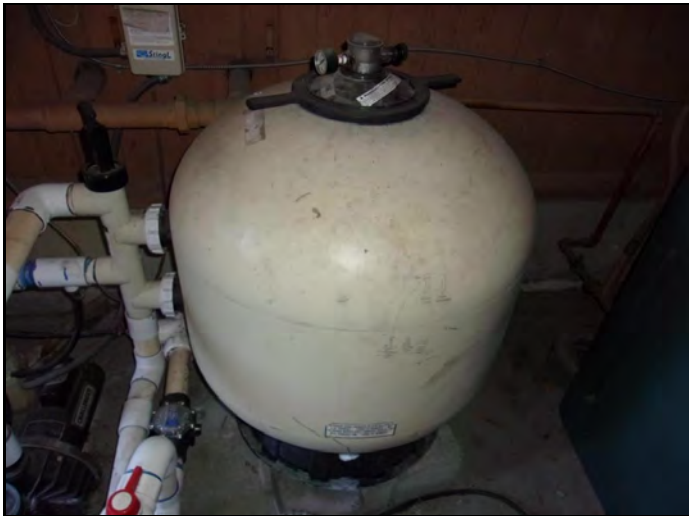
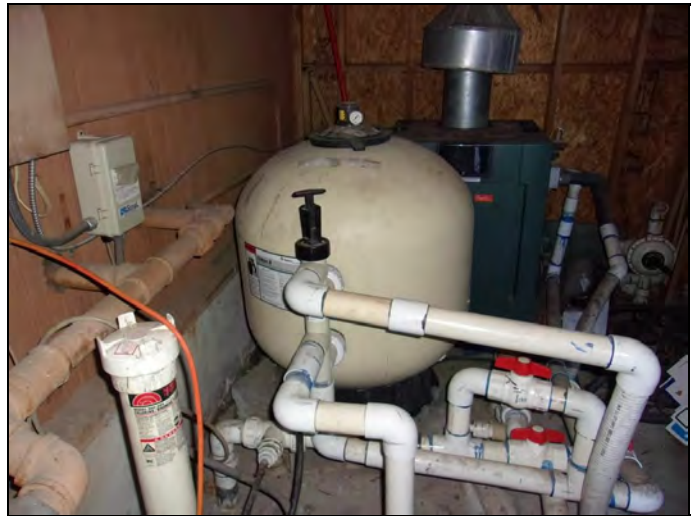
Comp #: 1107 Pool Filter - Replace

Location: **Pool Equipment Room**

Quantity: **(1) Filter**

The pool filter is in working condition. We recommend funding to replace this component approximately every 12 - 15 years. Remaining life based on current age.

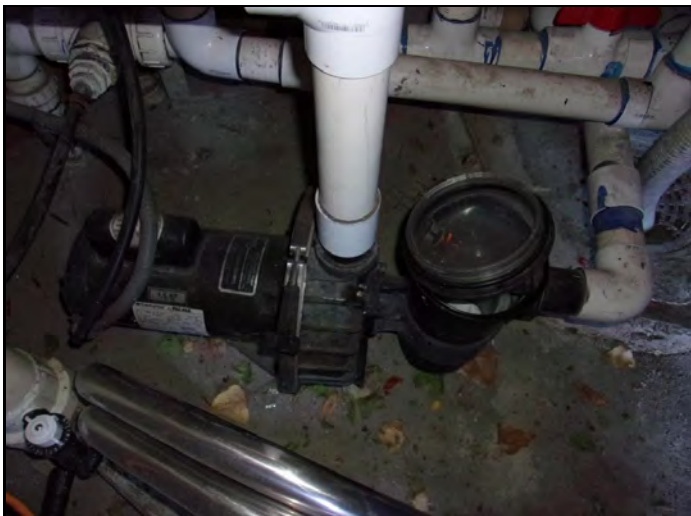
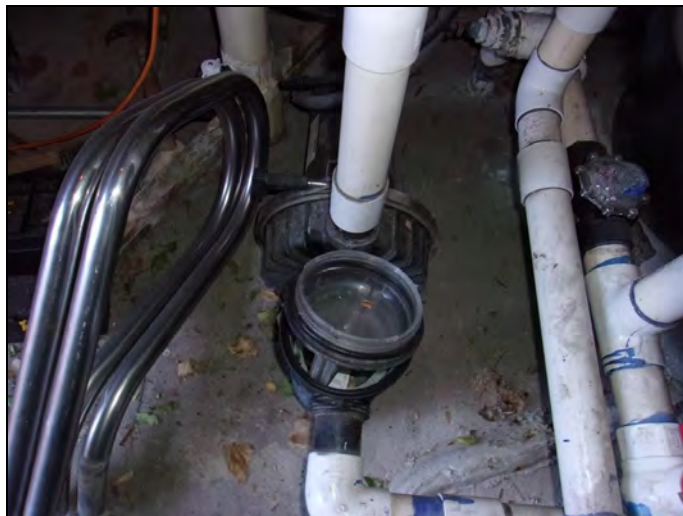
Comp #: 1110 Pool Pump - Replace

Location: **Pool Equipment Room**

Quantity: **(1) Pump**

Research with the client reveals this component is being replaced in 2021. We recommend funding to replace this component approximately every 8 - 10 years. Remaining life based on current age.

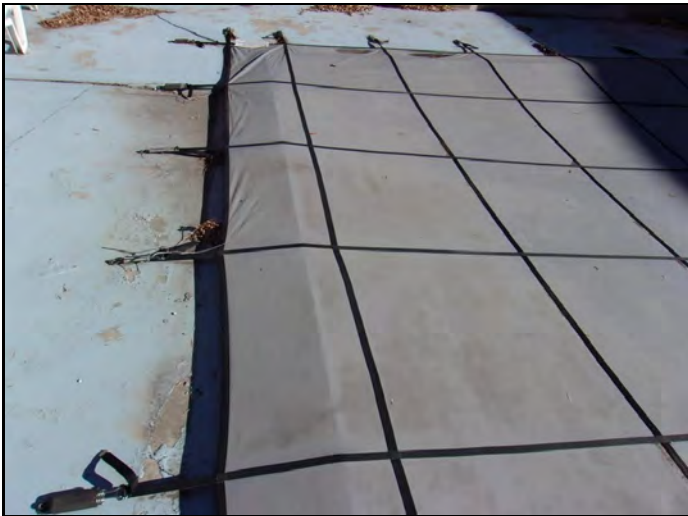
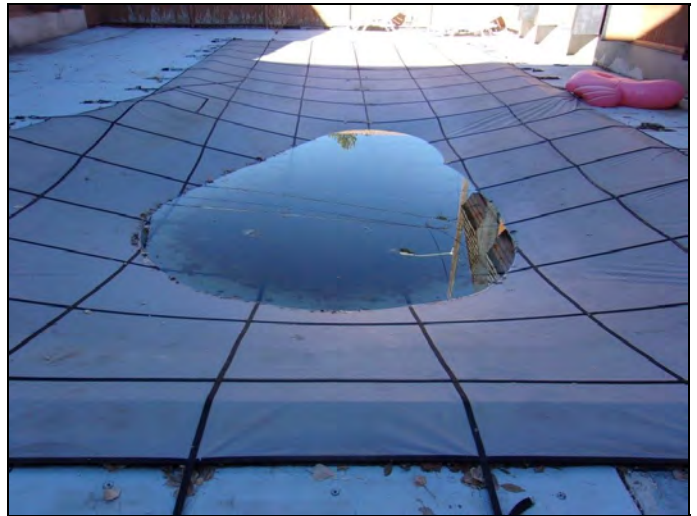
Comp #: 1112 Pool Cover - Replace

Location: **Pool Area**

Quantity: **(1) Cover**

The pool cover appears to be in good condition. We recommend funding to replace this component approximately every 10 years. Remaining life based on current age.

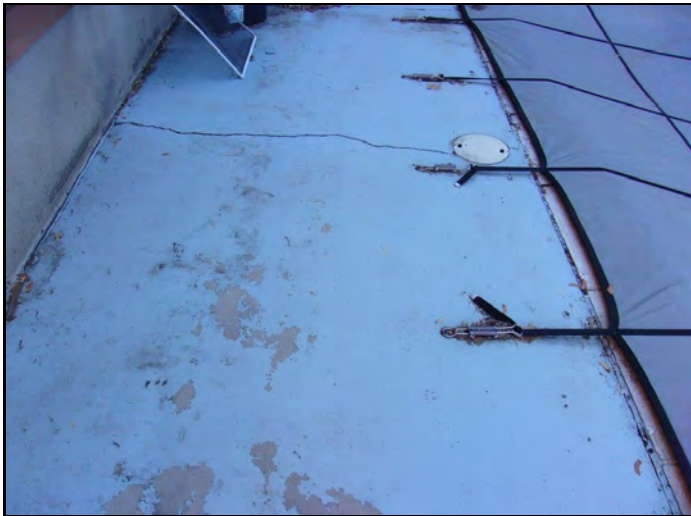
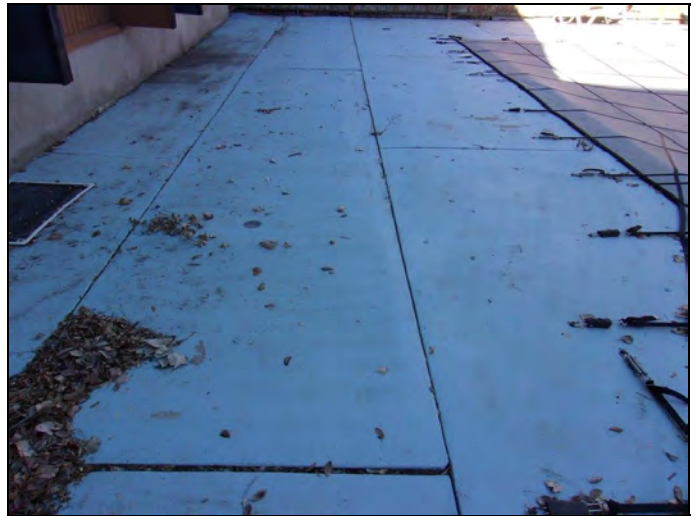
Comp #: 1117 Pool Deck - Repaint

Location: **Pool Area**

Quantity: **Approx 1,725 SF**

The pool deck painted surfaces are in poor condition. We recommend funding to repaint this component approximately every 8 years. Remaining life based on current condition.

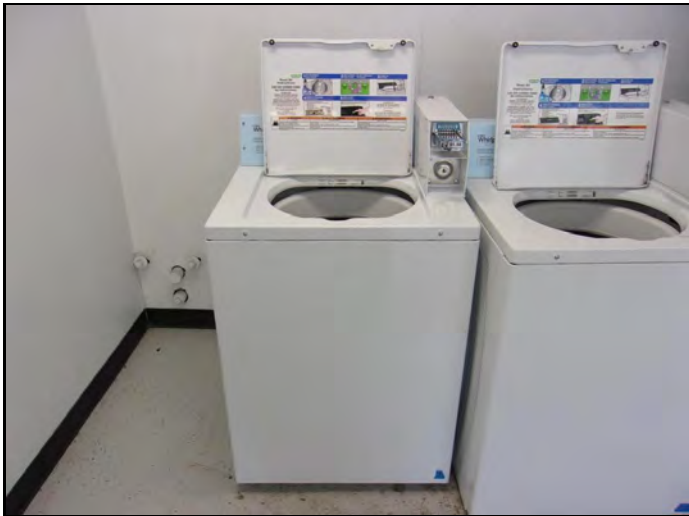
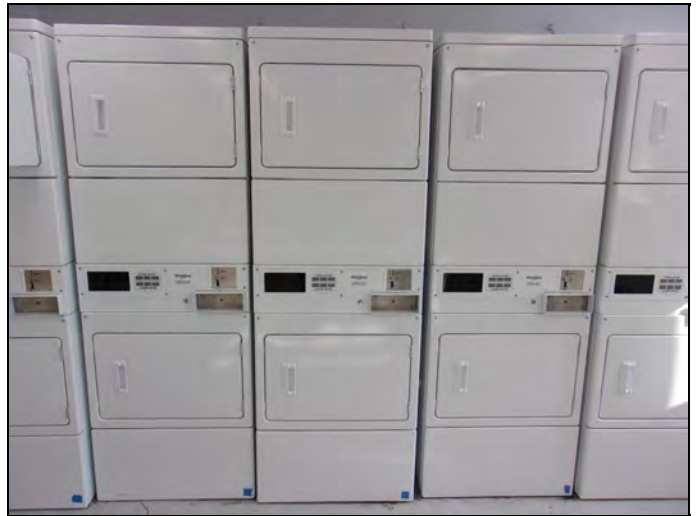
Comp #: 1401 Laundry Equipment - Replace

Location: **Laundry Room**

Quantity: **(13) Pieces**

The laundry equipment is in working condition. We recommend replacing this component approximately every 10 - 15 years. Remaining life based on current age.

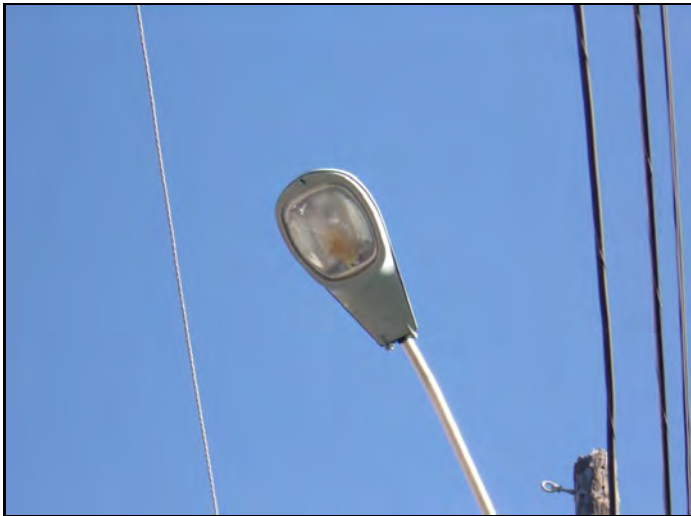
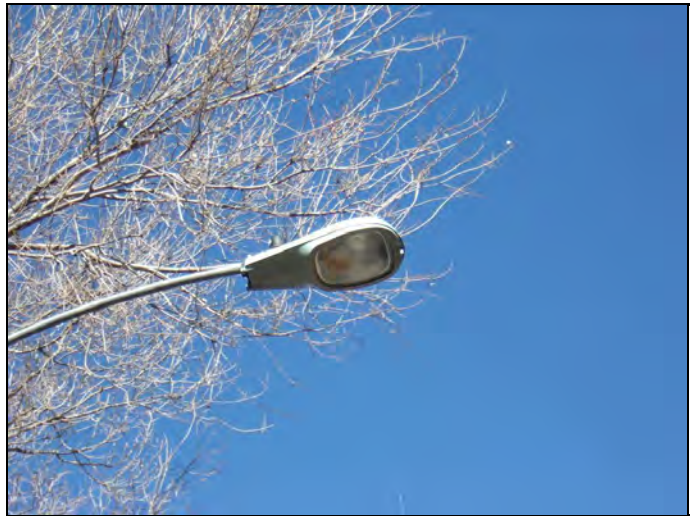
Comp #: 1609 Street Light Fixtures - Replace

Location: **Parking Lot**

Quantity: **(5) Fixtures**

The street light fixtures are in good condition. No expectation to replace the light poles. Paint poles as necessary as an operating expense. We recommend funding to replace this component approximately every 20 years. Remaining life based on current age and condition.

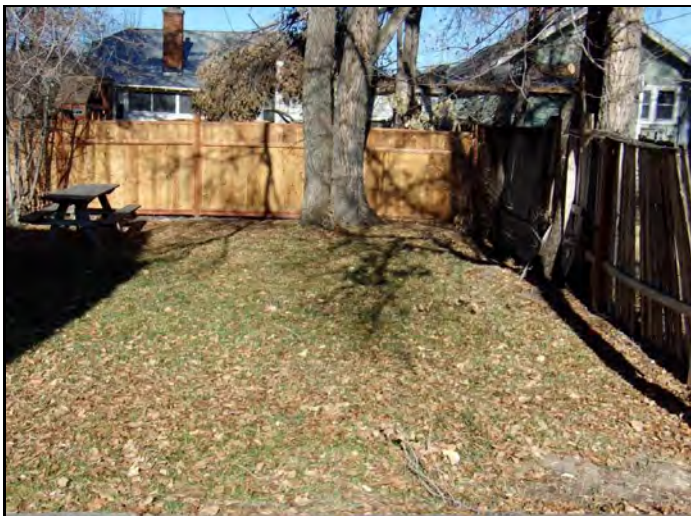
Comp #: 1812 Landscaping & Irrigation System - Renovate

Location: **Common Area**

Quantity: **Approx 11,500 SF**

The landscaping and irrigation system are in good to fair condition. We recommend funding for an allowance to renovate the landscaping and irrigation system approximately every 20 years. Remaining life based on current age.
