1600 Park Ave S. PH3

Level 1 Reserve Study

Report Period – 01/01/2026 – 12/31/2026

Executive Summary – 1600 Park Ave S. PH3 - ID # 19408

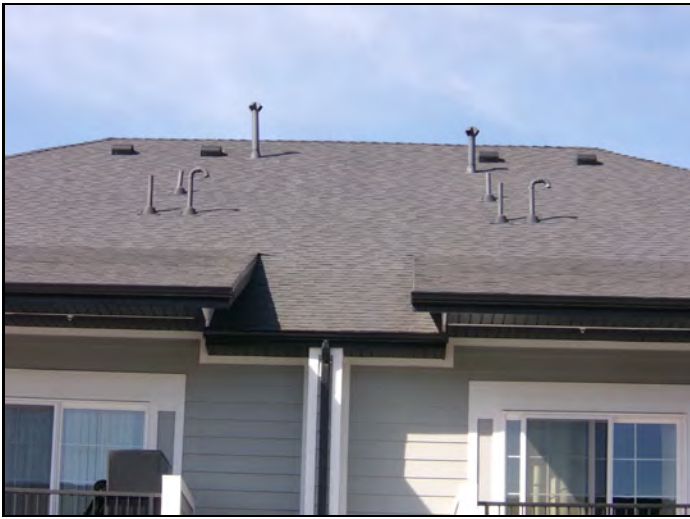
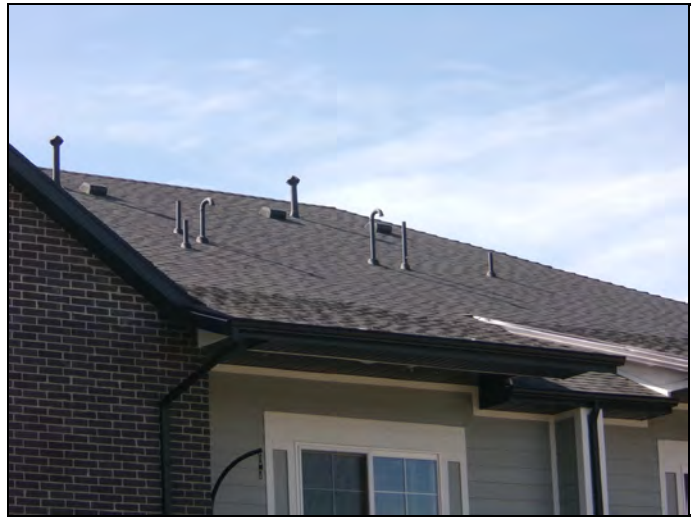
Comp #: 105 Roof - Replace

Location: **Building Roofs**

Quantity: **Approx. 6,480 SF**

Life Expectancy: **25** *Remaining Life:* **24**

Research with the client reveals this component will be completed in 2025. Pictures used in this report are from a reference building that is the same style of building. We recommend funding to replace this component approximately every 20 - 25 years. Remaining life based on current age.

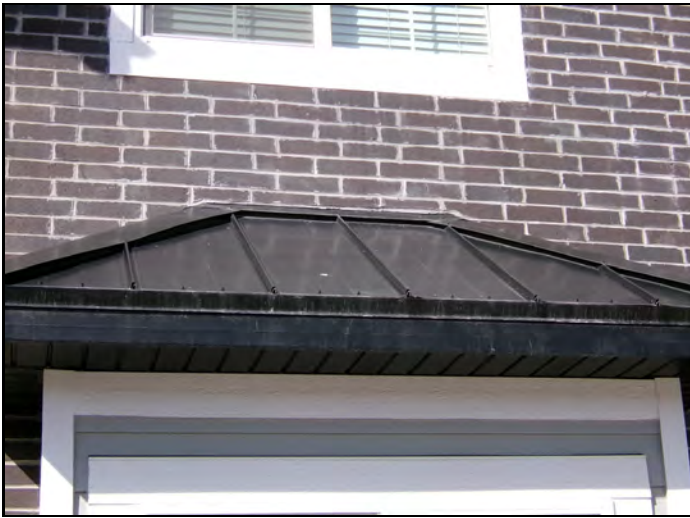
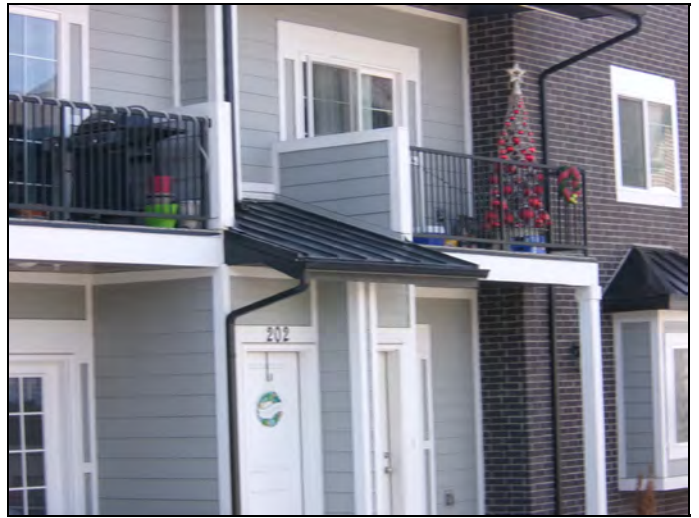
Comp #: 108 Metal Roofs - Replace

Location: **Building Roofs**

Quantity: **Approx. 400 SF**

Life Expectancy: **50** *Remaining Life:* **49**

Research with the client reveals this component will be completed in 2025. Pictures used in this report are from a reference building that is the same style of building. We recommend funding to replace this component approximately every 50 - 60 years. Remaining life based on current age.

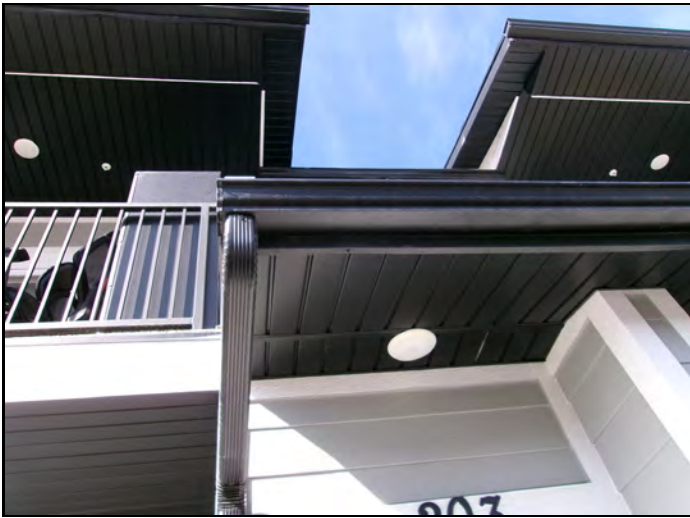
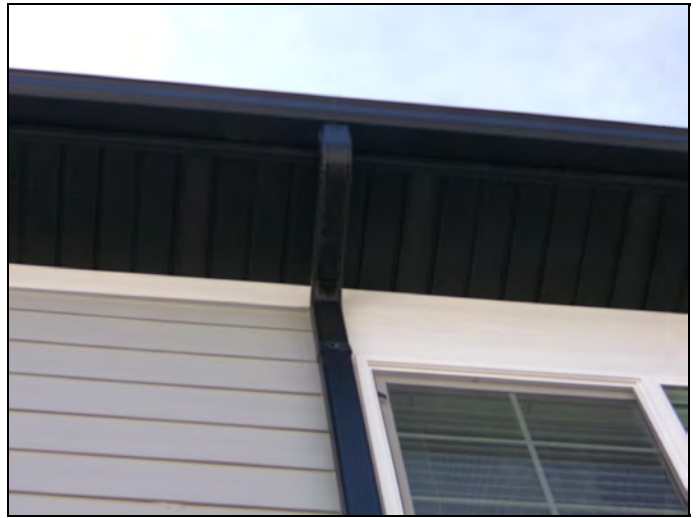
Comp #: 120 Rain Gutters/Downspouts - Replace

Location: **Building Exteriors**

Quantity: **Approx. 490 LF**

Life Expectancy: **30** *Remaining Life:* **29**

Research with the client reveals this component will be completed in 2025. Pictures used in this report are from a reference building that is the same style of building. We recommend funding to replace this component approximately every 25 - 30 years. Remaining life based on current age.

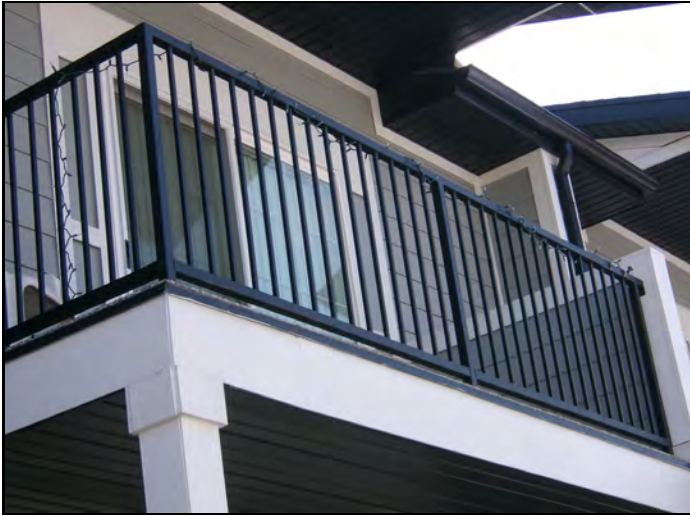
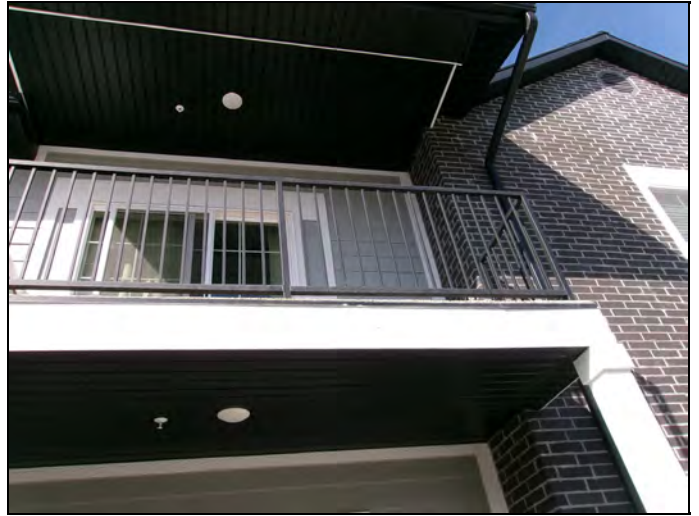
Comp #: 212 Balcony Railing - Repaint

Location: **Building Exterior**

Quantity: **Approx. 60 LF**

Research with the owner reveals this component is not the responsibility of the association. Pictures used in this report are from a reference building that is the same style of building.

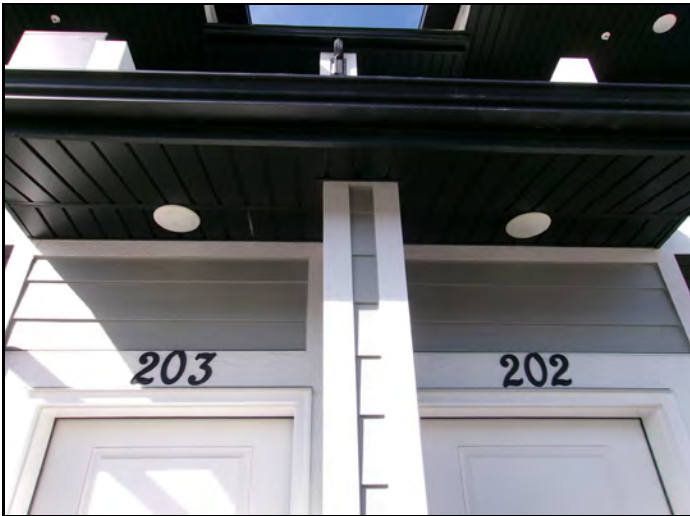
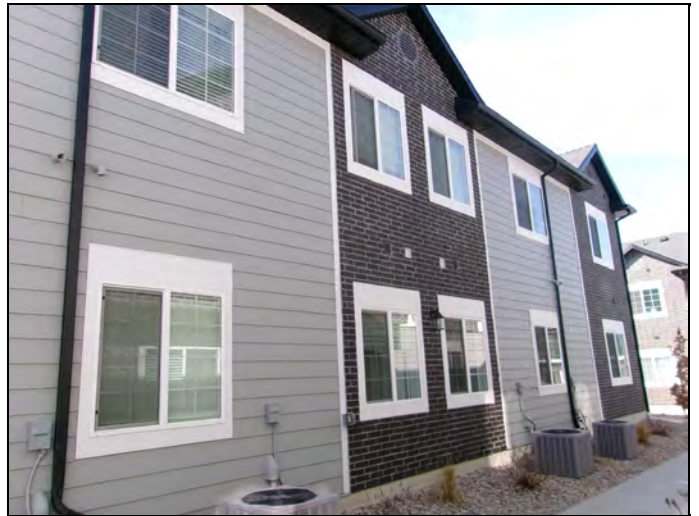
Comp #: 215 Siding - Repair/Repaint

Location: **Building Exterior**

Quantity: **Approx. 3,720 SF**

Life Expectancy: **10** *Remaining Life:* **9**

Research with the client reveals this component will be completed in 2025. Pictures used in this report are from a reference building that is the same style of building. We recommend funding to repair/repaint this component approximately every 8 - 10 years. Remaining life is based on current age.

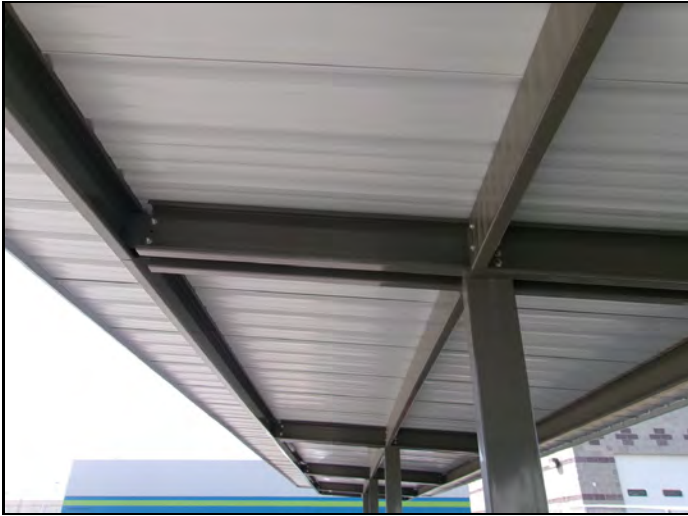
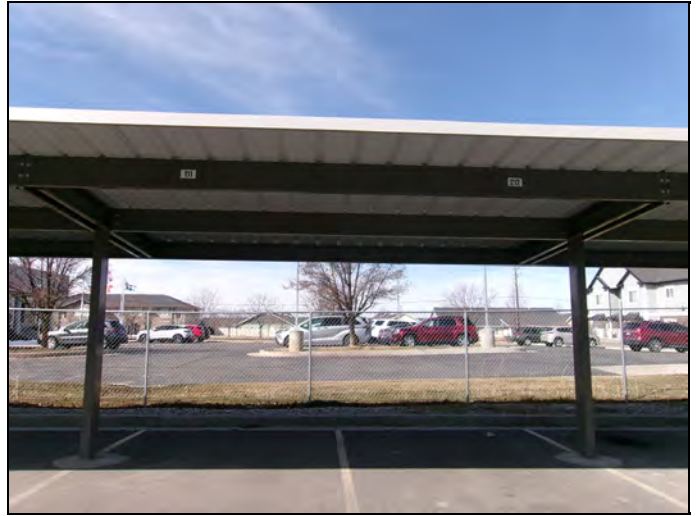
Comp #: 223 Carports - Repaint

Location: **Common Area**

Quantity: **(1) Carport**

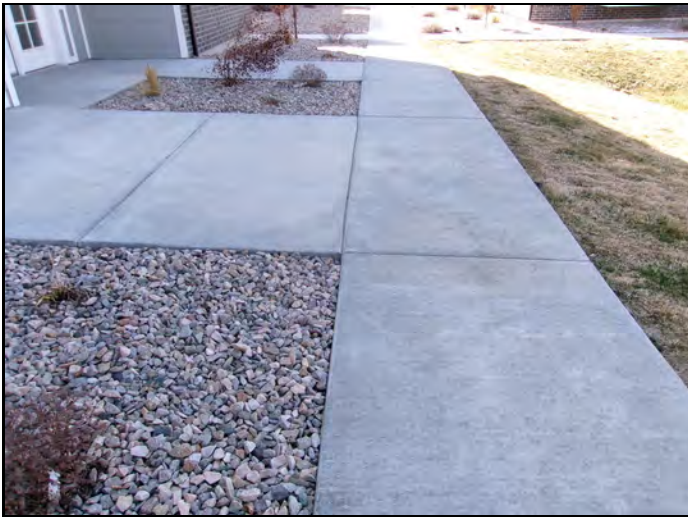
Comp #: 403 Concrete - Partial Repair/Replace

Location: **Common Area**

Quantity: **Minimal SF**

Research with the client reveals this component will be completed in 2025. Pictures used in this report are from a reference building that is the same style of building. This component has an extended useful life under normal conditions. We recommend funding to make repairs and partially replace this component approximately every 10 years. Remaining life based on current age.

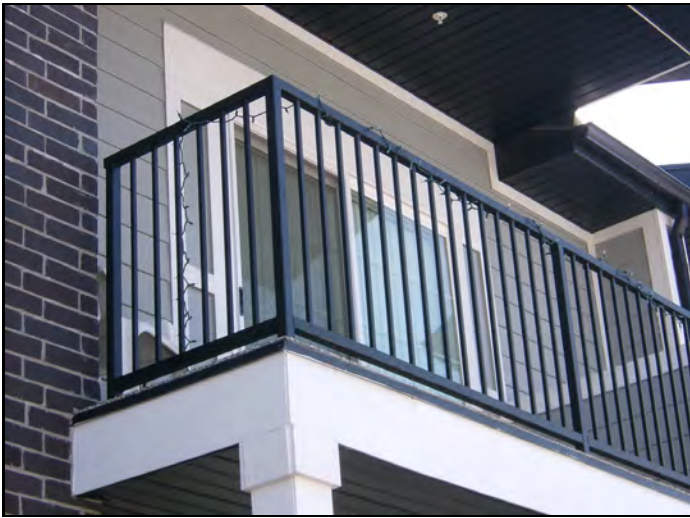
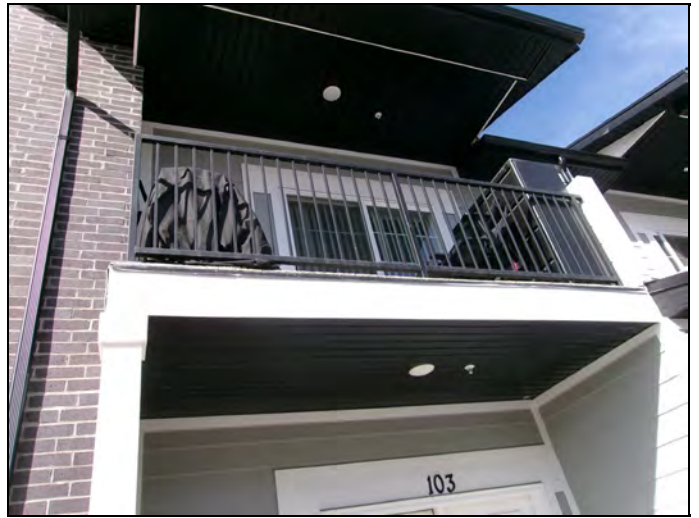
Comp #: 604 Balcony Decks - Resurface

Location: **Building Exterior**

Quantity: **Approx. 240 SF**

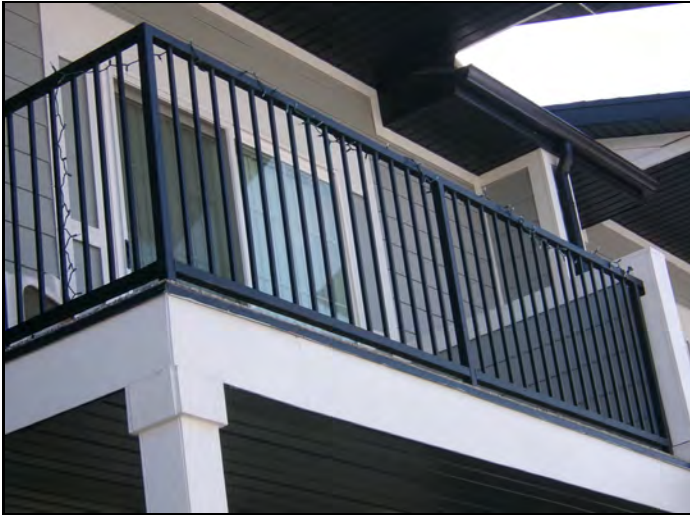
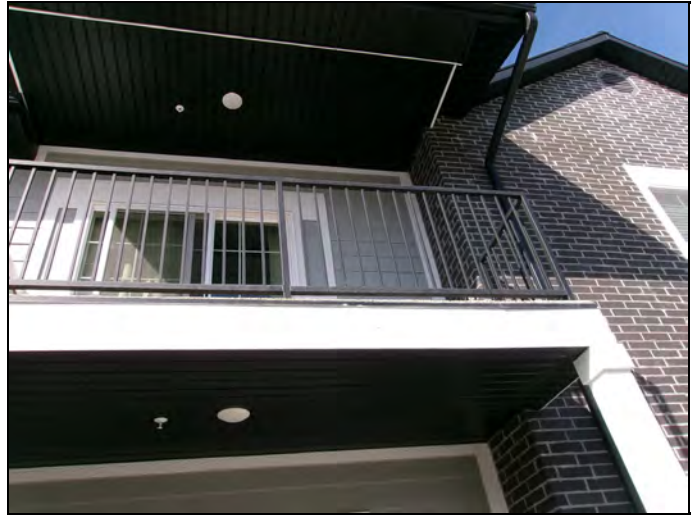
Comp #: 690 Balcony Railing - Replace

Location: **Building Exterior**

Quantity: **Approx. 60 LF**

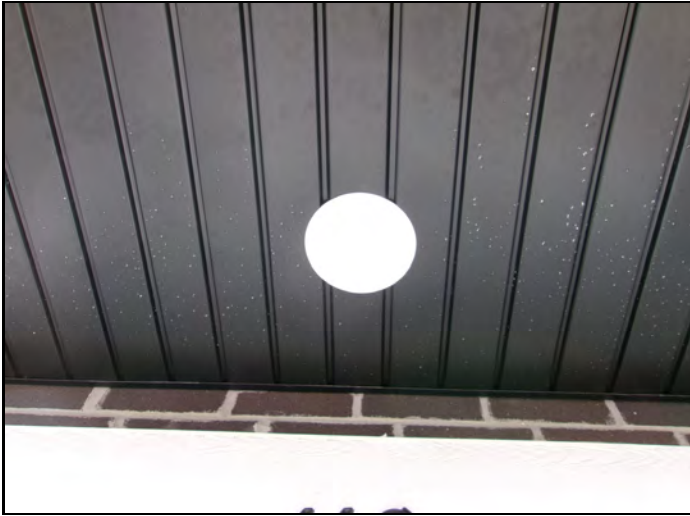
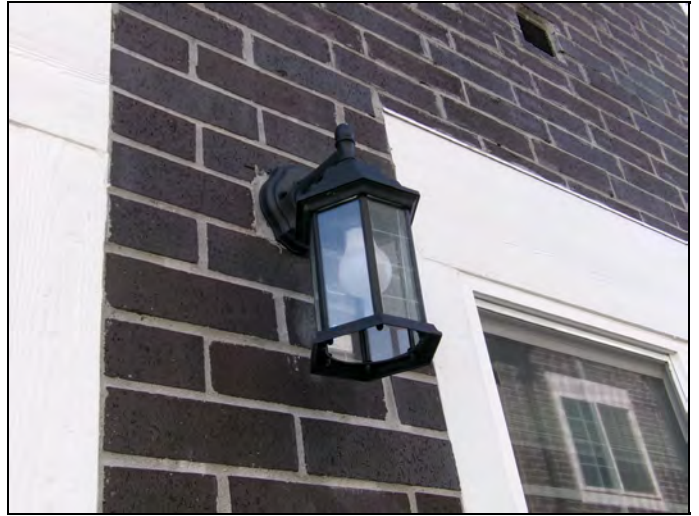
Comp #: 1602 Exterior Light Fixtures - Replace

Location: **Building Exteriors**

Quantity: **(22) Lights**

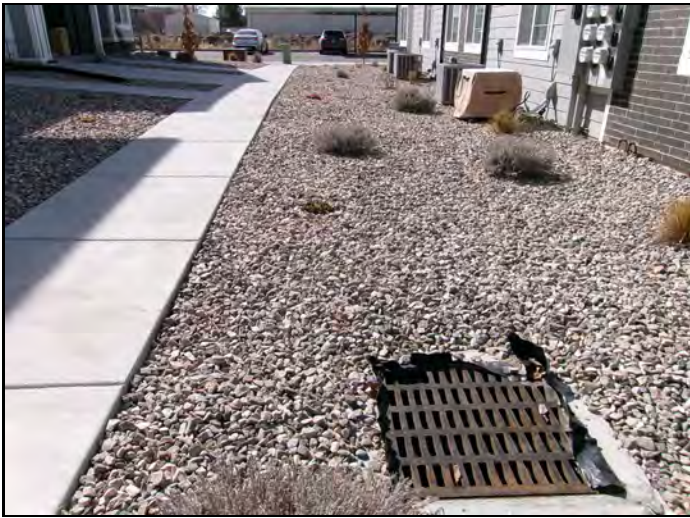
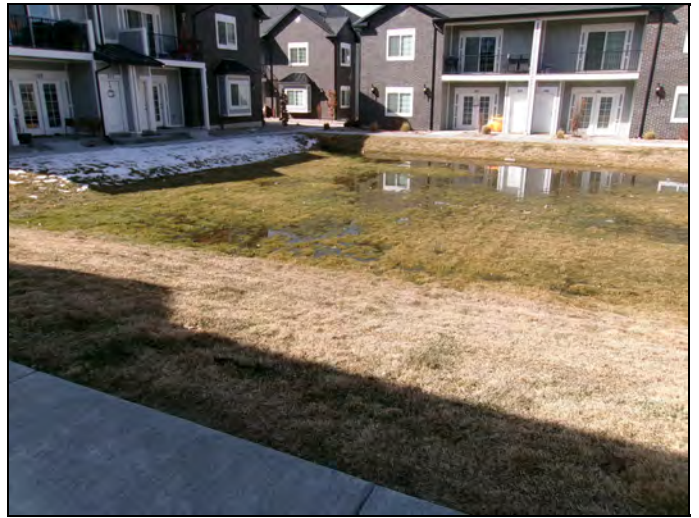
Comp #: 1812 Landscaping & Irrigation System - Renovate

Location: **Common Area**

Quantity: **Minimal SF**

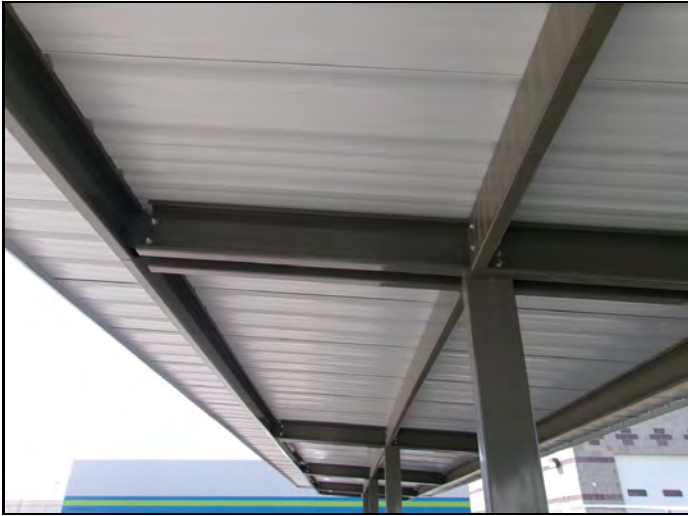
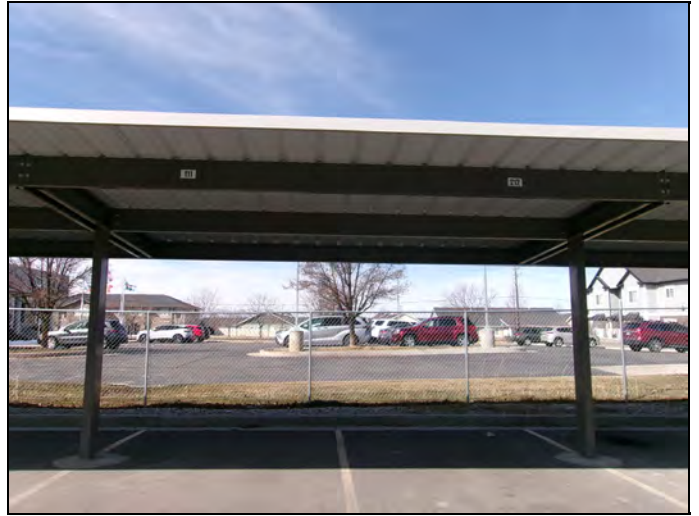
Comp #: 2307 Carport - Replace

Location: **Common Area**

Quantity: **(1) Carport**

Research with the client reveals this component will be completed in 2025. Pictures used in this report are from a reference building that is the same style of building. We recommend funding to replace this component approximately every 50 - 60 years. Remaining life based on current age.
