Hartford Parke HOA

Level 1 Reserve Study

Report Period – 01/01/2026 – 12/31/2026

Executive Summary – Hartford Parke HOA - ID # 19319

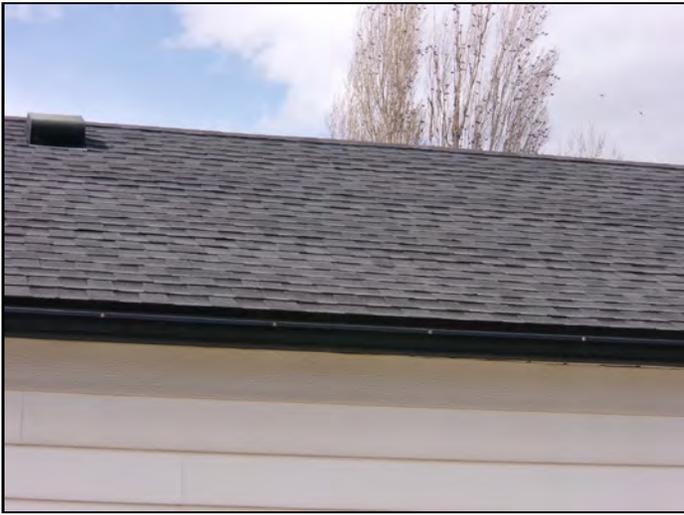
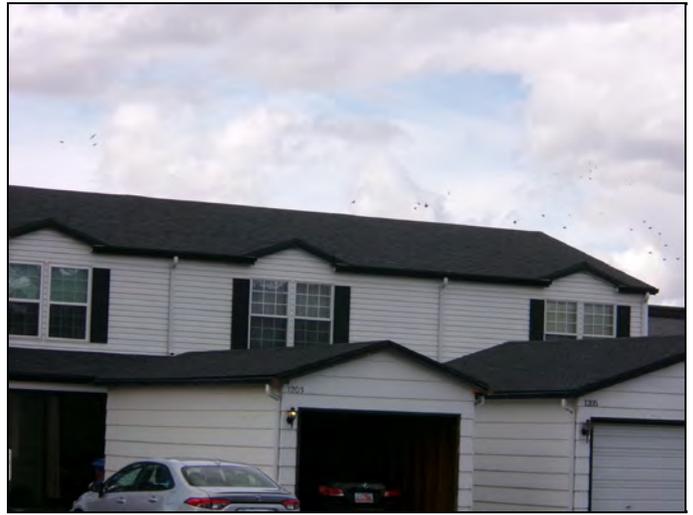
Comp #: 105 Roofs - Replace

The roofs appear to be in good to fair condition. We recommend funding to replace this component approximately every 20 - 25 years. Remaining life based on current age.

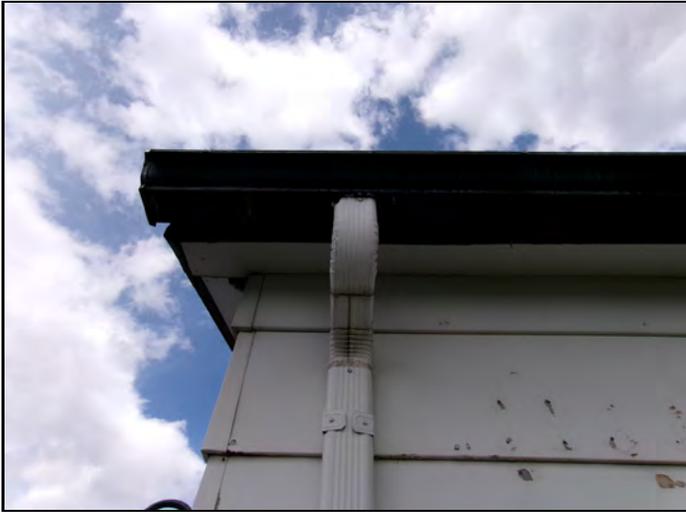
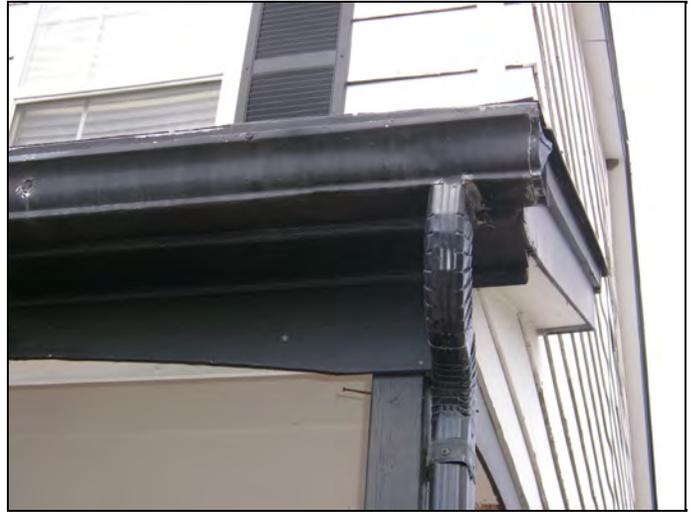
Comp #: 120 Rain Gutters/Downspouts - Replace

The rain gutters and downspouts appear to be in fair condition. We recommend funding to replace this component approximately every 25 - 30 years. Remaining life based on current age and condition.

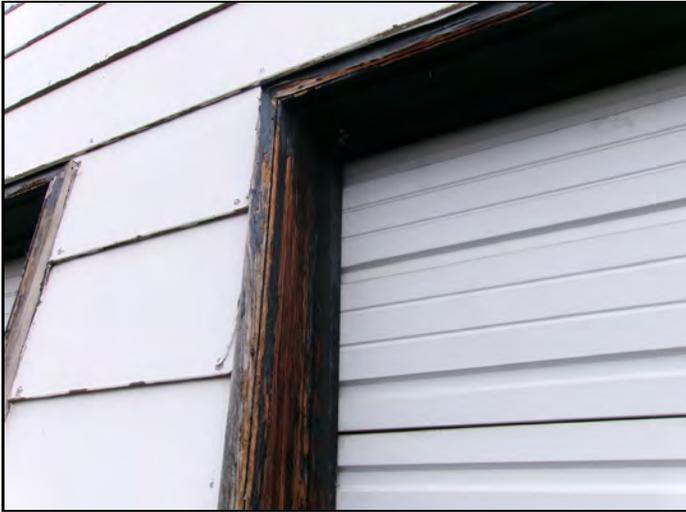
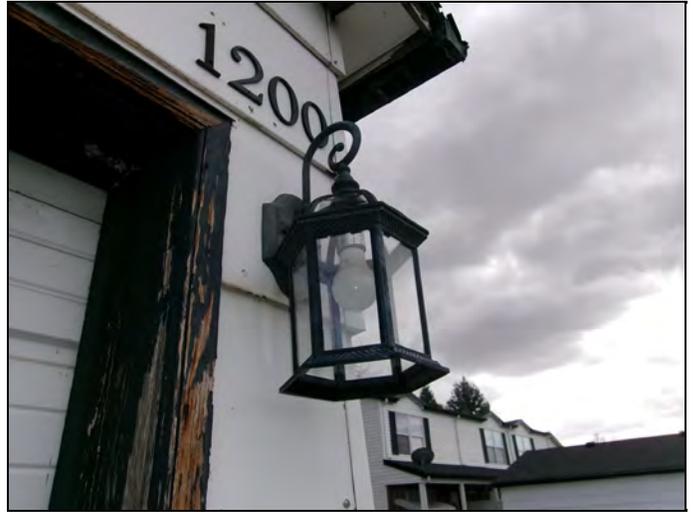
Comp #: 202 Wood Trim - Repair/Repaint

The painted wood trim surfaces are in poor condition. We recommend funding to repair/repaint this component approximately every 4 - 6 years. Remaining life based on current condition.

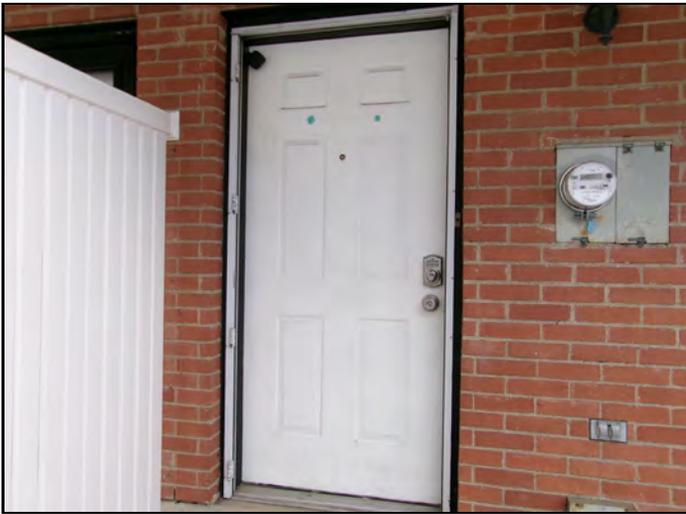
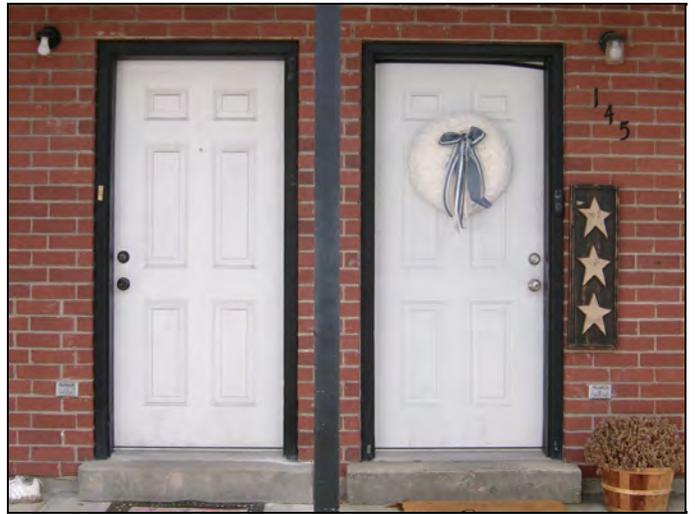
Comp #: 204 Front Doors - Repaint

The painted door surfaces are in fair to poor condition. We recommend funding to repaint this component approximately every 8 - 10 years. Remaining life based on current condition.

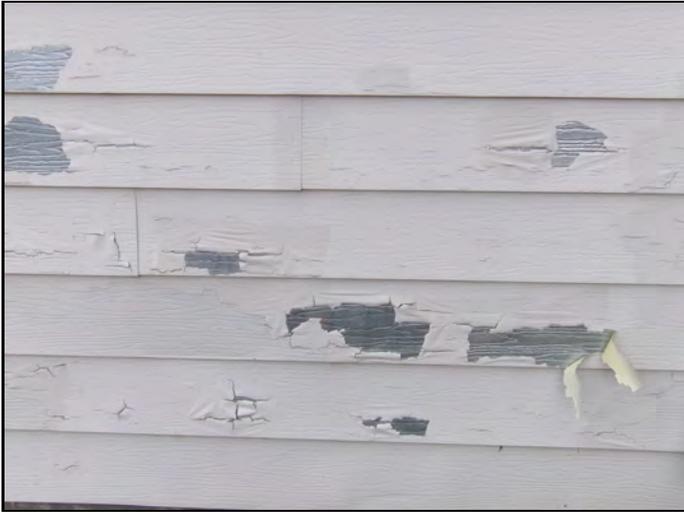
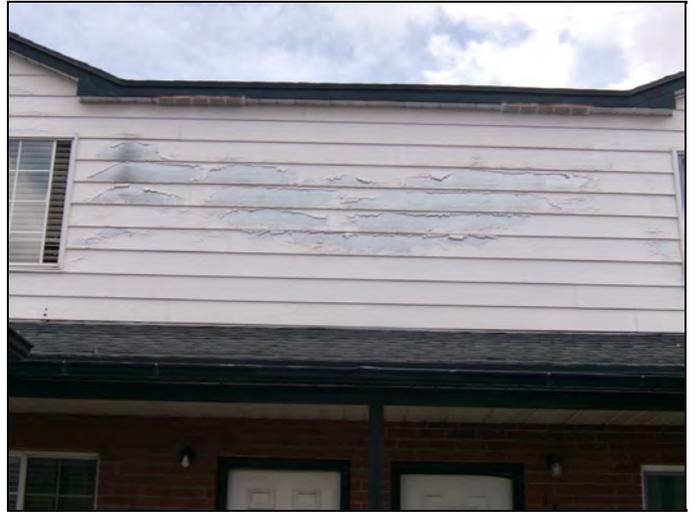
Comp #: 212 Metal Siding - Repair/Repaint

The painted metal siding surfaces are in poor condition. We recommend funding to repair/repaint this component approximately every 8 - 10 years. Remaining life is based on current condition.

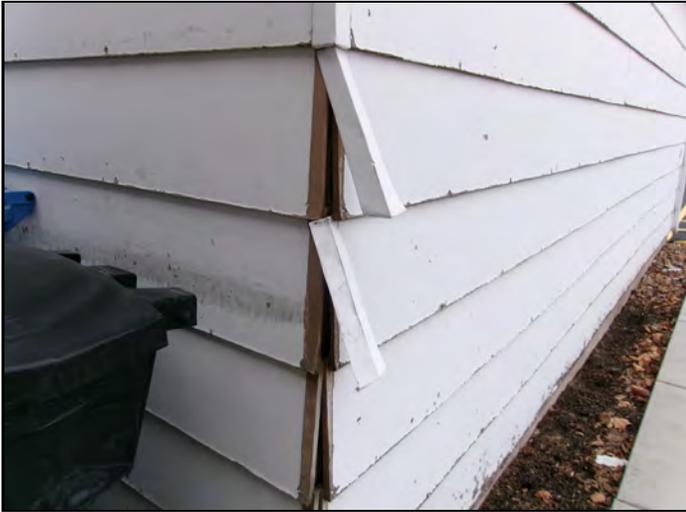
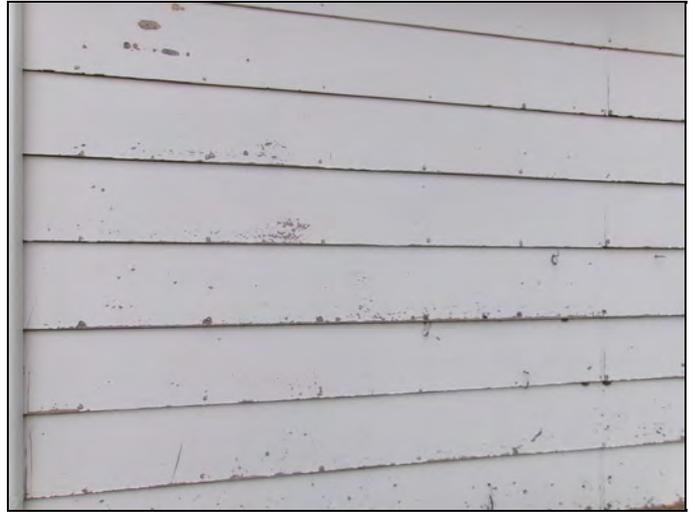
Comp #: 215 Cement Fiberboard Siding - Repair/Repaint

Research with the client reveals plans to replace this component with vinyl siding.

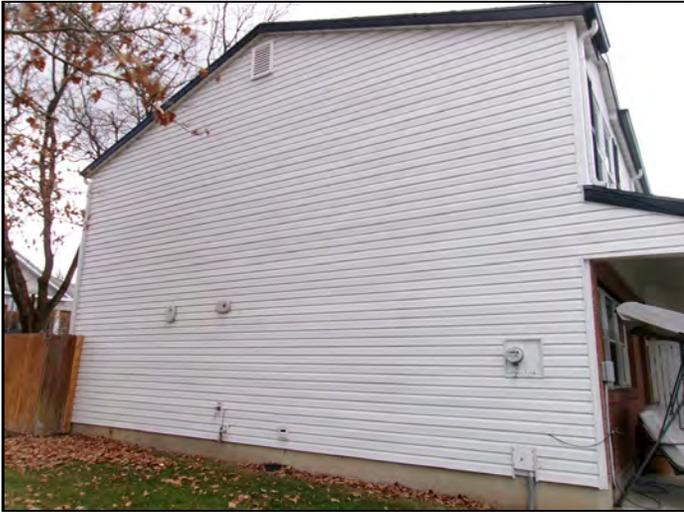
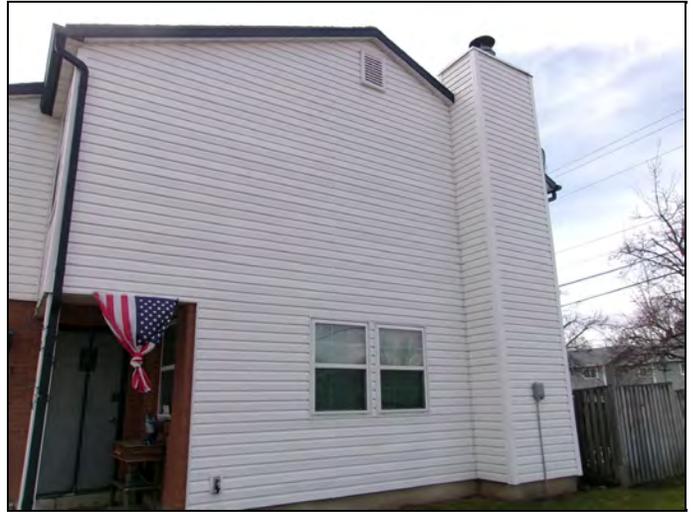
Comp #: 302 Vinyl Siding - Replace

The vinyl siding is in fair condition. We recommend funding to replace this component approximately every 40 - 50 years. Remaining life based on current age.

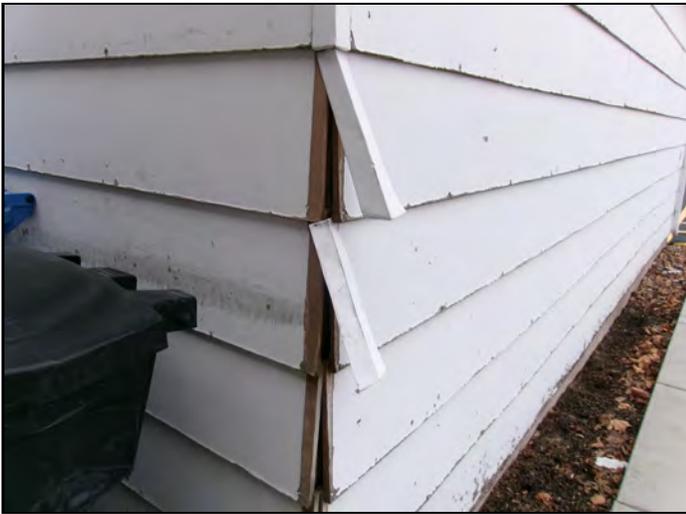
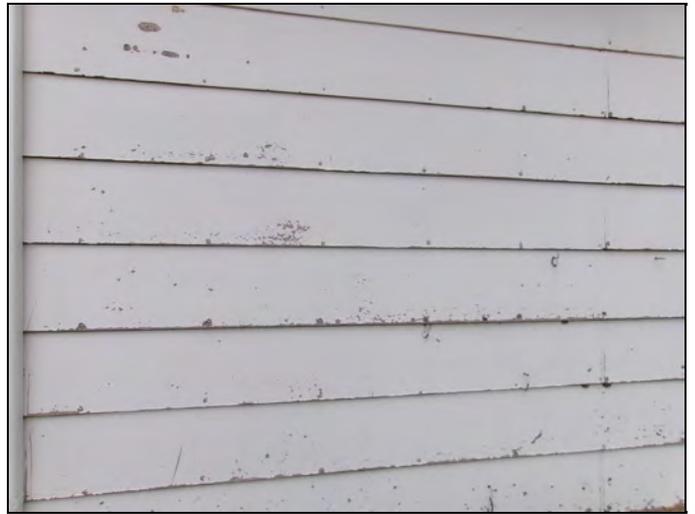
Comp #: 303 Cement Fiberboard Siding - Replace

Research with the client reveals plans to replace this component with vinyl siding. We recommend funding to replace this component approximately every 40 - 50 years. Remaining life based on current age.

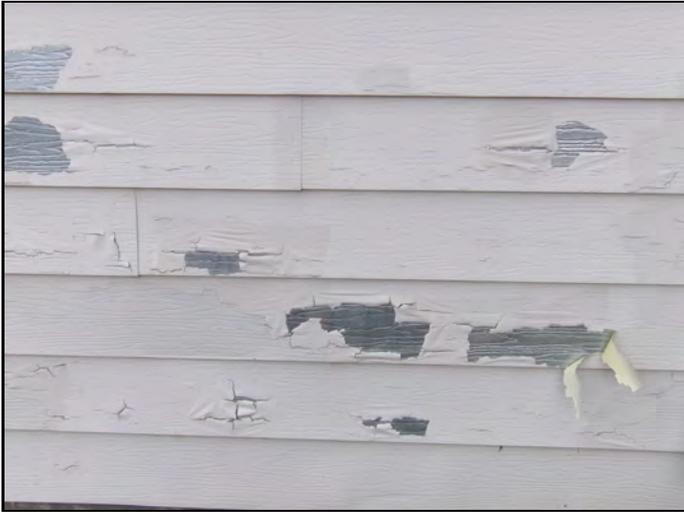
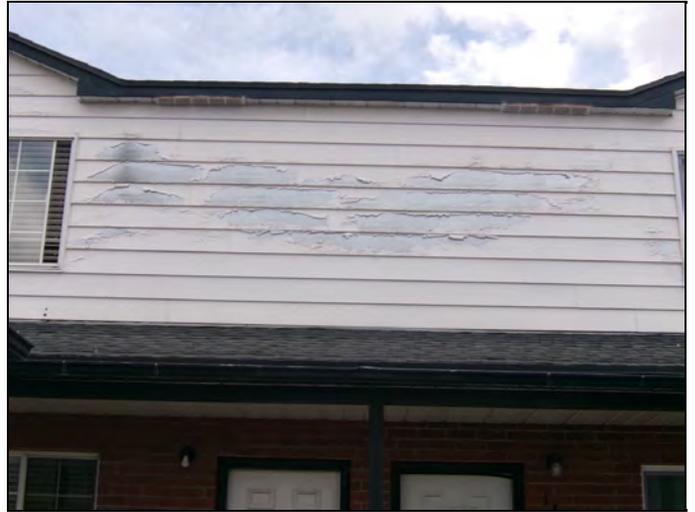
Comp #: 304 Metal Siding - Replace

The metal siding is in fair condition. We recommend funding to replace this component approximately every 40 - 50 years. Remaining life based on current age.

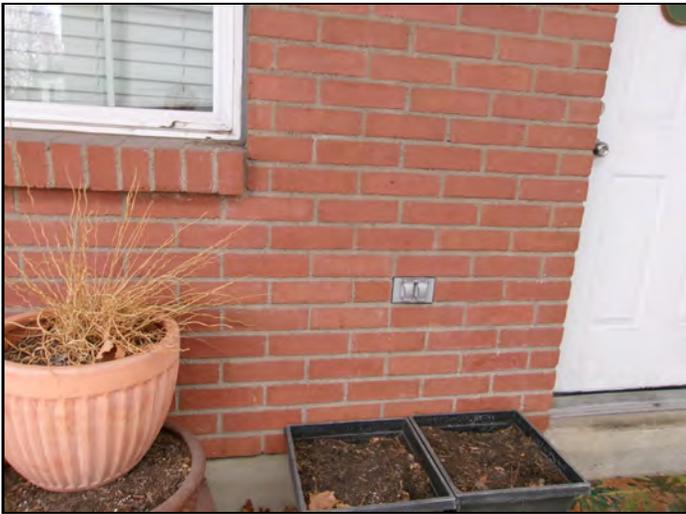
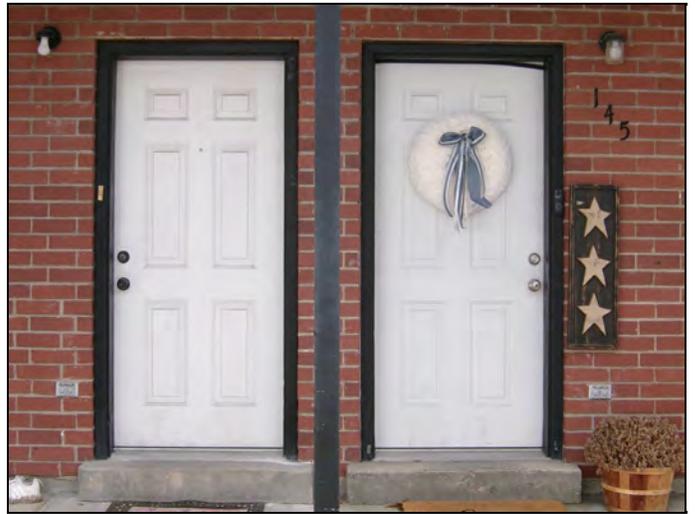
Comp #: 390 Brick Siding - Replace

This component has an extended useful life. We recommend making repairs as necessary as an operating expense. No reserve funding necessary.

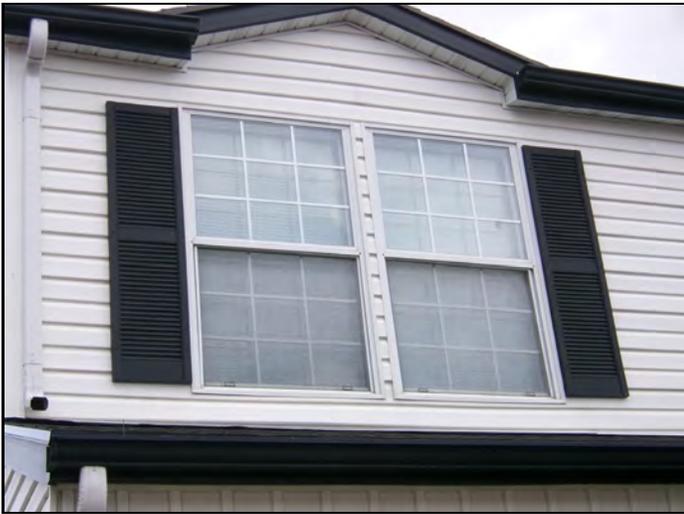
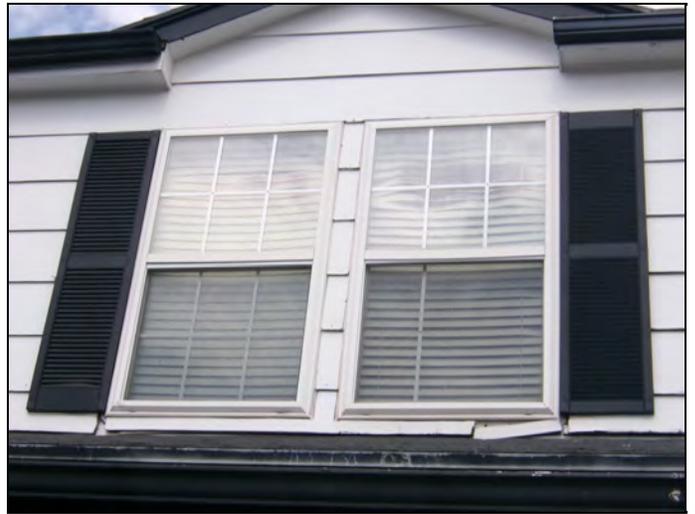
Comp #: 390 Shutters - Replace

The shutters are in good condition. We recommend funding to replace this component approximately every 30 - 40 years. Remaining life based on current condition.

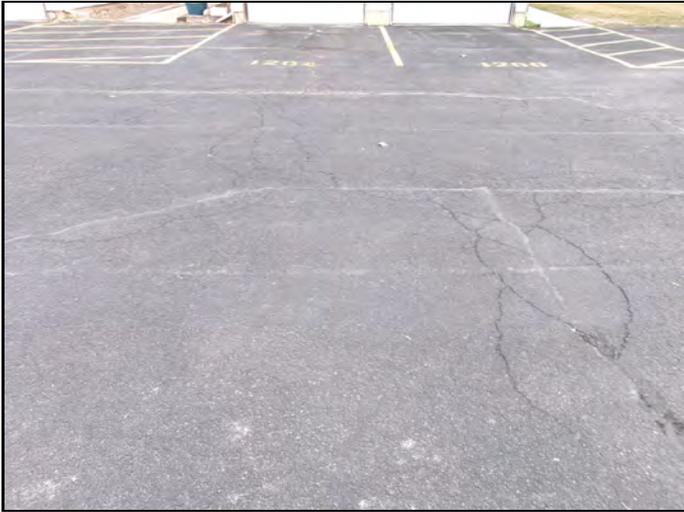
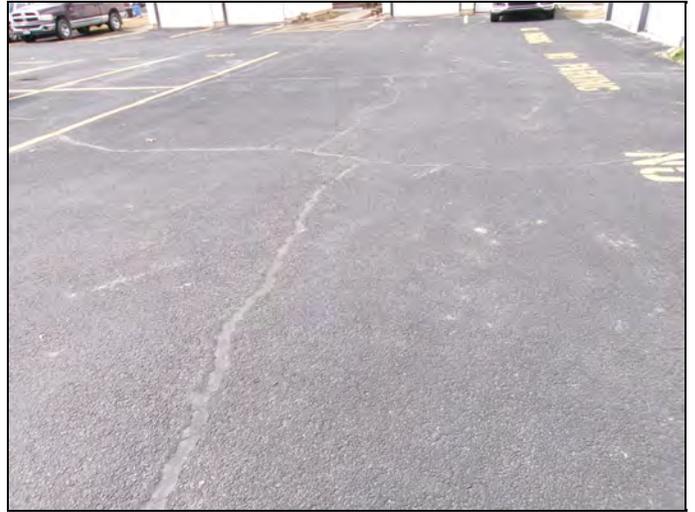
Comp #: 401 Asphalt - Major Rehab

The asphalt surfaces are in fair to poor condition. We recommend funding for a major rehab of this component approximately every 25 - 30 years. Remaining life based on current age and condition.

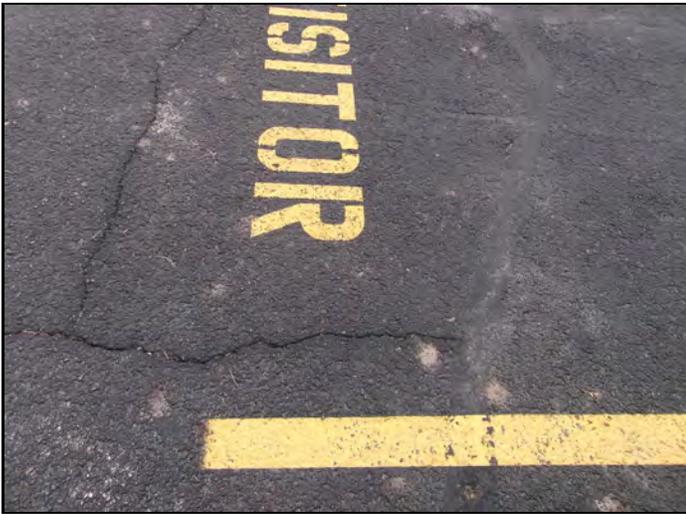
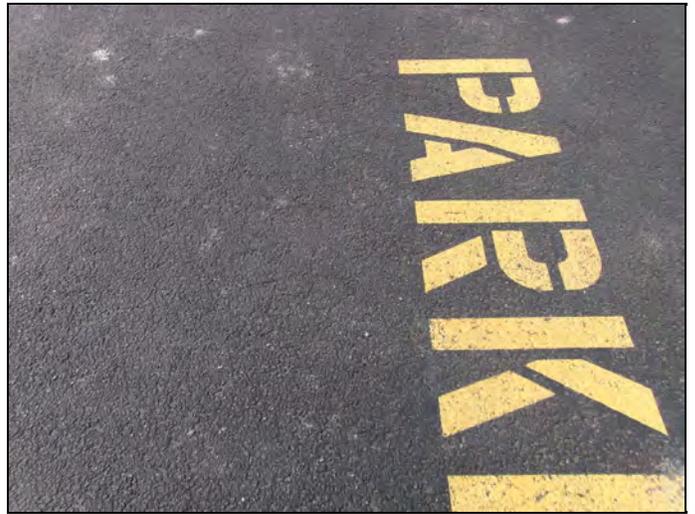
Comp #: 402 Asphalt - Seal Coat

The asphalt seal coat is in good condition. We recommend funding to seal this component approximately every 3 - 5 years. Remaining life based on current age.

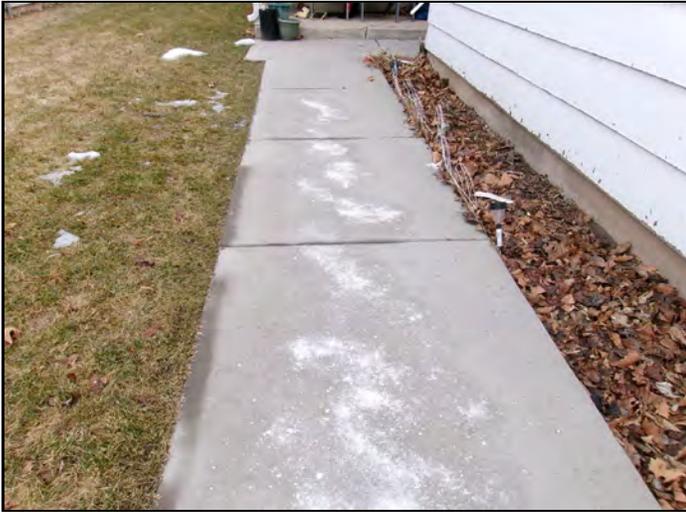
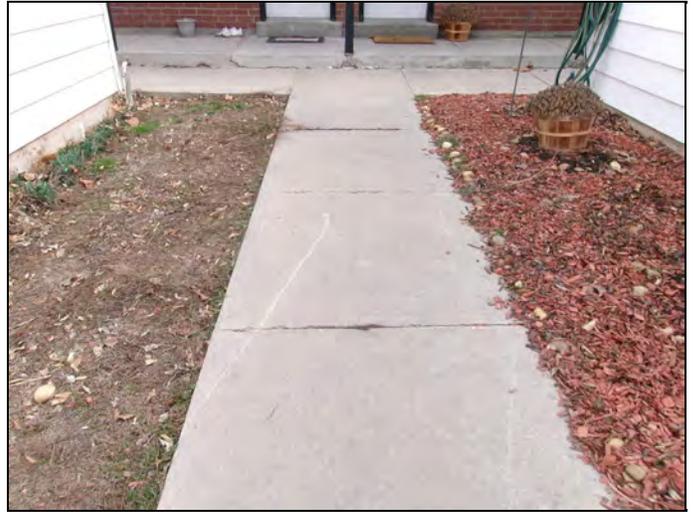
Comp #: 403 Concrete - Partial Repair/Replace

The concrete is generally in good to fair condition. This component has an extended useful life under normal conditions. We recommend funding to make repairs and partially replace this component approximately every 10 years. Remaining life based on current age.

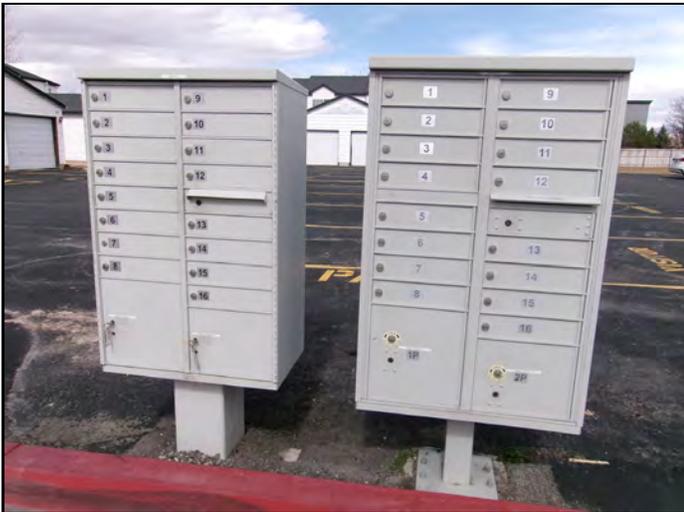
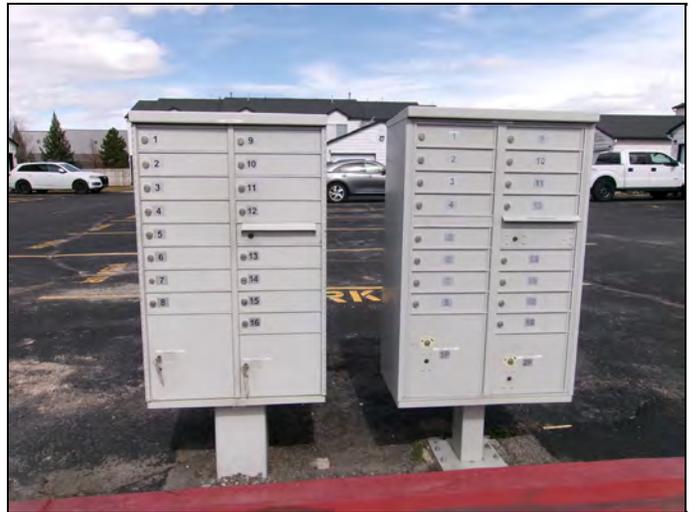
Comp #: 803 Mailboxes - Replace

The mailboxes are in fair condition. We recommend funding to replace this component approximately every 20 - 25 years. Remaining life based on current age.

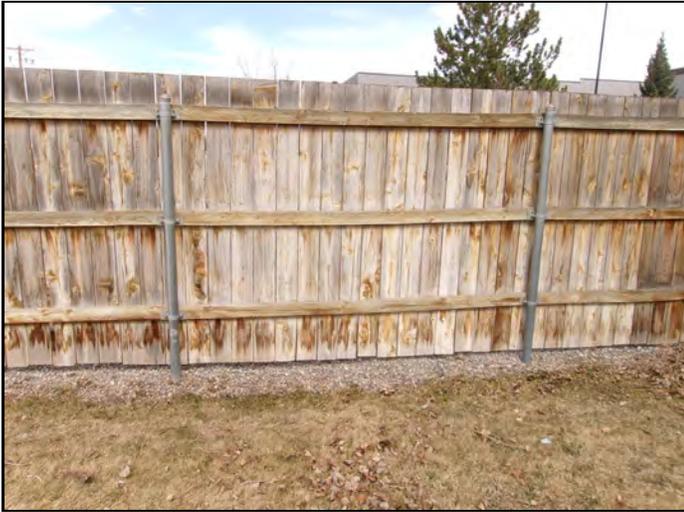
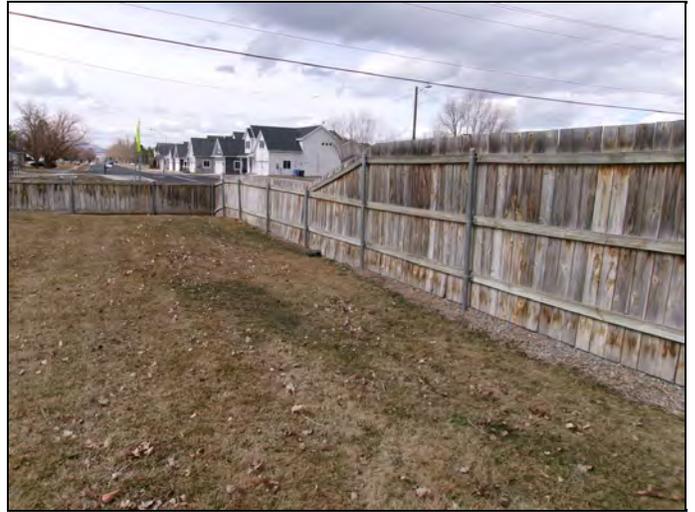
Comp #: 1001 Wood Fencing - Replace

Research with the client reveals this component is being replaced with vinyl fencing. We recommend funding to replace this component approximately every 25 - 30 years. Remaining life based on current age.

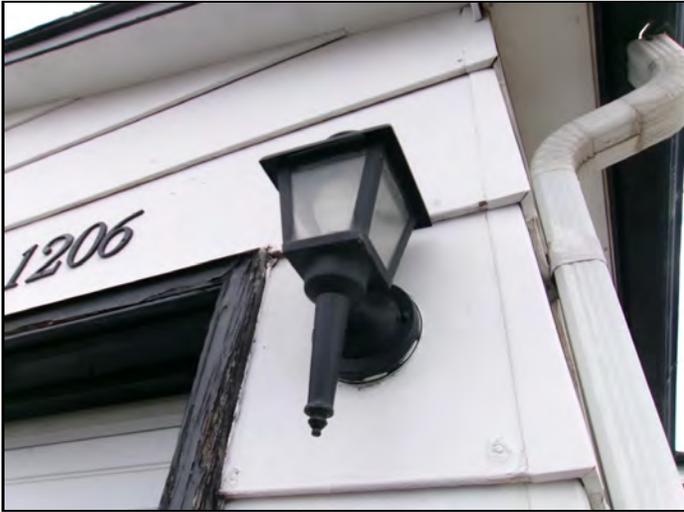
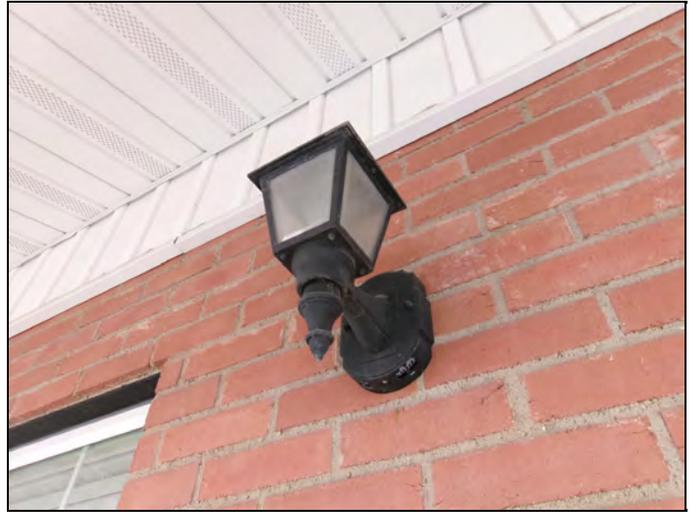
Comp #: 1602 Exterior Light Fixtures - Replace

The exterior light fixtures are in fair condition. We recommend funding to replace this component approximately every 16 - 20 years. Remaining life based on current age and condition.

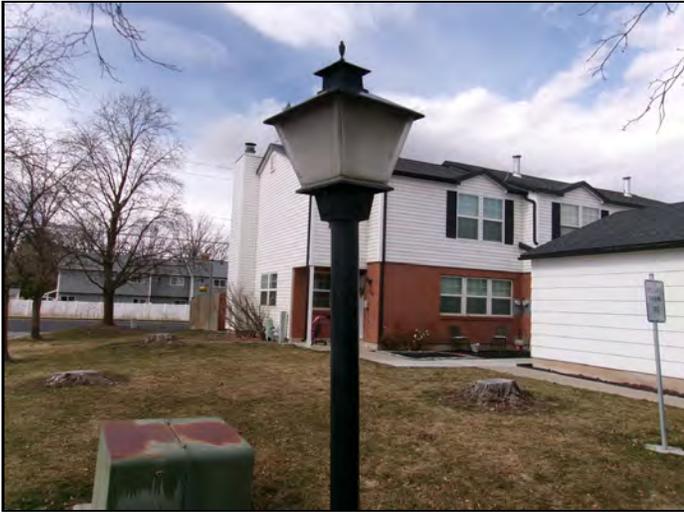
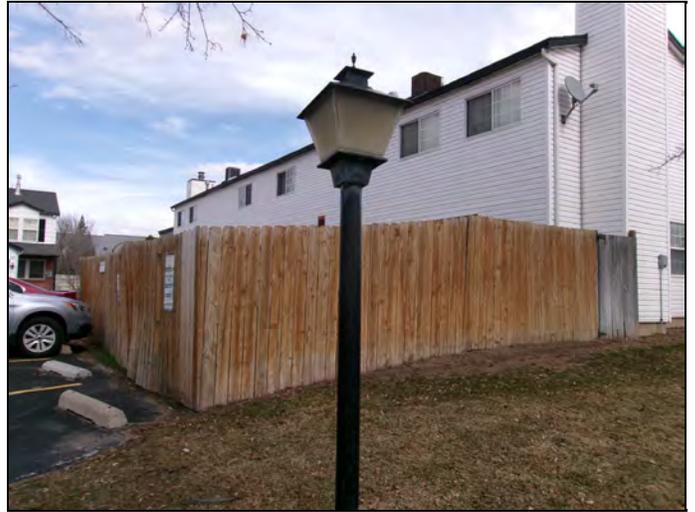
Comp #: 1604 Pole Lights - Replace

The pole lights are in fair to poor condition. We recommend funding to replace these pole light fixtures, poles and to refurbish the electrical approximately every 16 - 20 years. Remaining life based on current condition.

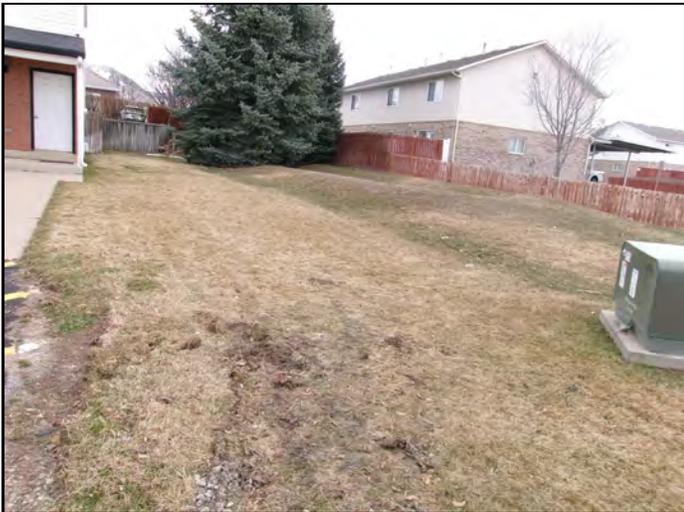
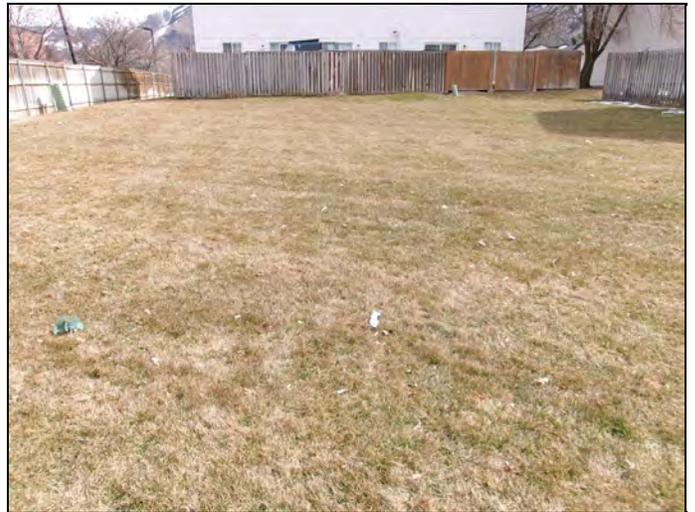
Comp #: 1812 Landscaping & Irrigation System - Renovate

The landscaping and irrigation system appear to be in fair condition. We recommend funding for an allowance to renovate this component approximately every 20 years. Remaining life based on current age and condition.
