Logan River Pointe

Level 1 Reserve Study

Report Period – 01/01/2026 – 12/31/2026

Executive Summary – Logan River Pointe - ID # 19577

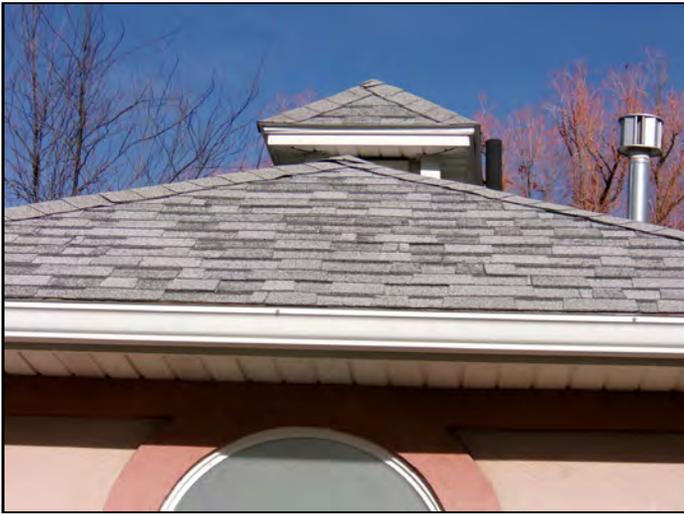
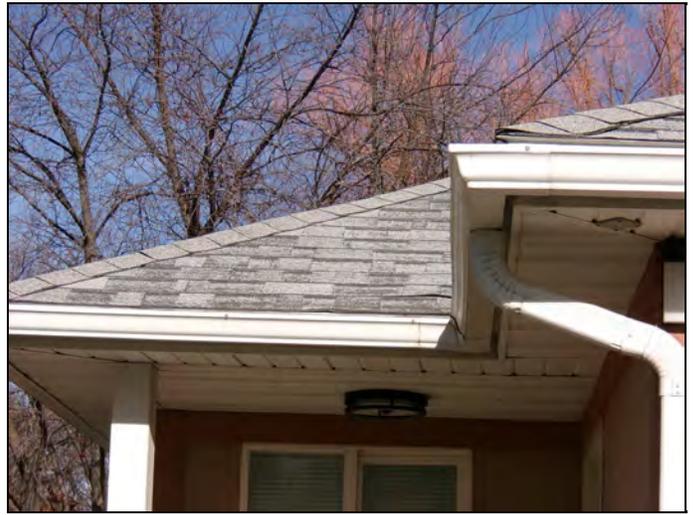
Comp #: 105 Roofs - Replace

Location: **Clubhouse**

Quantity: **Approx. 610 SF**

Research with the client reveals this component will be replaced in the near future. We recommend funding to replace this component approximately every 20 - 25 years. Remaining life based on current age.

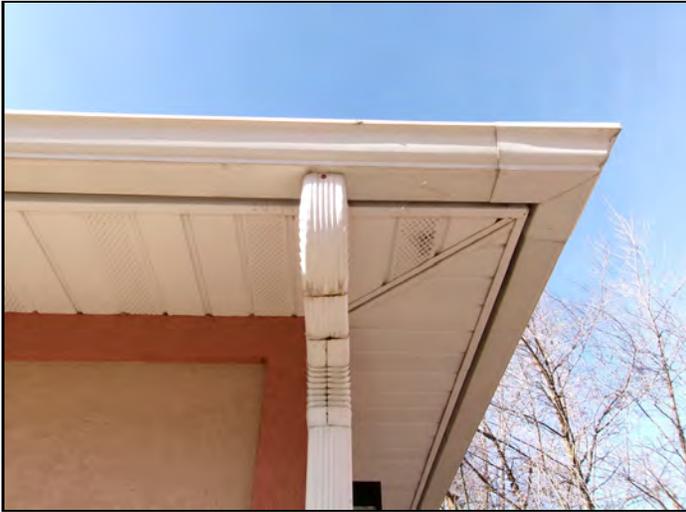
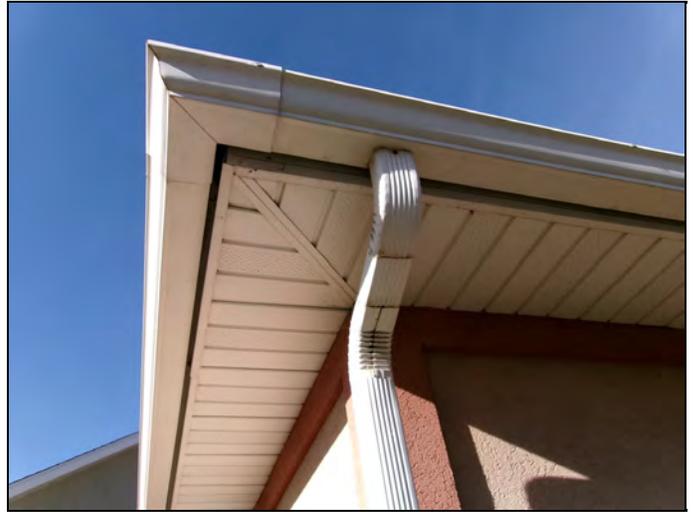
Comp #: 120 Rain Gutters/Downspouts - Replace

Location: **Clubhouse**

Quantity: **Approx. 140 LF**

The rain gutters and downspouts appear to be in fair condition. We recommend funding to replace this component approximately every 25 - 30 years. Remaining life based on current age and condition.

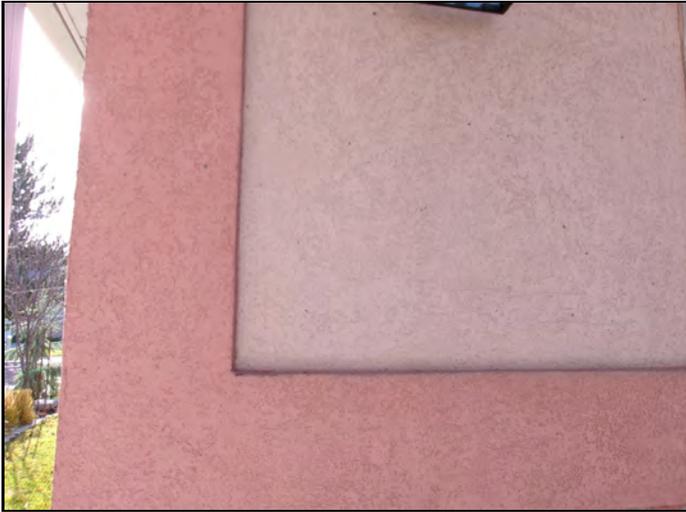
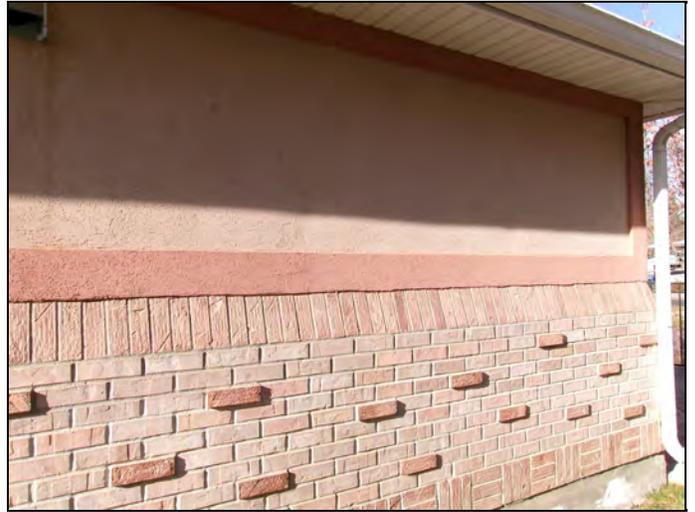
Comp #: 201 Stucco Surfaces - Repair/Repaint

Location: **Clubhouse**
Quantity: **Approx. 400 SF**
Life Expectancy: **N/A** *Remaining Life:*
Best Cost: **\$0**

Due to the minimal cost of maintaining this component, reserve funding is not appropriate. Repair/repaint as necessary as an operating expense.

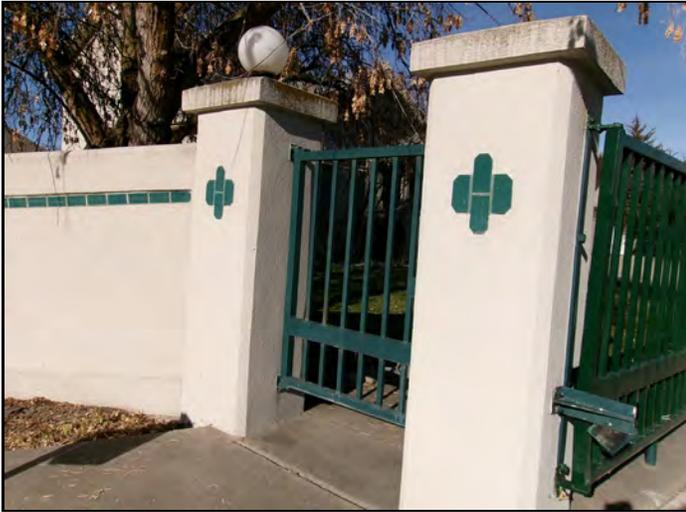
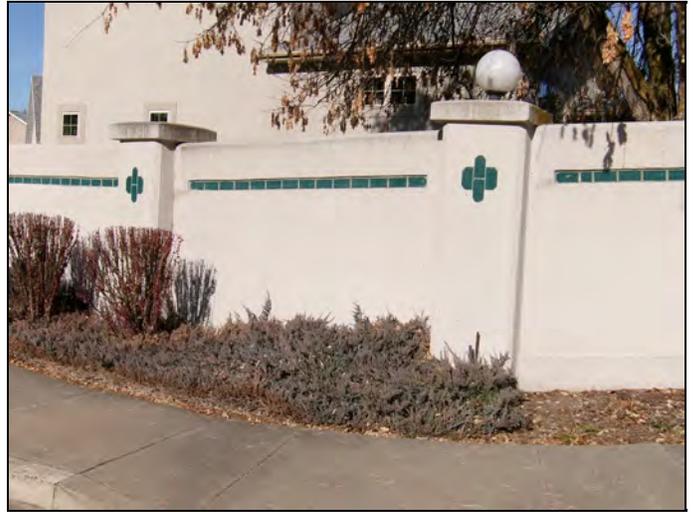
Comp #: 208 Stucco Covered Wall - Repair/Repaint

Location: **South Perimeter**

Quantity: **Approx. 450 LF**

The stucco surfaces appear to be in fair condition. We recommend funding to repair/repaint this component approximately every 12 - 15 years. Remaining life based on current condition.

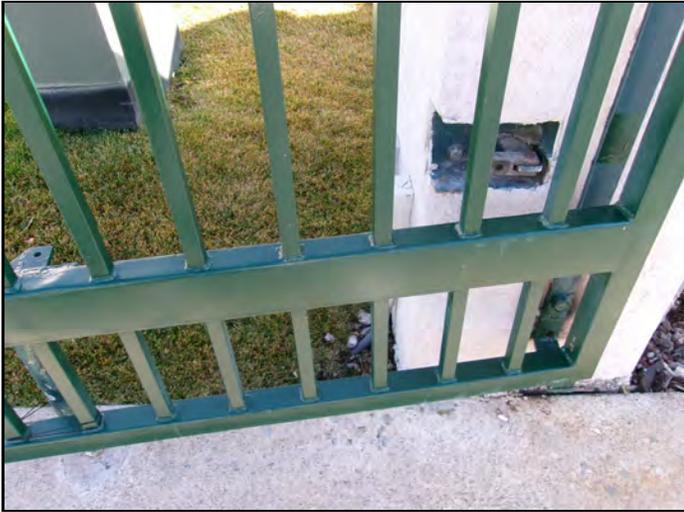
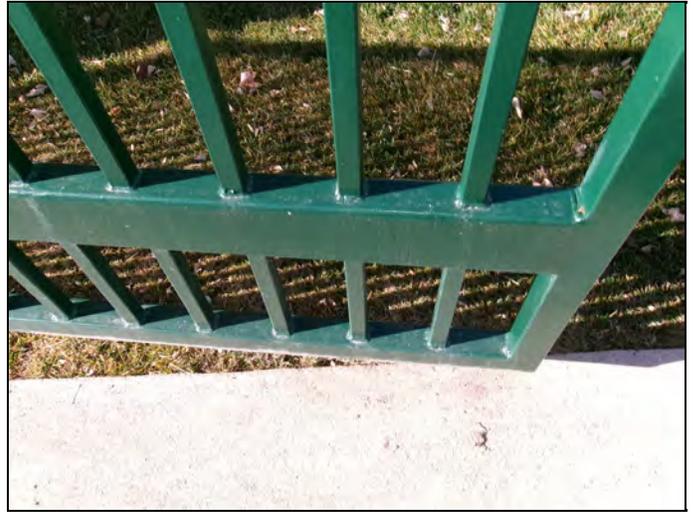
Comp #: 212 Vehicle Gates - Repaint

Location: **Vehicle Gates**
Quantity: **Approx. 40 LF**
Life Expectancy: **N/A** *Remaining Life:*
Best Cost: **\$0**

Due to the minimal cost of repainting this component, reserve funding is not appropriate. Repaint as necessary as an operating expense.

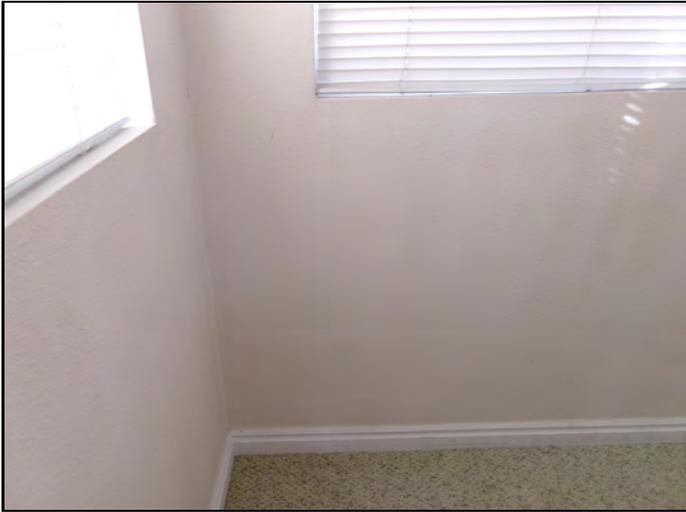
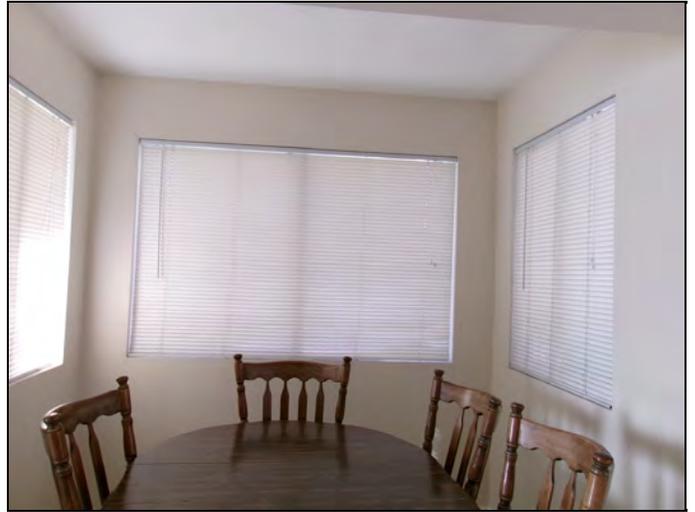
Comp #: 216 Interior Surfaces - Repaint

Location: **Clubhouse**
Quantity: **Approx. 705 SF**
Life Expectancy: **N/A** *Remaining Life:*
Best Cost: **\$0**

Due to the minimal cost of repainting this component, reserve funding is not appropriate. Repaint as necessary as an operating expense.

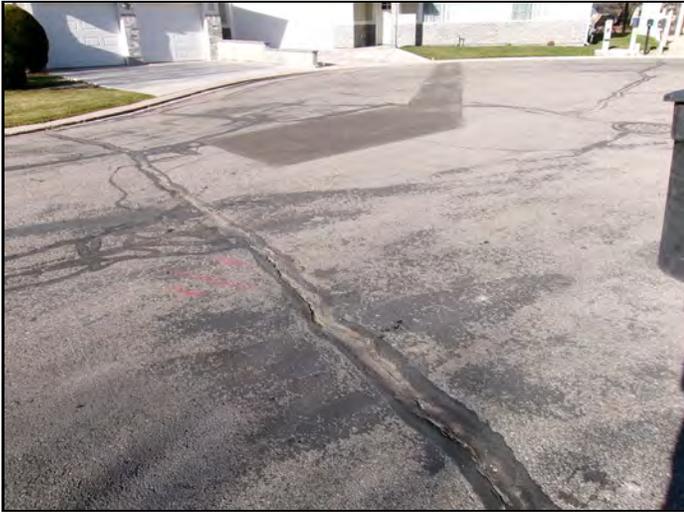
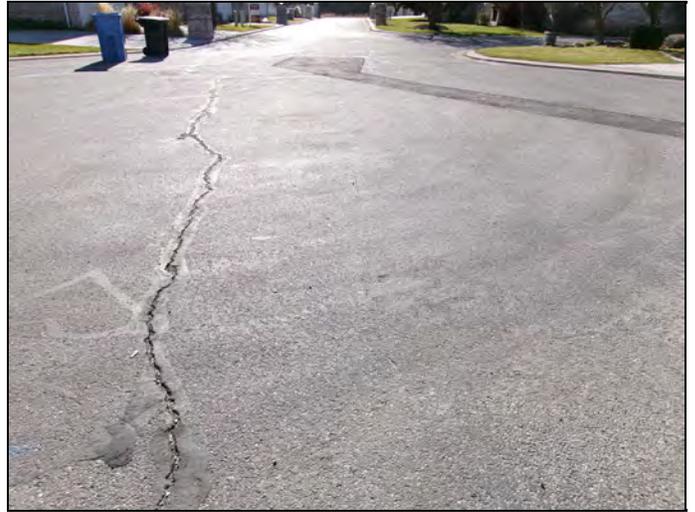
Comp #: 401 Asphalt - Major Rehab

Location: **Community Streets**

Quantity: **Approx. 16,500 SF**

The asphalt surfaces appear to be in fair condition. We recommend funding for a major rehab of this component approximately every 25 - 30 years. Remaining life based on current age and condition.

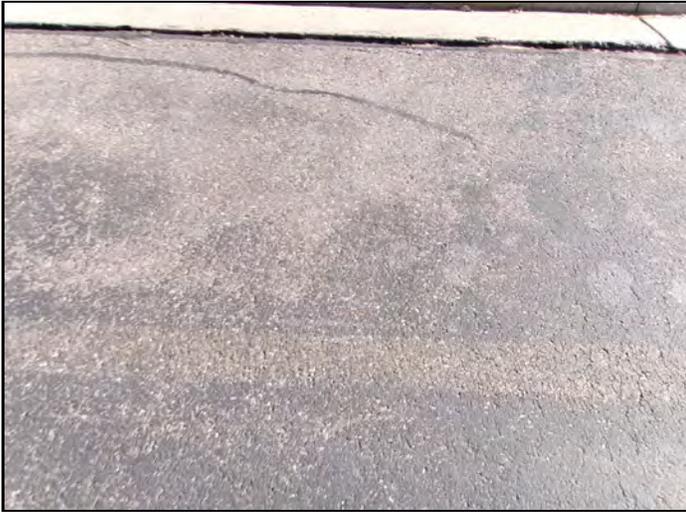
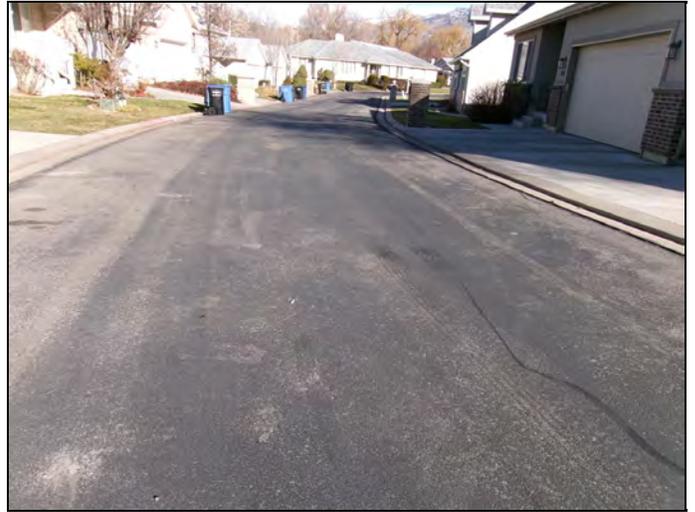
Comp #: 402 Asphalt - Seal Coat

Location: **Community Streets**

Quantity: **Approx. 16,500 SF**

The asphalt seal coat is in poor condition. We recommend funding to seal this component approximately every 3 - 5 years. Remaining life based on current condition.

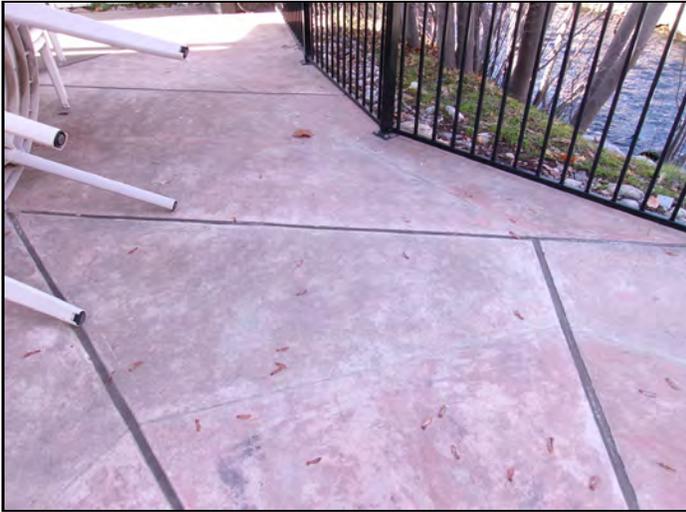
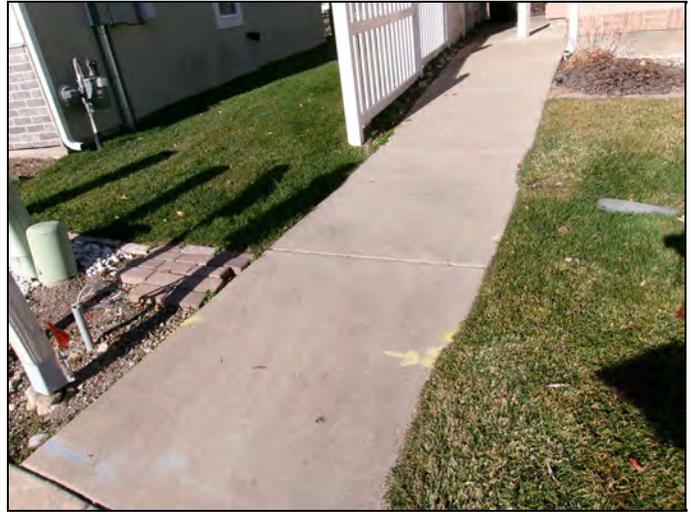
Comp #: 403 Concrete - Partial Repair/Replace

Location: **Clubhouse Patio**

Quantity: **Minimal SF**

Due to the minimal cost of maintaining this component, reserve funding is not appropriate. Repair/repaint as necessary as an operating expense.

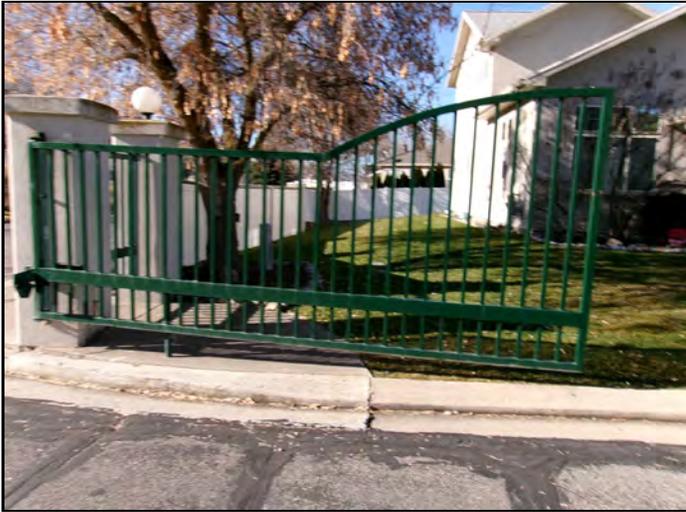
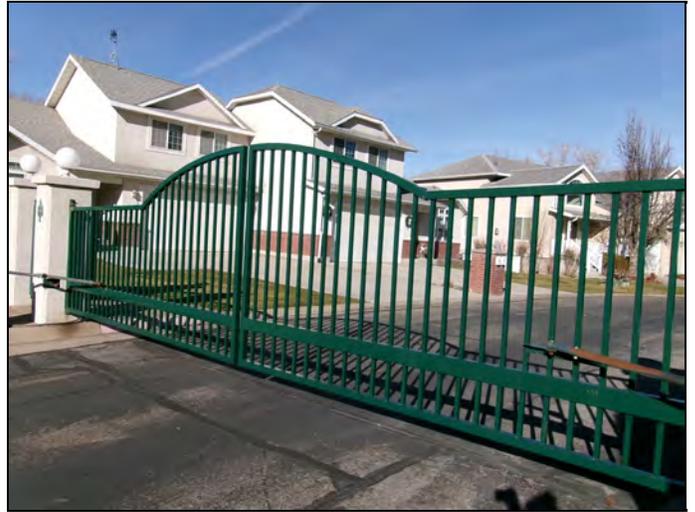
Comp #: 504 Vehicle Gates - Replace

Location: **Vehicle Gates**

Quantity: **Approx. 40 LF**

The vehicle gates are in good condition. We recommend funding to replace this component approximately every 25 - 30 years. Remaining life based on current age and condition.

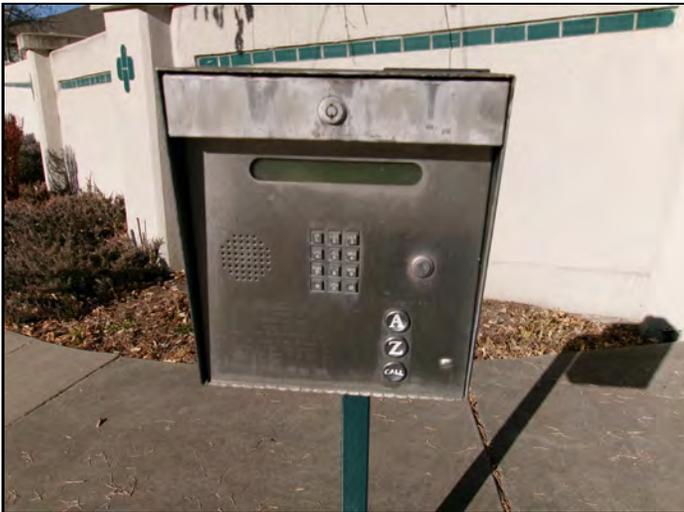
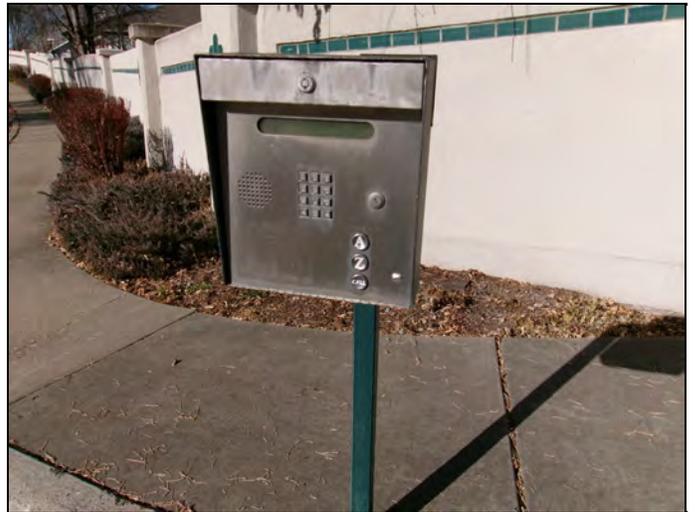
Comp #: 506 Phone Entry System - Replace

Location: **South East Gate**

Quantity: **(1) System**

Research with the client reveals this component is not in working condition and they have no plans to fix it.

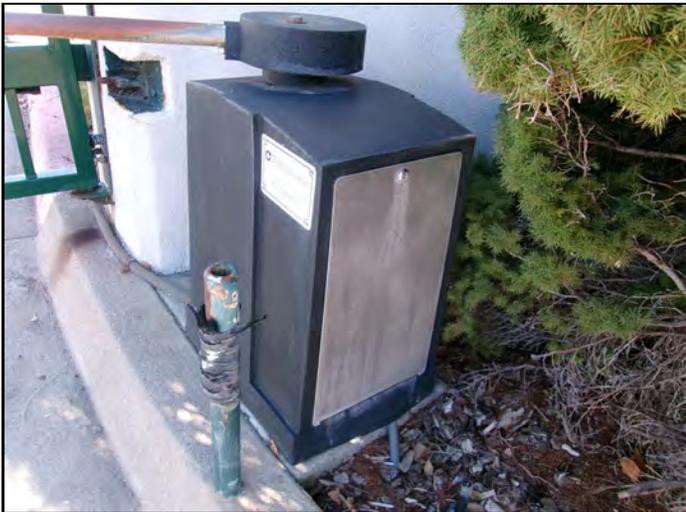
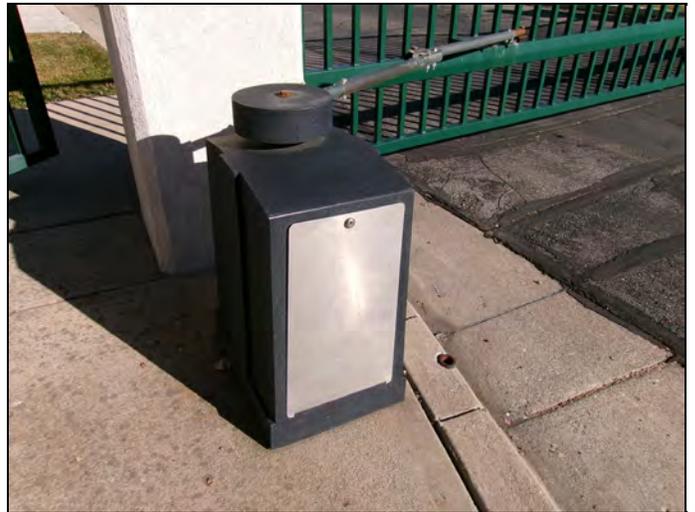
Comp #: 507 Vehicle Gate Operators - Replace

Location: **South West Gate ONLY**

Quantity: **(2) Operators**

The vehicle gate operators are in working condition. We recommend funding to replace this component approximately every 12 years. Remaining life based on current age and condition.

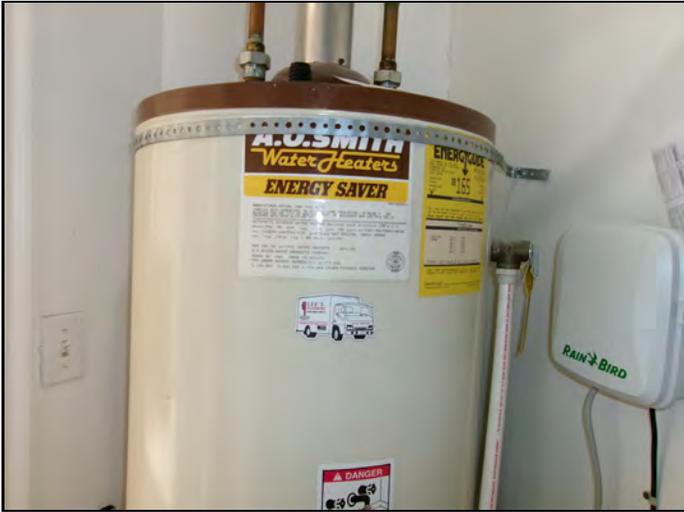
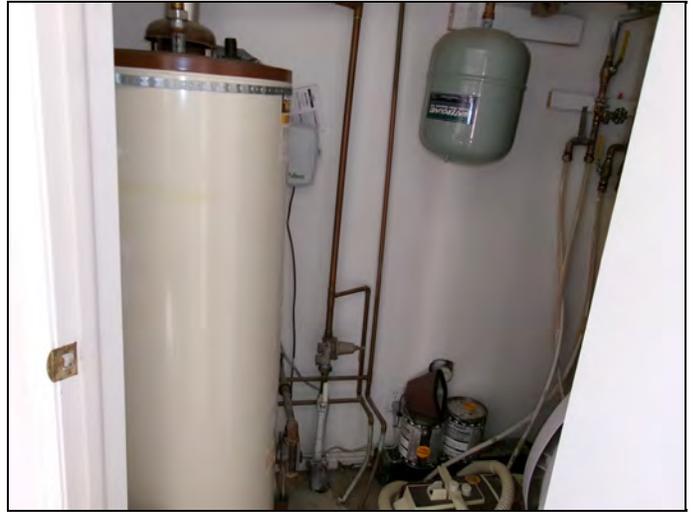
Comp #: 703 Water Heater - Replace

Location: Clubhouse

Quantity: (1) Heater

The water heater is in working condition. We recommend funding to replace this component approximately every 12 years. Remaining life based on current age and condition.

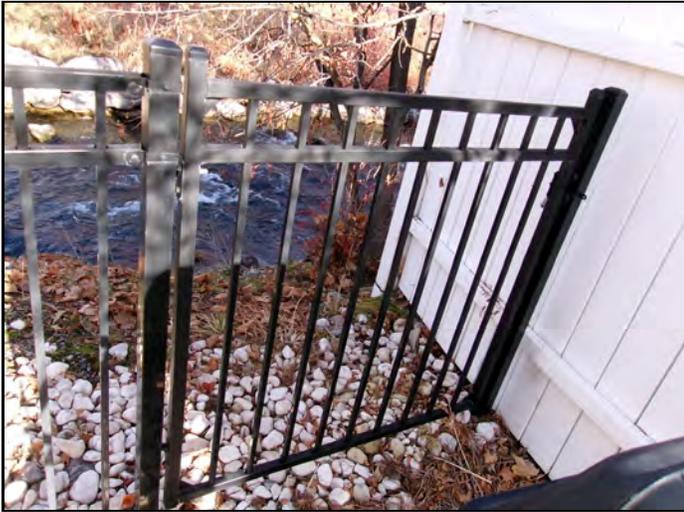
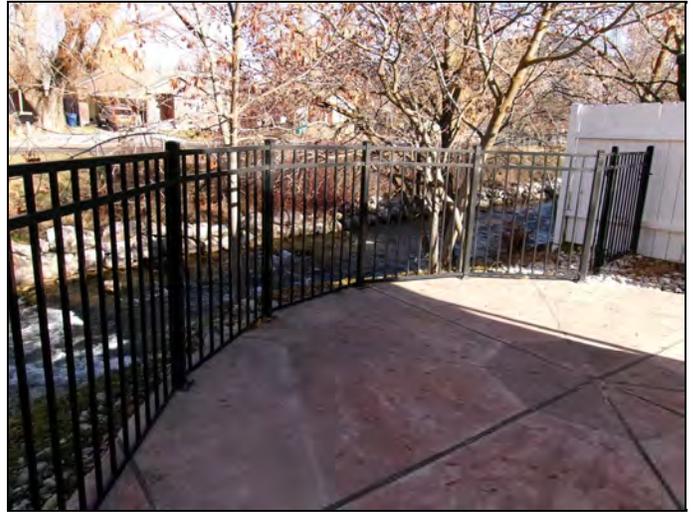
Comp #: 1002 Metal Fencing - Replace

Location: **Clubhouse Patio**

Quantity: **Approx. 55 LF**

The metal fencing is in fair condition. We recommend funding to replace this component approximately every 40 - 50 years. Remaining life based on current age.

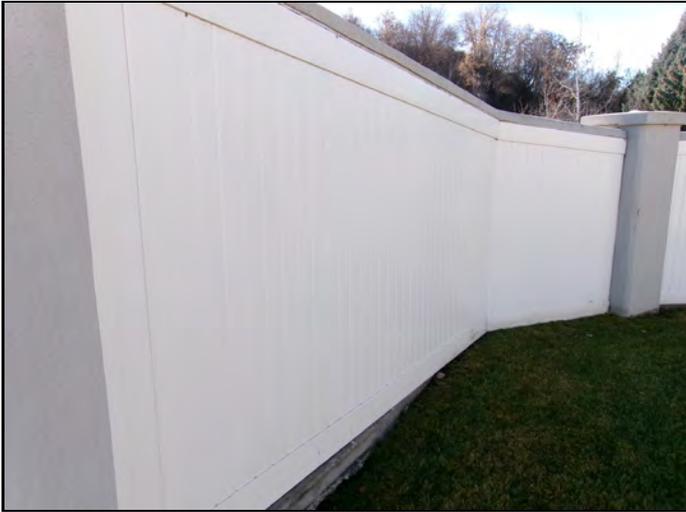
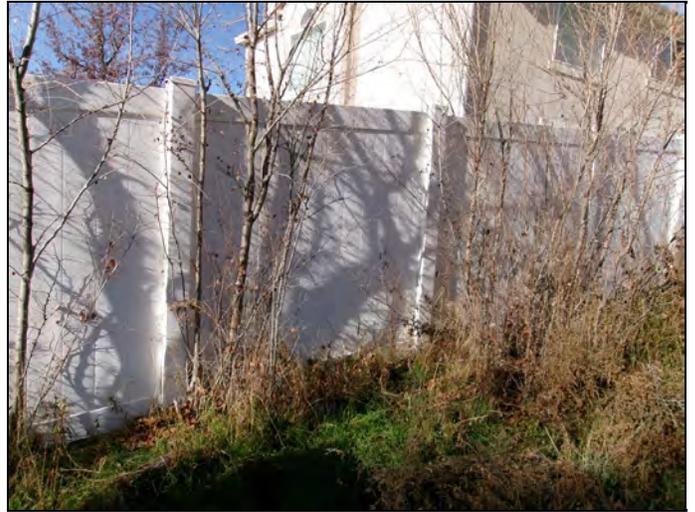
Comp #: 1008 Vinyl Fencing - Replace

Location: **East Perimeter**

Quantity: **Approx. 860 LF**

The vinyl fencing appears to be in good to fair condition. We recommend funding to replace this component approximately every 25 - 30 years. Remaining life based on current age and condition.

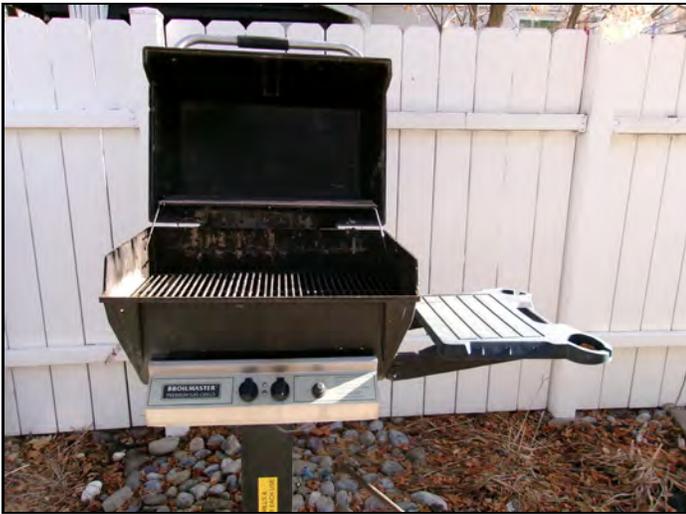
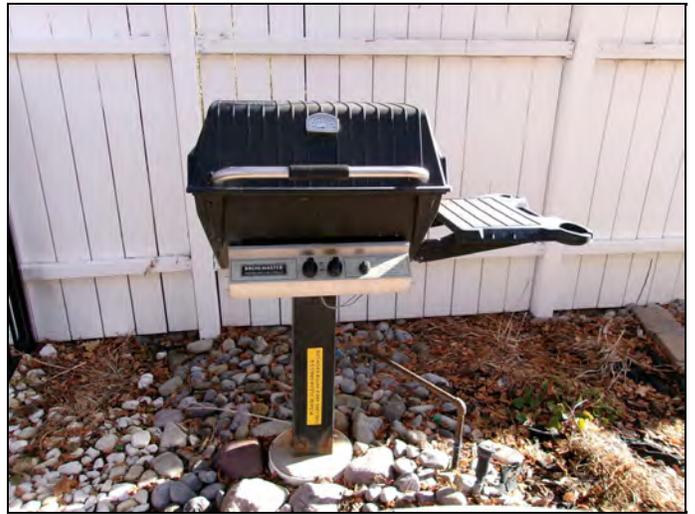
Comp #: 1305 Barbecue Grill - Replace

Location: Clubhouse Patio

Quantity: (1) Grill

Due to the minimal cost of replacing this component, reserve funding is not appropriate. Replace as necessary as an operating expense.

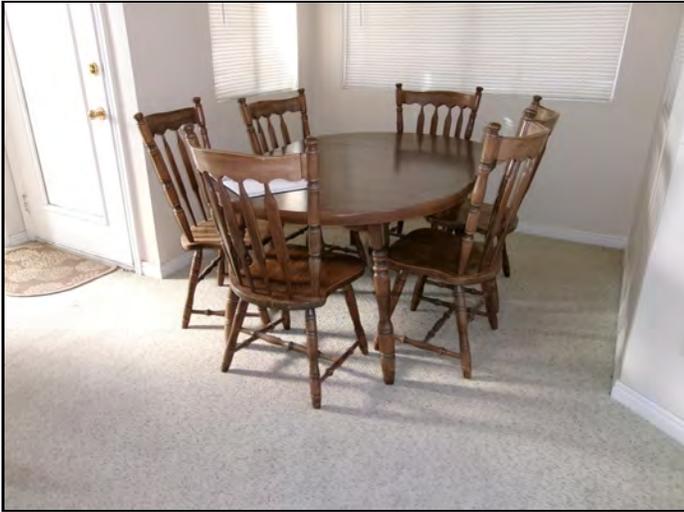
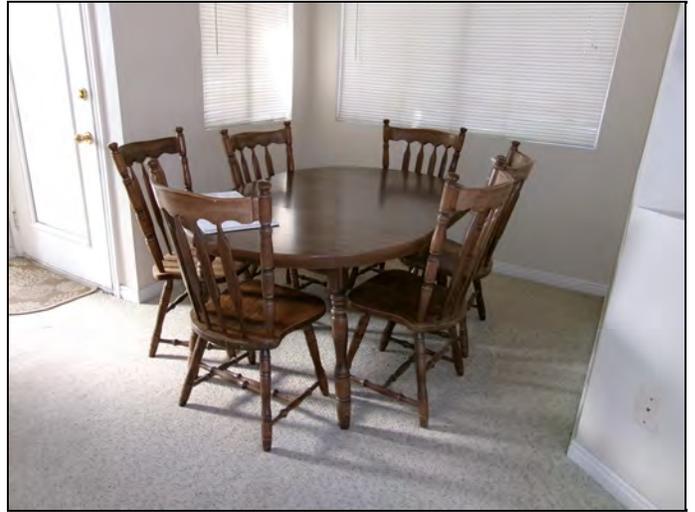
Comp #: 1405 Furniture - Replace

Location: **Clubhouse**

Quantity: **(7) Pieces**

Due to the minimal cost of replacing this component, reserve funding is not appropriate. Replace as necessary as an operating expense.

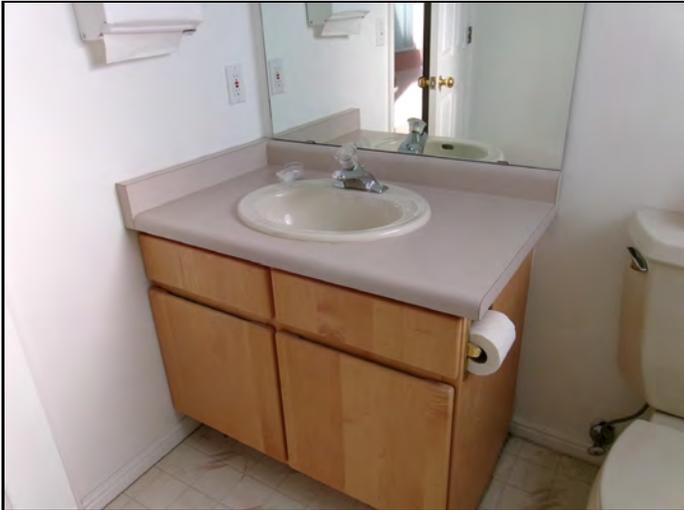
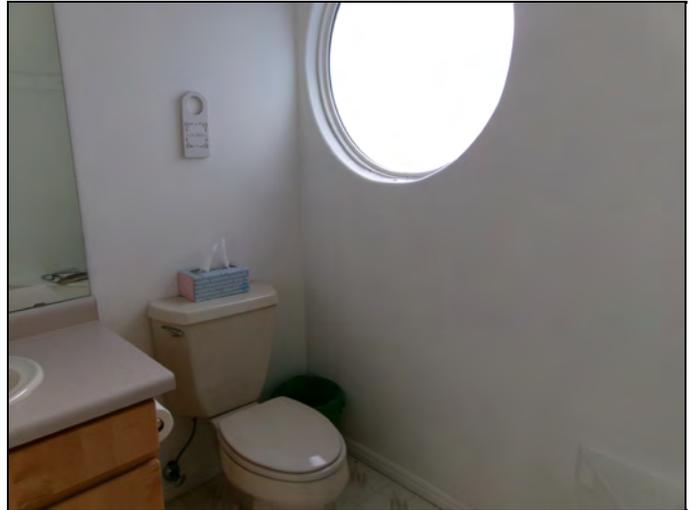
Comp #: 1413 Restroom - Remodel

Location: **Clubhouse**

Quantity: **(1) Restroom**

The restrooms are in fair condition. We recommend funding to remodel this component approximately every 20 - 25 years. Remaining life based on current age and condition.

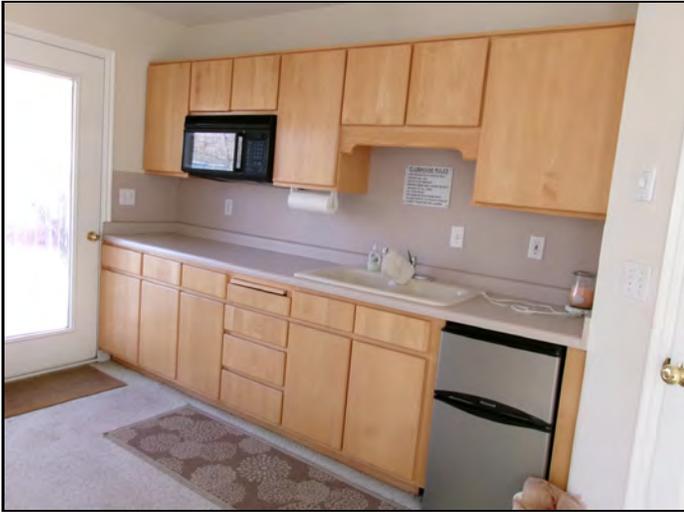
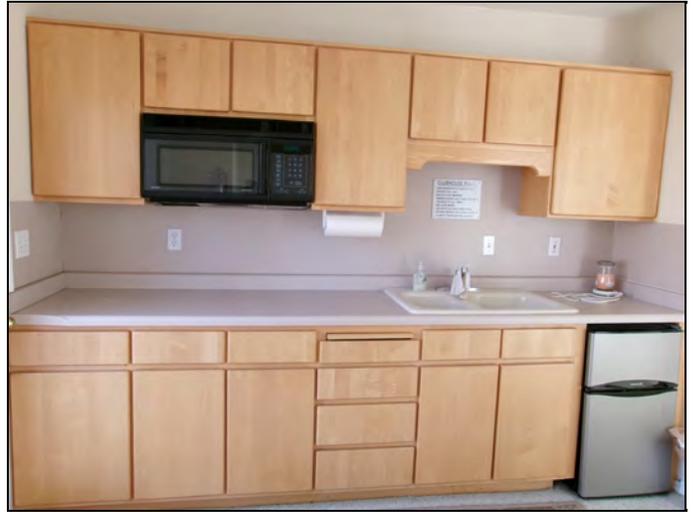
Comp #: 1417 Kitchenette - Remodel

Location: **Clubhouse Interior**

Quantity: **(1) Kitchenette**

The kitchen is in fair condition. We recommend funding to remodel this component approximately every 20 years. Remaining life based on current age and condition.

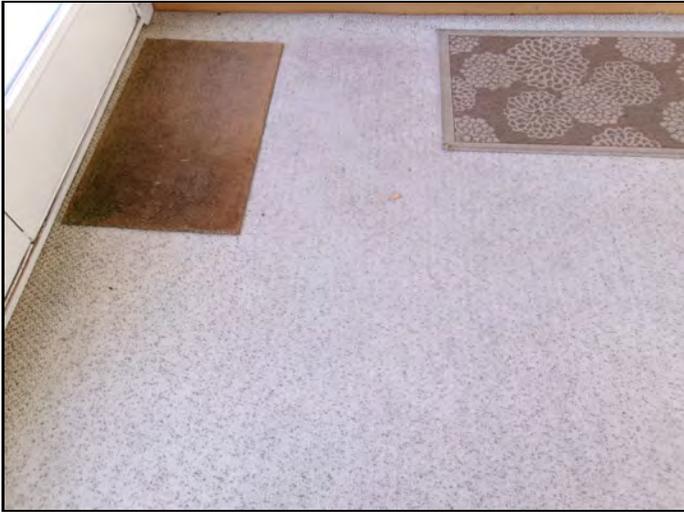
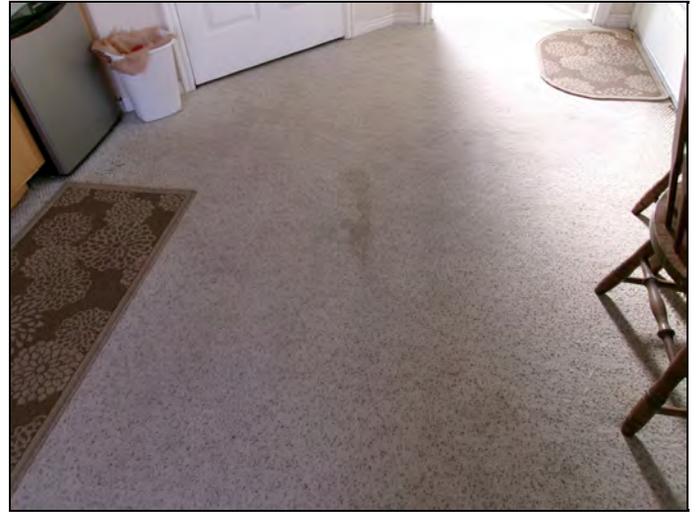
Comp #: 1501 Carpeting - Replace

Location: **Clubhouse**

Quantity: **Approx. 190 SF**

Due to the minimal cost of replacing this component, reserve funding is not appropriate. Replace as necessary as an operating expense.

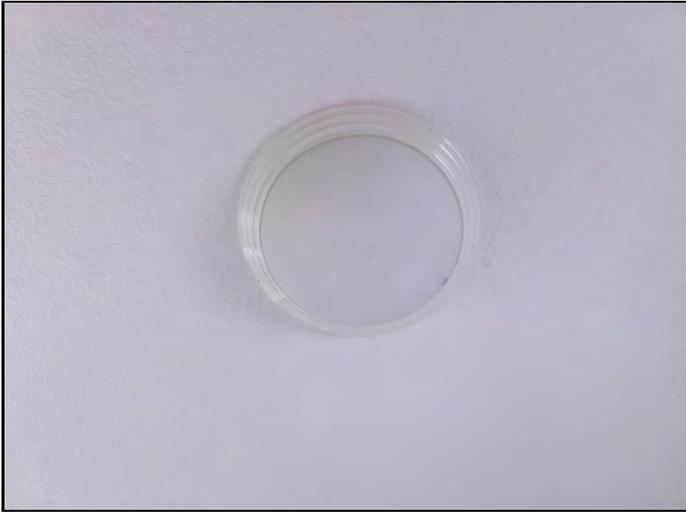
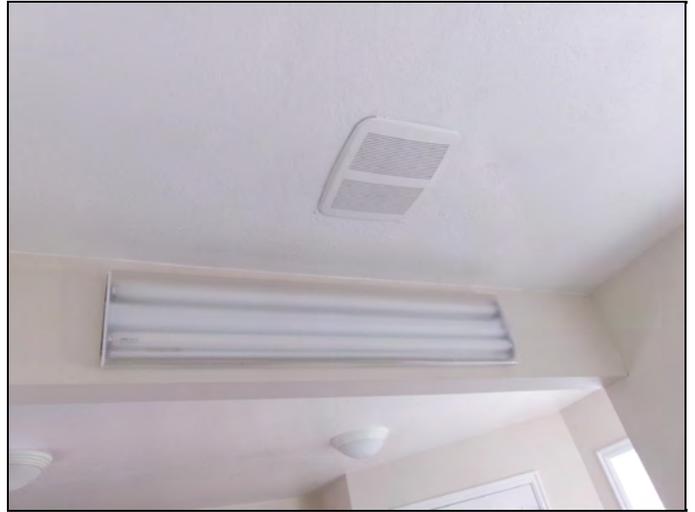
Comp #: 1601 Interior Light Fixtures - Replace

Location: **Clubhouse**

Quantity: **(4) Fixtures**

Due to the minimal cost of replacing this component, reserve funding is not appropriate. Replace as necessary as an operating expense.

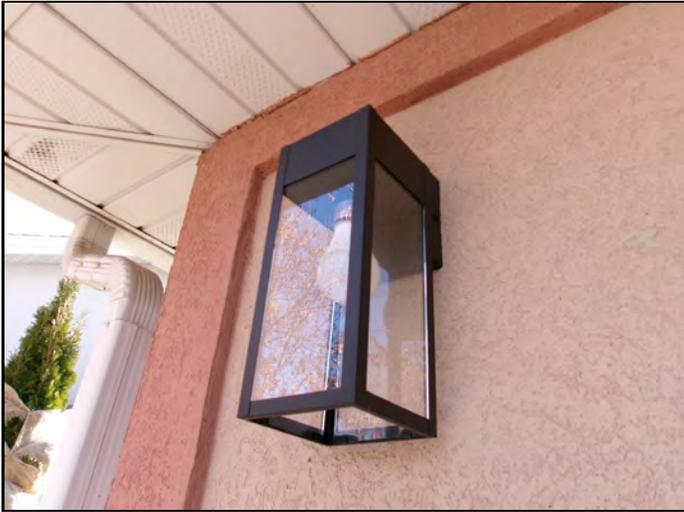
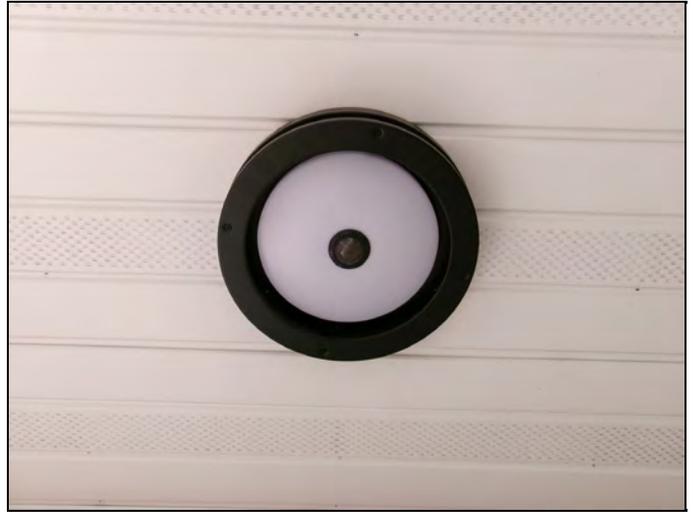
Comp #: 1602 Exterior Light Fixtures - Replace

Location: **Clubhouse**

Quantity: **(4) Fixtures**

Due to the minimal cost of replacing this component, reserve funding is not appropriate. Replace as necessary as an operating expense.

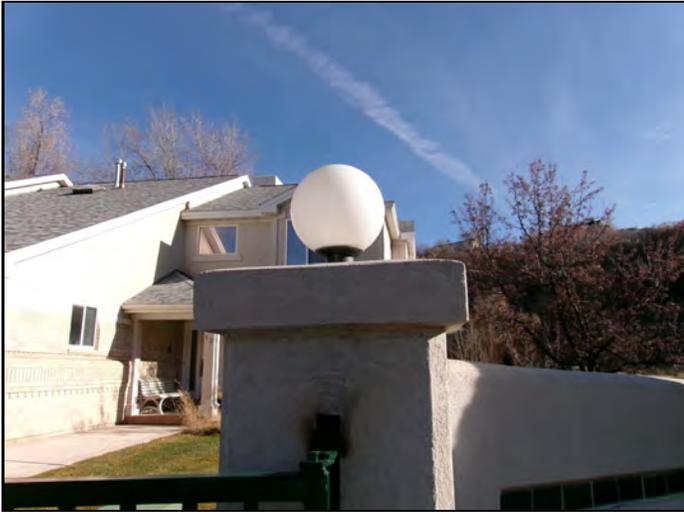
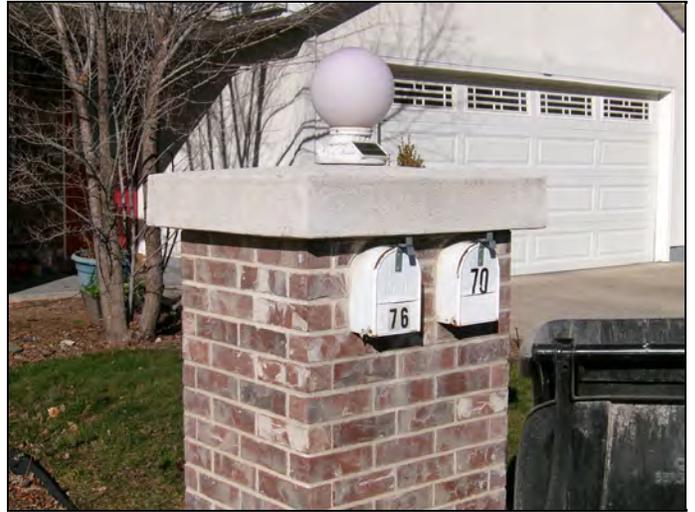
Comp #: 1604 Post Lights - Replace

Location: **Common Area**

Quantity: **(24) Post Lights**

The post lights are in fair to poor condition. We recommend funding to replace these pole light fixtures, and to refurbish the electrical approximately every 16 - 20 years. Remaining life based on current age and condition.

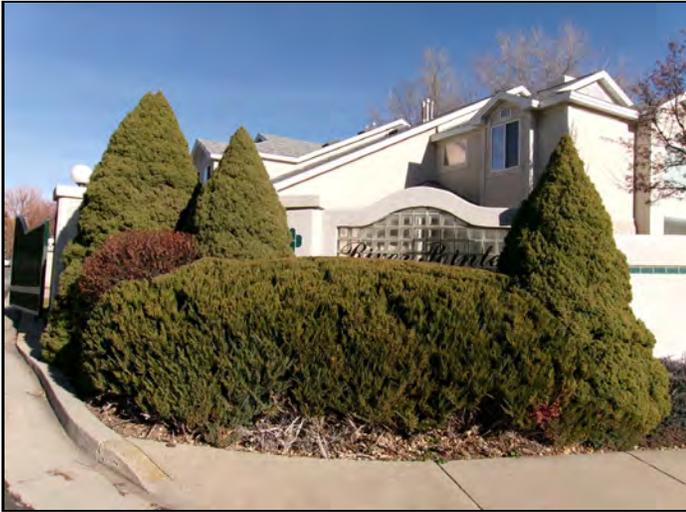
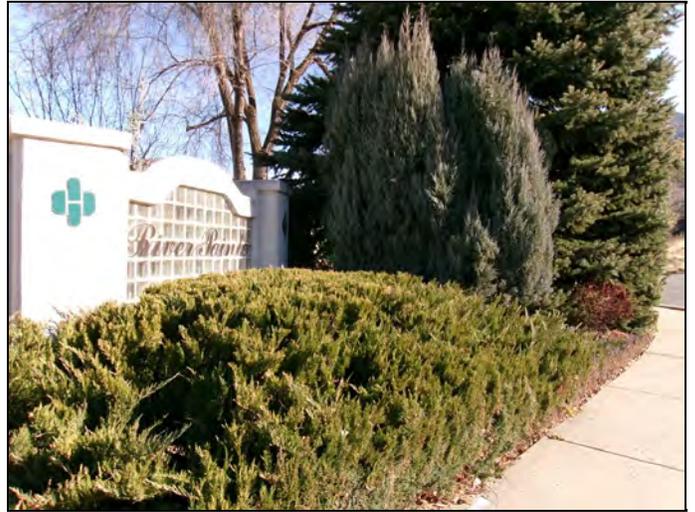
Comp #: 1812 Landscaping & Irrigation System - Renovate

Location: **Common Area**

Quantity: **Minimal SF**

The landscaping and irrigation system appear to be in fair condition. We recommend funding for an allowance to renovate this component approximately every 20 years. Remaining life based on current age.

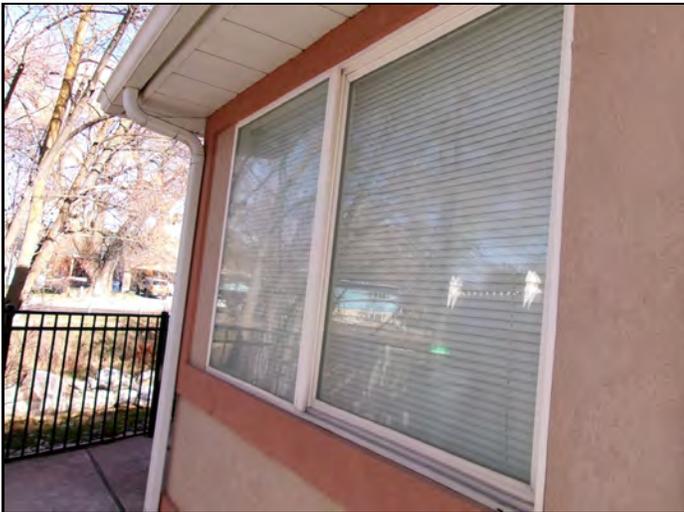
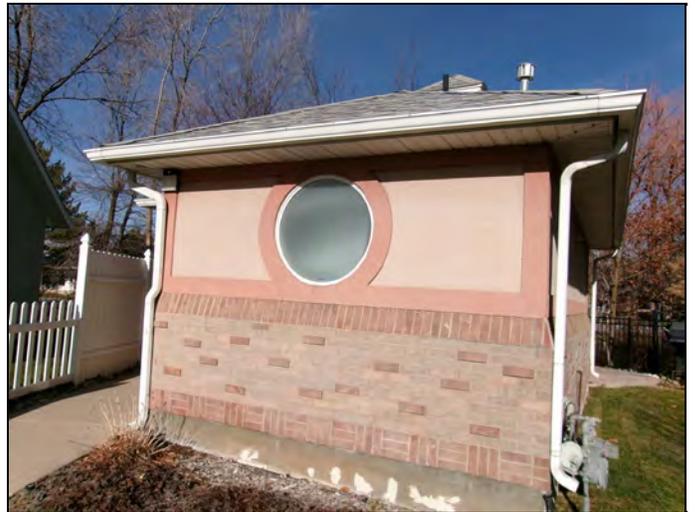
Comp #: 2303 Windows - Replace

Location: **Clubhouse**

Quantity: **(4) Windows**

The windows appear to be in fair condition. We recommend funding to replace this component approximately every 40 - 50 years. Remaining life based on current age.

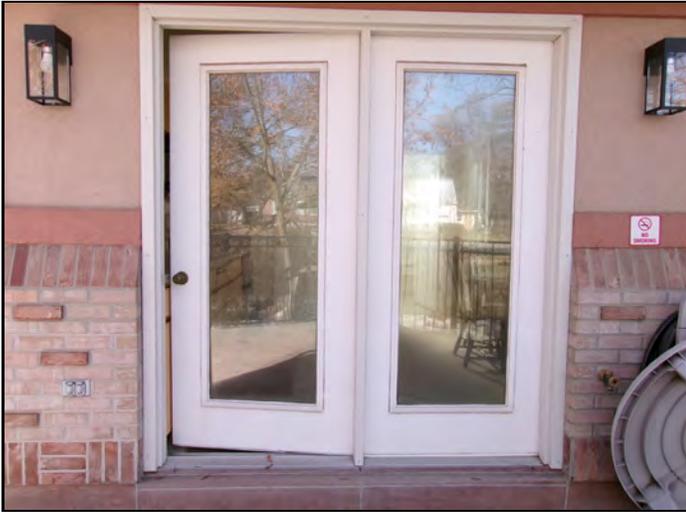
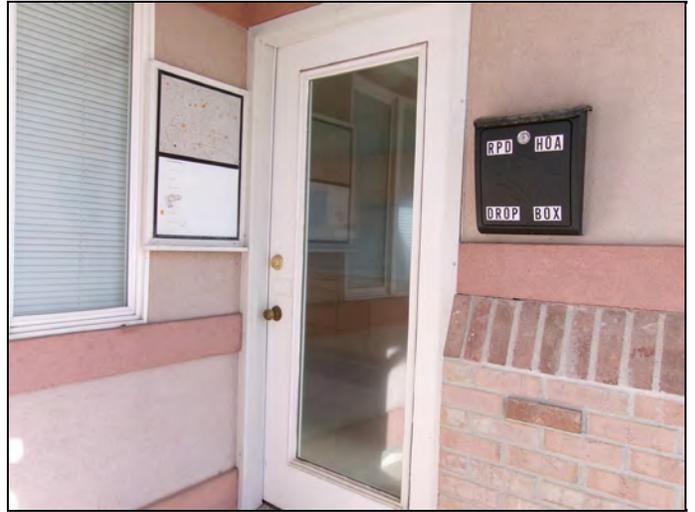
Comp #: 2304 Exterior Doors - Replace

Location: **Clubhouse**

Quantity: **(3) Doors**

The doors appear to be in fair condition. We recommend funding to replace this component approximately every 40 - 50 years. Remaining life based on current age.
