# **Cobble Creek**

## **Level 1 Reserve Study**

**Report Period – 01/01/2027 – 12/31/2027**

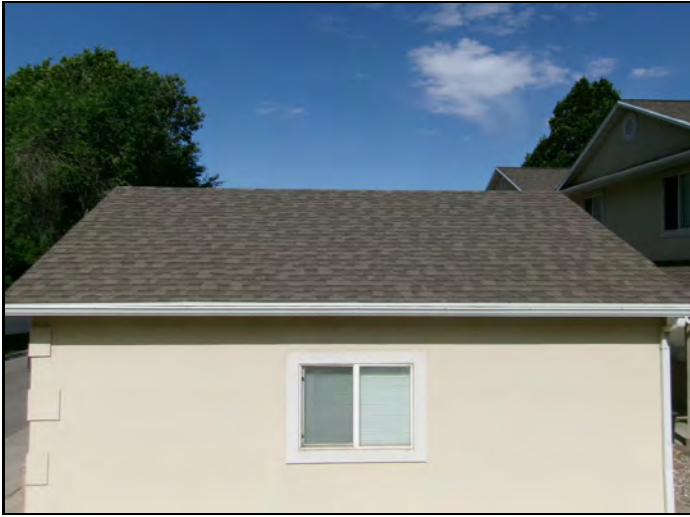
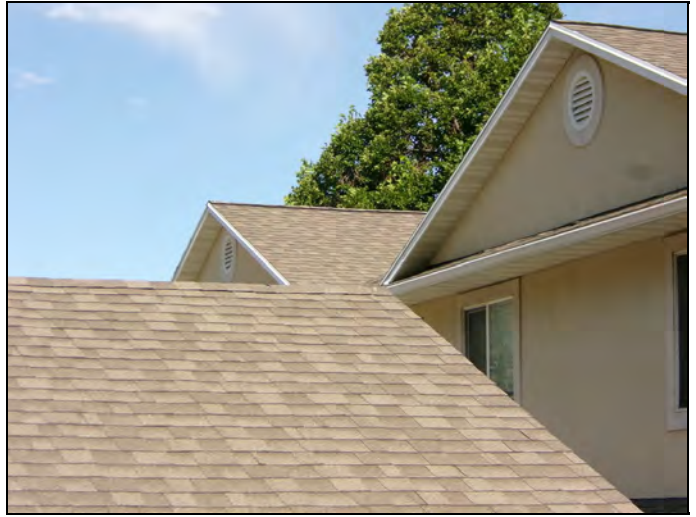
Comp #: 105    Roofs - Replace

The roofs appear to be in good to fair condition. We recommend funding to replace this component approximately every 20 - 25 years. Remaining life based on current age.

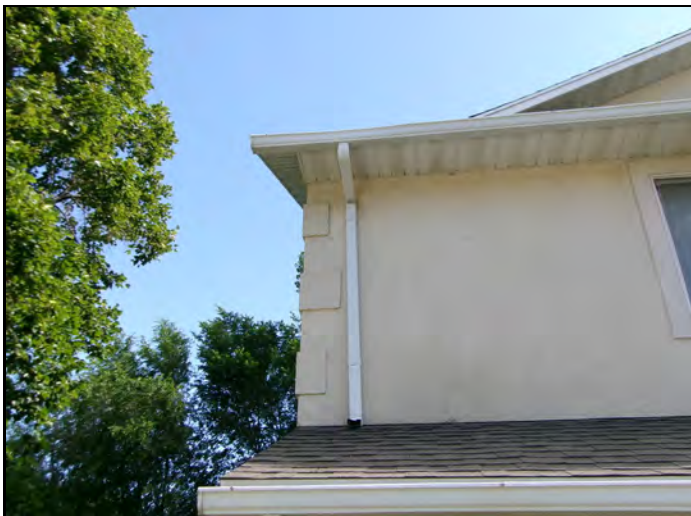
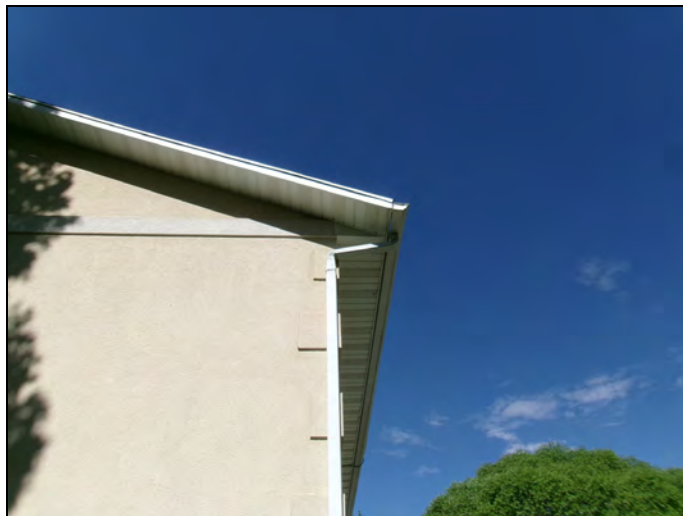
Comp #: 120 Rain Gutters/Downspouts - Replace

The rain gutters and downspouts appear to be in fair condition. We recommend funding to replace this component approximately every 25 - 30 years. Remaining life based on current age and condition.

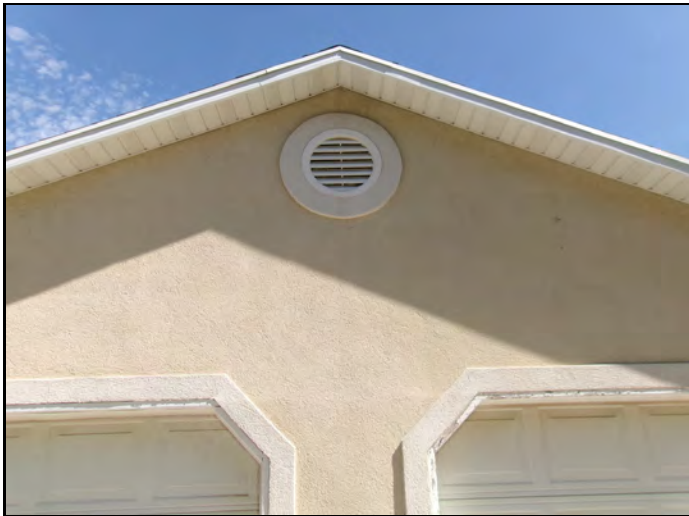
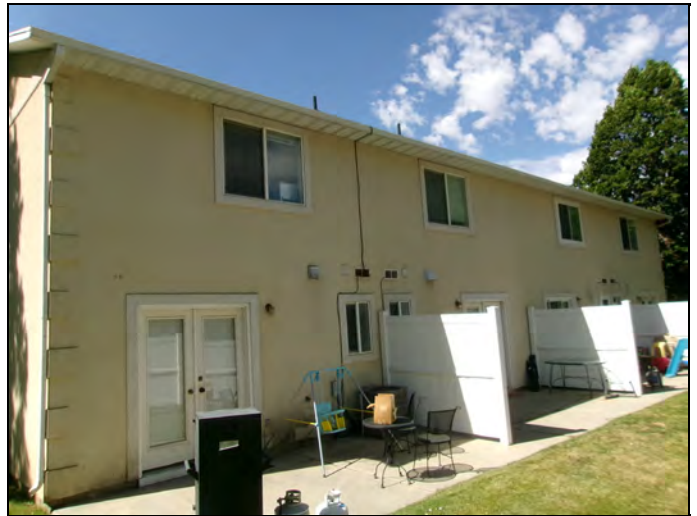
Comp #: 201 Stucco Surfaces - Repair/Repaint

The stucco surfaces appear to be in good to fair condition. We recommend funding to repair/repaint this component approximately every 12 - 15 years. Remaining life based on current age and condition.

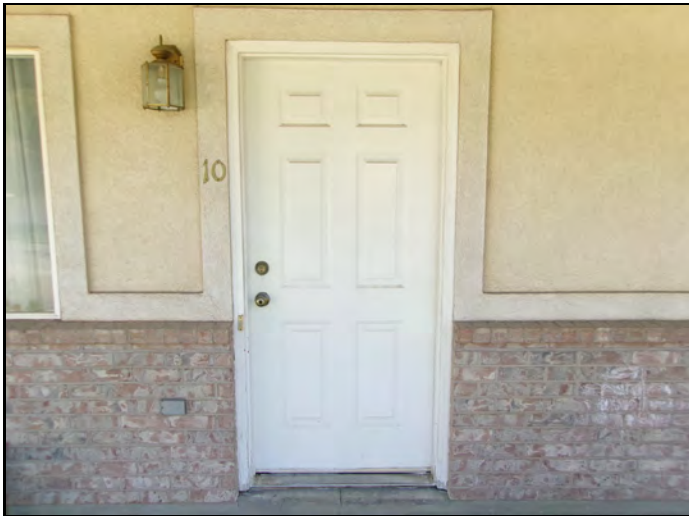
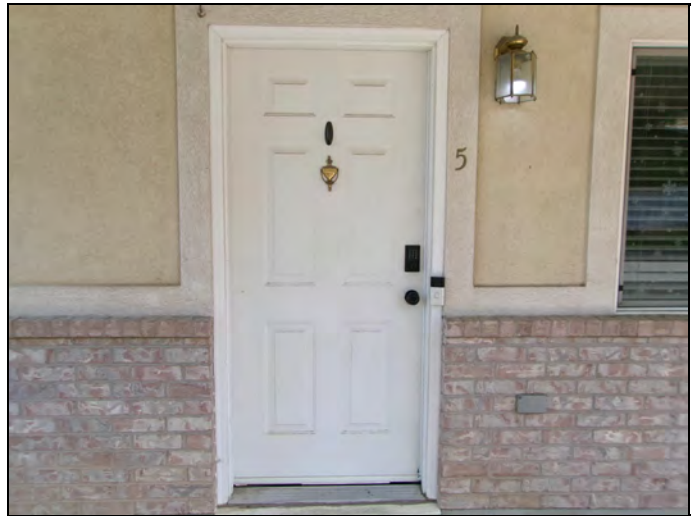
Comp #: 204 Front Doors - Repaint

The painted surfaces are in good to fair condition. We recommend funding to paint this component approximately every 8 - 10 years. Remaining life based on current age and condition.

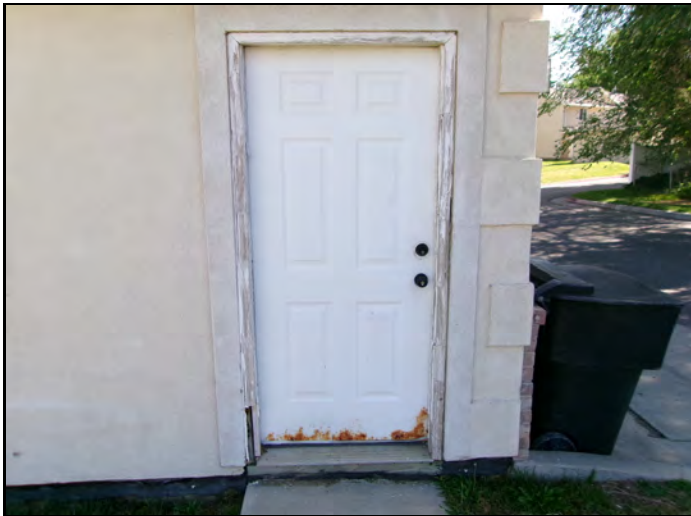
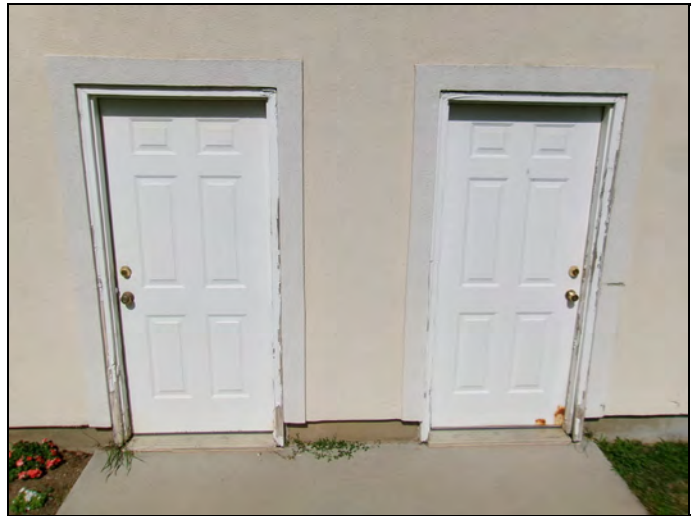
Comp #: 205 Garage Pedestrian Doors - Repaint

The painted surfaces are in poor condition. We recommend funding to paint this component approximately every 8 - 10 years. Remaining life based on current condition.

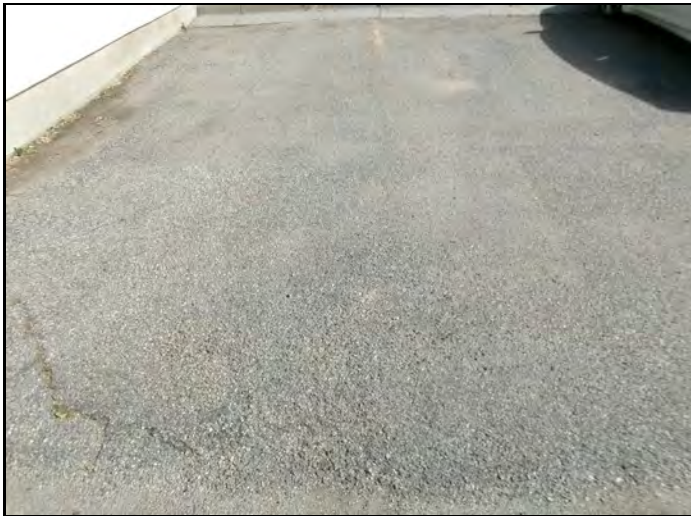
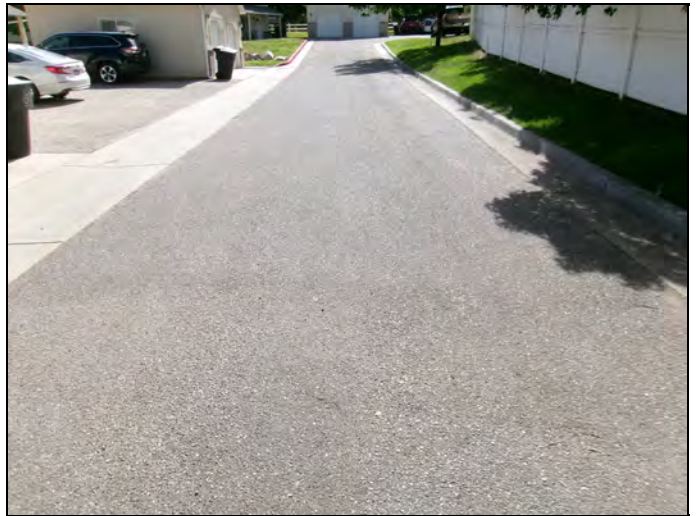
Comp #: 401 Asphalt - Major Rehab

The asphalt surfaces appear to be in fair condition. We recommend funding for a major rehab of this component approximately every 25 - 30 years. Remaining life based on current age and condition.

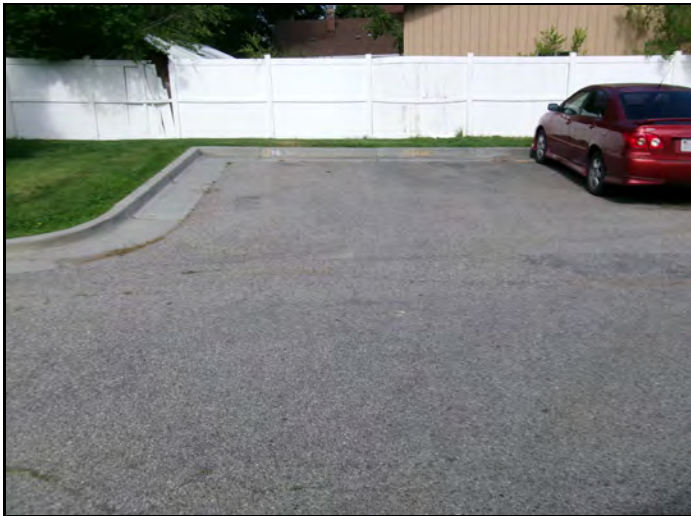
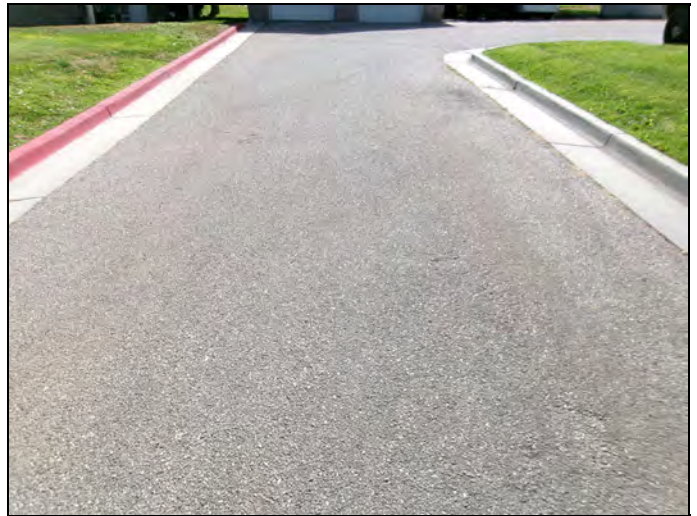
Comp #: 402 Asphalt - Seal Coat

The asphalt seal coat is in poor condition. We recommend funding to seal this component approximately every 3 - 5 years. Remaining life based on current condition.

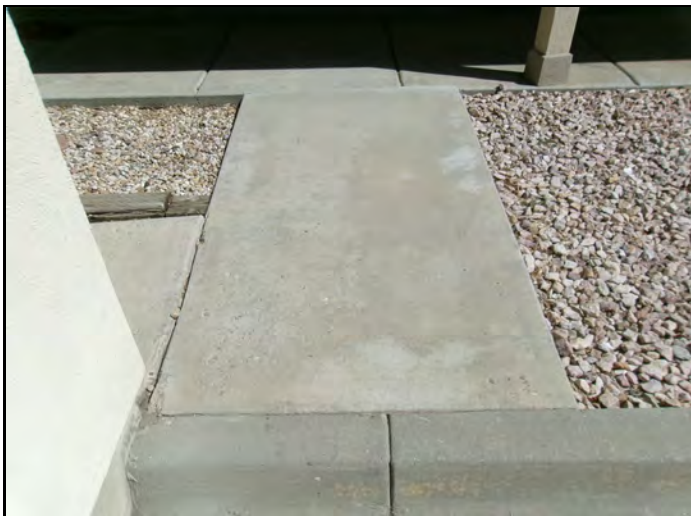
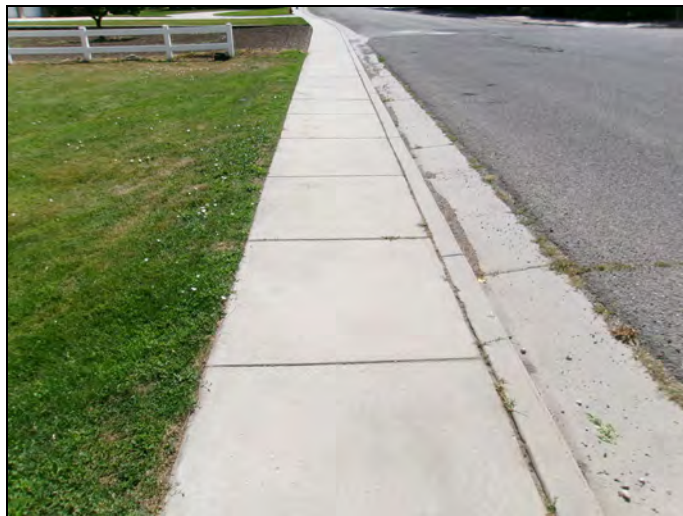
Comp #: 403 Concrete - Partial Repair/Replace

The concrete appears to be in good condition. This component has an extended useful life under normal conditions. We recommend funding to make repairs and partially replace this component approximately every 10 years. Remaining life based on current age and condition.

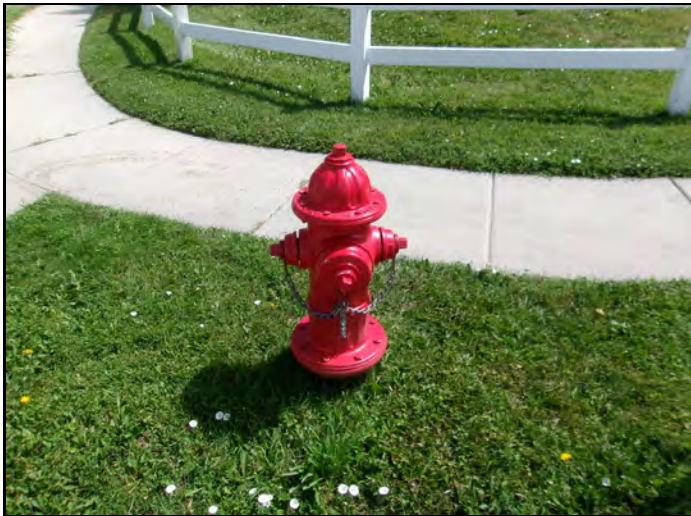
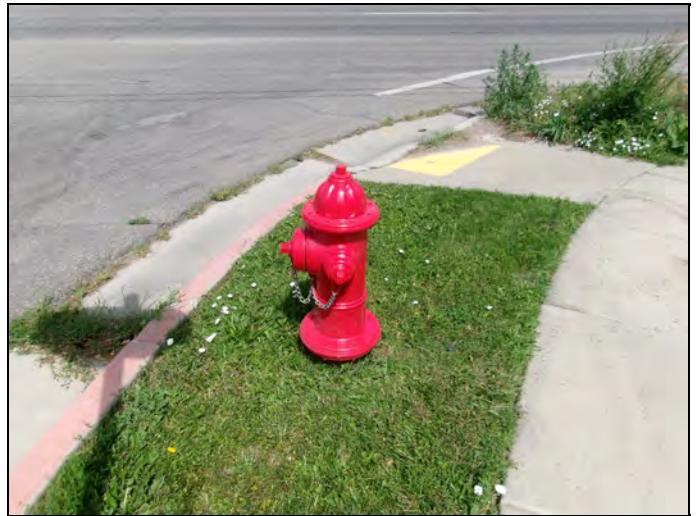
Comp #: 990 Fire Hydrant - Repair/Replace

The fire hydrants appear to be in working condition. We recommend funding to repair/replace this component approximately every 40 - 50 years. Remaining life based on current age.

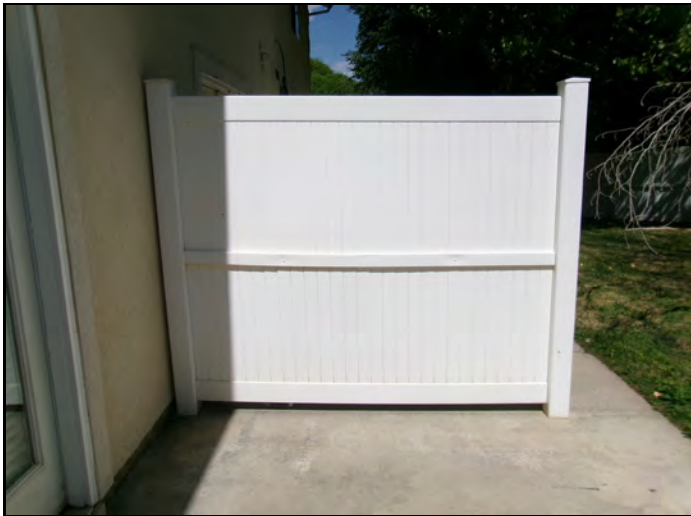
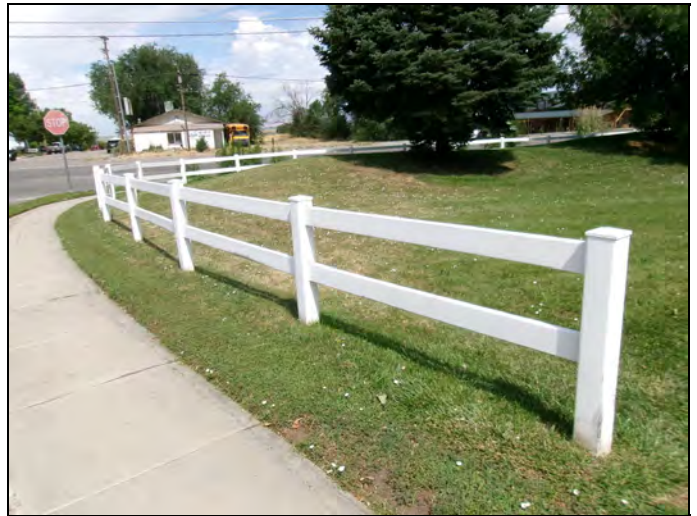
Comp #: 1008 Vinyl Fencing - Replace

The vinyl fencing appears to be generally in fair condition. We recommend funding to replace this component approximately every 25 - 30 years. Remaining life based on current age and condition.

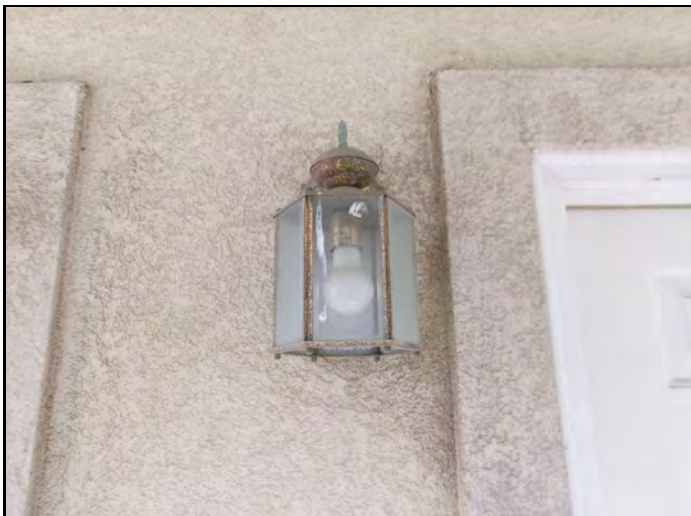
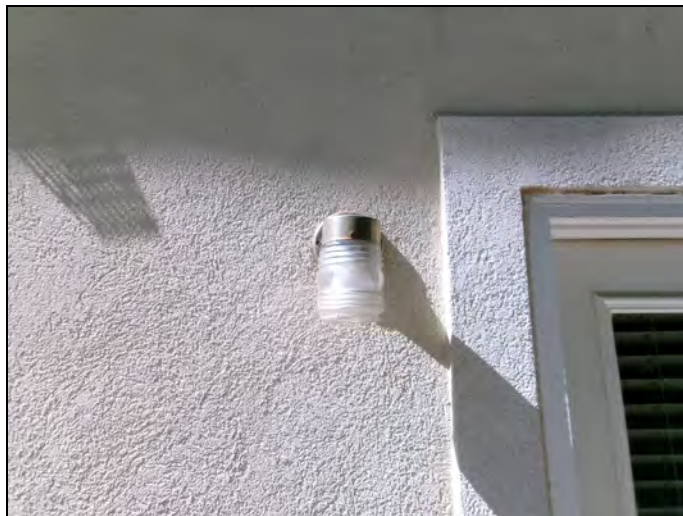
## Comp #: 1602 Exterior Light Fixtures - Replace

The exterior light fixtures appear to be in fair condition. We recommend funding to replace this component approximately every 16 - 20 years. Remaining life based on current age and condition.

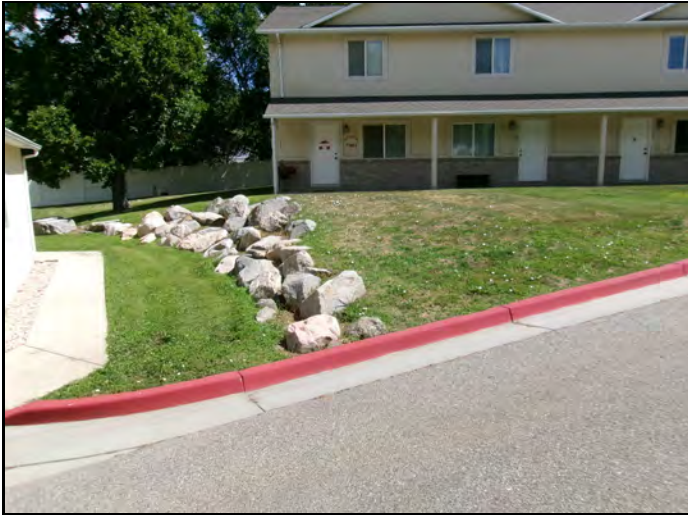
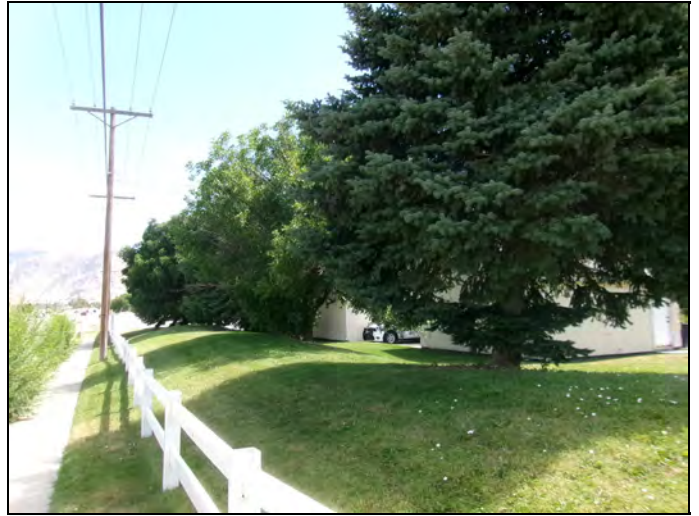
Comp #: 1812 Landscaping & Irrigation System - Renovate

The landscaping and irrigation system appear to be in good to fair condition. We recommend funding for an allowance to renovate this component approximately every 20 years. Remaining life based on current age.
