# Logan River Pointe

## Level 1 Reserve Study

**Report Period – 01/01/2026 – 12/31/2026**

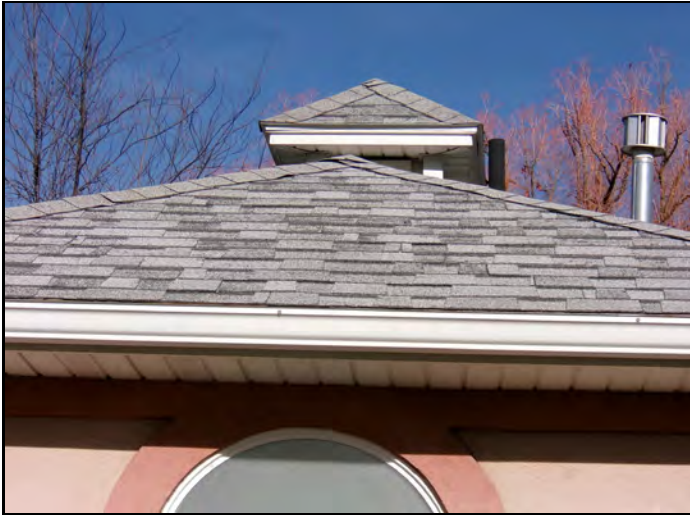
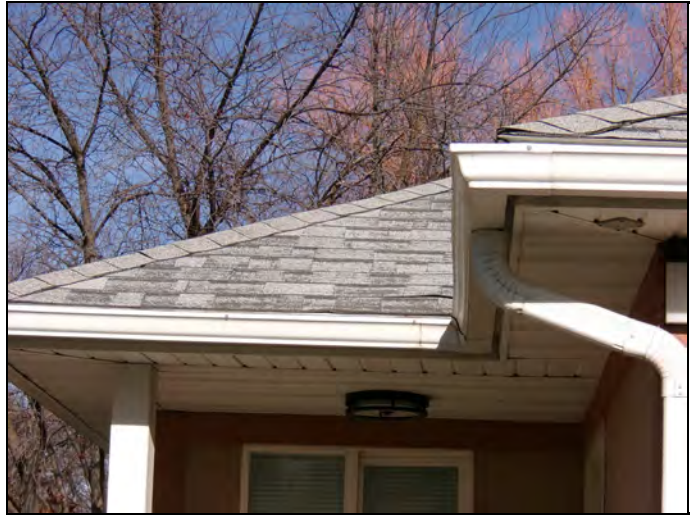
Comp #: 105    Roofs - Replace

*Location:*            **Clubhouse**

*Quantity:*           **Approx. 610 SF**

Research with the client reveals this component will be replaced in the near future. We recommend funding to replace this component approximately every 20 - 25 years. Remaining life based on current age.

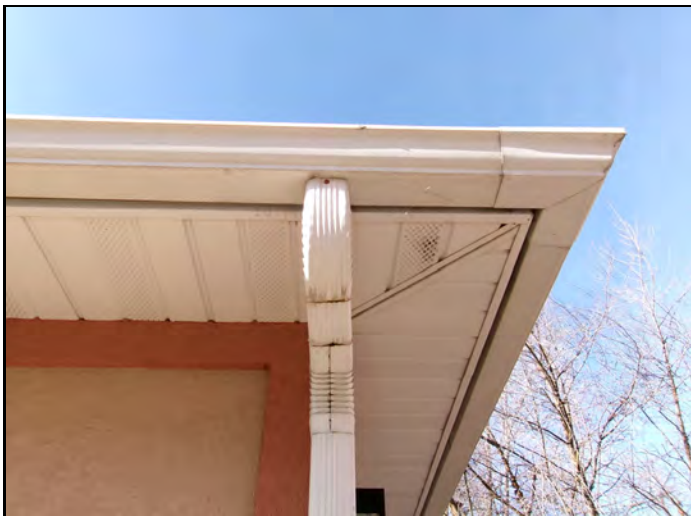
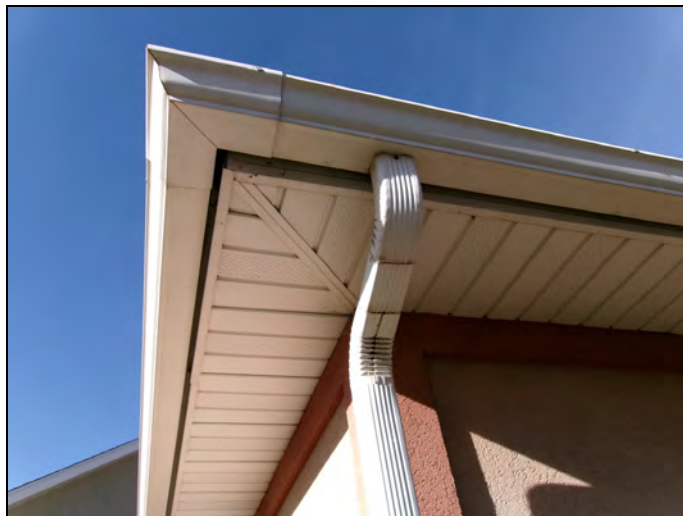
Comp #: 120 Rain Gutters/Downspouts - Replace

*Location:* Clubhouse

*Quantity:* Approx. 140 LF

The rain gutters and downspouts appear to be in fair condition. We recommend funding to replace this component approximately every 25 - 30 years. Remaining life based on current age and condition.

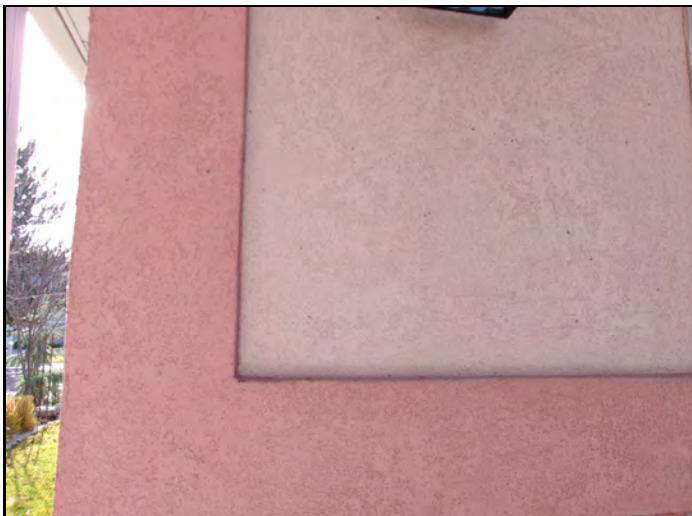
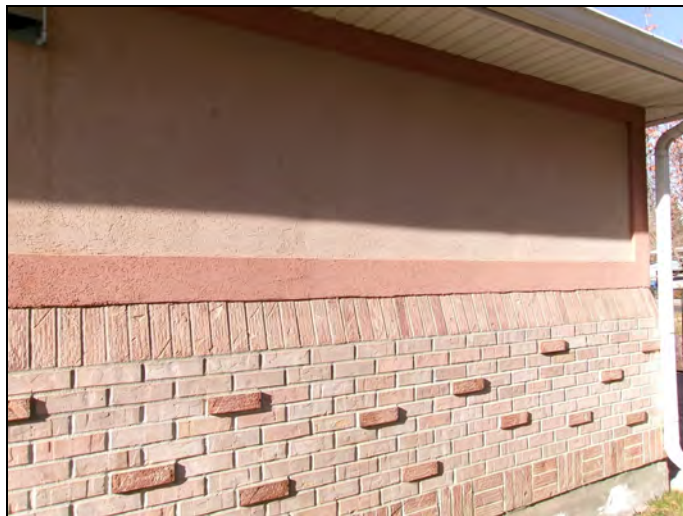
Comp #: 201 Stucco Surfaces - Repair/Repaint

*Location:* **Clubhouse**

*Quantity:* **Approx. 400 SF**

Due to the minimal cost of maintaining this component, reserve funding is not appropriate. Repair/repaint as necessary as an operating expense.

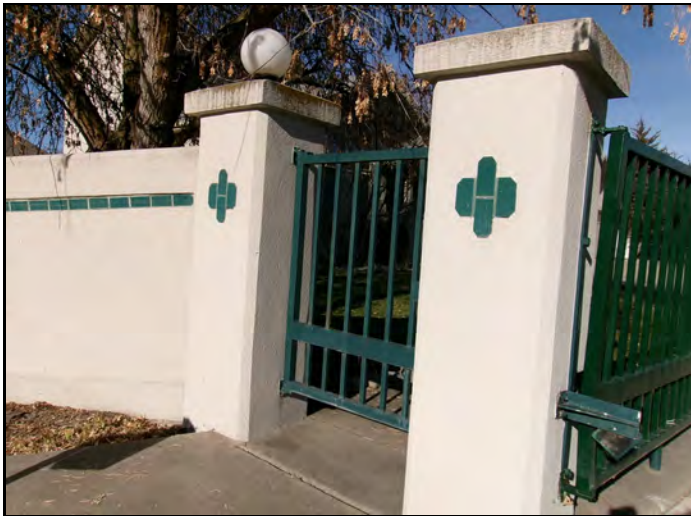
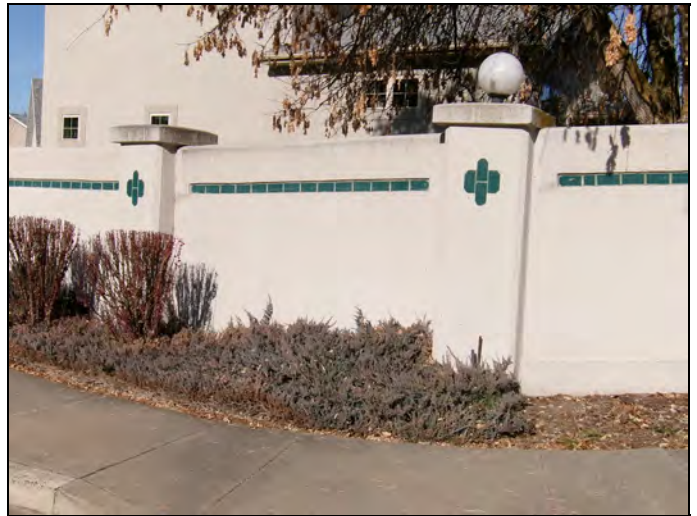
Comp #: 208 Stucco Covered Wall - Repair/Repaint

*Location:* **South Perimeter**

*Quantity:* **Approx. 450 LF**

The stucco surfaces appear to be in fair condition. We recommend funding to repair/repaint this component approximately every 12 - 15 years. Remaining life based on current condition.

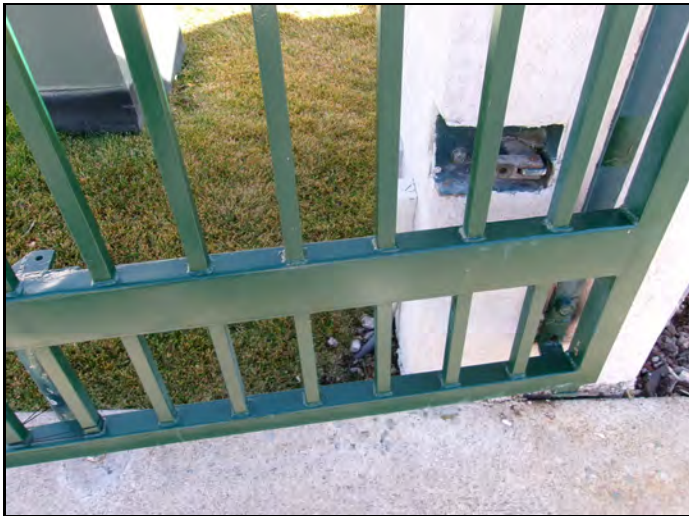
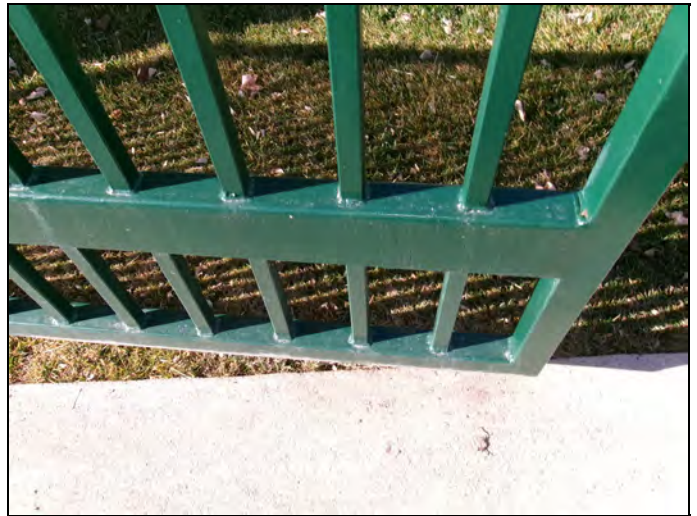
Comp #: 212 Vehicle Gates - Repaint

*Location:* **Vehicle Gates**

*Quantity:* **Approx. 40 LF**

Due to the minimal cost of repainting this component, reserve funding is not appropriate. Repaint as necessary as an operating expense.

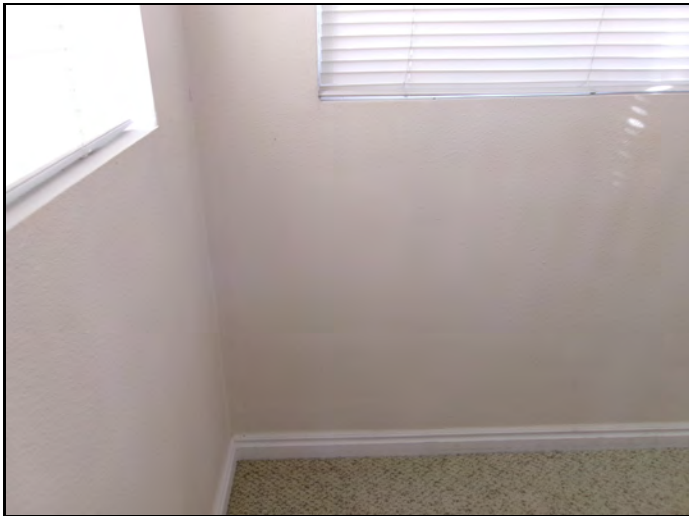
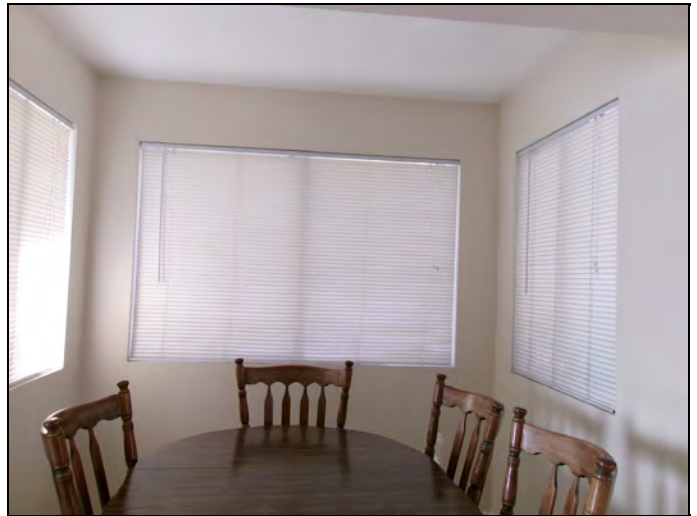
Comp #: 216 Interior Surfaces - Repaint

*Location:* **Clubhouse**

*Quantity:* **Approx. 705 SF**

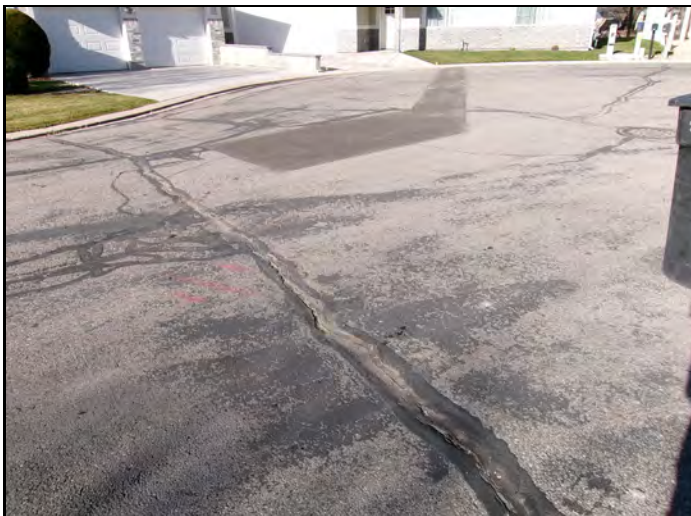
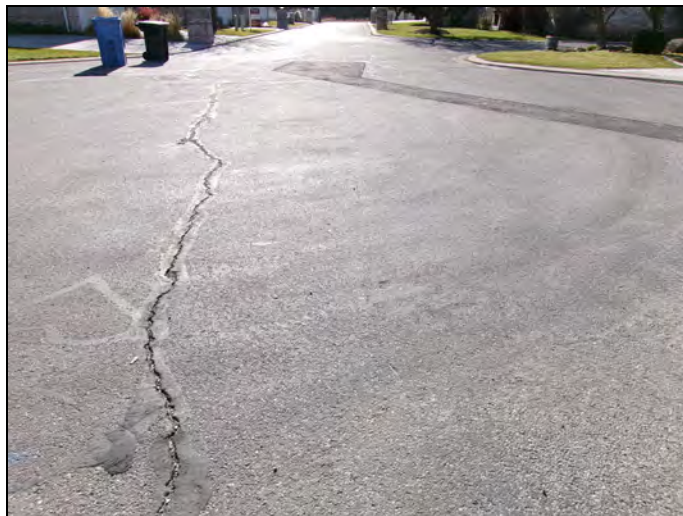
Comp #: 401 Asphalt - Major Rehab

*Location:* **Community Streets**

*Quantity:* **Approx. 16,500 SF**

The asphalt surfaces appear to be in fair condition. We recommend funding for a major rehab of this component approximately every 25 - 30 years. Remaining life based on current age and condition.

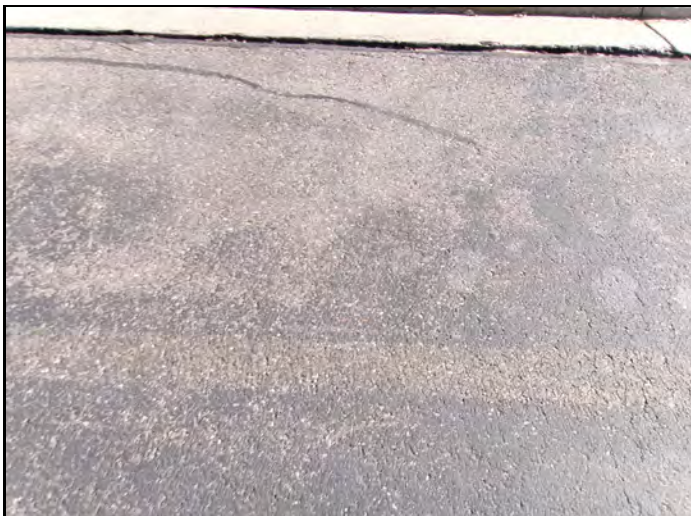
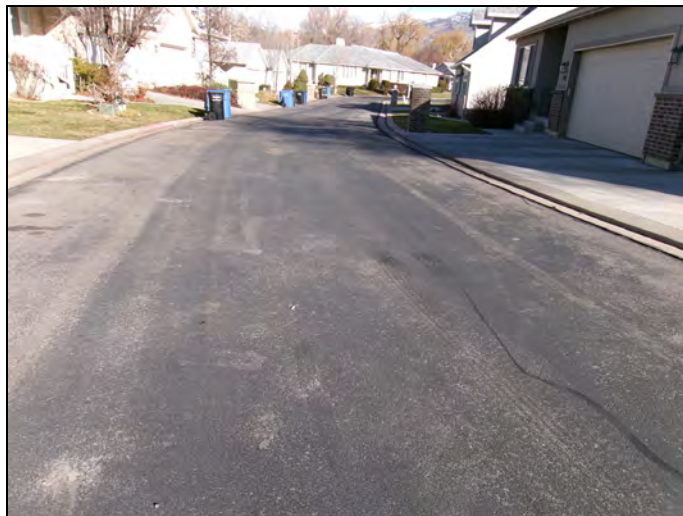
Comp #: 402 Asphalt - Seal Coat

*Location:* **Community Streets**

*Quantity:* **Approx. 16,500 SF**

The asphalt seal coat is in poor condition. We recommend funding to seal this component approximately every 3 - 5 years. Remaining life based on current condition.

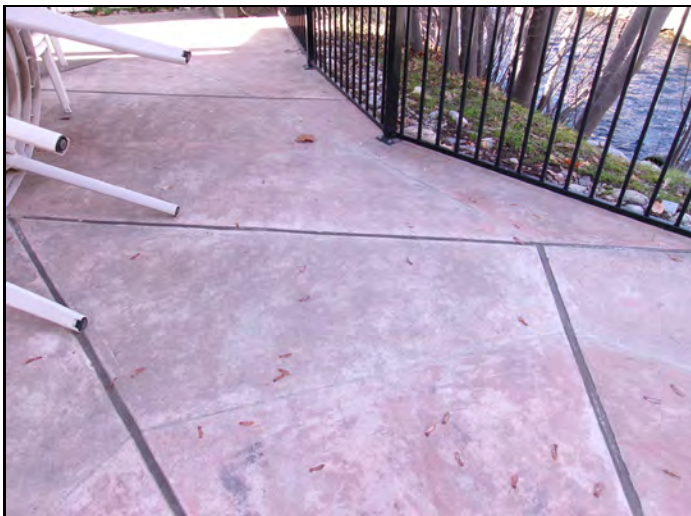
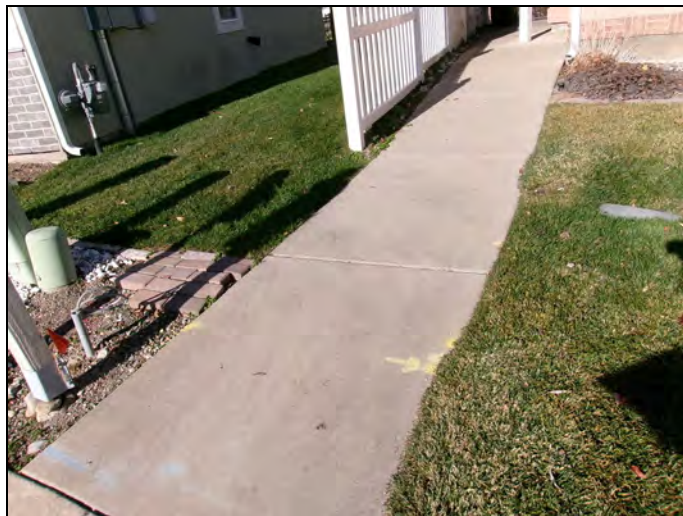
Comp #: 403 Concrete - Partial Repair/Replace

*Location:* **Clubhouse Patio**

*Quantity:* **Minimal SF**

Due to the minimal cost of maintaining this component, reserve funding is not appropriate. Repair/repaint as necessary as an operating expense.

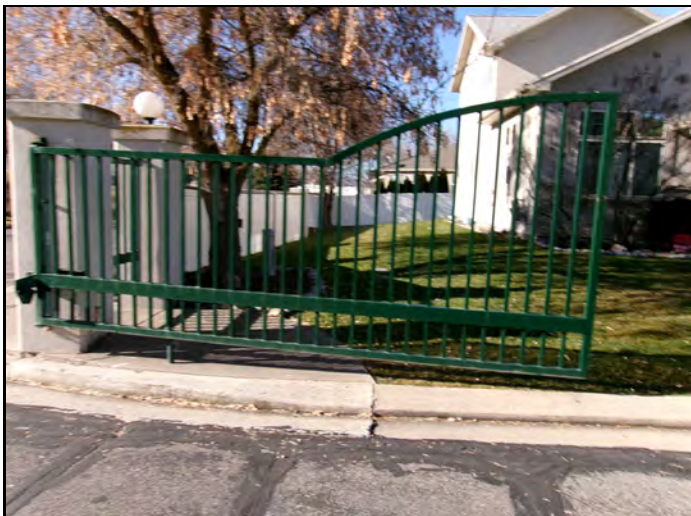
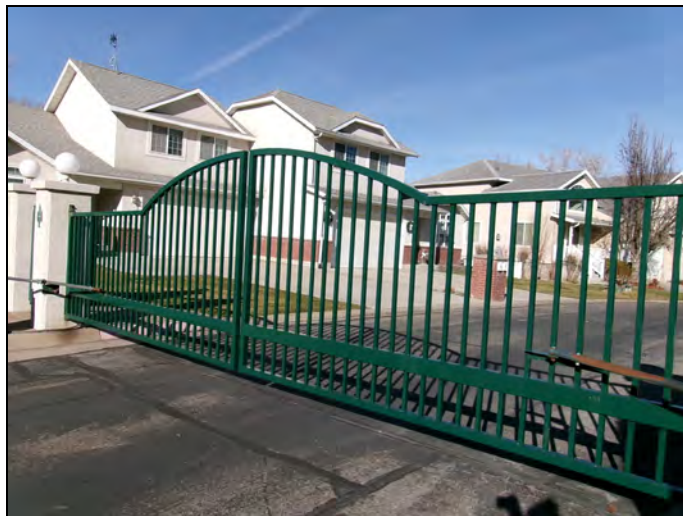
Comp #: 504 Vehicle Gates - Replace

*Location:* **Vehicle Gates**

*Quantity:* **Approx. 40 LF**

The vehicle gates are in good condition. We recommend funding to replace this component approximately every 25 - 30 years. Remaining life based on current age and condition.

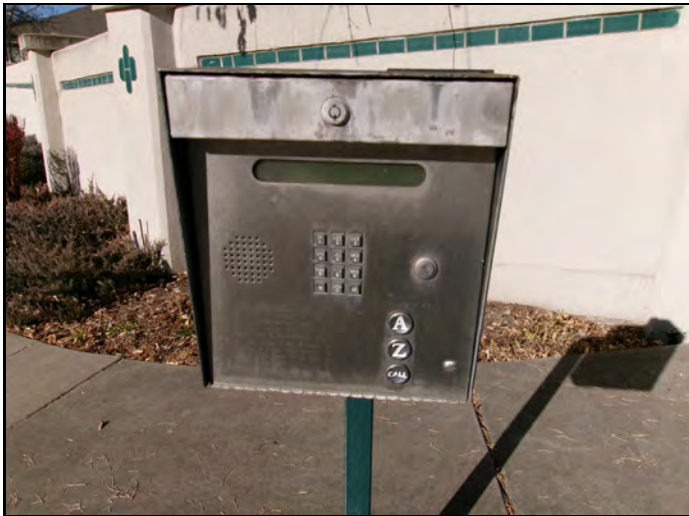
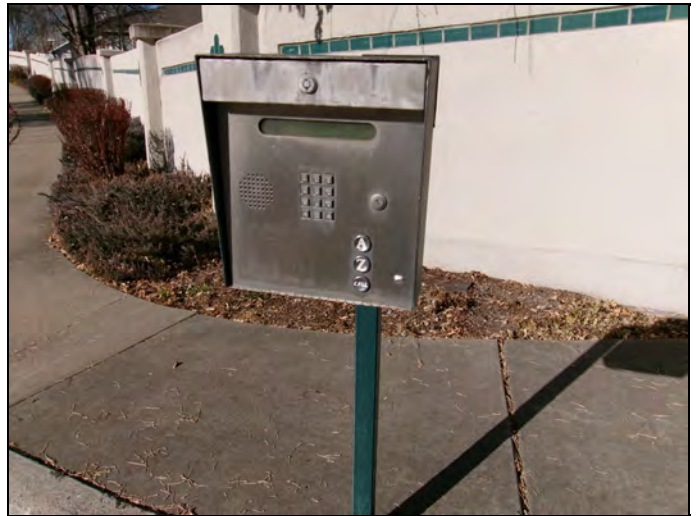
Comp #: 506 Phone Entry System - Replace

*Location:* **South East Gate**

*Quantity:* **(1) System**

Research with the client reveals this component is not in working condition and they have no plans to fix it.

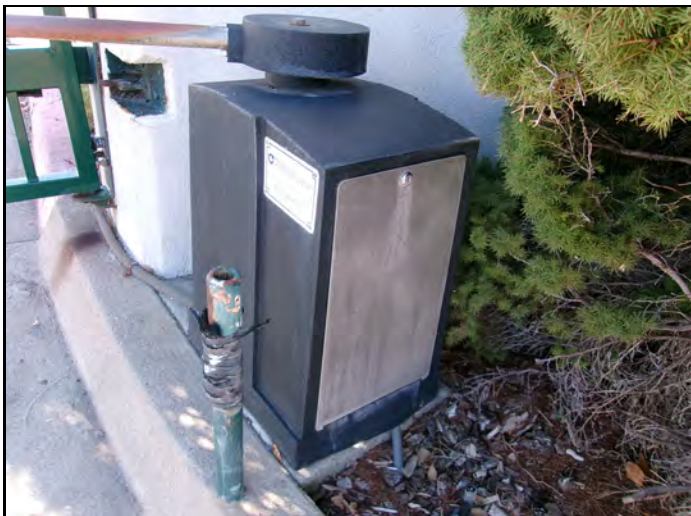
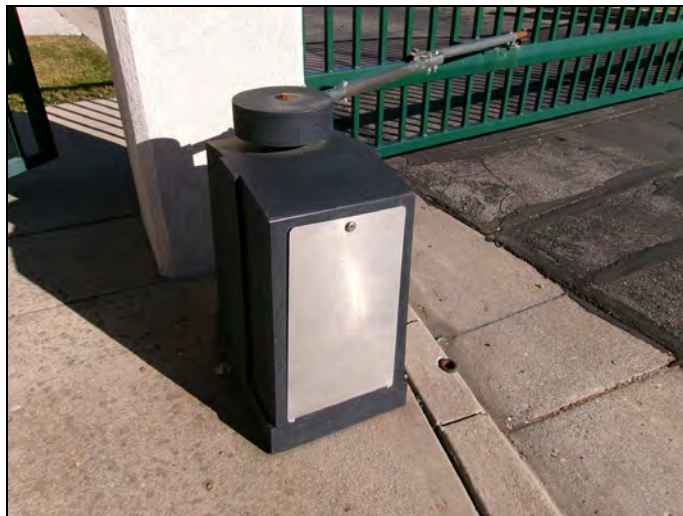
Comp #: 507 Vehicle Gate Operators - Replace

*Location:* **South West Gate ONLY**

*Quantity:* **(2) Operators**

The vehicle gate operators are in working condition. We recommend funding to replace this component approximately every 12 years. Remaining life based on current age and condition.

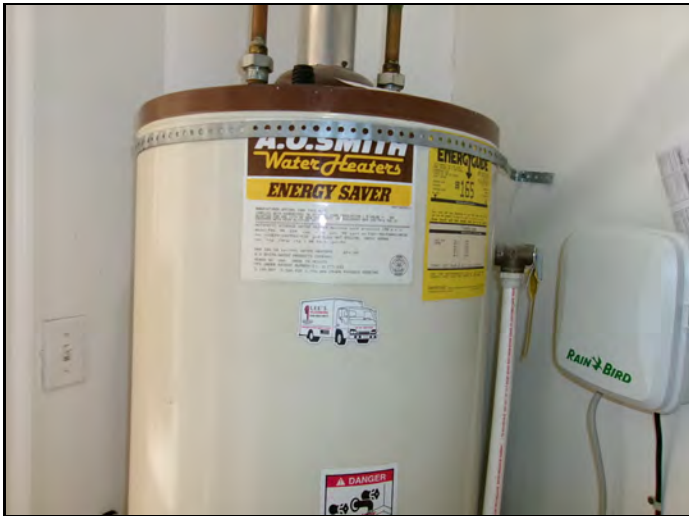
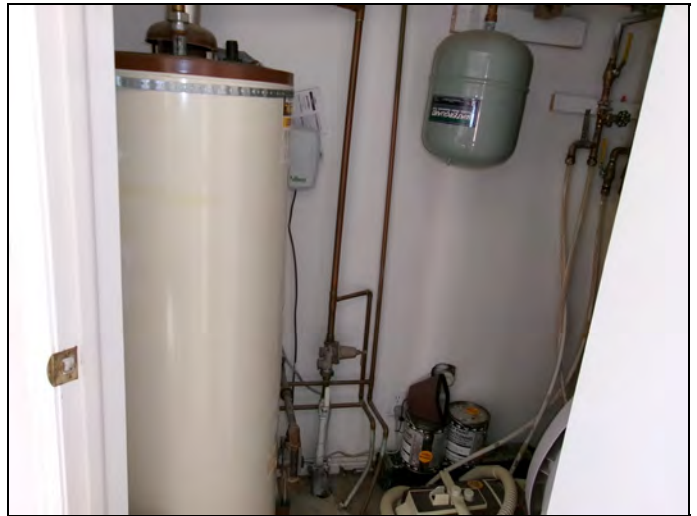
Comp #: 703 Water Heater - Replace

Location: Clubhouse

Quantity: (1) Heater

The water heater is in working condition. We recommend funding to replace this component approximately every 12 years. Remaining life based on current age and condition.

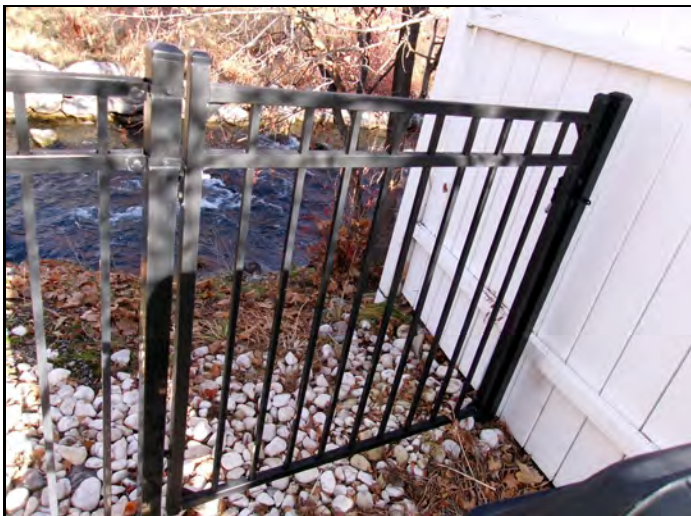
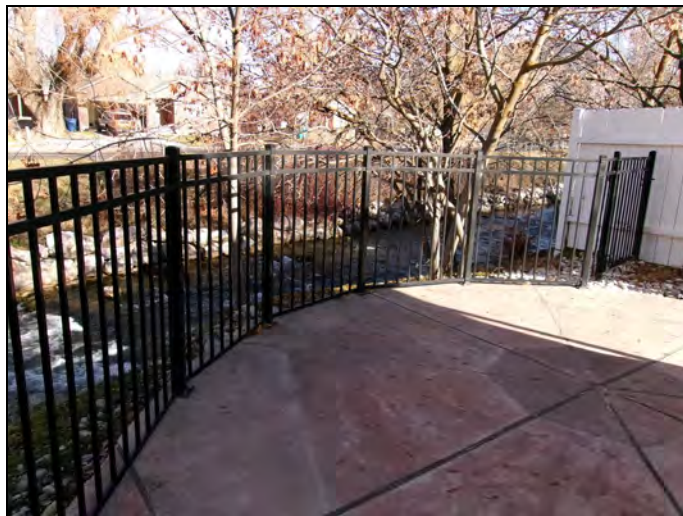
Comp #: 1002 Metal Fencing - Replace

*Location:* Clubhouse Patio

*Quantity:* Approx. 55 LF

The metal fencing is in fair condition. We recommend funding to replace this component approximately every 40 - 50 years. Remaining life based on current age.

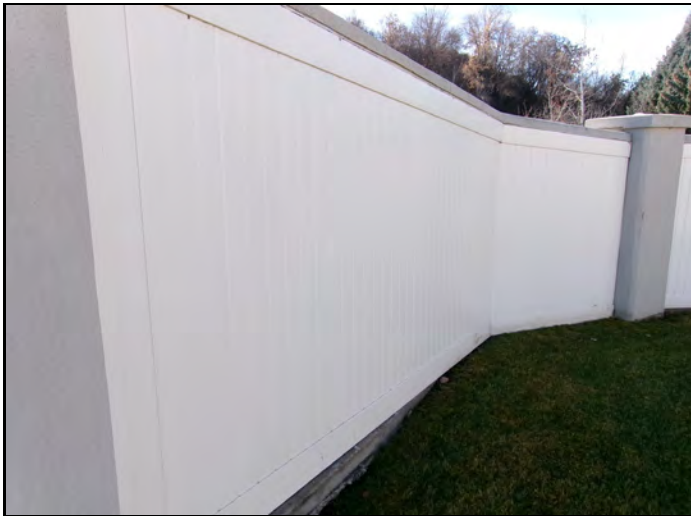
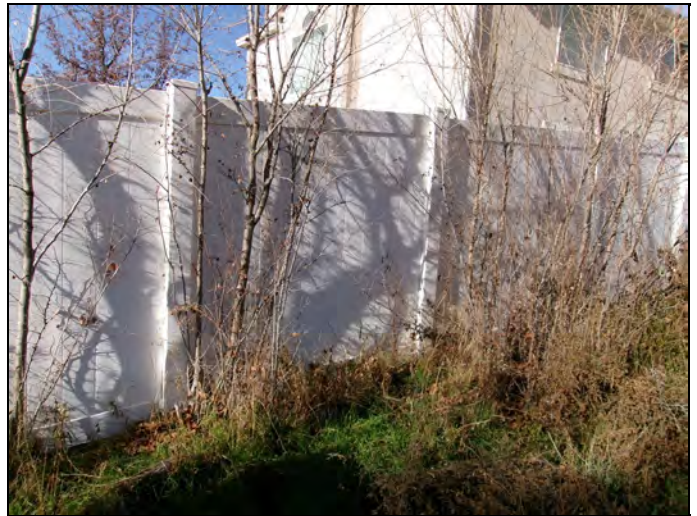
Comp #: 1008 Vinyl Fencing - Replace

*Location:* **East Perimeter**

*Quantity:* **Approx. 860 LF**

The vinyl fencing appears to be in good to fair condition. We recommend funding to replace this component approximately every 25 - 30 years. Remaining life based on current age and condition.

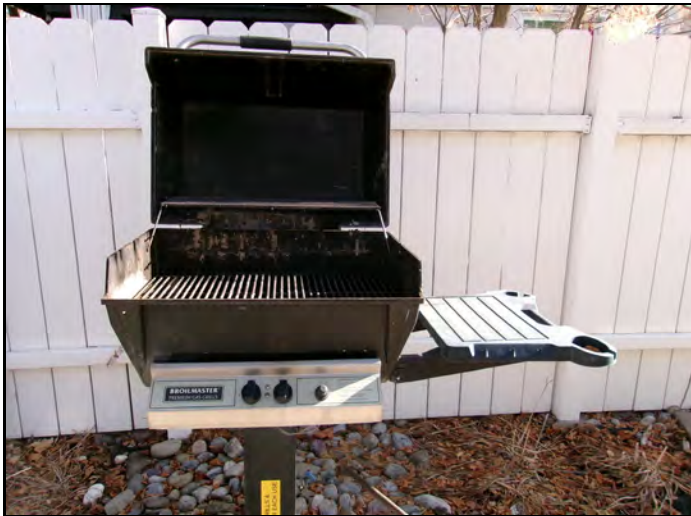
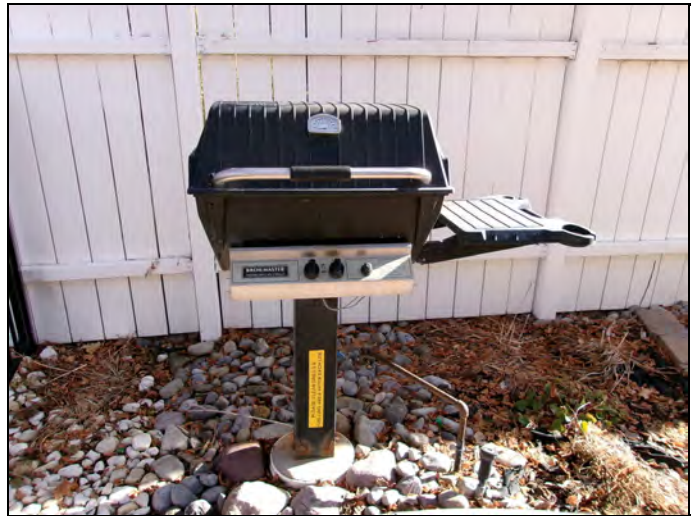
Comp #: 1305 Barbecue Grill - Replace

*Location:* Clubhouse Patio

*Quantity:* (1) Grill

Due to the minimal cost of replacing this component, reserve funding is not appropriate. Replace as necessary as an operating expense.

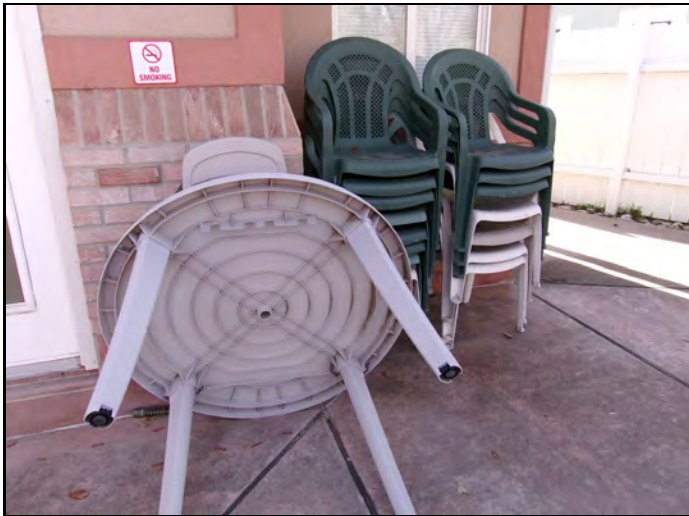
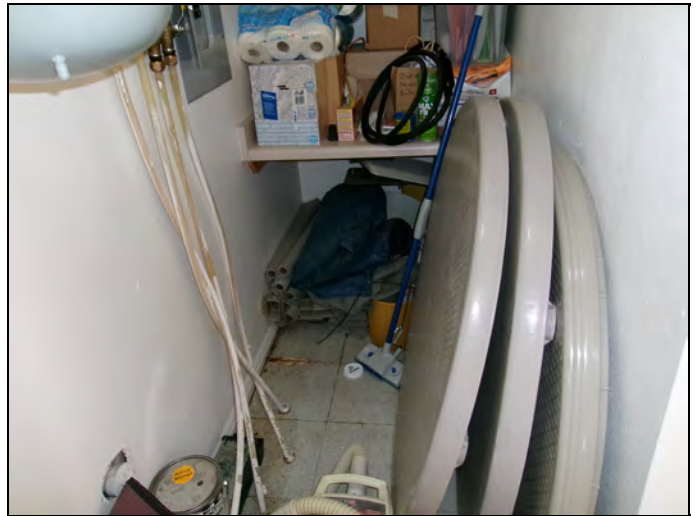
Comp #: 1404 Patio Furniture - Replace

*Location:* Clubhouse Patio

*Quantity:* (19) Pieces

Due to the minimal cost of replacing this component, reserve funding is not appropriate. Replace as necessary as an operating expense.

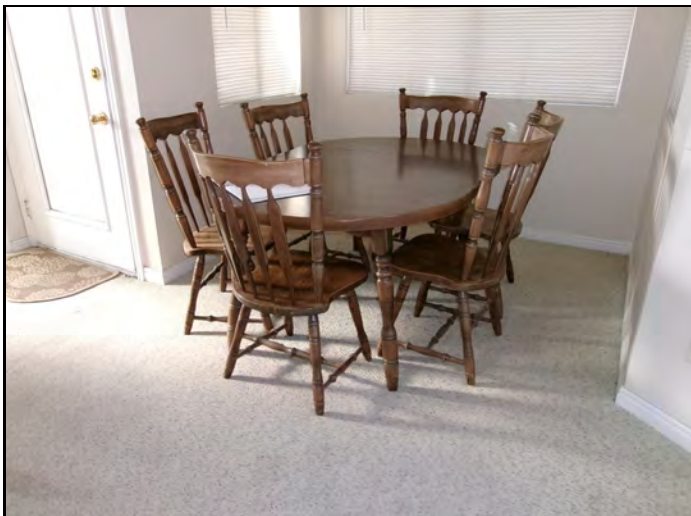
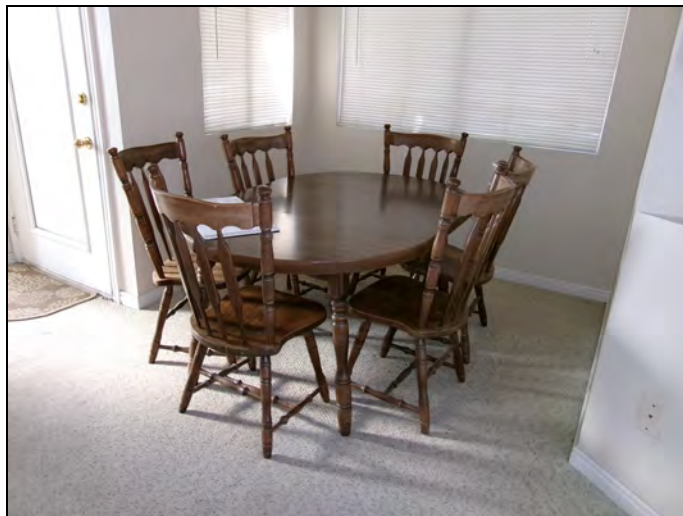
Comp #: 1405 Furniture - Replace

*Location:* **Clubhouse**

*Quantity:* **(7) Pieces**

Due to the minimal cost of replacing this component, reserve funding is not appropriate. Replace as necessary as an operating expense.

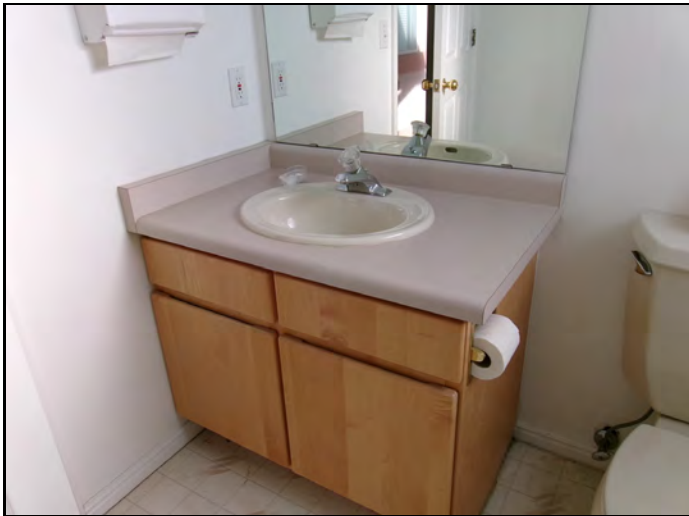
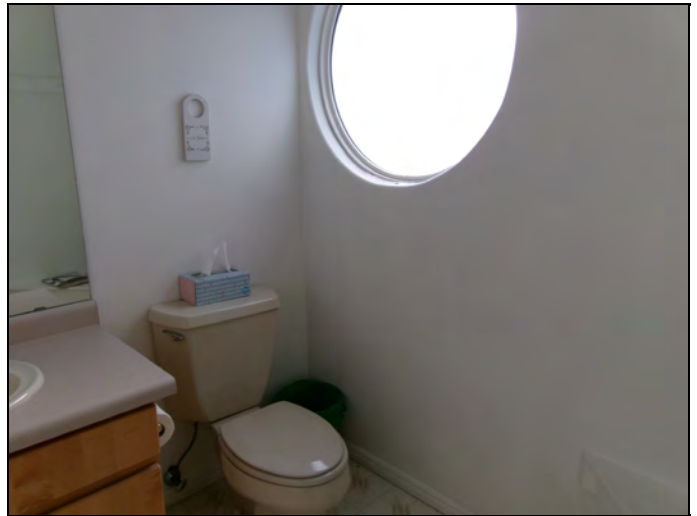
## Comp #: 1413 Restroom - Remodel

*Location:* **Clubhouse**

*Quantity:* **(1) Restroom**

The restrooms are in fair condition. We recommend funding to remodel this component approximately every 20 - 25 years. Remaining life based on current age and condition.

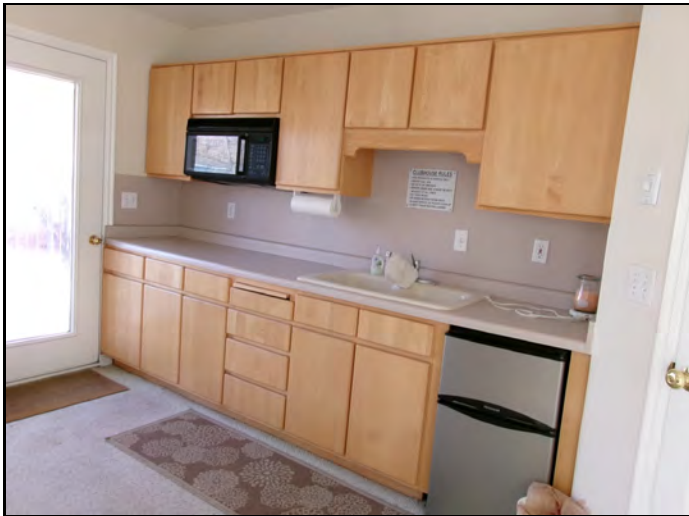
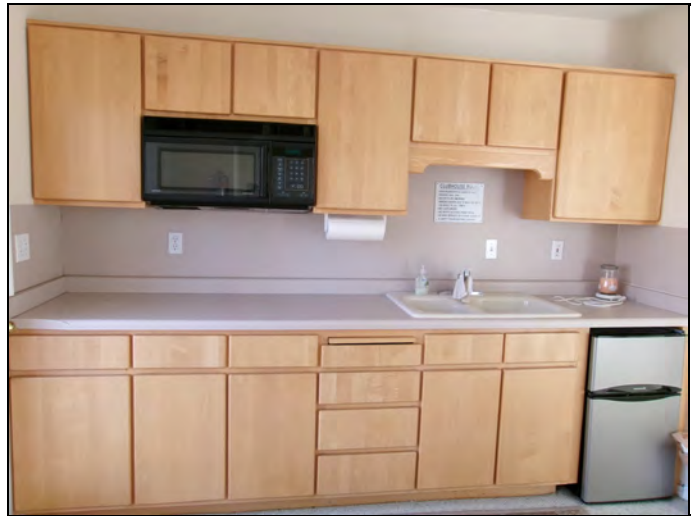
## Comp #: 1417 Kitchenette - Remodel

*Location:* Clubhouse Interior

*Quantity:* (1) Kitchenette

The kitchen is in fair condition. We recommend funding to remodel this component approximately every 20 years. Remaining life based on current age and condition.

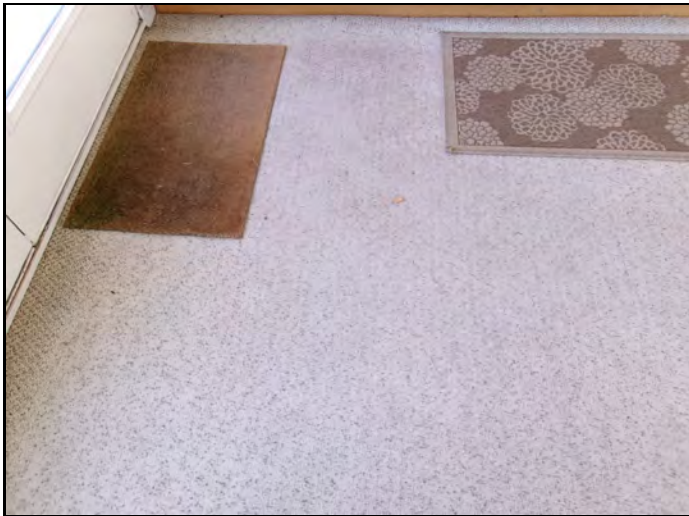
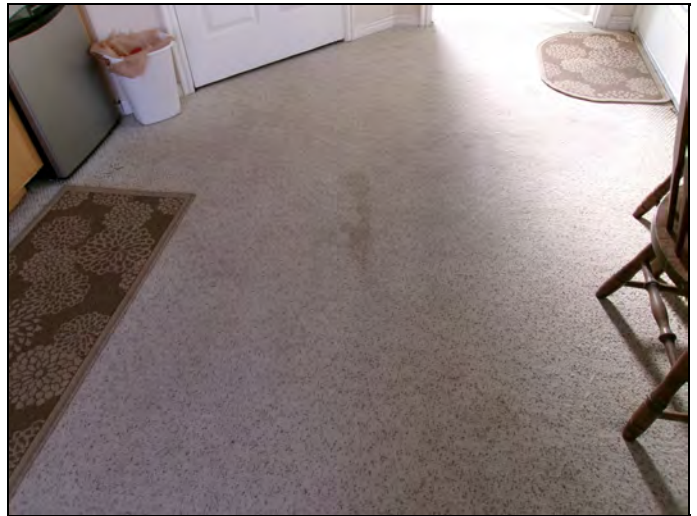
Comp #: 1501 Carpeting - Replace

*Location:* **Clubhouse**

*Quantity:* **Approx. 190 SF**

Due to the minimal cost of replacing this component, reserve funding is not appropriate. Replace as necessary as an operating expense.

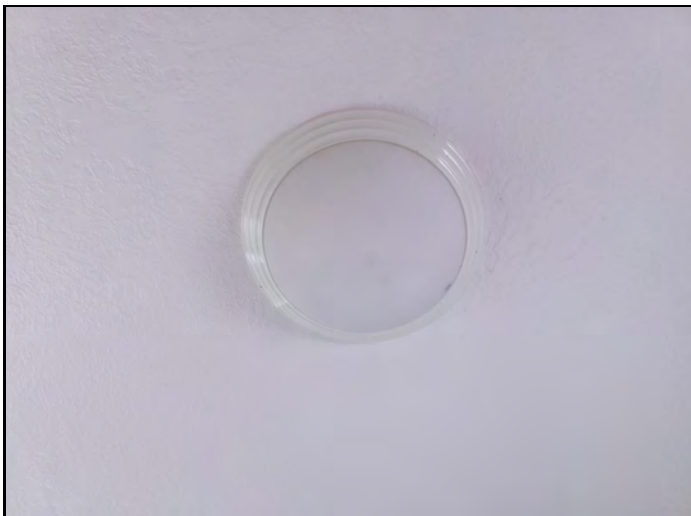
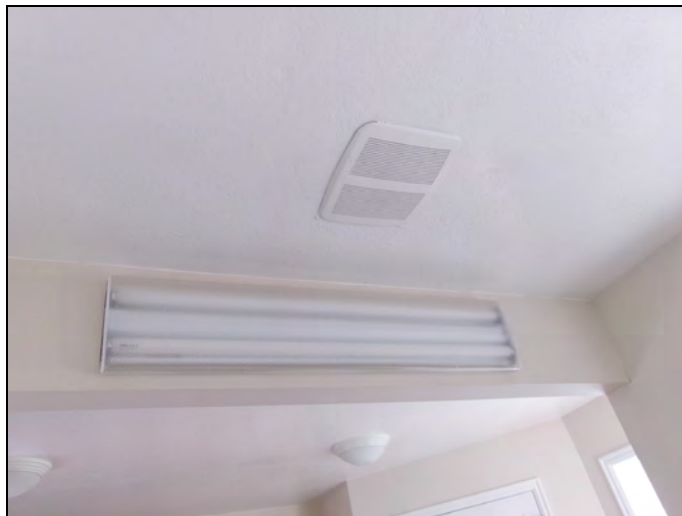
Comp #: 1601 Interior Light Fixtures - Replace

*Location:* **Clubhouse**

*Quantity:* **(4) Fixtures**

Due to the minimal cost of replacing this component, reserve funding is not appropriate. Replace as necessary as an operating expense.

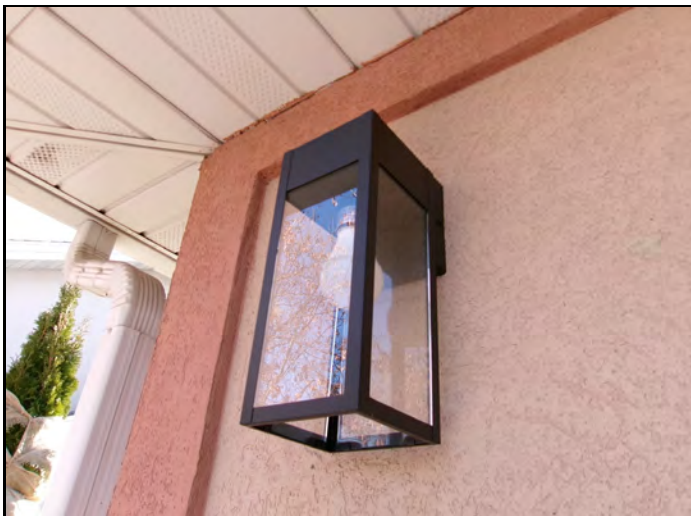
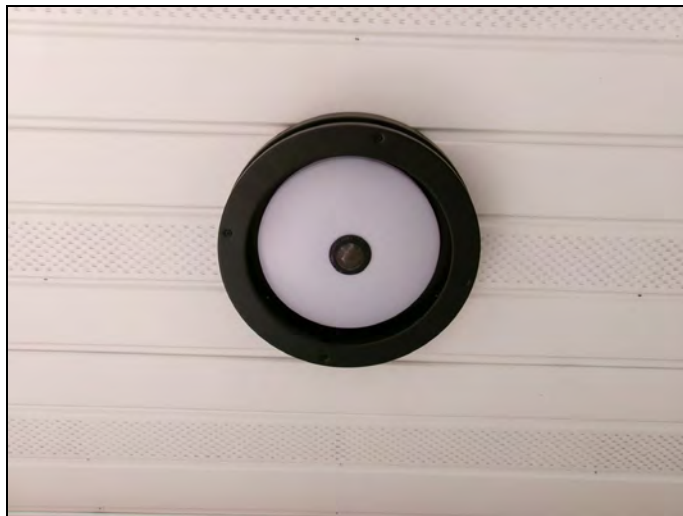
Comp #: 1602 Exterior Light Fixtures - Replace

*Location:* **Clubhouse**

*Quantity:* **(4) Fixtures**

Due to the minimal cost of replacing this component, reserve funding is not appropriate. Replace as necessary as an operating expense.

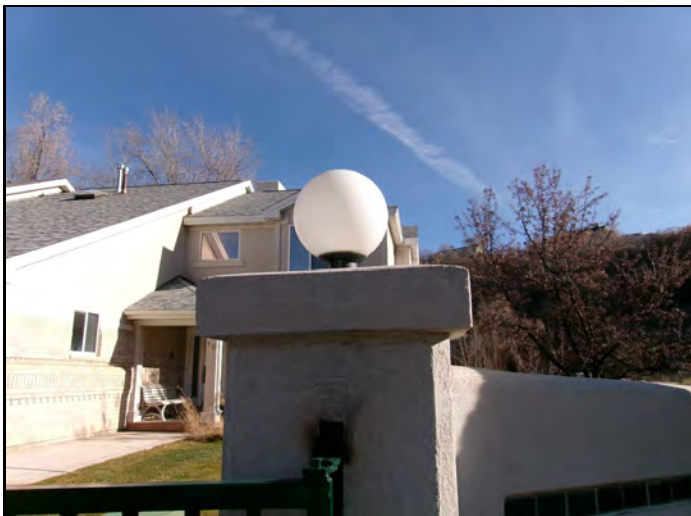
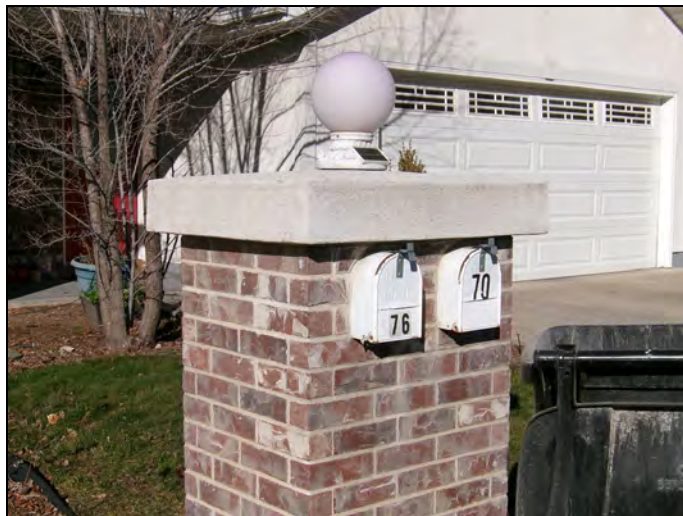
## Comp #: 1604 Post Lights - Replace

*Location:* **Common Area**

*Quantity:* **(24) Post Lights**

The post lights are in fair to poor condition. We recommend funding to replace these pole light fixtures, and to refurbish the electrical approximately every 16 - 20 years. Remaining life based on current age and condition.

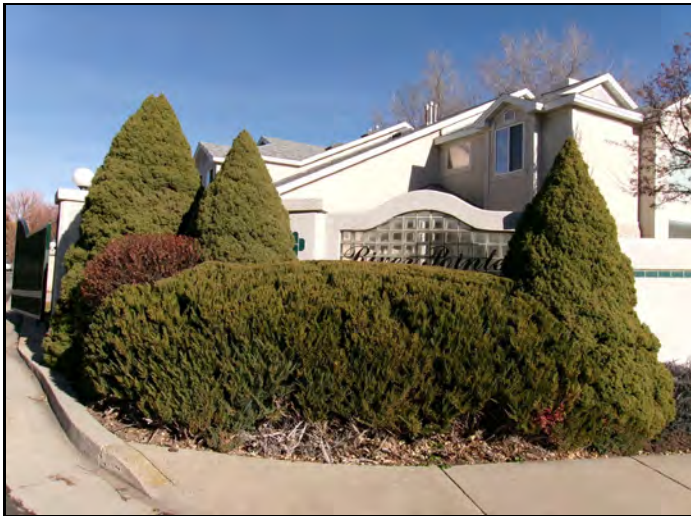
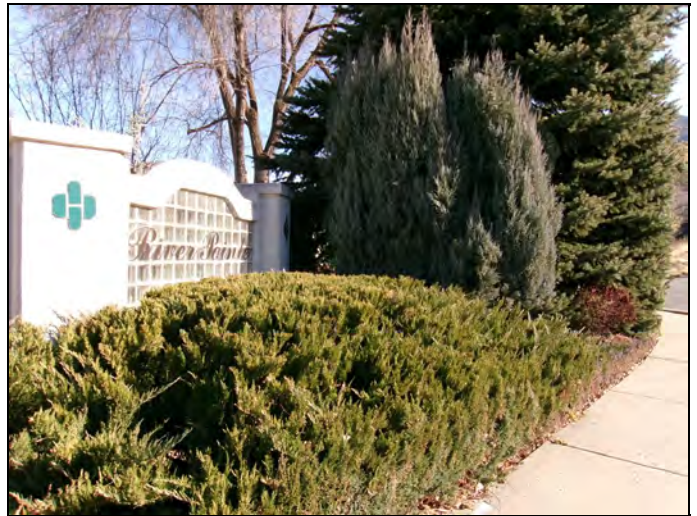
Comp #: 1812 Landscaping & Irrigation System - Renovate

*Location:* **Common Area**

*Quantity:* **Minimal SF**

The landscaping and irrigation system appear to be in fair condition. We recommend funding for an allowance to renovate this component approximately every 20 years. Remaining life based on current age.

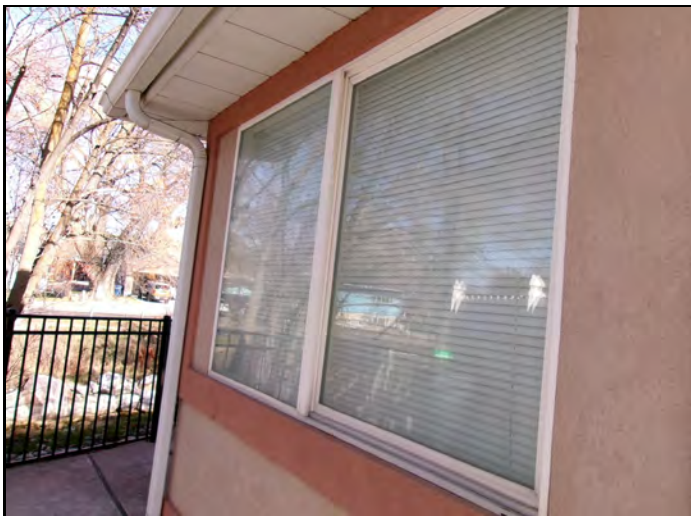
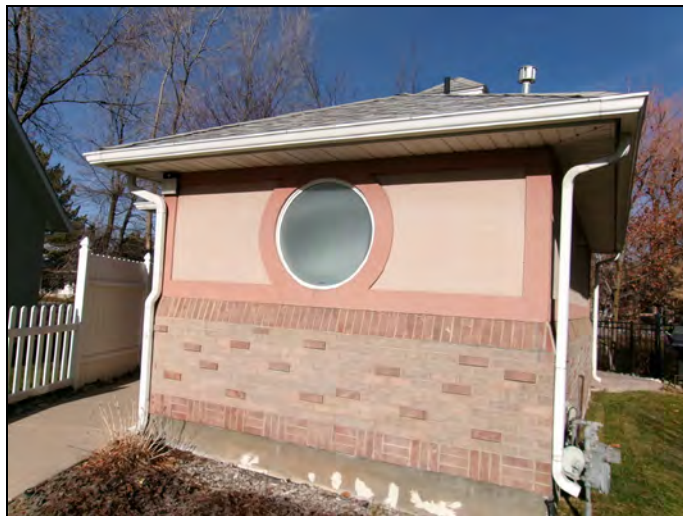
Comp #: 2303 Windows - Replace

*Location:* Clubhouse

*Quantity:* (4) Windows

The windows appear to be in fair condition. We recommend funding to replace this component approximately every 40 - 50 years. Remaining life based on current age.

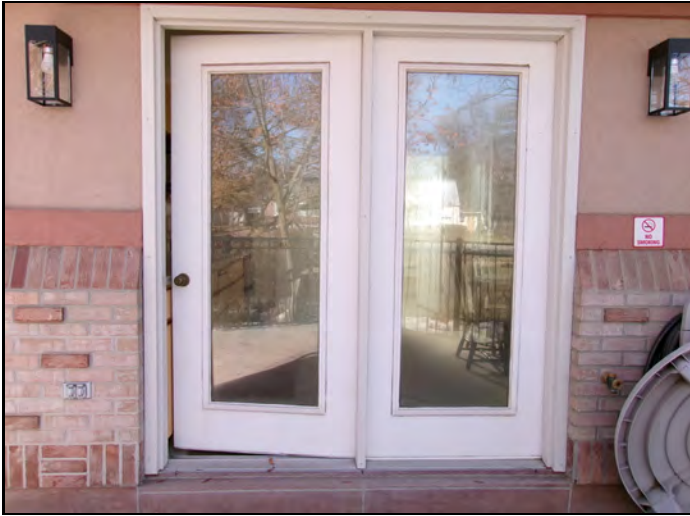
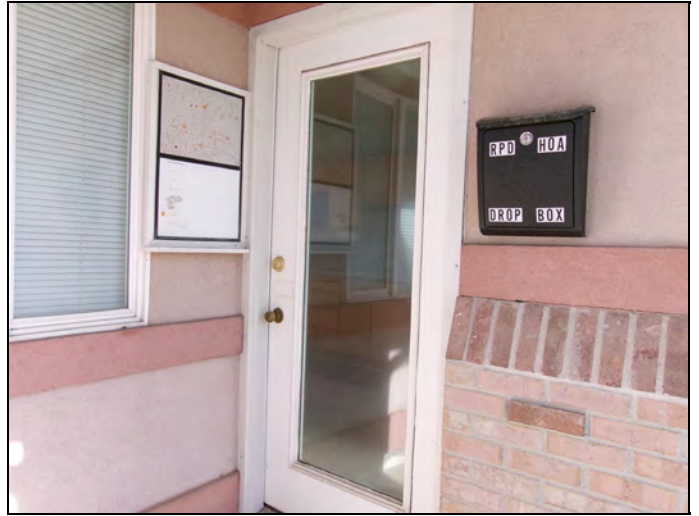
Comp #: 2304 Exterior Doors - Replace

*Location:* **Clubhouse**

*Quantity:* **(3) Doors**

The doors appear to be in fair condition. We recommend funding to replace this component approximately every 40 - 50 years. Remaining life based on current age.
