# Aspen Ridges (Townhomes)

## Level 1 Reserve Study

**Report Period – 01/01/2027 – 12/31/2027**

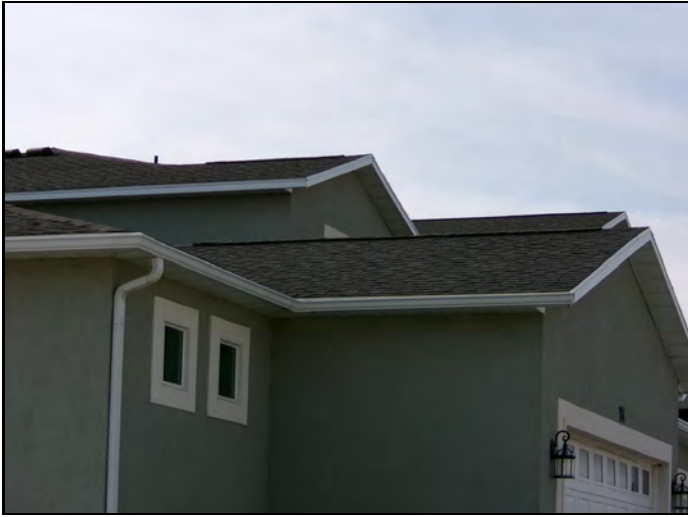
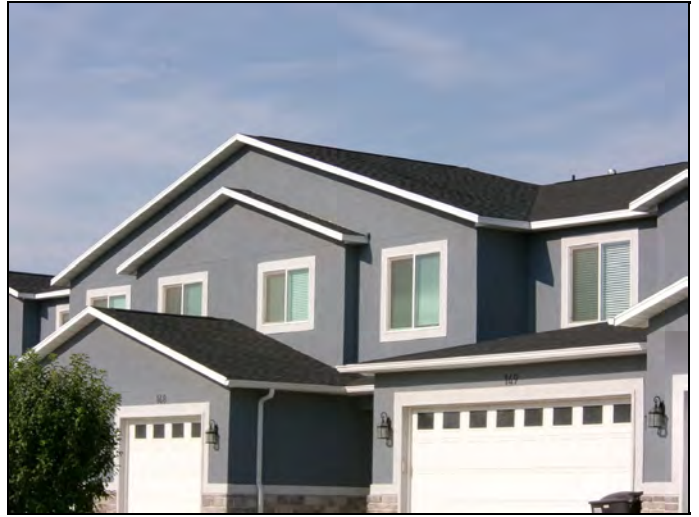
Comp #: 105    Roofs - Replace

The roofs appear to be in good condition. We recommend funding to replace this component approximately every 20 - 25 years. Remaining life based on current age.

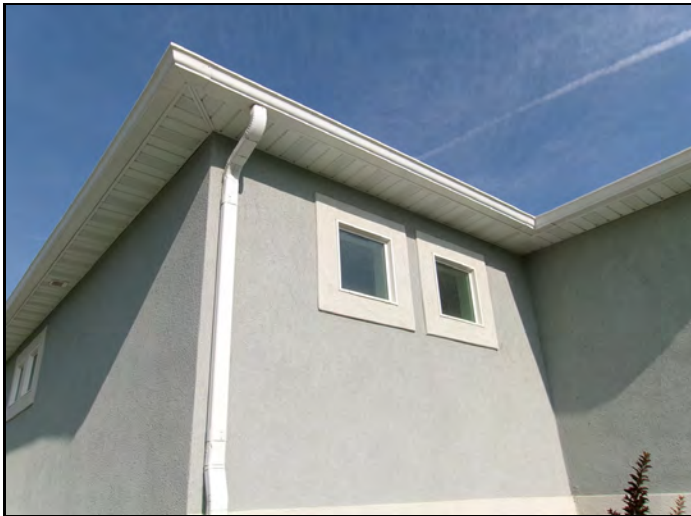
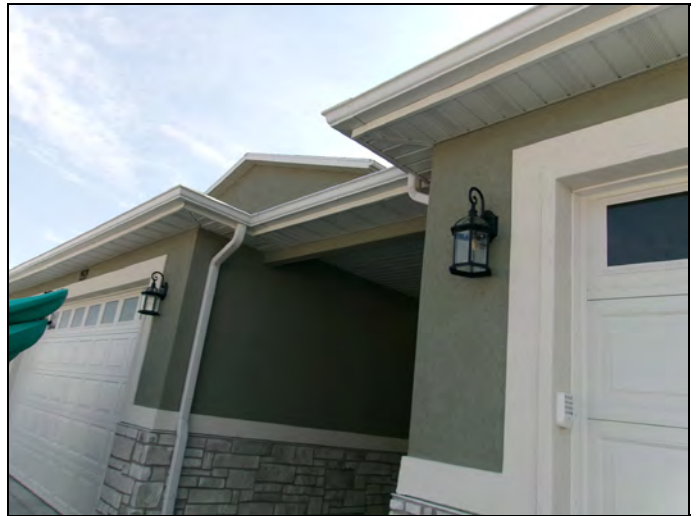
Comp #: 120 Rain Gutters/Downspouts - Replace

The rain gutters and downspouts appear to be in good condition. We recommend funding to replace this component approximately every 25 - 30 years. Remaining life based on current age.

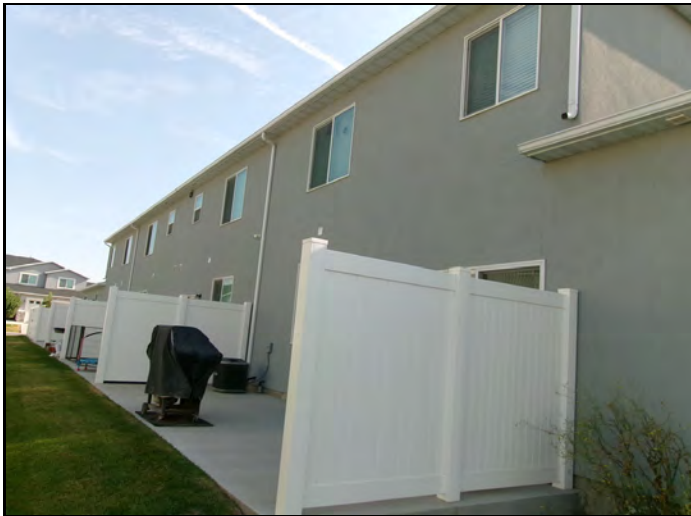
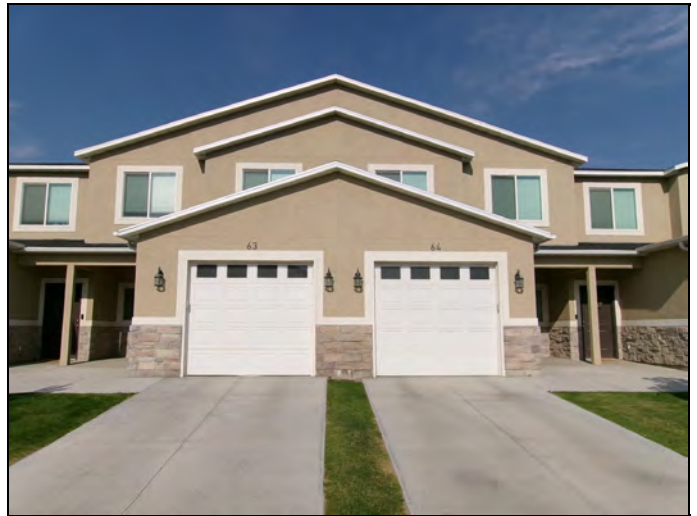
Comp #: 201 Stucco Surfaces - Repair/Repaint

The stucco surfaces appear to be in good condition. We recommend funding to repair/repaint this component approximately every 12 - 15 years. Remaining life based on current age.

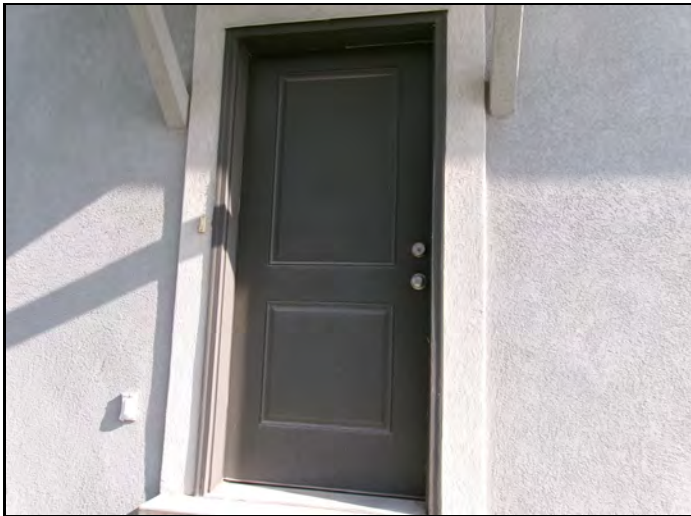
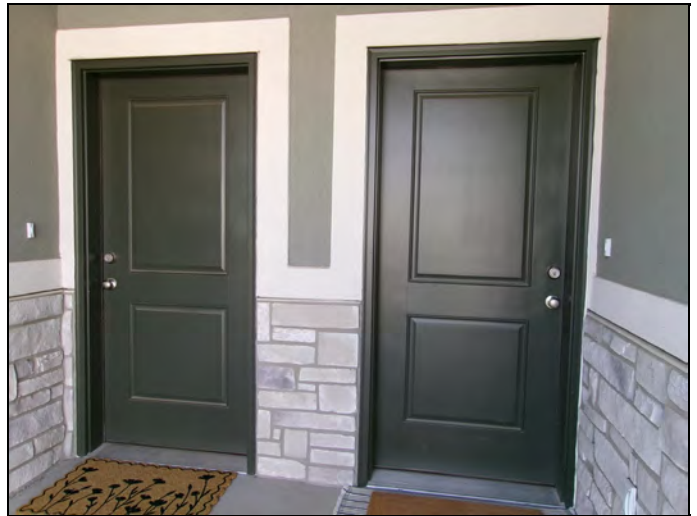
Comp #: 204 Front Doors - Repaint

The painted surfaces appear to be in good condition. We recommend funding to paint this component approximately every 8 - 10 years. Remaining life based on current age.

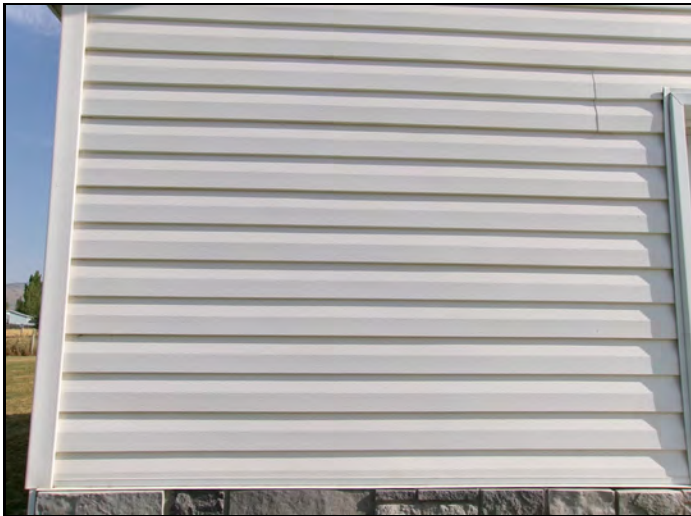
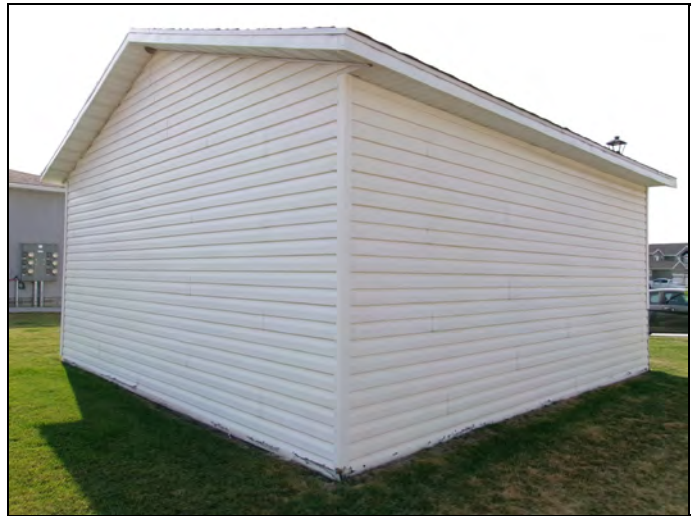
Comp #: 302 Vinyl Siding - Replace

The vinyl siding appears to be in good condition. We recommend funding to replace this component approximately every 40 - 50 years. Remaining life based on current age.

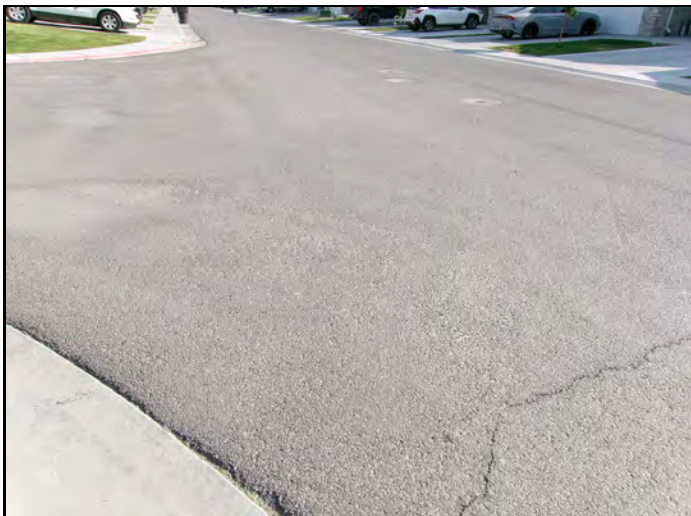
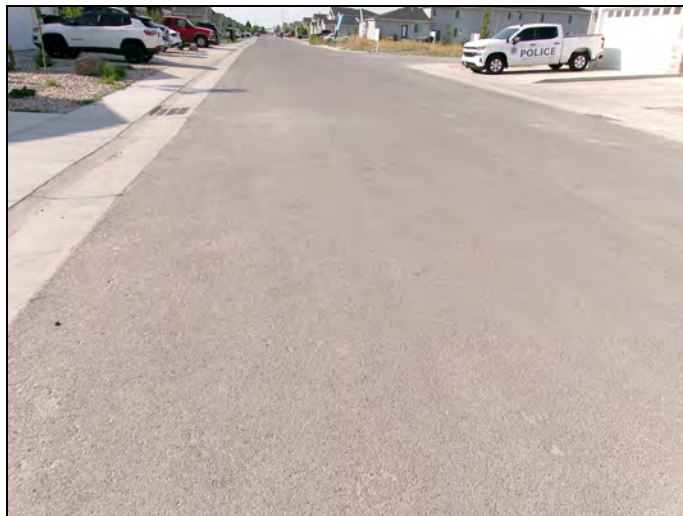
Comp #: 401 Asphalt - Major Rehab

The asphalt surfaces appear to be in good condition. We recommend funding for a major rehab of this component approximately every 25 - 30 years. Remaining life based on current age.

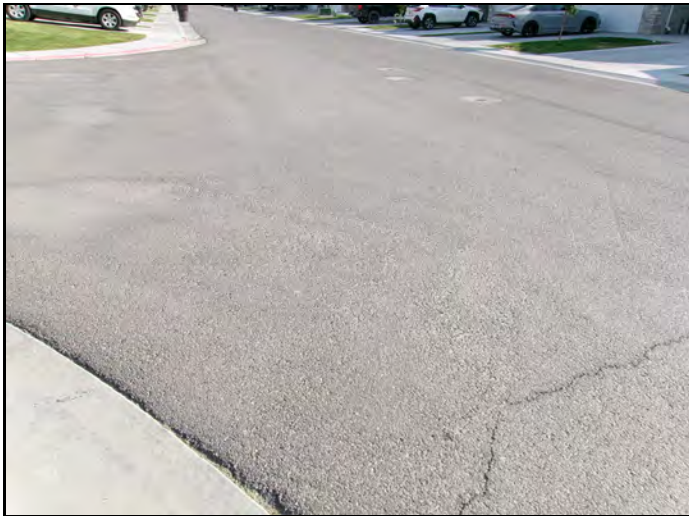
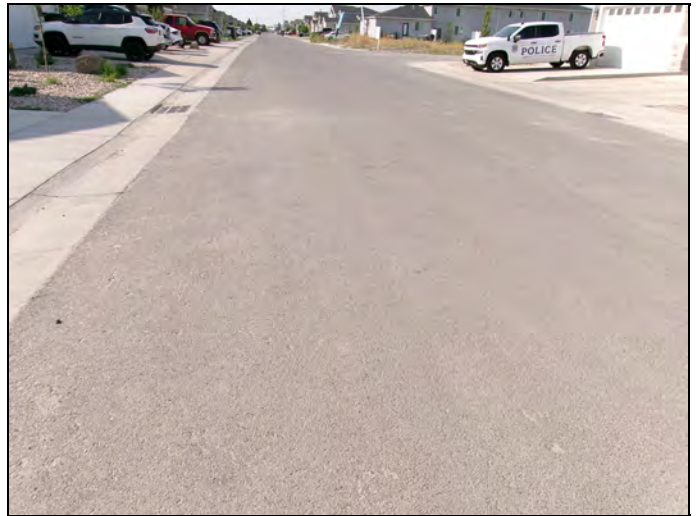
Comp #: 402 Asphalt - Seal Coat

The asphalt seal coat is in poor condition. We recommend funding to seal this component approximately every 3 - 5 years. Remaining life based on current condition.

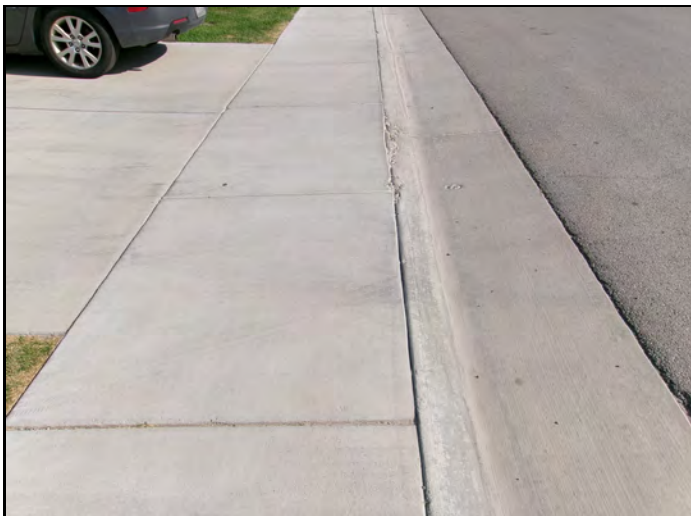
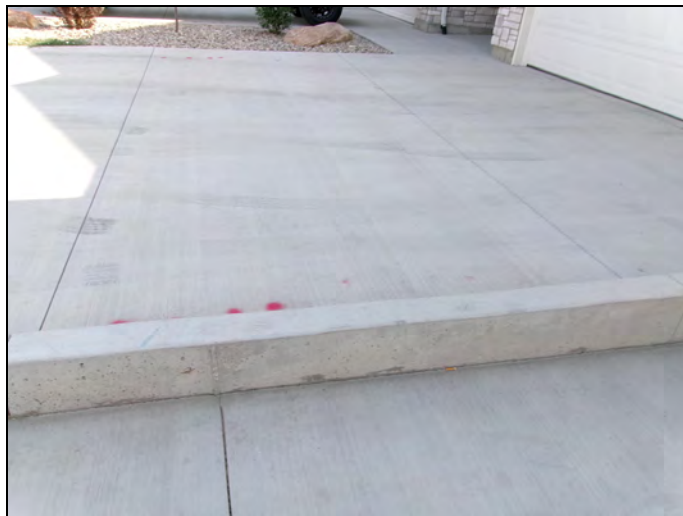
Comp #: 403 Concrete - Partial Repair/Replace

The concrete appears to be in good condition. This component has an extended useful life under normal conditions. We recommend funding to make repairs and partially replace this component approximately every 10 years. Remaining life based on current age.

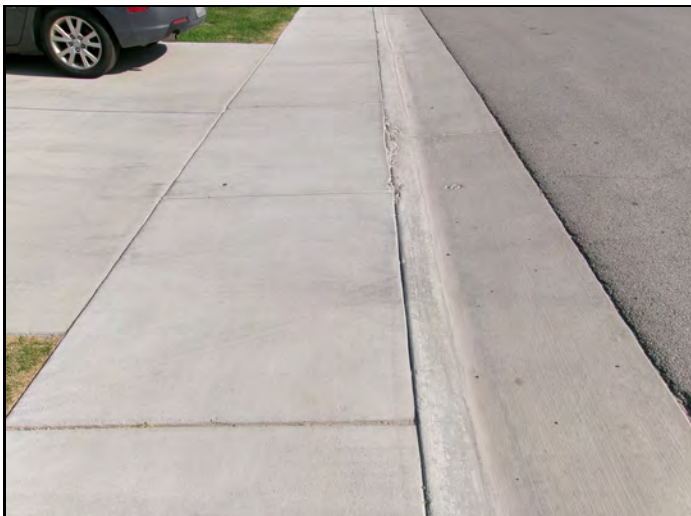
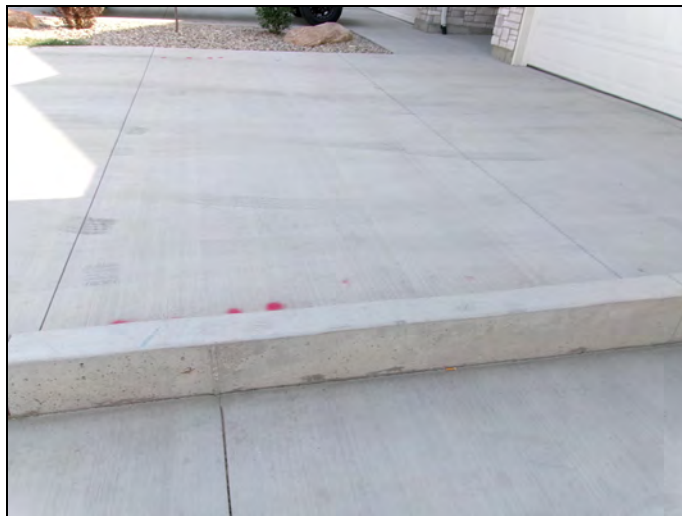
Comp #: 490 Concrete Parking - Replace

The concrete appears to be in good condition. We recommend funding to make repairs and partially replace this component approximately every 40 - 50 years. Remaining life based on current age.

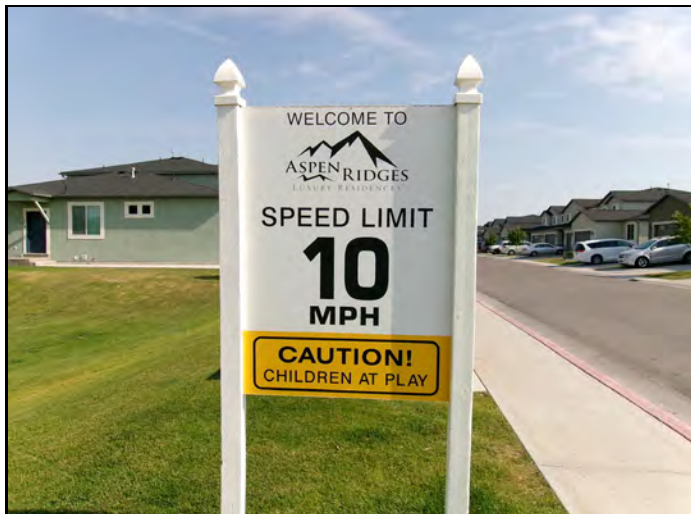
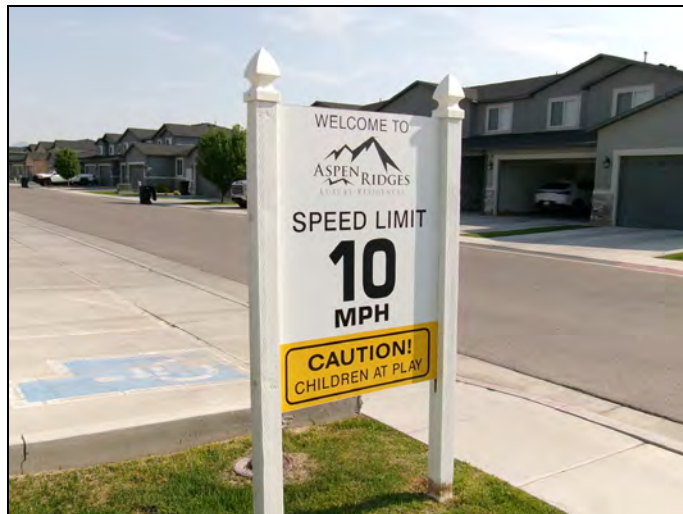
Comp #: 801 Community Signs - Refurbish

Due to the minimal cost of this component, reserve funding is not appropriate. Replace as necessary as an operating expense.

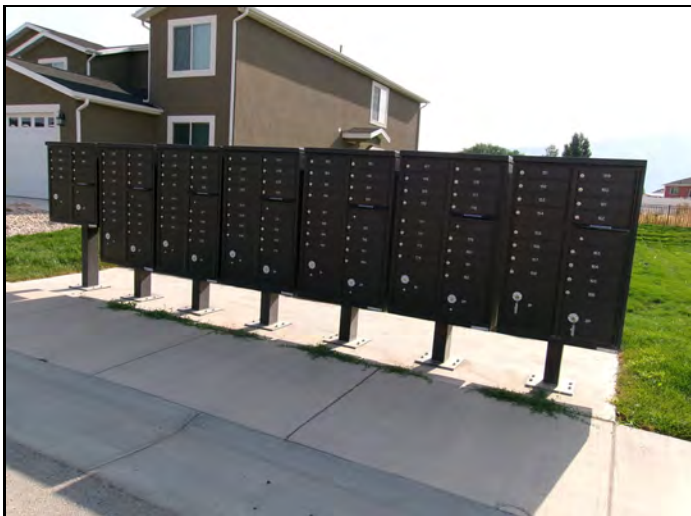
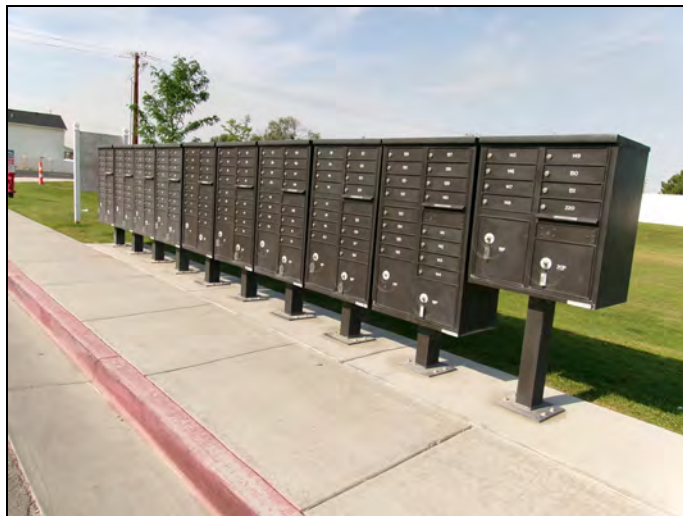
Comp #: 803 Mailboxes - Replace

The mailboxes appear to be in good condition. We recommend funding to replace this component approximately every 20 - 25 years. Remaining life based on current age.

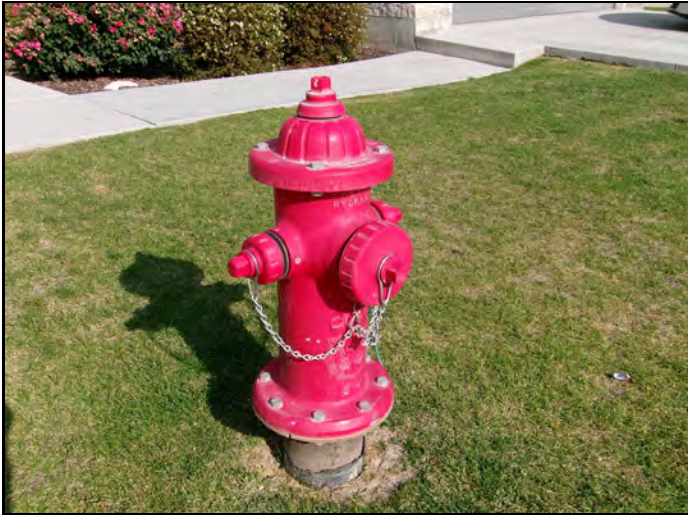
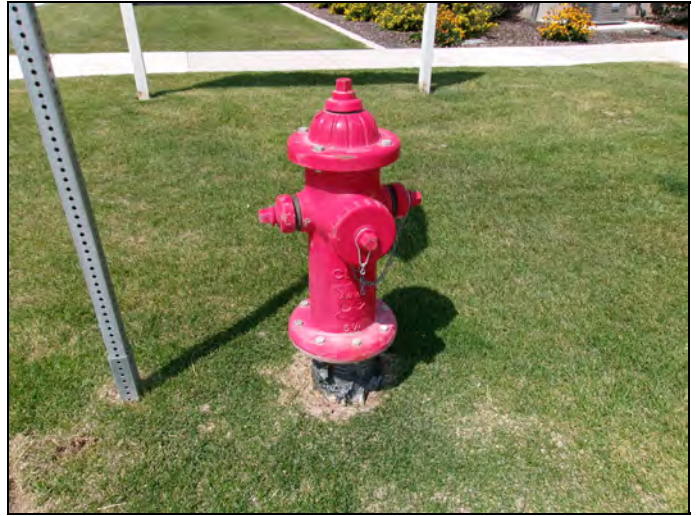
Comp #: 990 Fire Hydrants - Replace

The fire hydrants appear to be in working condition. We recommend funding to repair/replace this component approximately every 40 - 50 years. Remaining life based on current age.

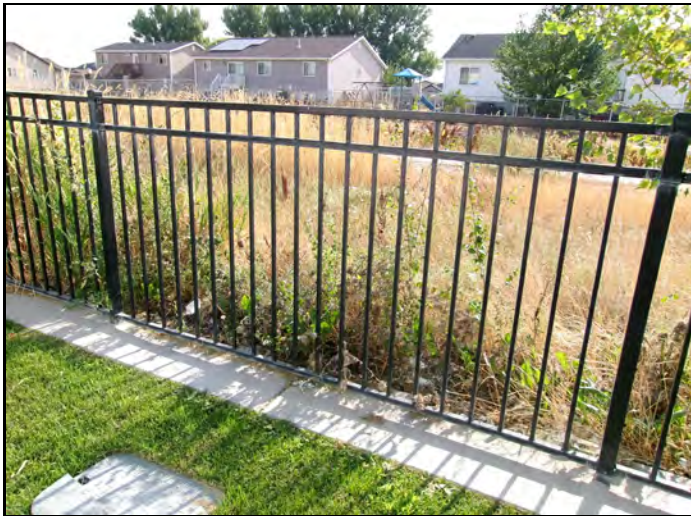
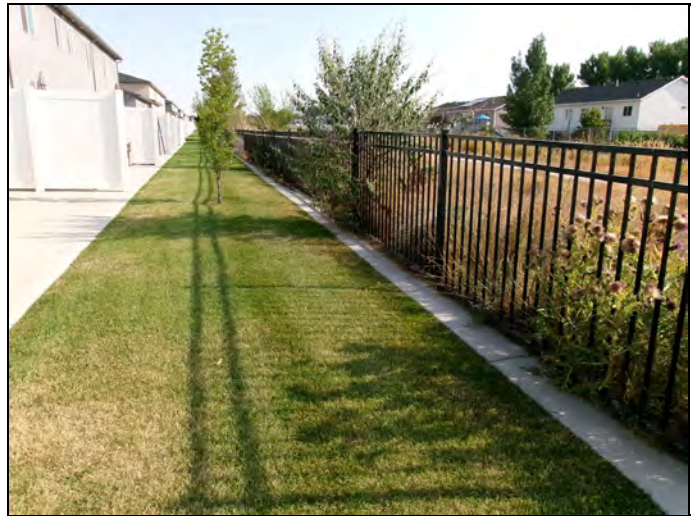
Comp #: 1002 Metal Fencing - Replace

The metal fencing appears to be in good to fair condition. We recommend funding to replace this component approximately every 40 - 50 years. Remaining life based on current age.

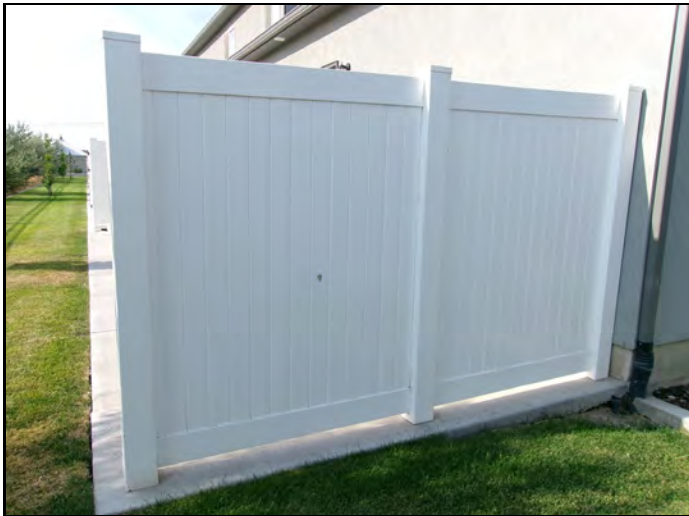
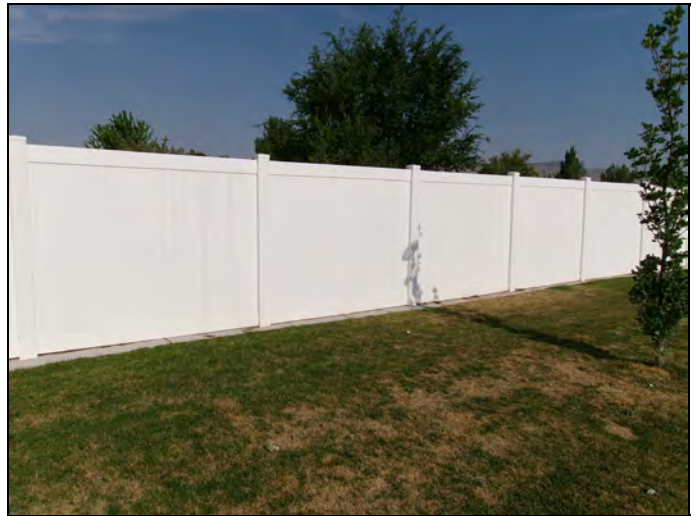
Comp #: 1008 Vinyl Fencing - Replace

The vinyl fencing appears to be in good condition. We recommend funding to replace this component approximately every 25 - 30 years. Remaining life based on current age.

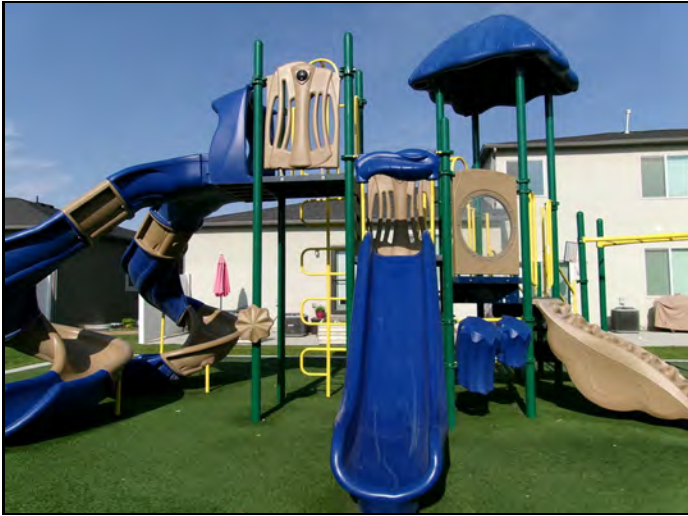
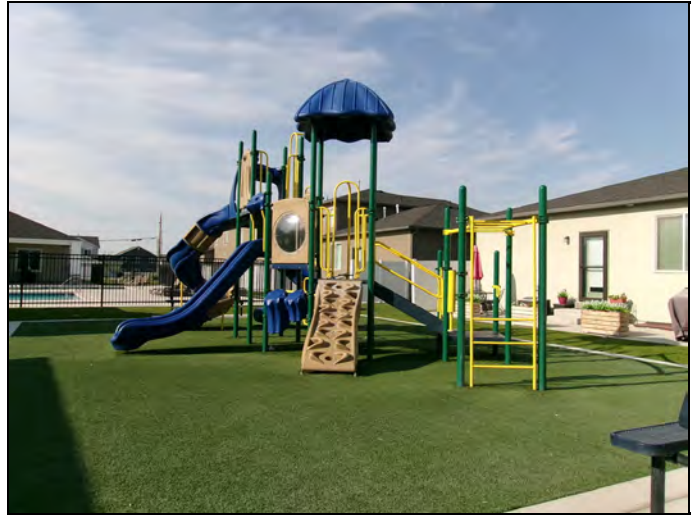
Comp #: 1301 Play Structure - Replace

The play structure appears to be in good condition. We recommend funding to replace this component approximately every 20 - 25 years. Remaining life based on current age.

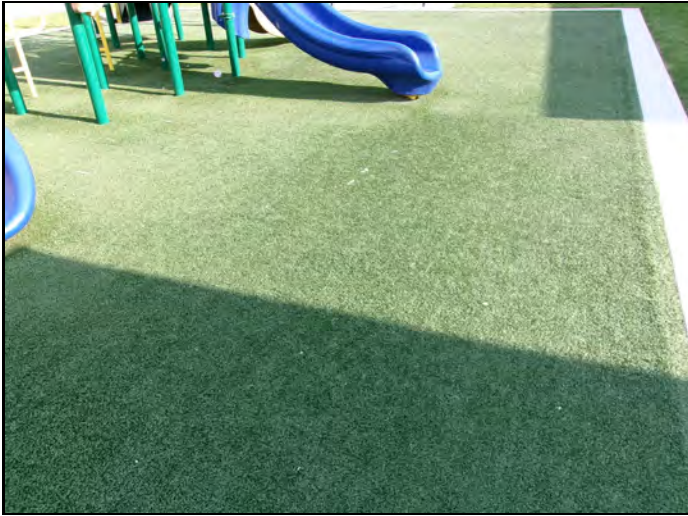
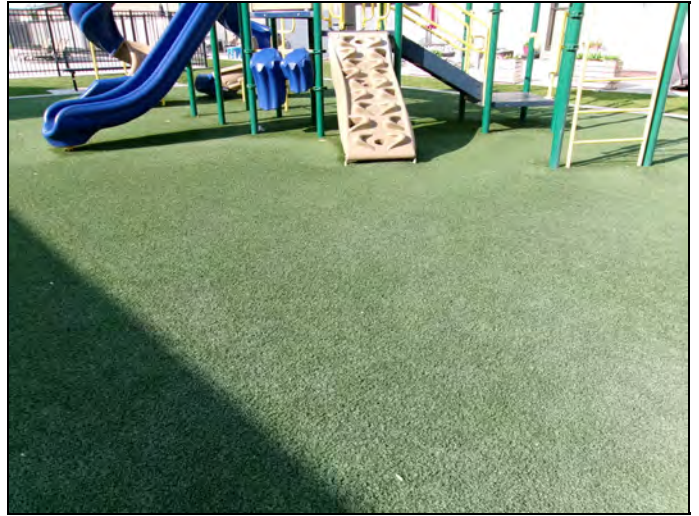
Comp #: 1303 Play Area Artificial Turf - Replace

The artificial turf appears to be in good condition. We recommend funding to replace this component approximately every 20 - 25 years. Reaming life based on current age.

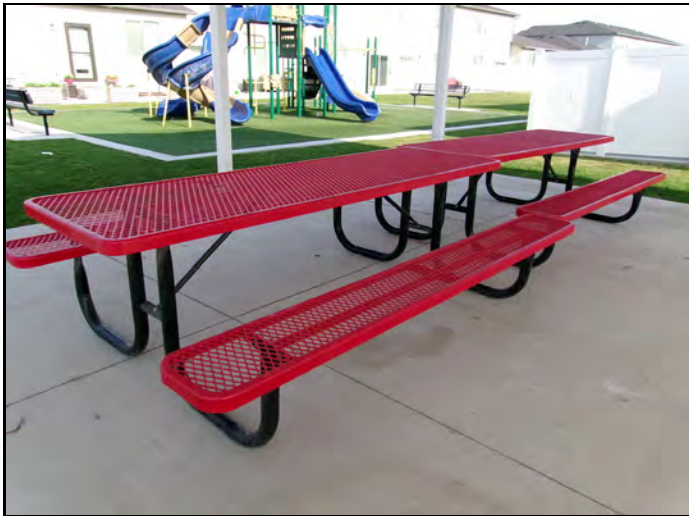
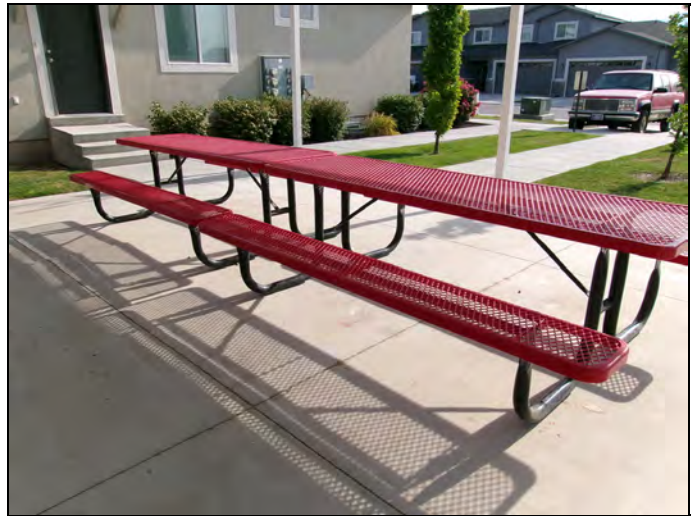
Comp #: 1306 Picnic Tables - Replace

The picnic tables appear to be in good condition. We recommend funding to replace this component approximately every 10 - 15 years. Remaining life based on current age.

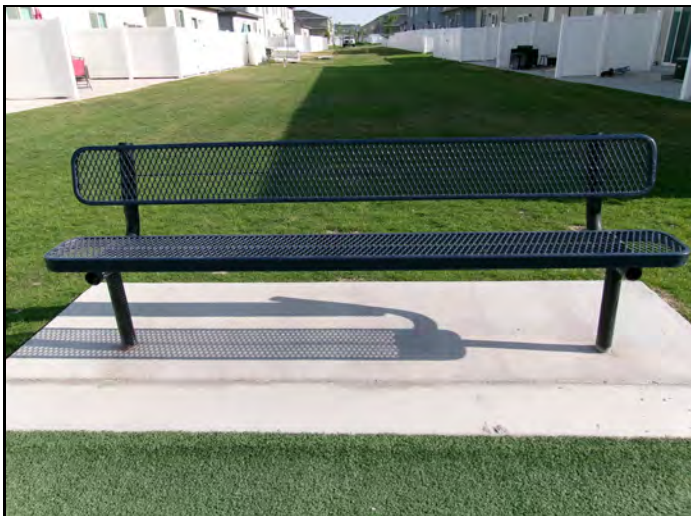
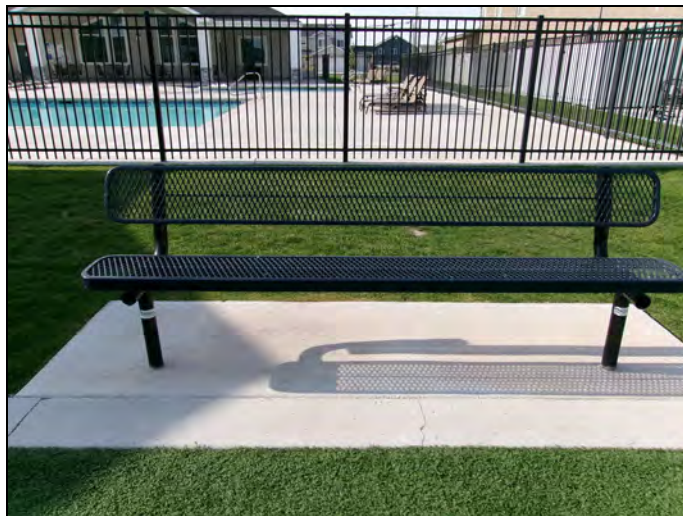
## Comp #: 1307 Benches - Replace

The benches appear to be in good condition. We recommend funding to replace this component approximately every 10 - 15 years. Remaining life based on current age.

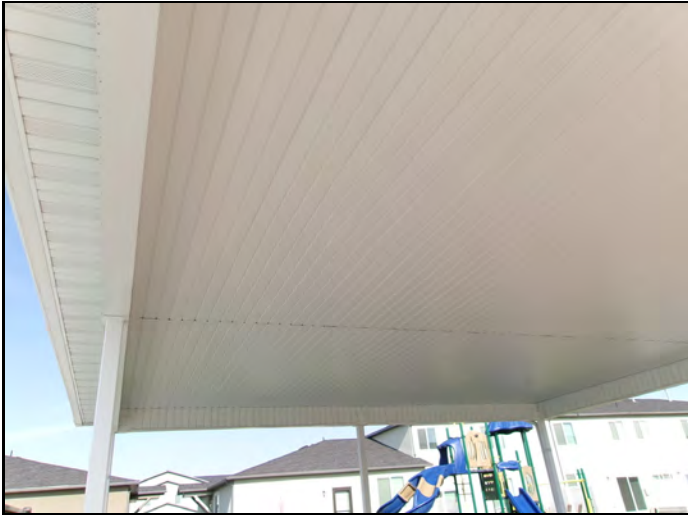
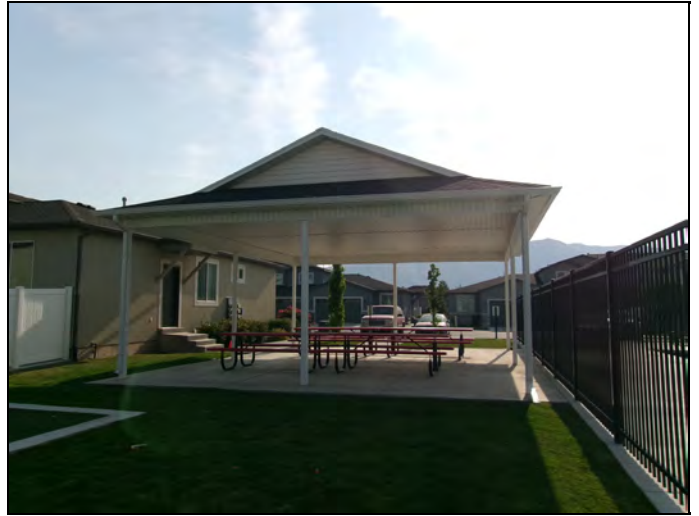
Comp #: 1309 Pavilion - Replace

Due to the extended life of this component, reserve funding is not appropriate. Repair/repaint as necessary as an operating expense.

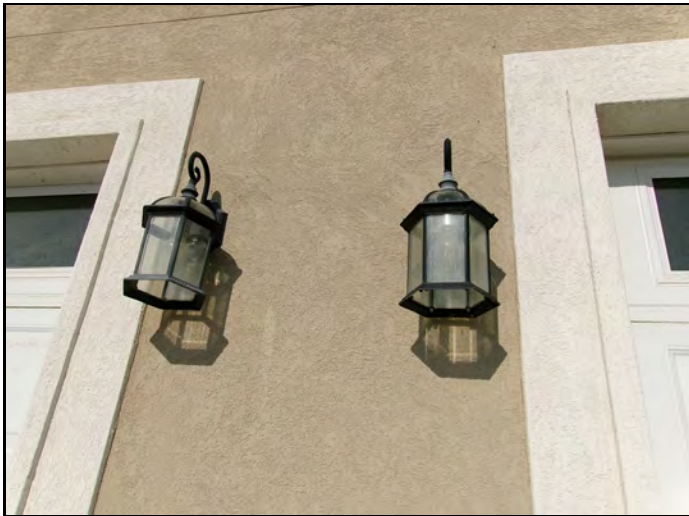
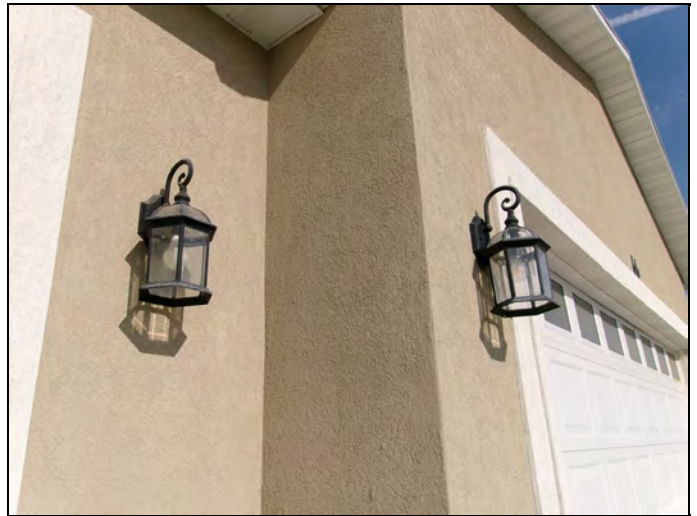
Comp #: 1602 Exterior Light Fixtures - Replace

The exterior light fixtures appear to be in good condition. We recommend funding to replace this component approximately every 16 - 20 years. Remaining life based on current age.

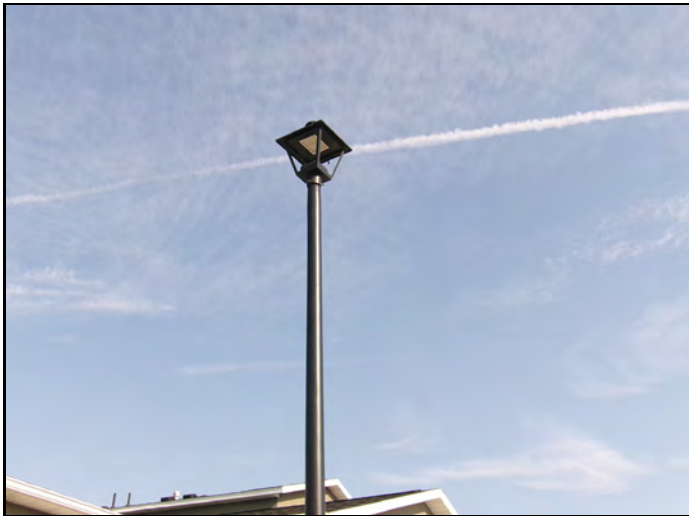
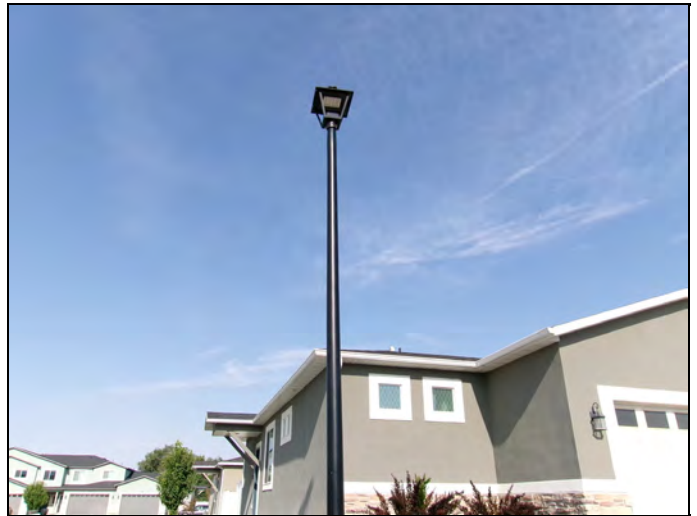
Comp #: 1609 Street Light Fixtures - Replace

The street light fixtures appear to be in good condition. No expectation to replace the light poles. Paint poles as necessary as an operating expense. We recommend funding to replace this component approximately every 20 years. Remaining life based on current age.

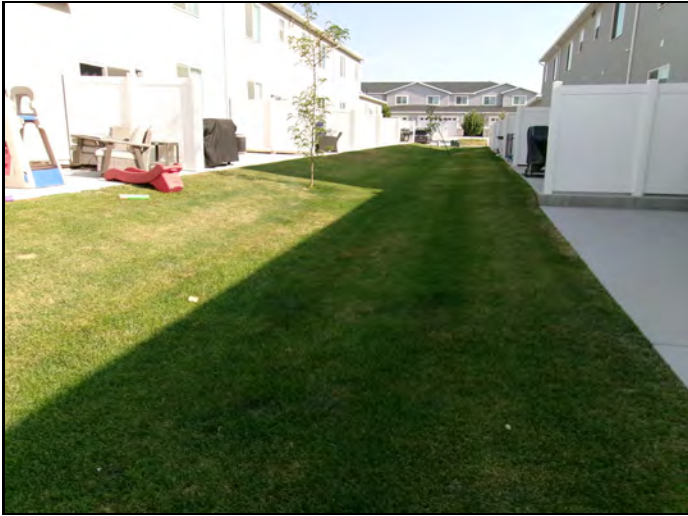
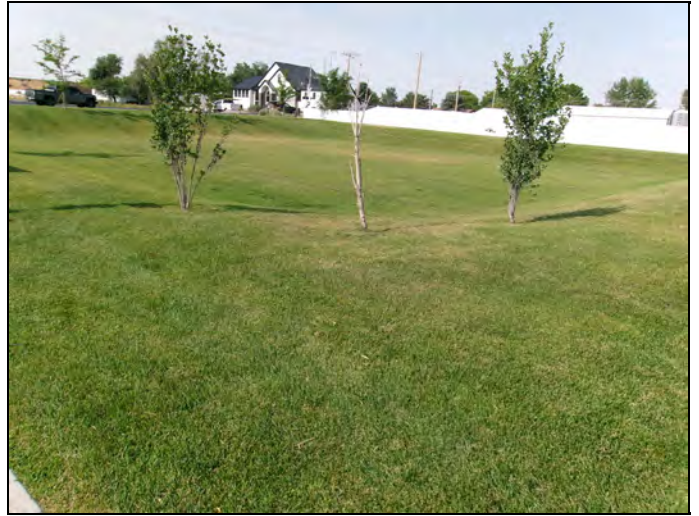
Comp #: 1812 Landscaping & Irrigation System - Renovate

The landscaping and irrigation system appear to be in good condition. We recommend funding for an allowance to renovate this component approximately every 20 years. Remaining life based on current age.
