Legacy Beach HOA

Level 1 Reserve Study

Report Period – 01/01/2026 – 12/31/2026

Type of Study	Full Study
Date of Property Inspection	1/7/2025
Prepared By	Dale Gifford
Analysis Method	Cash Flow
Funding Goal	Full Funding

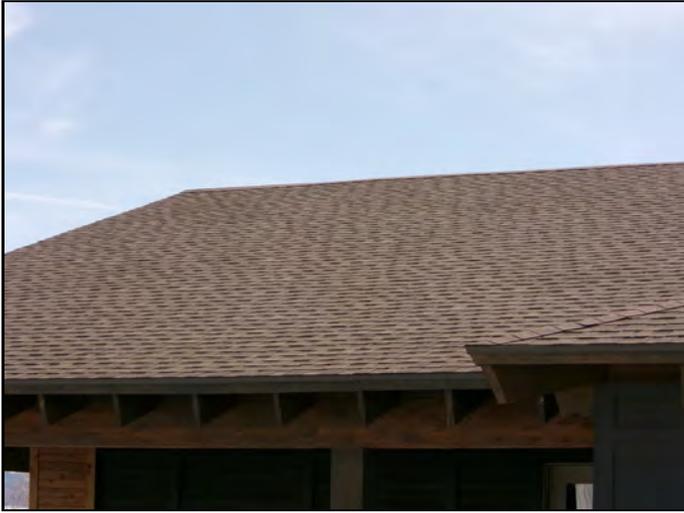
Comp #: 105 East Building Roofs - Replace

Location: **East Pavilion, Pool, & Shed**

Quantity: **Approx 5,215 SF**

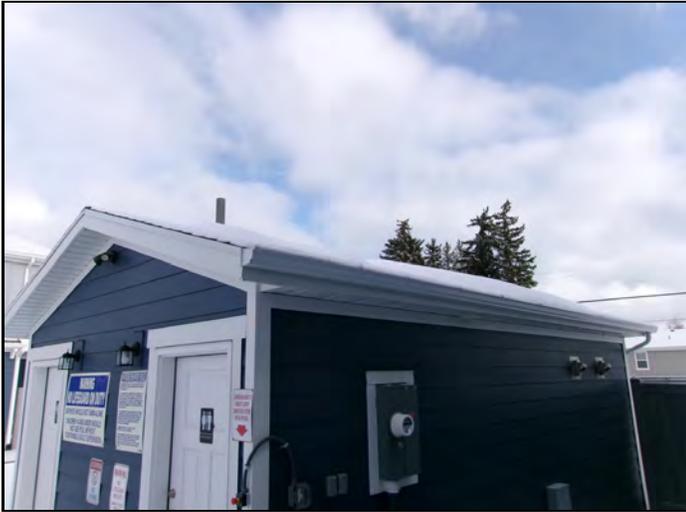
Comp #: 105 East/West Building Roofs - Replace

Location: **West Pool, & East Shed**

Quantity: **Approx 840 SF**

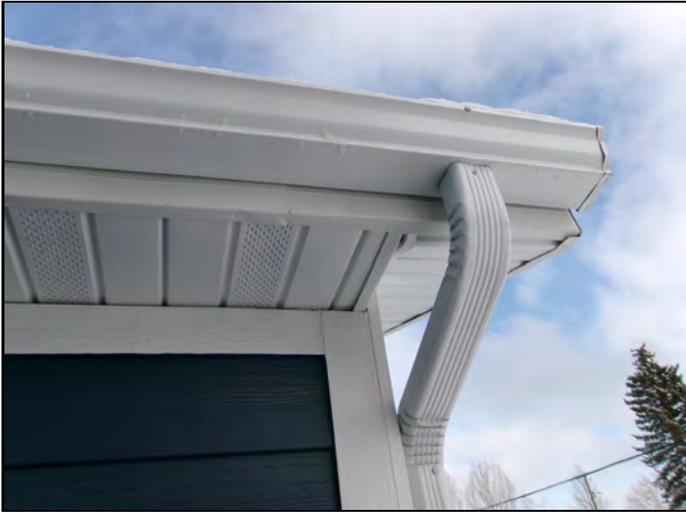
Comp #: 120 Rain Gutters/Downspouts - Replace

Location: **West Pool Building**

Quantity: **Approx 70 LF**

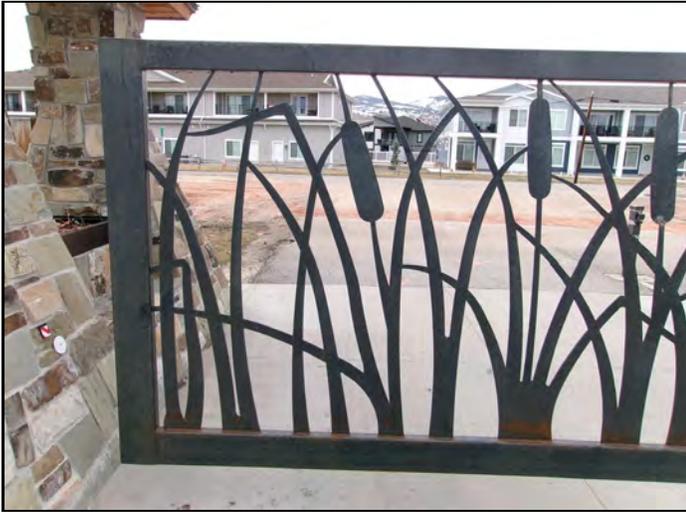
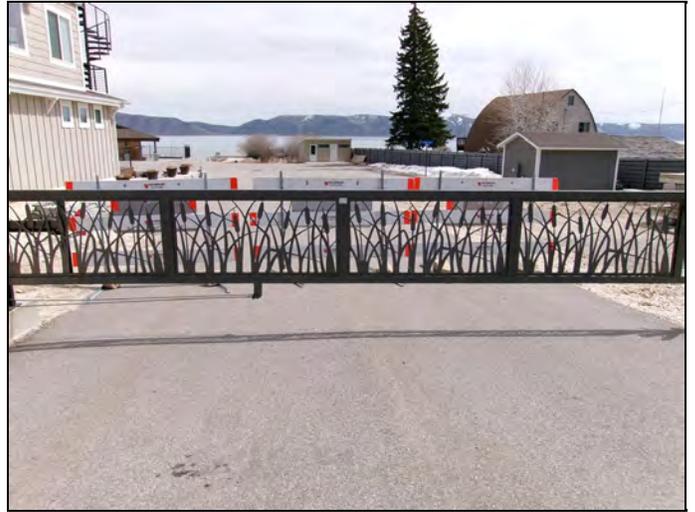
Comp #: 208 Vehicle Gates - Repaint

Location: **Entrances**

Quantity: **Approx 80 LF**

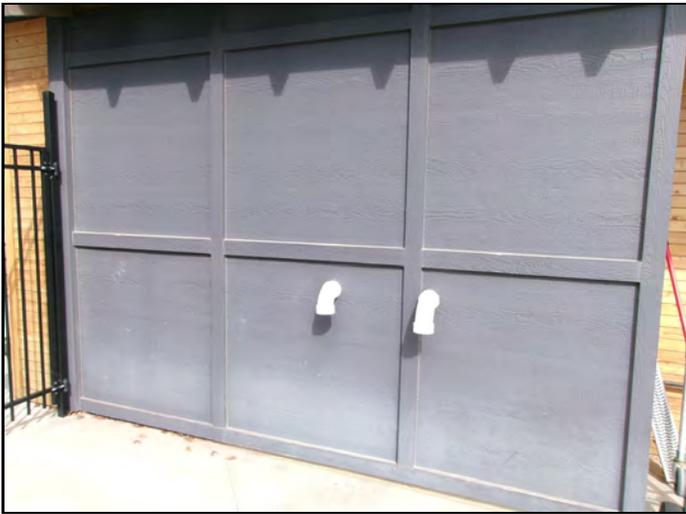
Comp #: 215 East Buildings Exteriors - Repair/Repaint

Location: **East Pavilion, Pool, & Shed**

Quantity: **Approx 11,745 SF**

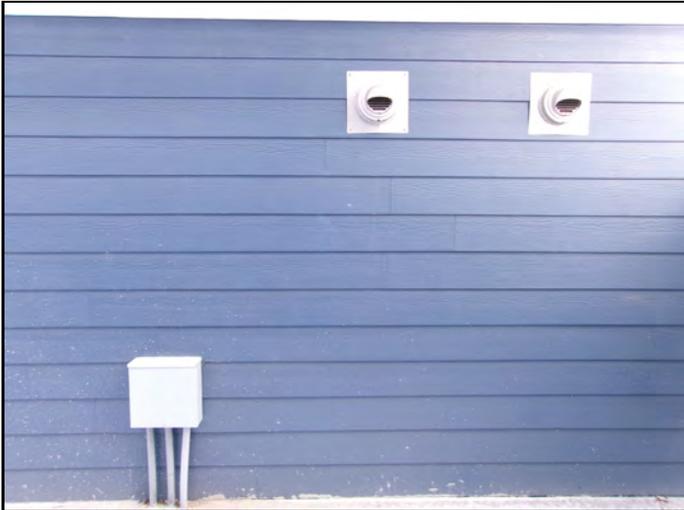
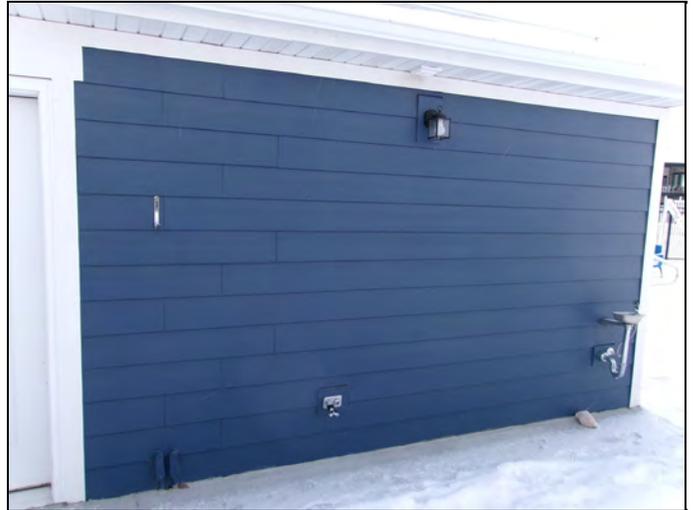
Comp #: 215 West Building Exteriors - Repair/Repaint

The siding painted surfaces appear to be in good condition. We recommend funding to repair/repaint this component approximately every 8 - 10 years. Remaining life is based on current age.

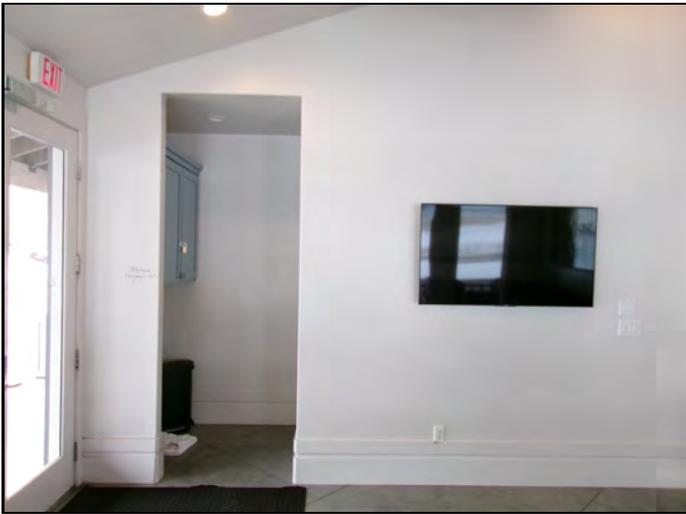
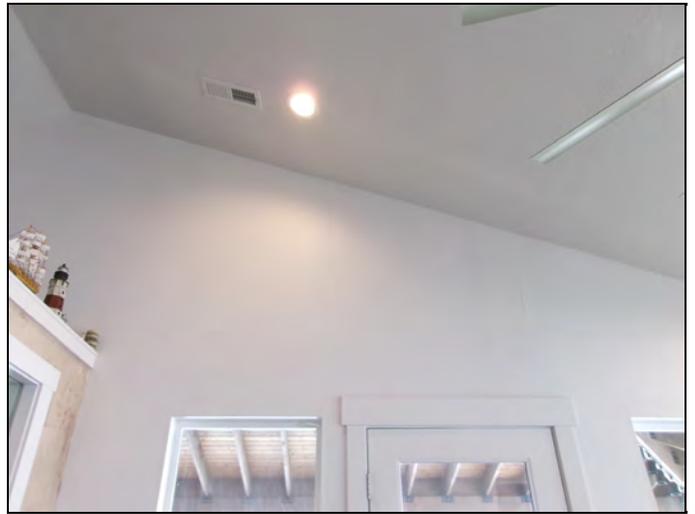
Comp #: 216 Interior Surfaces - Repaint

Location: **East Pool Building**

Quantity: **Approx 1,925 SF**

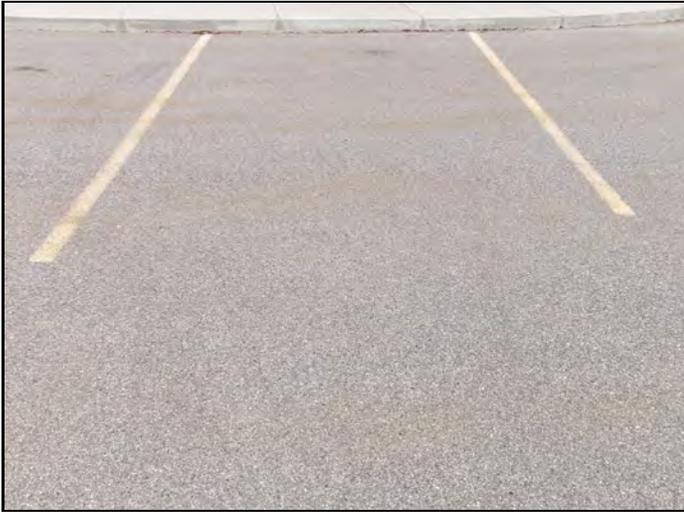
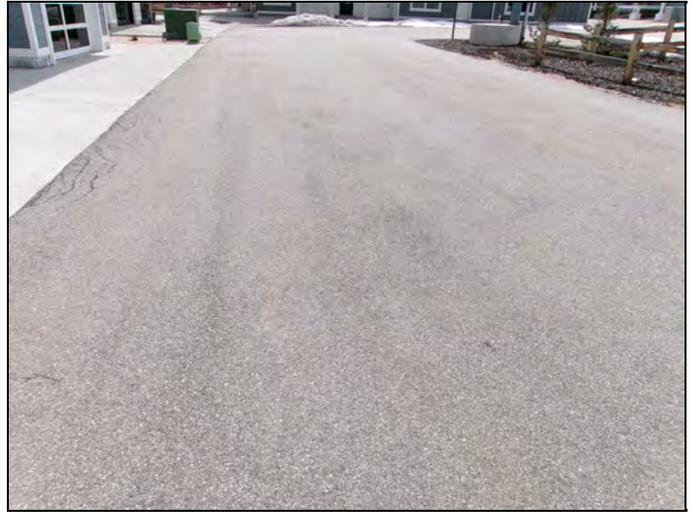
Comp #: 401 Asphalt - East - Major Rehab

Location: **East Common Area**

Quantity: **Approx 51,805 SF**

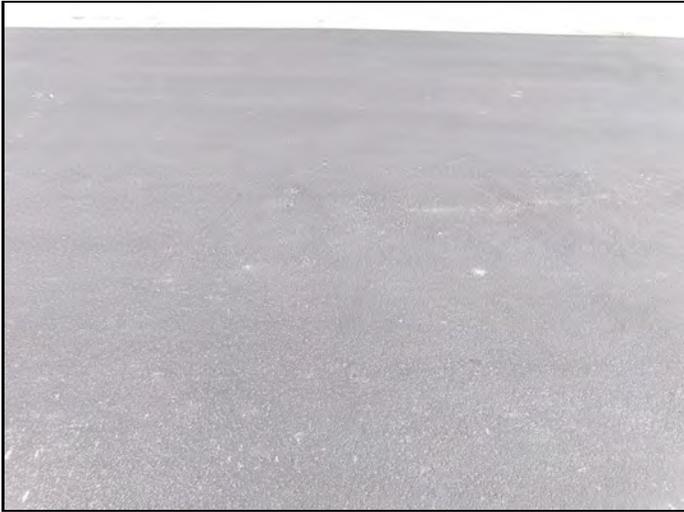
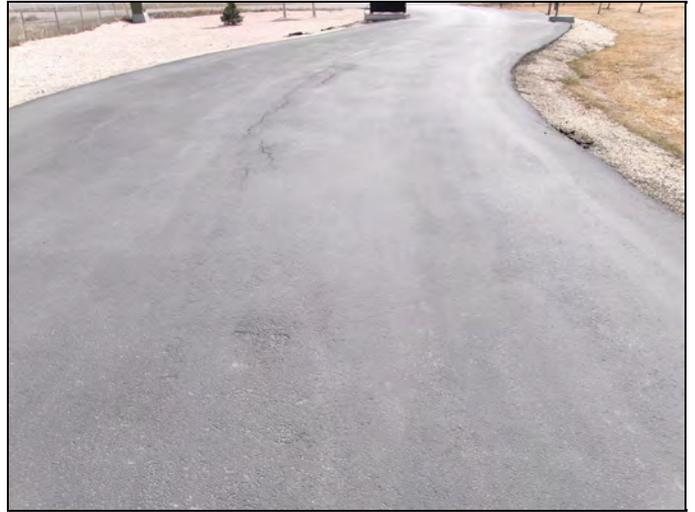
Comp #: 401 Asphalt - West 2016-2020 - Major Rehab

Location: **West Parking & Street**

Quantity: **Approx 38,560 SF**

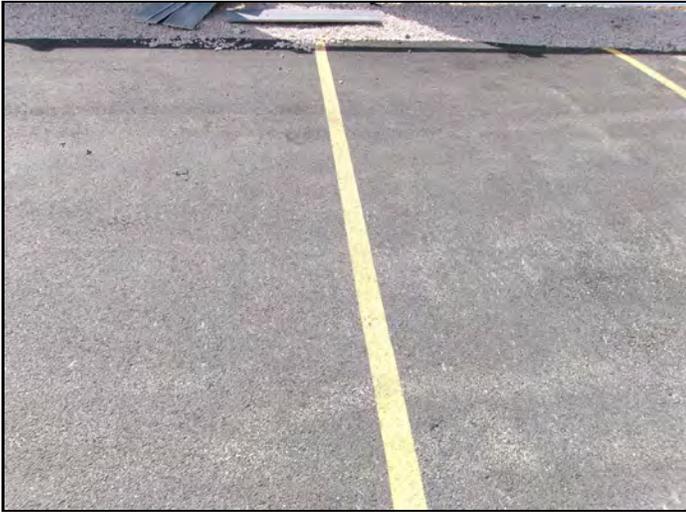
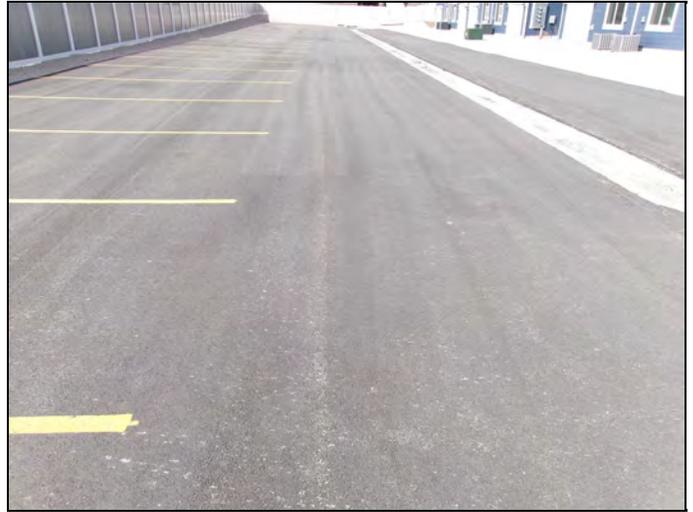
Comp #: 401 Asphalt - West 2022-2023 - Major Rehab

Location: **West Parking & Street**

Quantity: **Approx 22,205 SF**

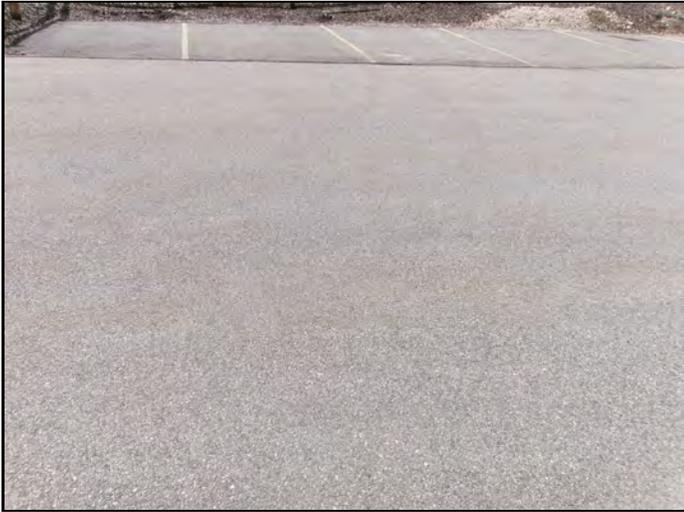
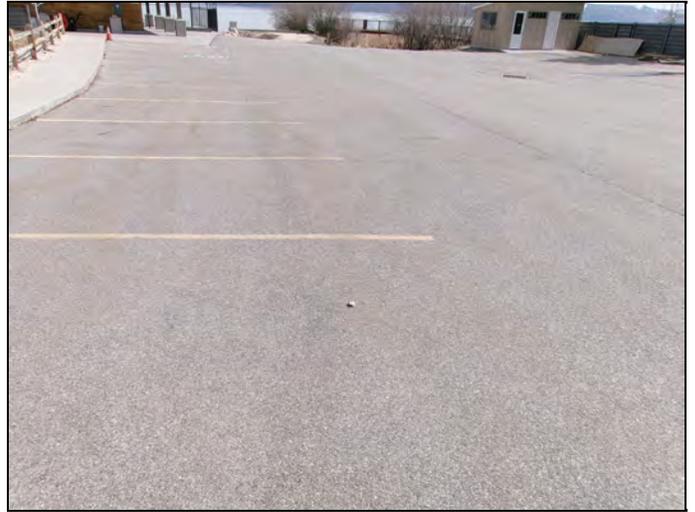
Comp #: 402 Asphalt - East - Seal Coat

Location: **East Common Area**

Quantity: **Approx 51,805 SF**

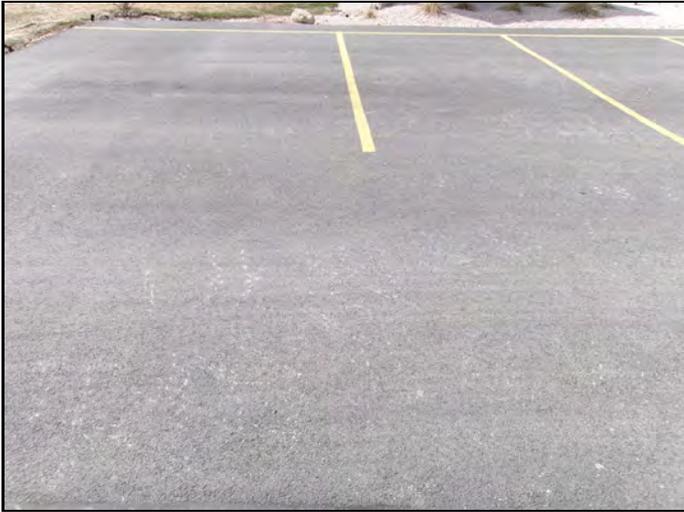
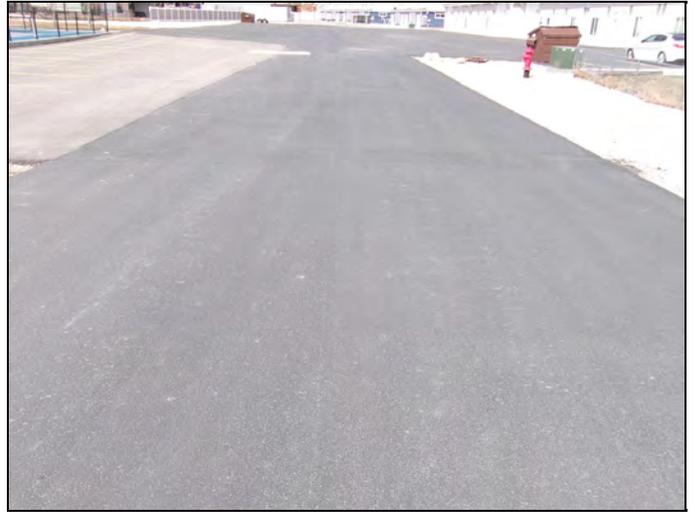
Comp #: 402 Asphalt - West 2016-2020 - Seal Coat

Location: **West Parking & Street**

Quantity: **Approx 38,560 SF**

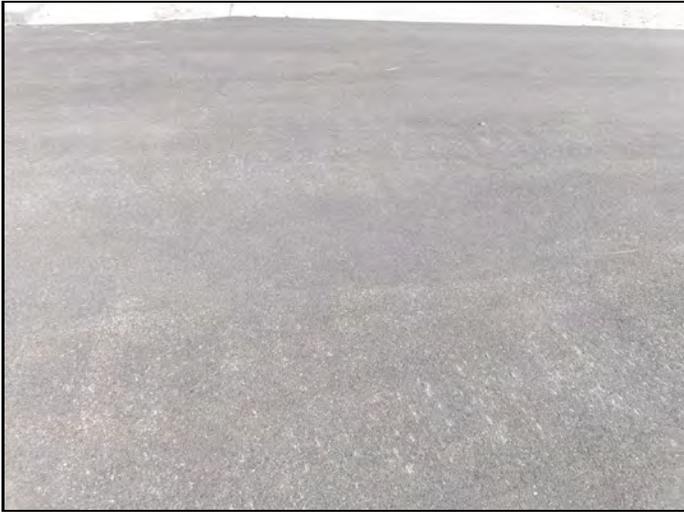
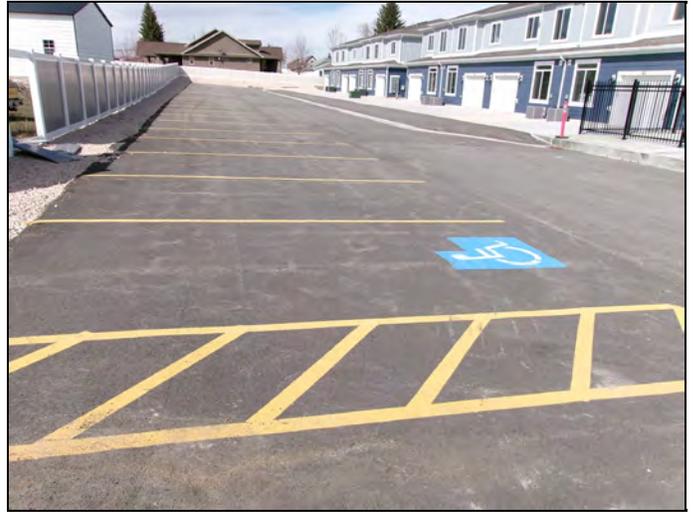
Comp #: 402 Asphalt - West 2022-2023 - Seal Coat

Location: **West Parking & Street**

Quantity: **Approx 22,205 SF**

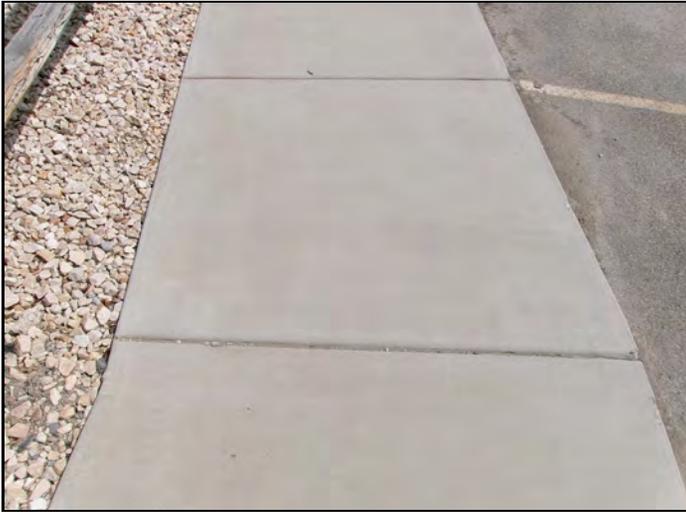
Comp #: 403 Concrete - Partial Repair/Replace

Location: **Common Area**

Quantity: **Moderate SF**

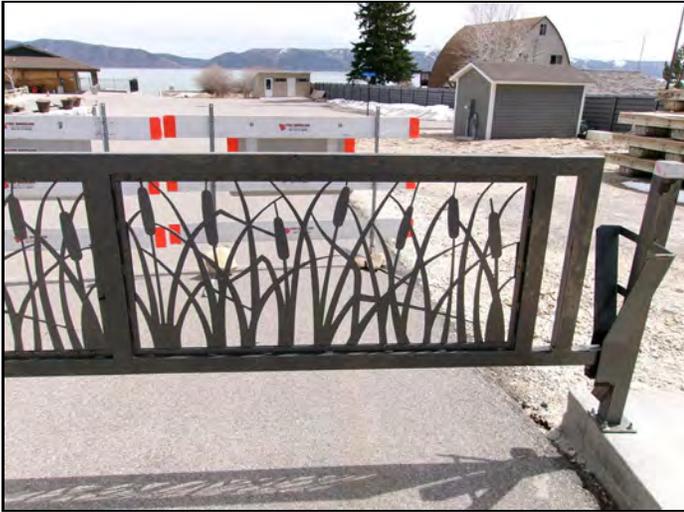
Comp #: 504 East Vehicle Gate - South - Replace

Location: **East Side, South Entrance**

Quantity: **(1) Gate**

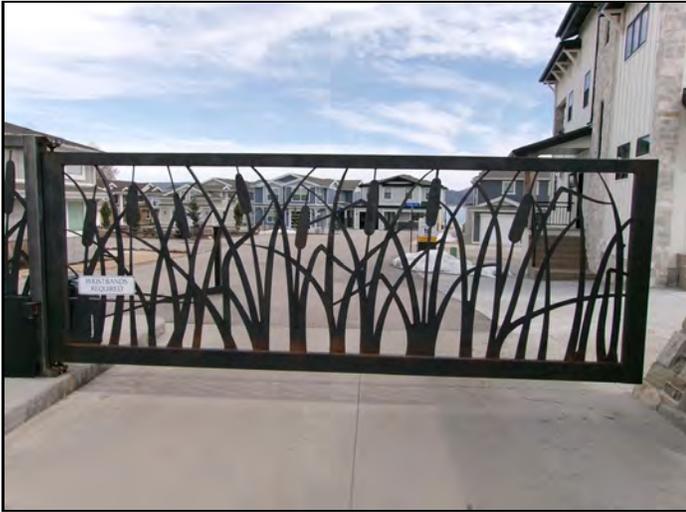
Comp #: 504 East Vehicle Gates - North - Replace

Location: **East Area, North Gates**

Quantity: **(2) Gates**

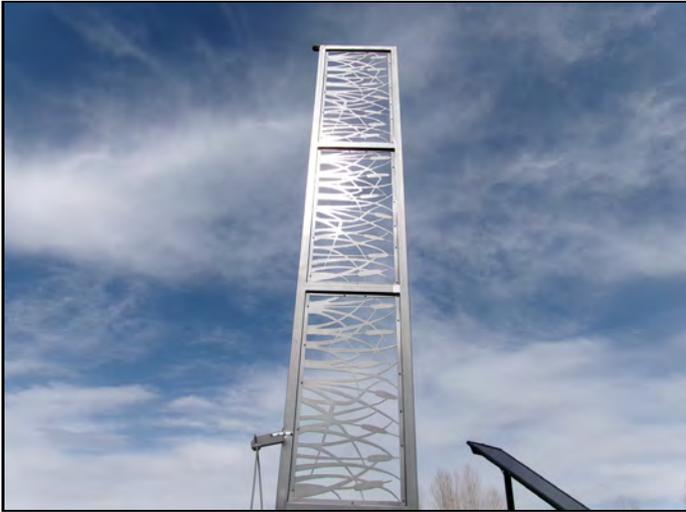
Comp #: 504 West Vehicle Gate - Replace

Location: **West Area**

Quantity: **(1) Gate**

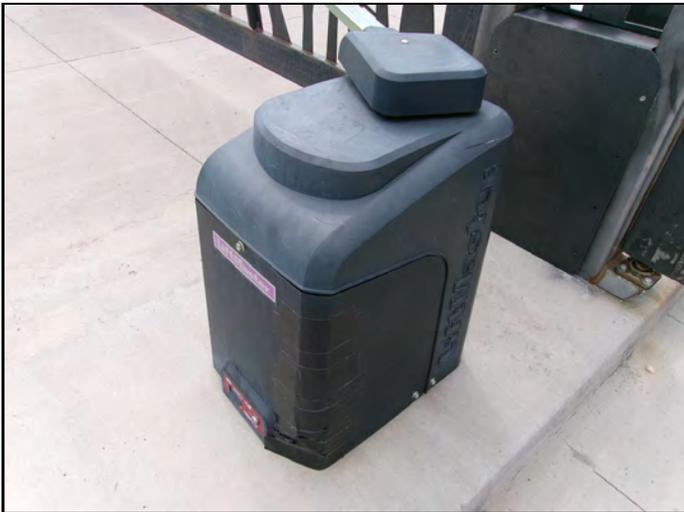
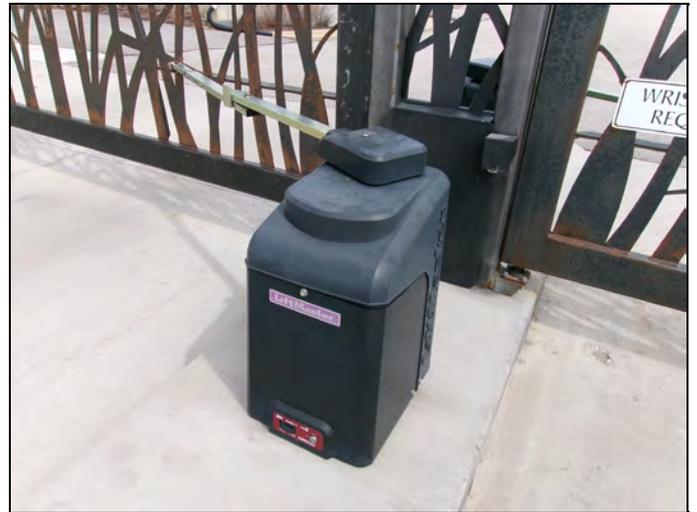
Comp #: 507 East Vehicle Gate Operators - North - Replace

Location: **East Area, North Gates**

Quantity: **(2) Operators**

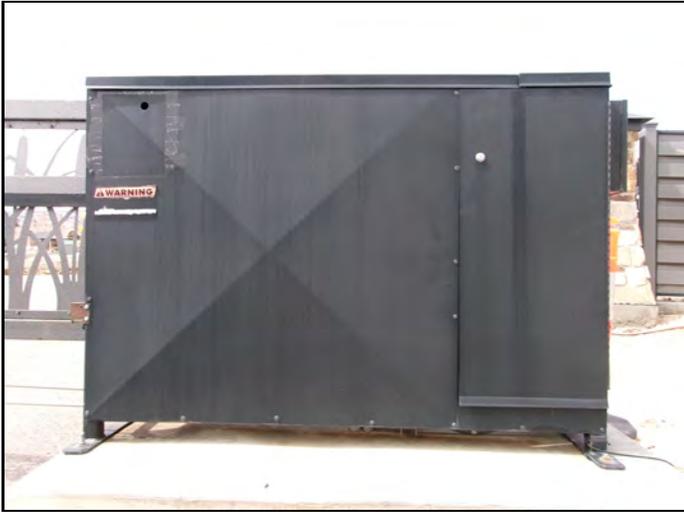
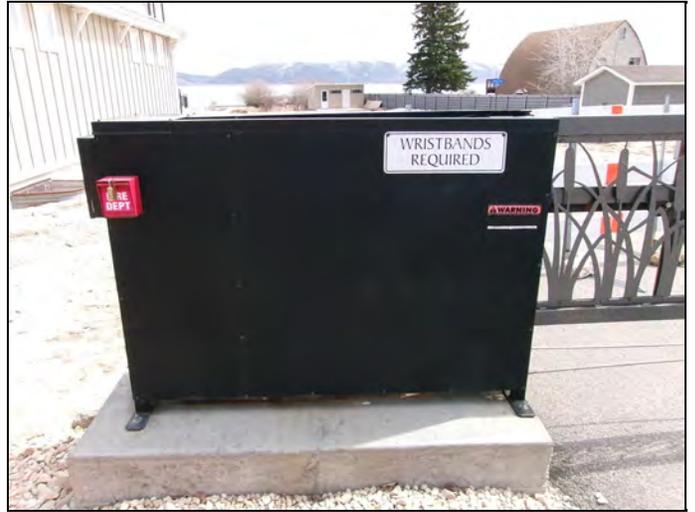
Comp #: 507 East Vehicle Gate Operators - South - Replace

Location: **East Side, South Gate**

Quantity: **(1) Pivot Gate Operator**

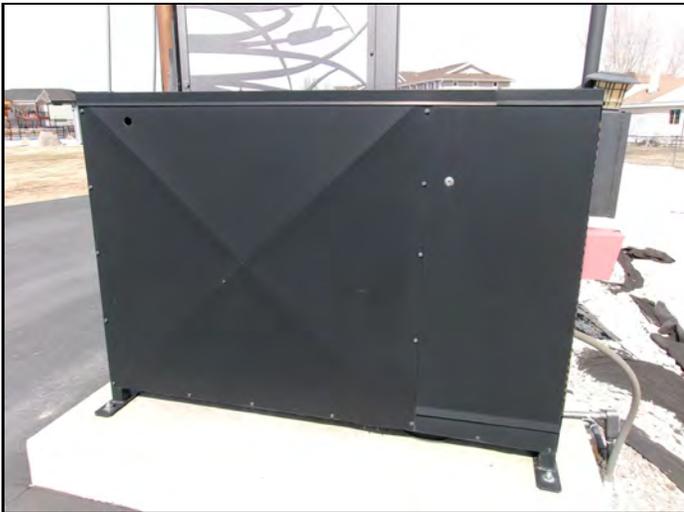
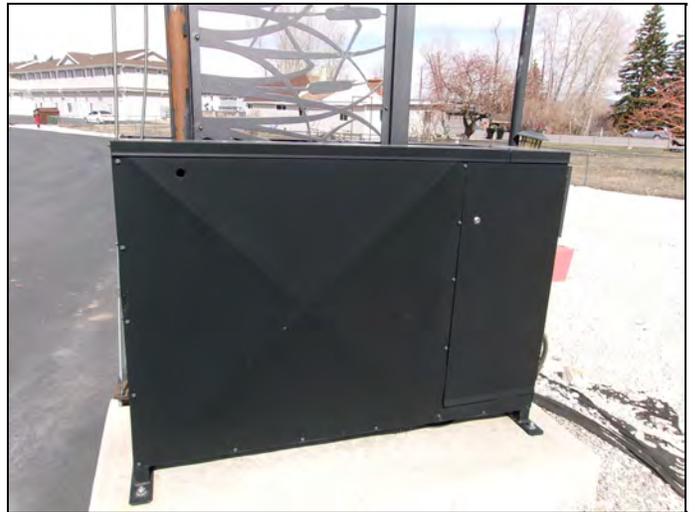
Comp #: 507 West Vehicle Gate Operator - Replace

Location: **West Area**

Quantity: **(1) Pivot Gate Operator**

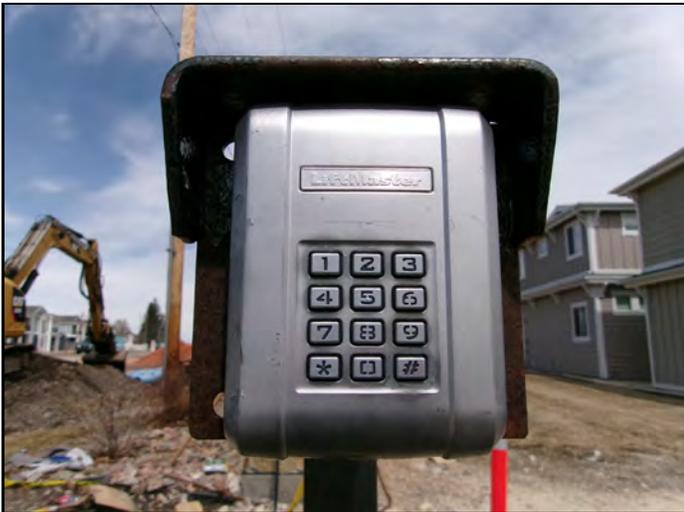
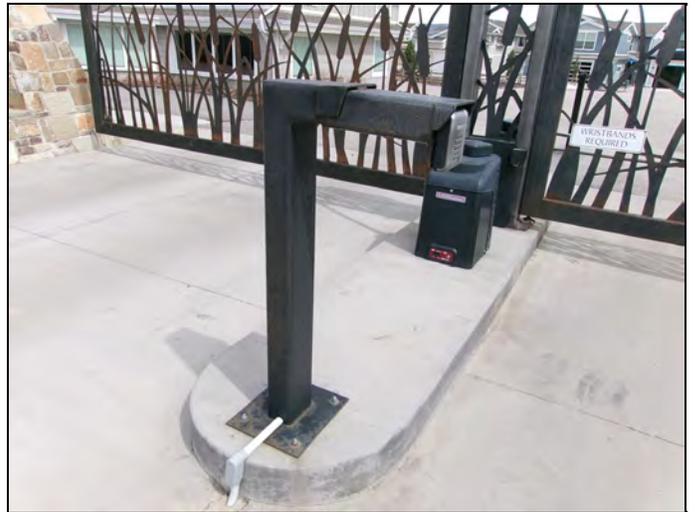
Comp #: 508 Keypads - Replace

The key pads are in working condition. We recommend funding to replace this component approximately every 10 - 12 years. Remaining life based on current age.

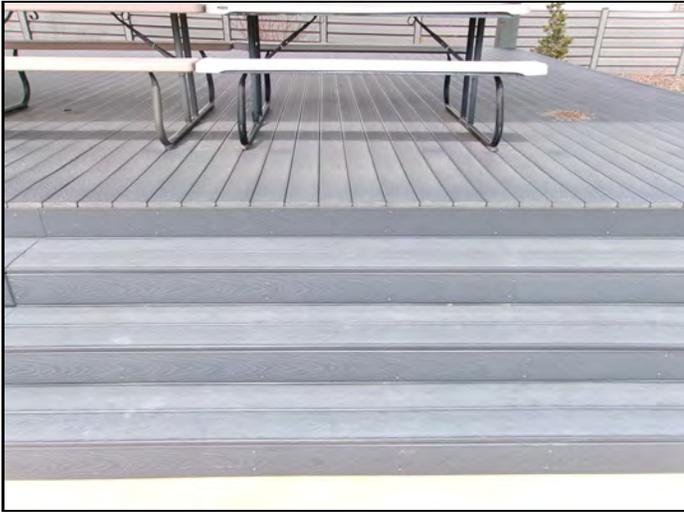
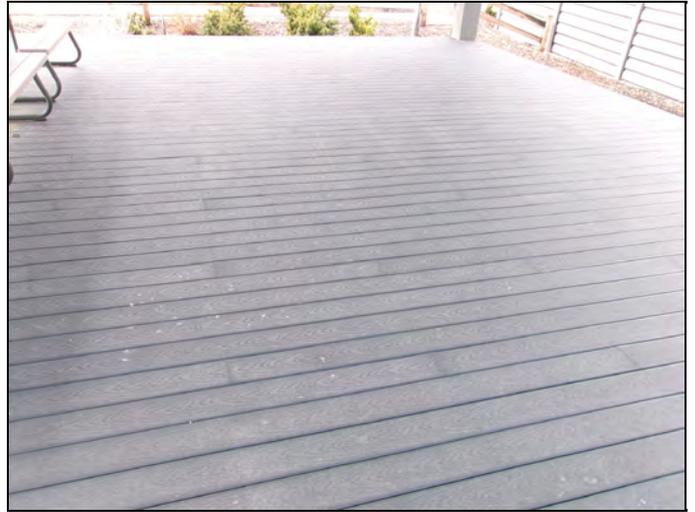
Comp #: 609 Pavilion Decking - Replace

The decking appears to be in good condition. We recommend funding to replace this component approximately every 25 - 30 years. Remaining life based on current age.

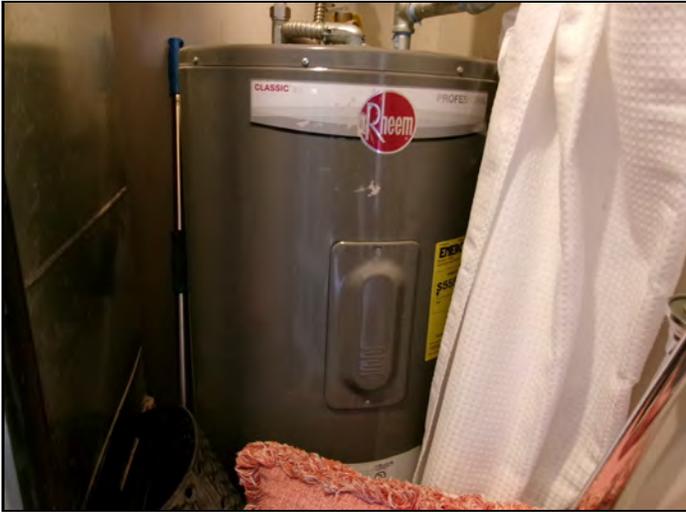
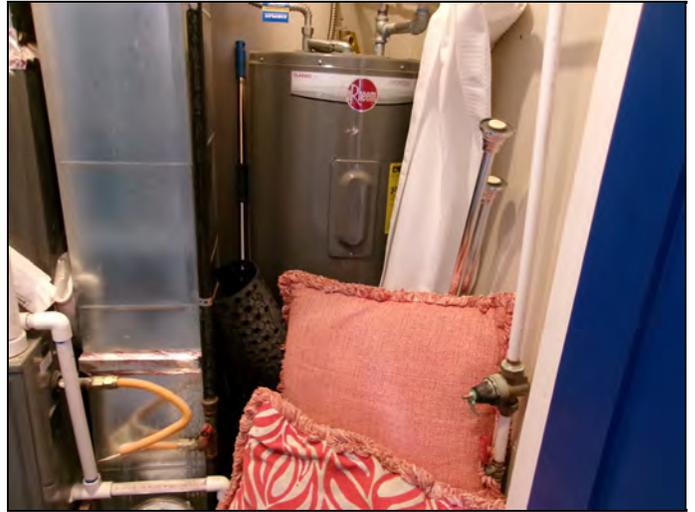
Comp #: 703 East Water Heater - Replace

The water heater is in working condition. We recommend funding to replace this component approximately every 12 years. Remaining life based on current age.

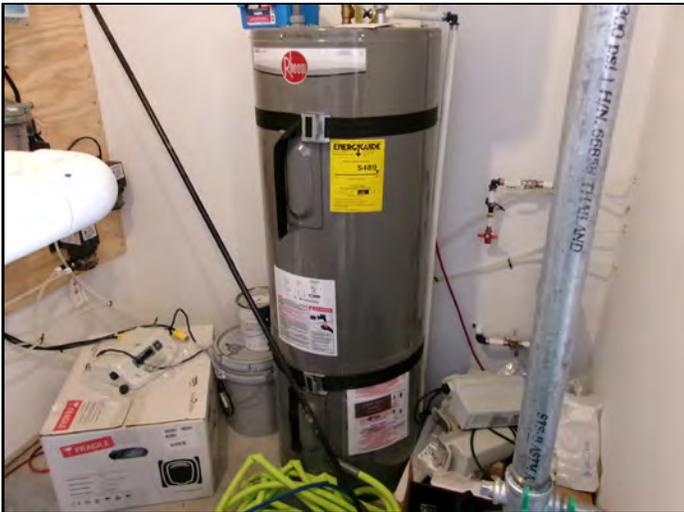
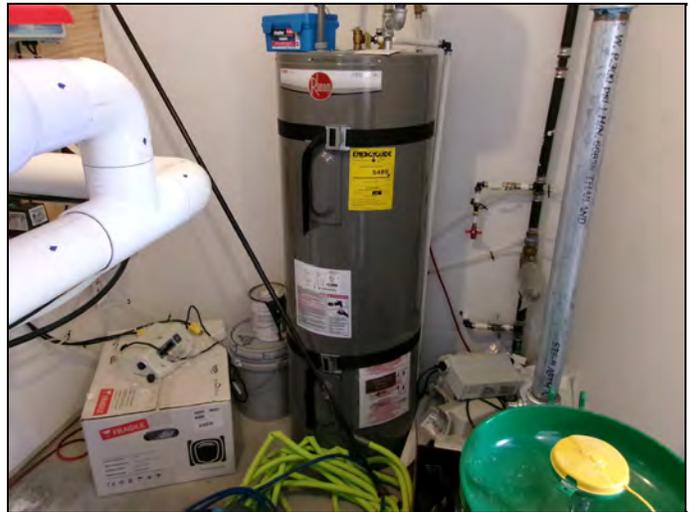
Comp #: 703 West Water Heater - Replace

The water heater is in working condition. We recommend funding to replace this component approximately every 12 years. Remaining life based on current age.

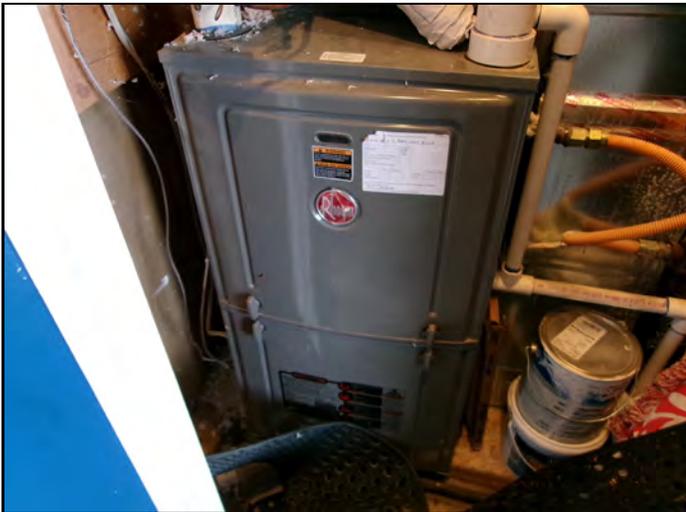
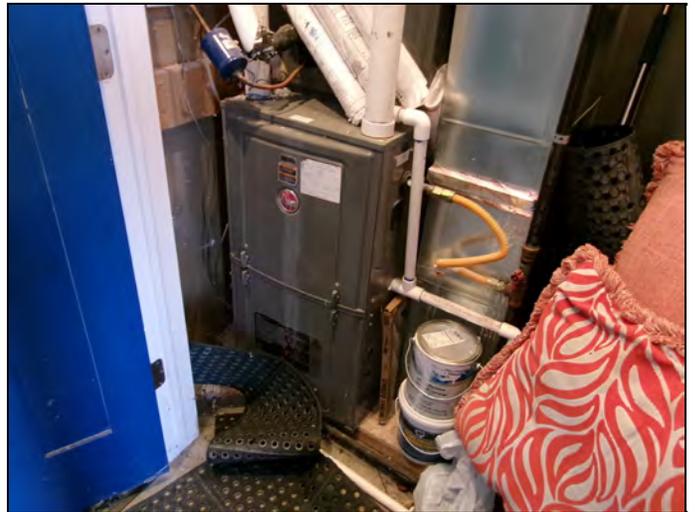
Comp #: 706 HVAC Furnace - Replace

The furnace is in working condition. We recommend funding to replace this component approximately every 20 years. Remaining life based on current age.

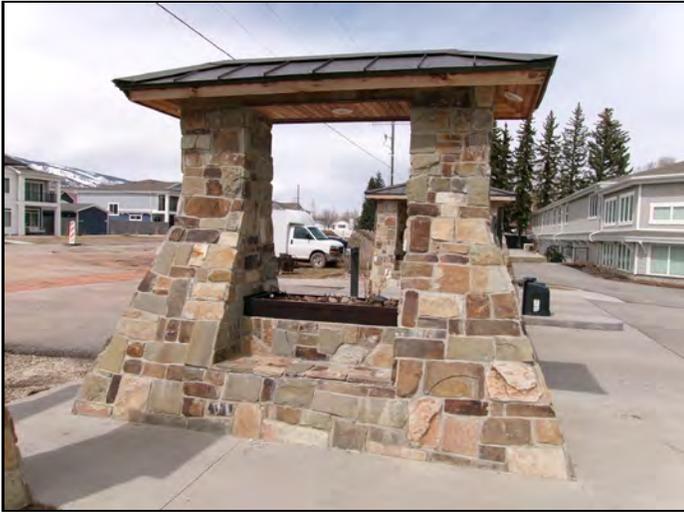
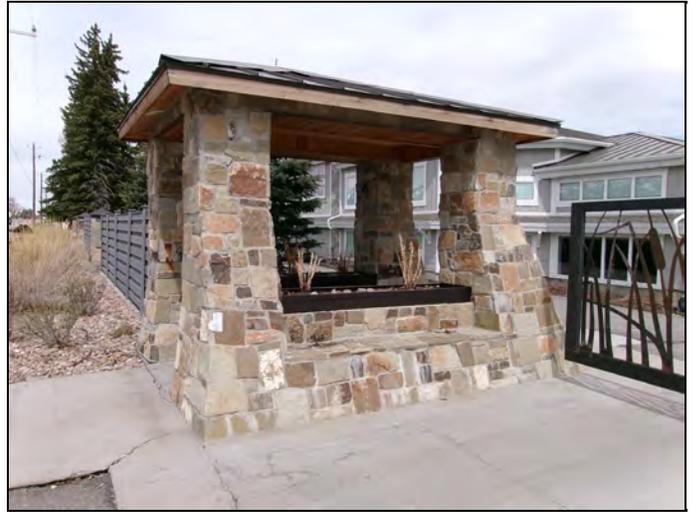
Comp #: 801 Entrance Structures - Refurbish

The entrance structures are in good to fair condition. We recommend funding to refurbish this component approximately every 15 - 20 years. Remaining life is based on current age.

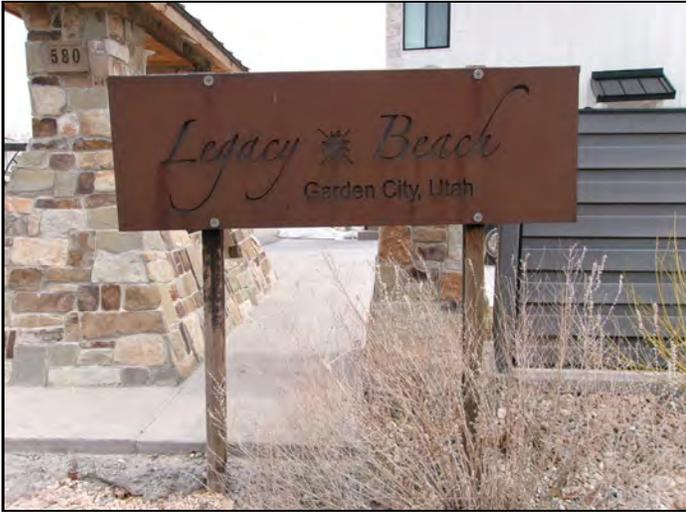
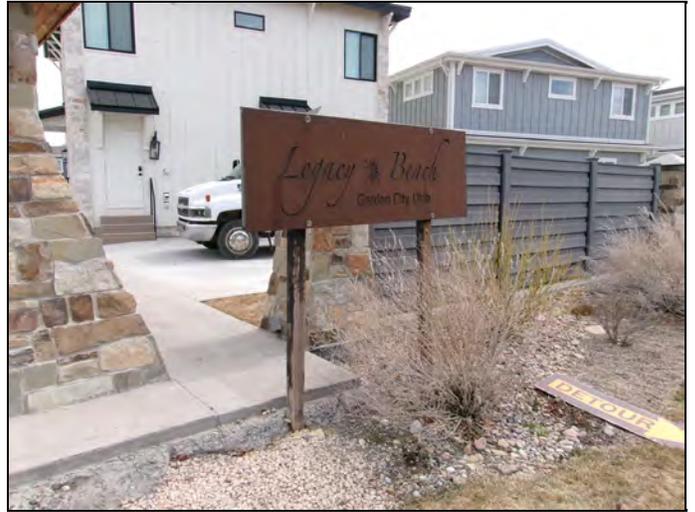
Comp #: 805 Community Sign - Replace

Due to the minimal cost of replacing this component, reserve funding is not appropriate. Replace as necessary as an operating expense.

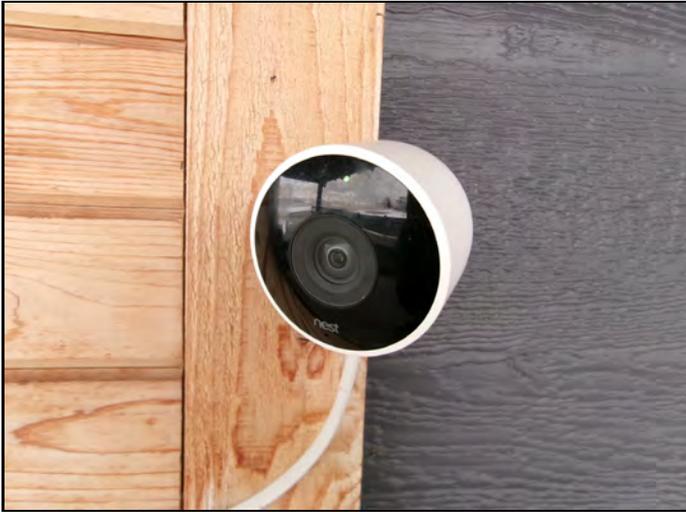
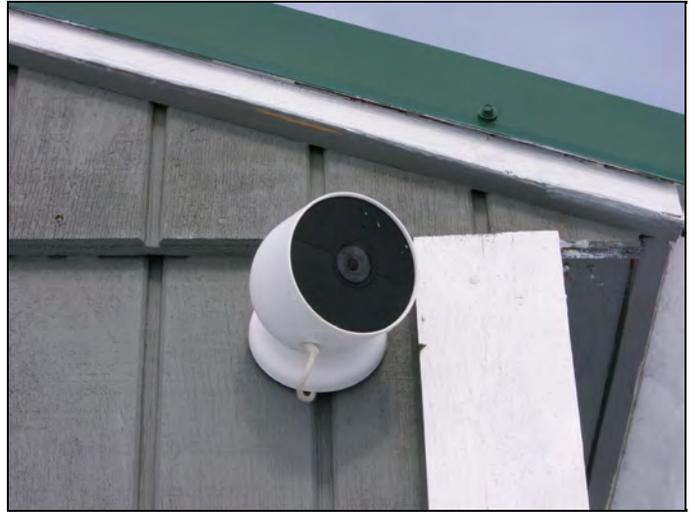
Comp #: 903 Security Camera System - Replace

Due to the minimal cost of replacing this component, reserve funding is not appropriate. Replace as necessary as an operating expense.

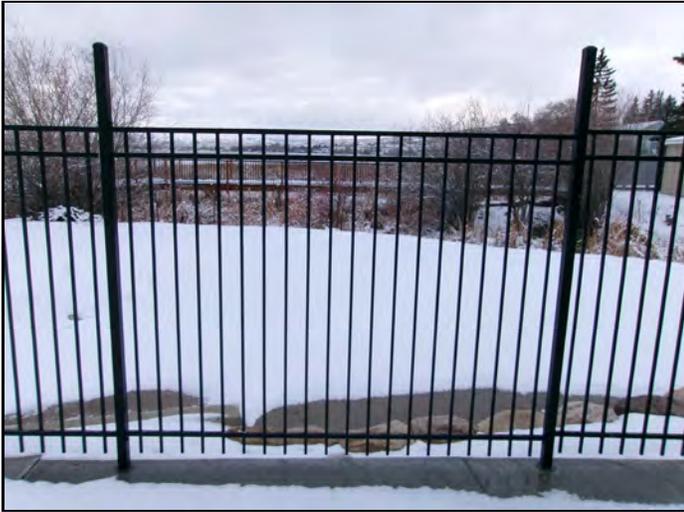
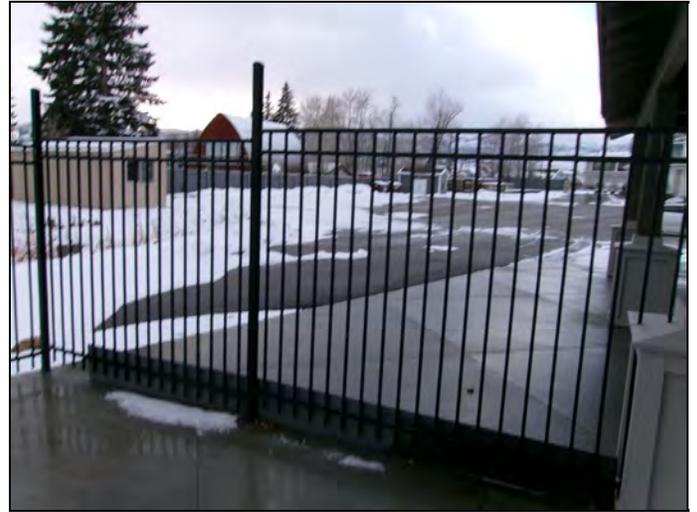
Comp #: 1002 East Metal Fencing - Replace

The metal fencing is in good condition. We recommend funding to replace this component approximately every 40 - 50 years. Remaining life based on current age.

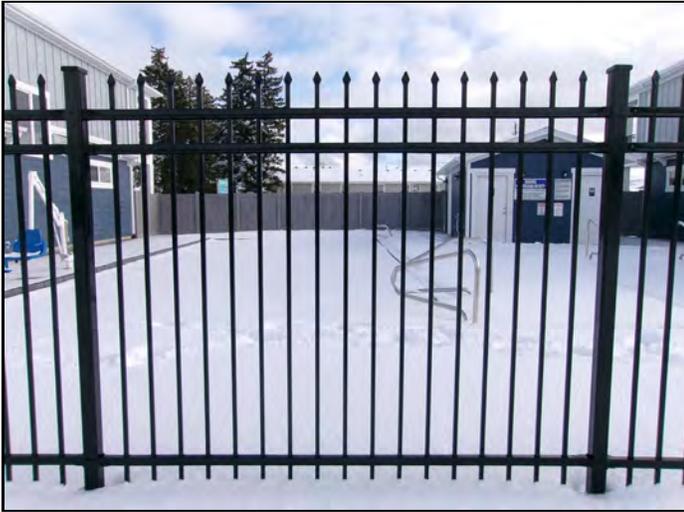
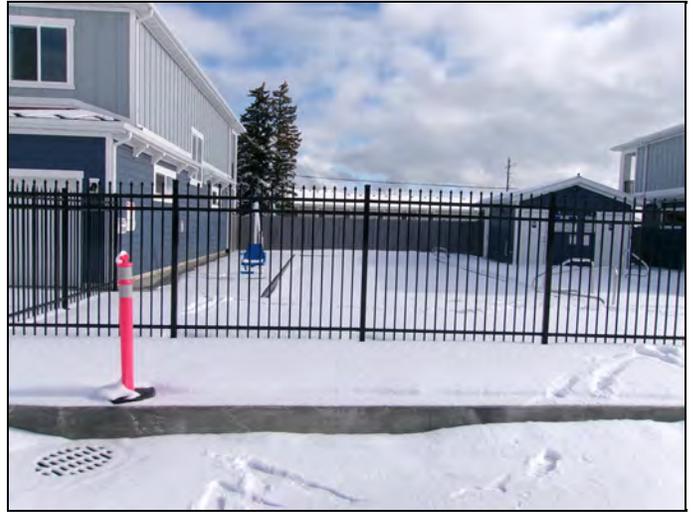
Comp #: 1002 West Metal Fencing - Replace

The metal fencing is in good condition. We recommend funding to replace this component approximately every 40 - 50 years. Remaining life based on current age.

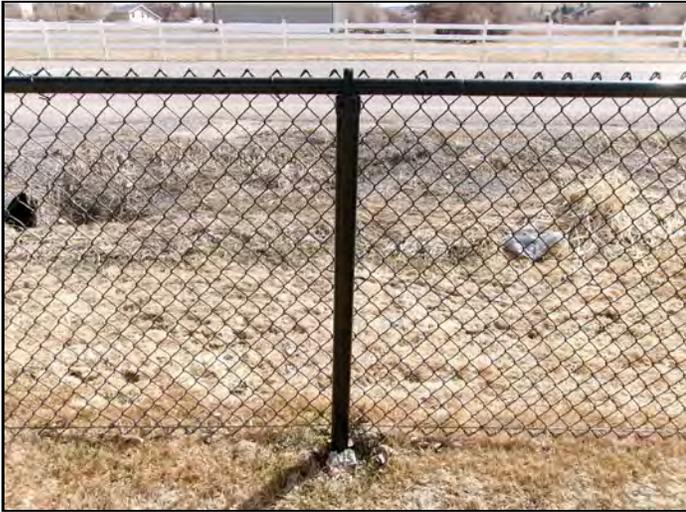
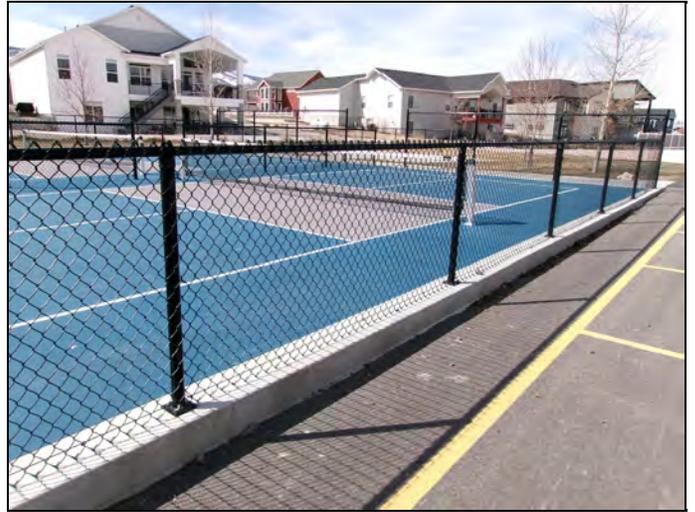
Comp #: 1003 Chain Link Fencing - Replace

The chain link fencing is in good condition. We recommend funding to replace this component approximately every 30 - 40 years. Remaining life based on current age.

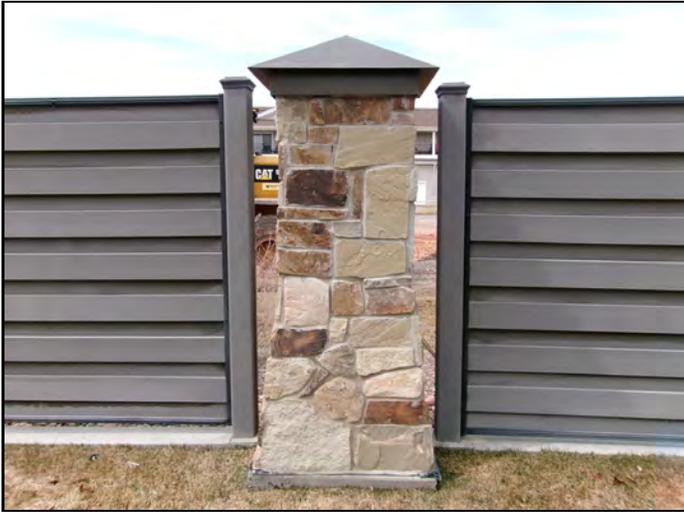
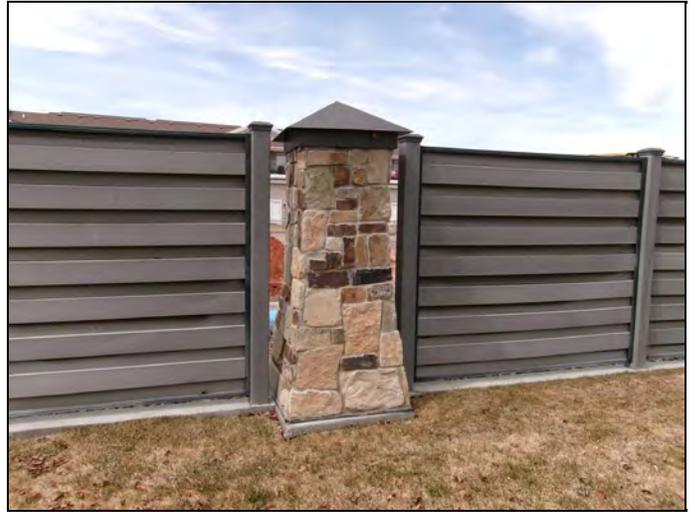
Comp #: 1007 Stone Pillars - Refurbish

The stone pillars are in good condition. We recommend funding to refurbish this component approximately every 15 - 20 years. Remaining life based on current age.

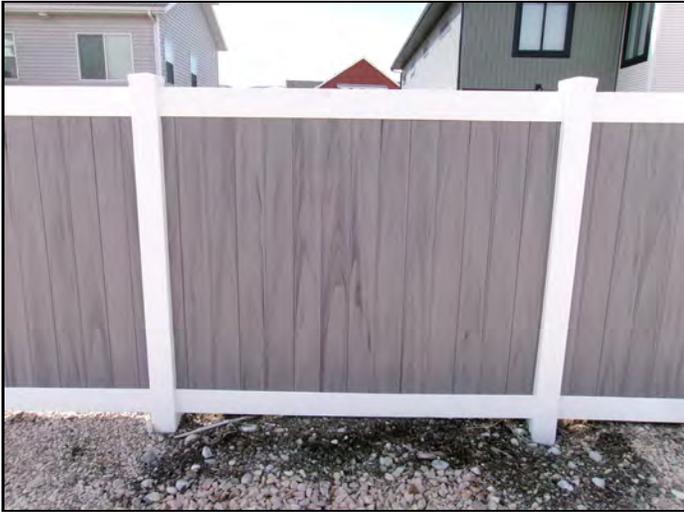
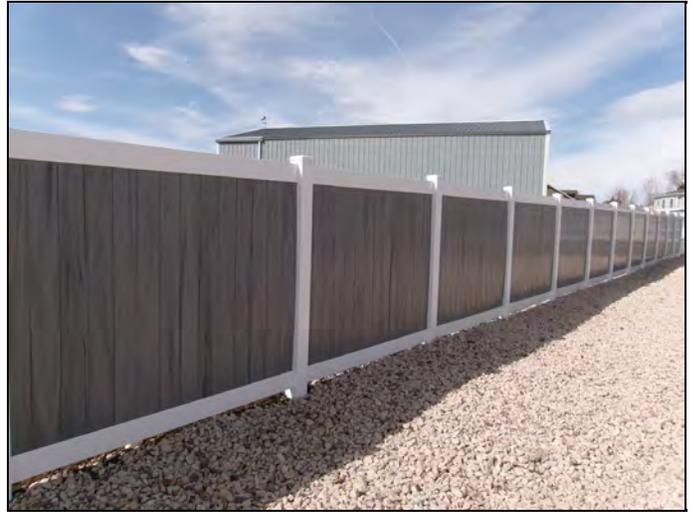
Comp #: 1008 Vinyl Fencing - Replace

The vinyl fencing is generally in good condition. We recommend funding to replace this component approximately every 25 - 30 years. Remaining life based on current age.

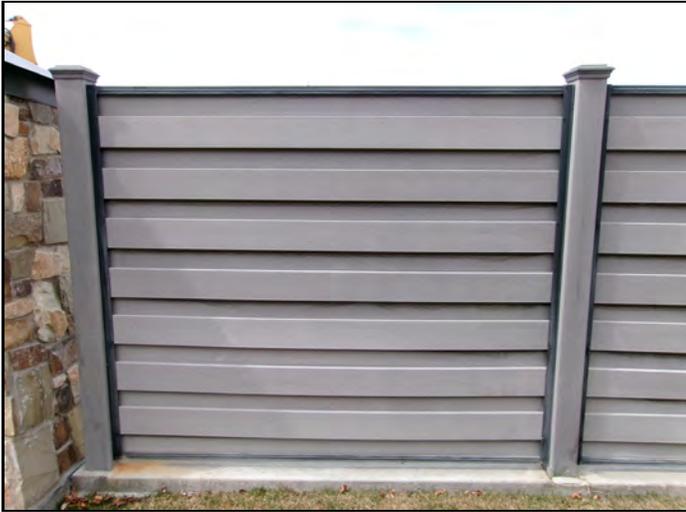
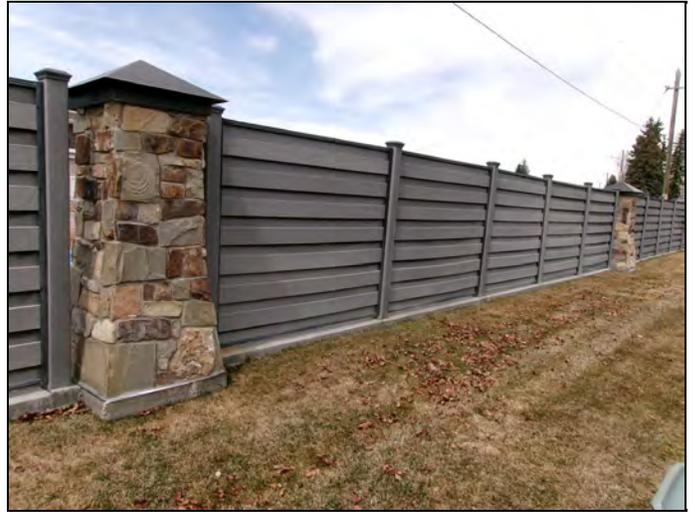
Comp #: 1009 Composite Fencing - Replace

The composite fencing is generally in good condition. We recommend funding to replace this component approximately every 30 - 40 years. Remaining life based on current age.
