Legacy Beach HOA

Level 1 Reserve Study

Report Period – 01/01/2026 – 12/31/2026

Type of Study	Full Study
Date of Property Inspection	1/7/2025
Prepared By	Dale Gifford
Analysis Method	Cash Flow
Funding Goal	Full Funding

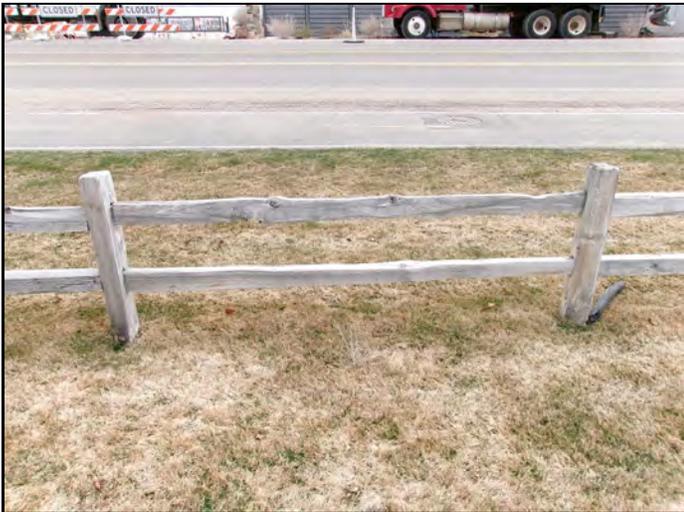
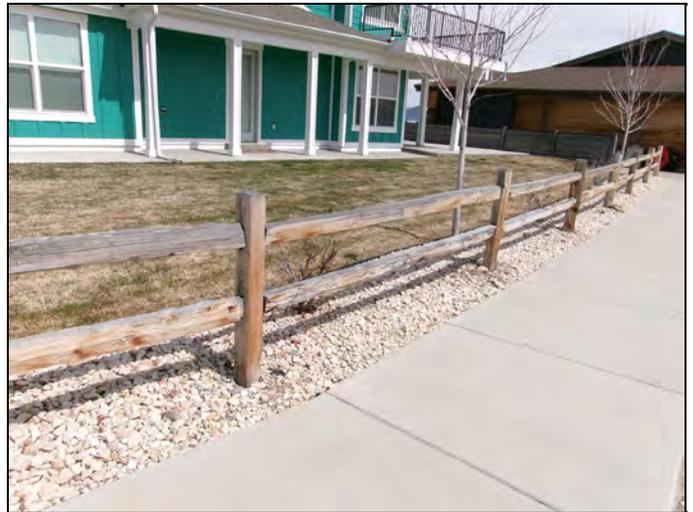
Comp #: 1009 Split Rail Fencing - Replace

The split rail fence appears to be in fair condition. We recommend funding to replace this component approximately every 25 - 30 years. Remaining life based on current age.

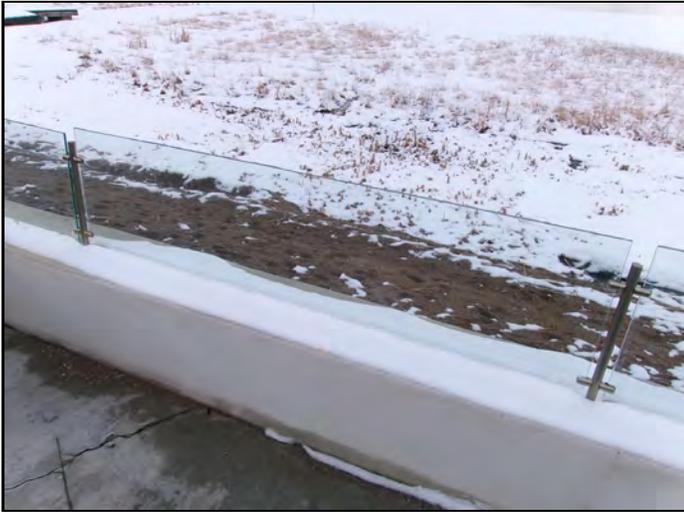
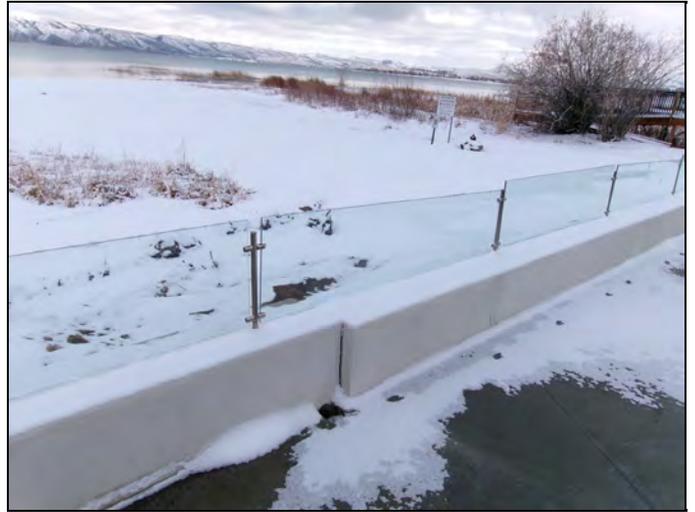
Comp #: 1090 Glass Railing - Replace

The glass railing is in good condition. We recommend funding to replace this component approximately every 40 - 50 years. Remaining life based on current age.

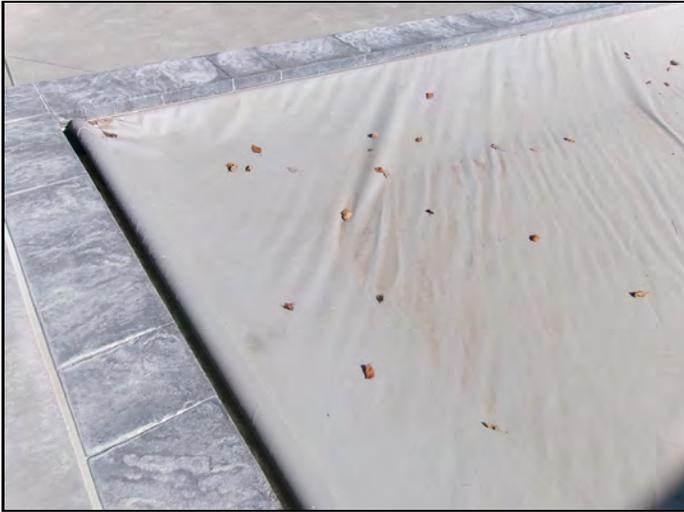
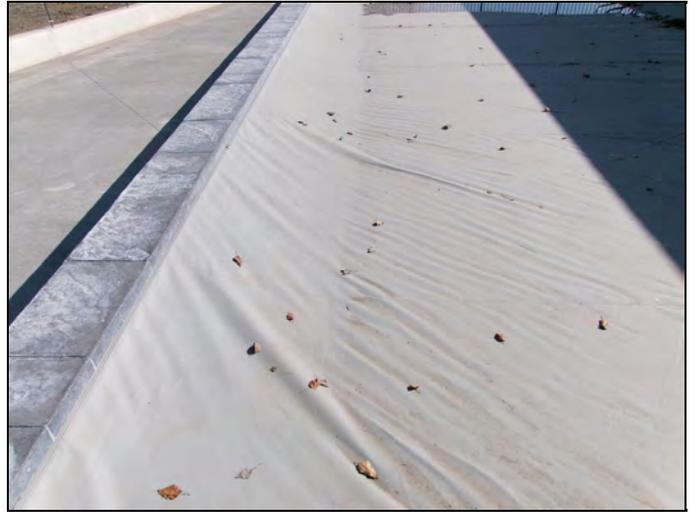
Comp #: 1101 East Pool - Resurface

Unable to inspect this component at the time of the site visit. We recommend funding to resurface this component every 10 - 12 years. Remaining life based on current age.

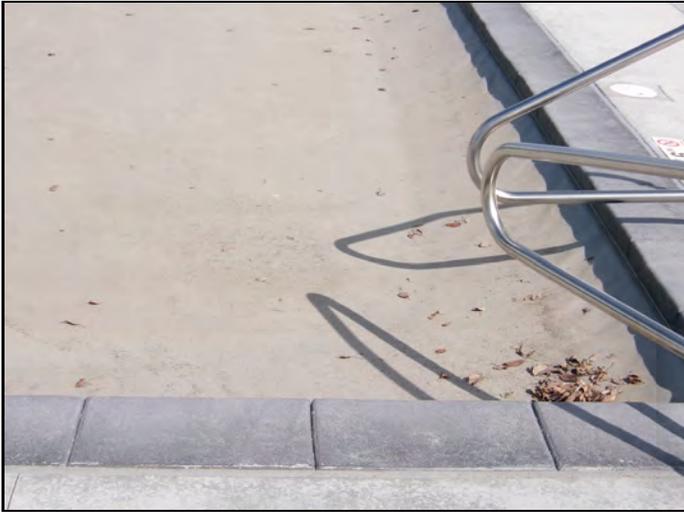
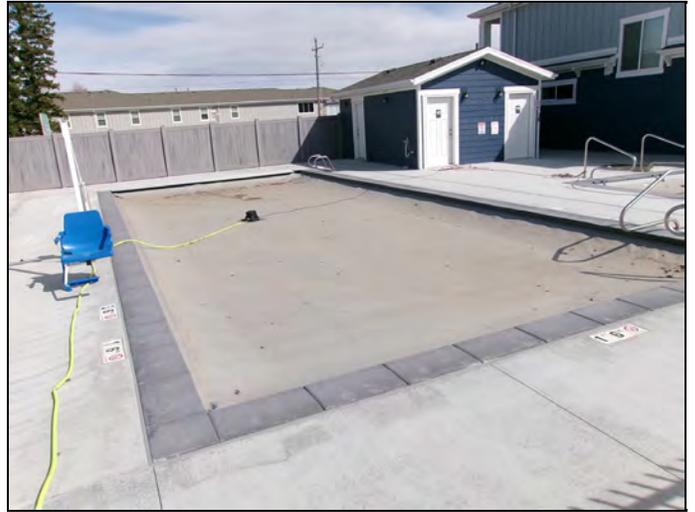
Comp #: 1101 West Pool - Resurface

Unable to inspect this component at the time of the site visit. We recommend funding to resurface this component every 10 - 12 years. Remaining life based on current age.

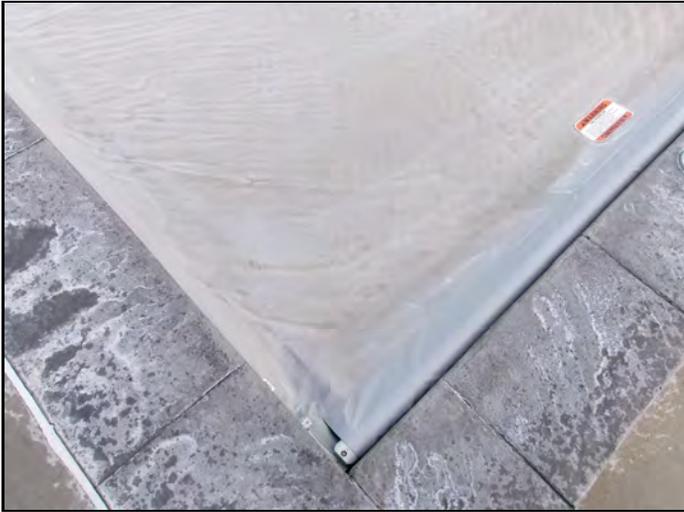
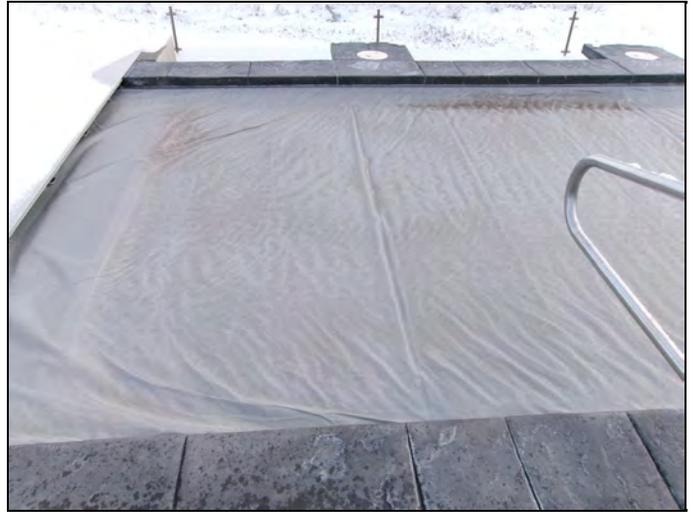
Comp #: 1102 East Spa - Resurface

Unable to inspect this component at the time of the site visit. We recommend funding to resurface this component every 10 - 12 years. Remaining life based on current age.

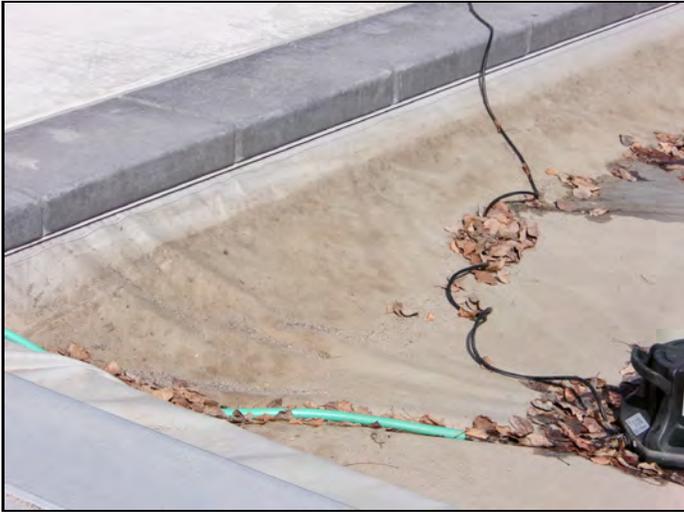
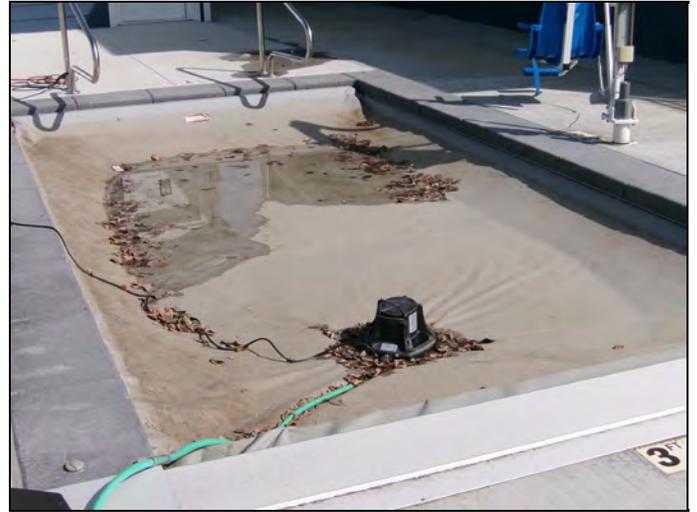
Comp #: 1102 West Spa - Resurface

Unable to inspect this component at the time of the site visit. We recommend funding to resurface this component every 10 - 12 years. Remaining life based on current age.

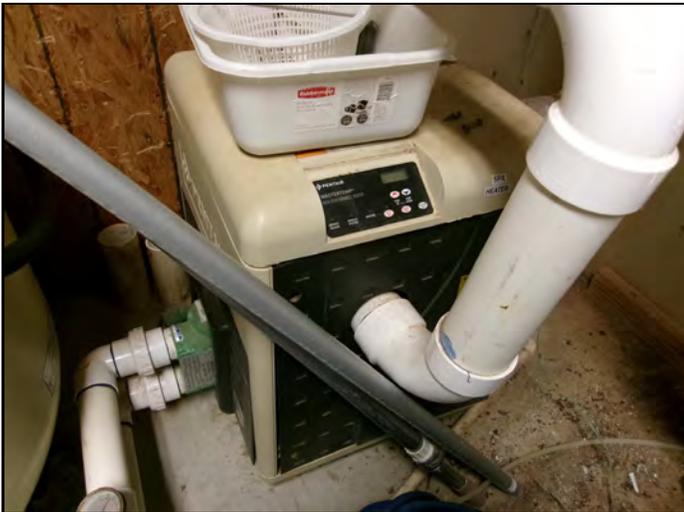
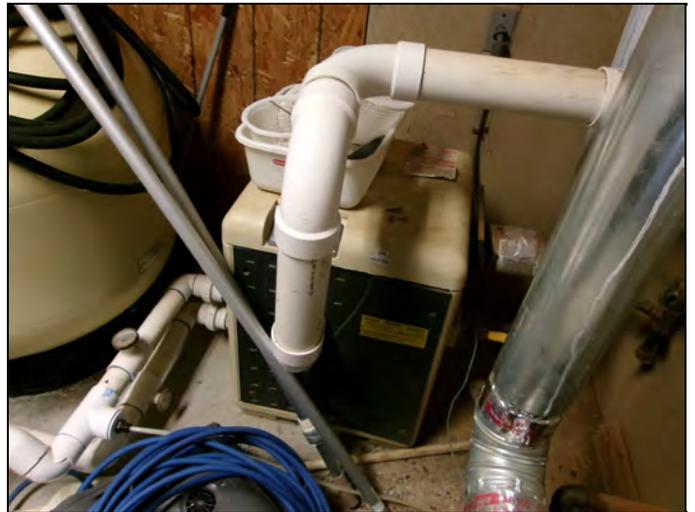
Comp #: 1104 East Pool Heater - Replace

The pool heater is in working condition. We recommend funding to replace this component approximately every 12 years. Remaining life based on current age.

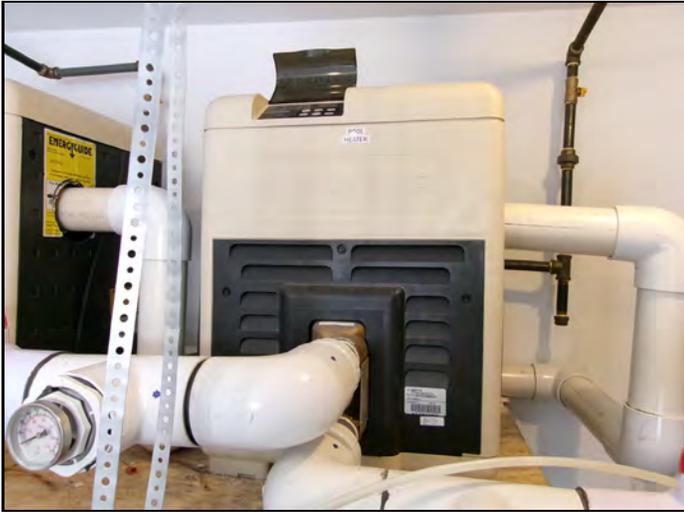
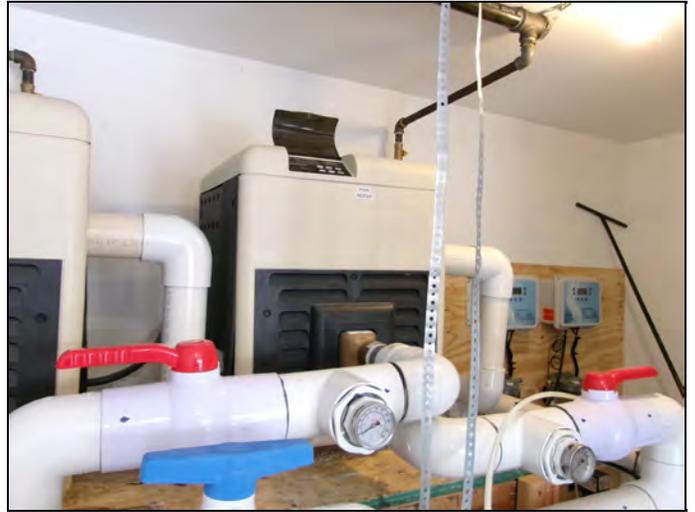
Comp #: 1104 West Pool Heater - Replace

The pool heater is in working condition. We recommend funding to replace this component approximately every 12 years. Remaining life based on current age.

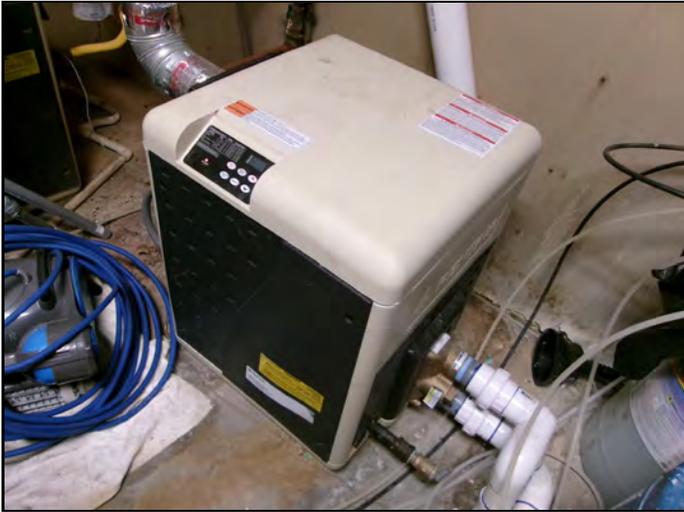
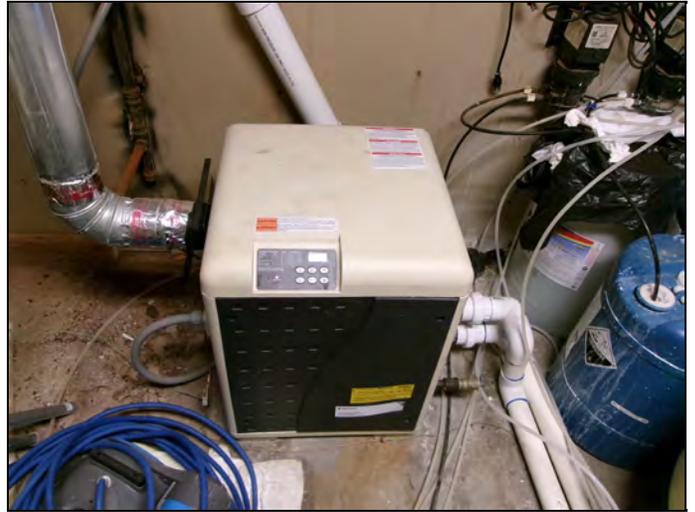
Comp #: 1105 East Spa Heater - Replace

The spa heater is in working condition. We recommend funding to replace this component approximately every 12 years. Remaining life is based on current age.

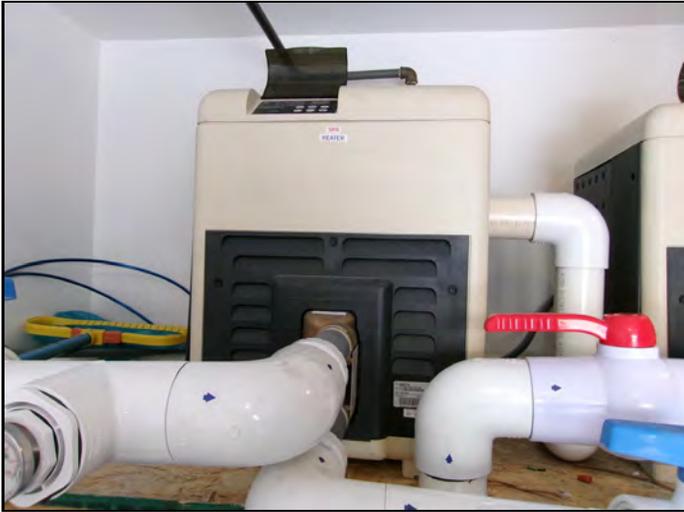
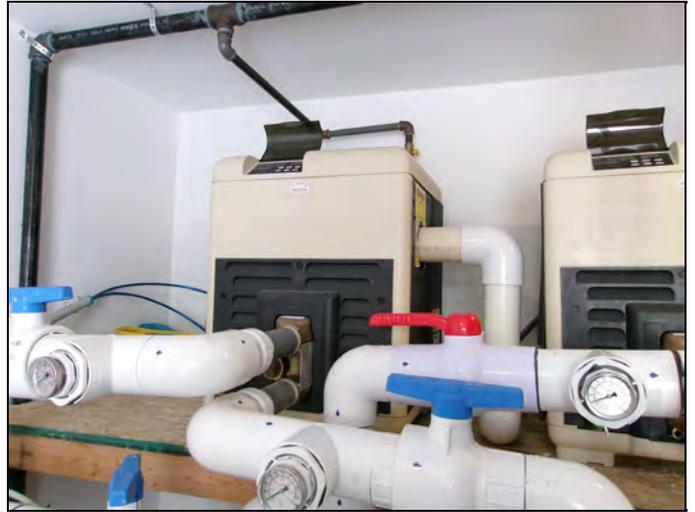
Comp #: 1105 West Spa Heater - Replace

The spa heater is in working condition. We recommend funding to replace this component approximately every 12 years. Remaining life is based on current age.

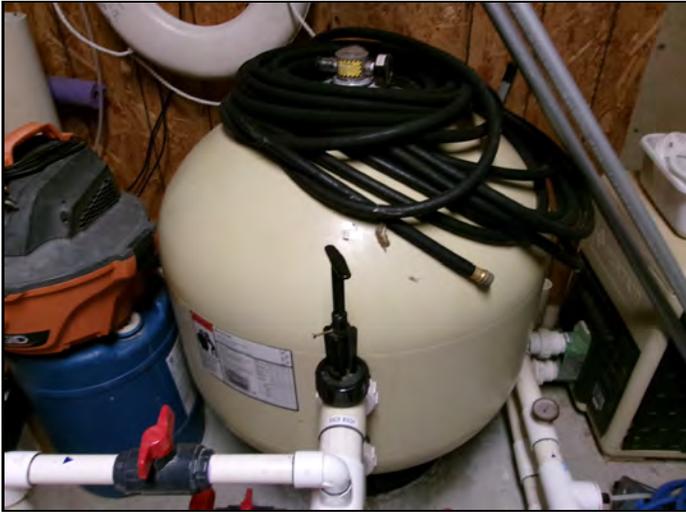
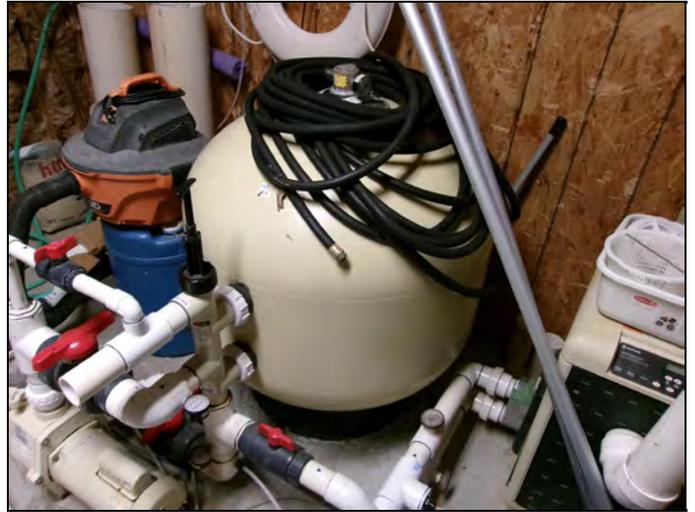
Comp #: 1107 East Pool Filter - Replace

The pool filter is in working condition. We recommend funding to replace this component approximately every 12 - 15 years. Remaining life based on current age.

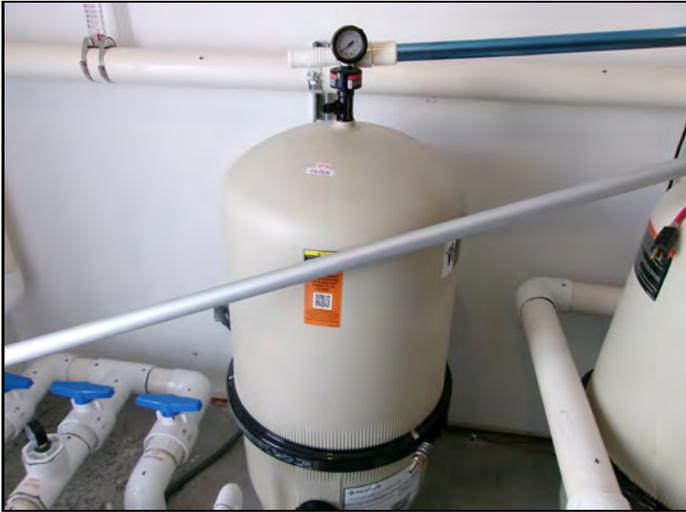
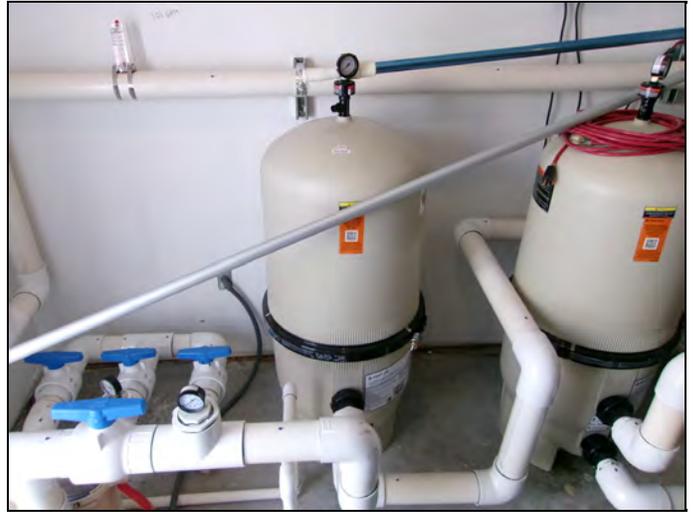
Comp #: 1107 West Pool Filter - Replace

The pool filter is in working condition. We recommend funding to replace this component approximately every 12 - 15 years. Remaining life based on current age.

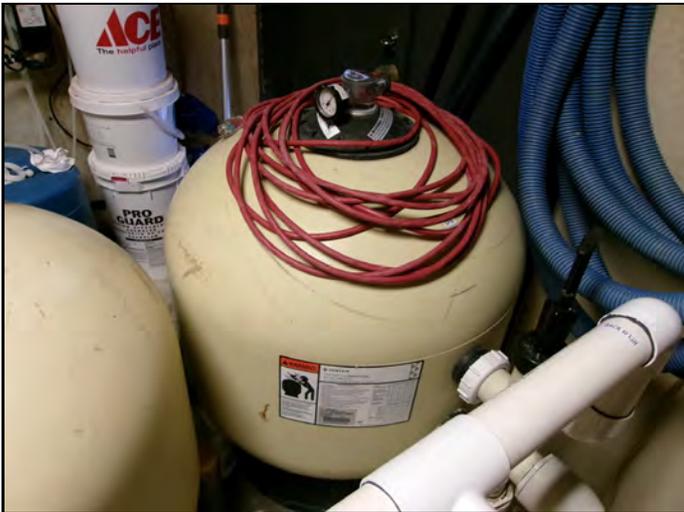
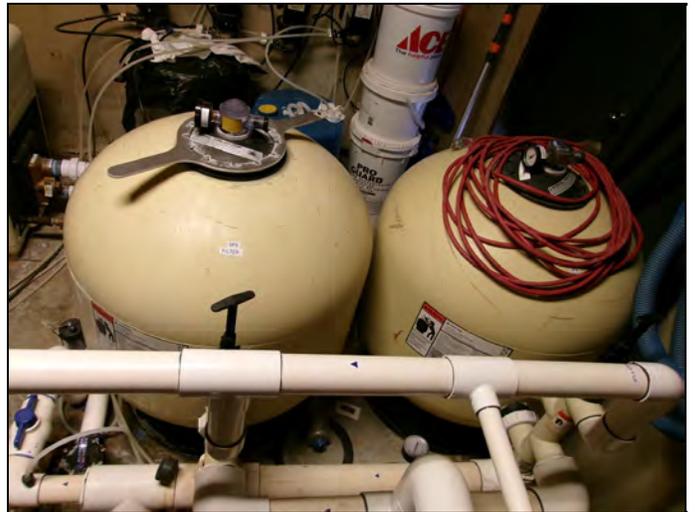
Comp #: 1108 East Spa Filters - Replace

The spa filters are in working condition. We recommend funding to replace this component approximately every 12 - 15 years. Remaining life based on current age.

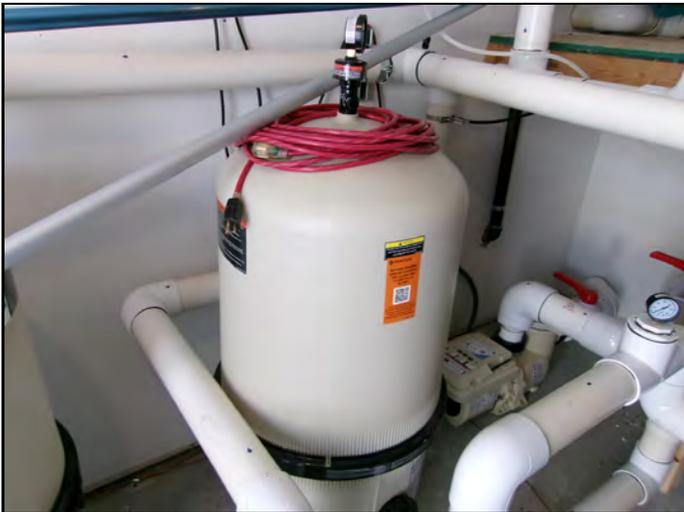
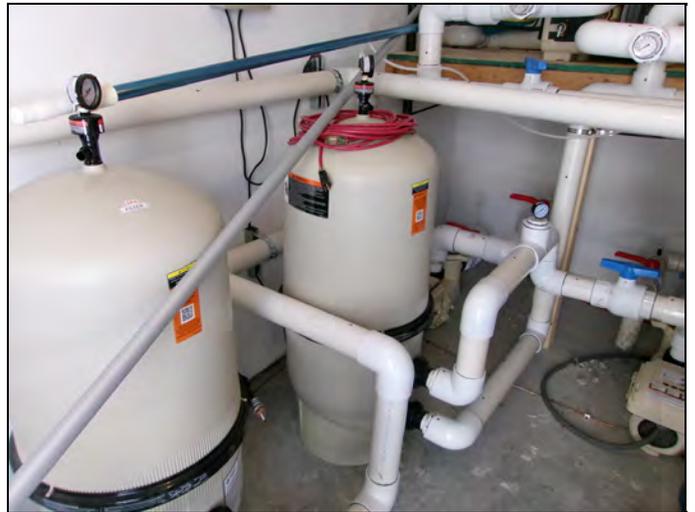
Comp #: 1108 West Spa Filter - Replace

The spa filter is in working condition. We recommend funding to replace this component approximately every 12 - 15 years. Remaining life based on current age.

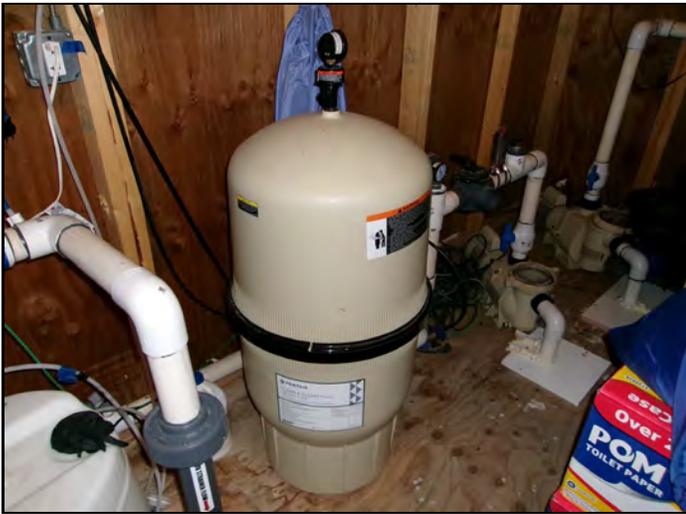
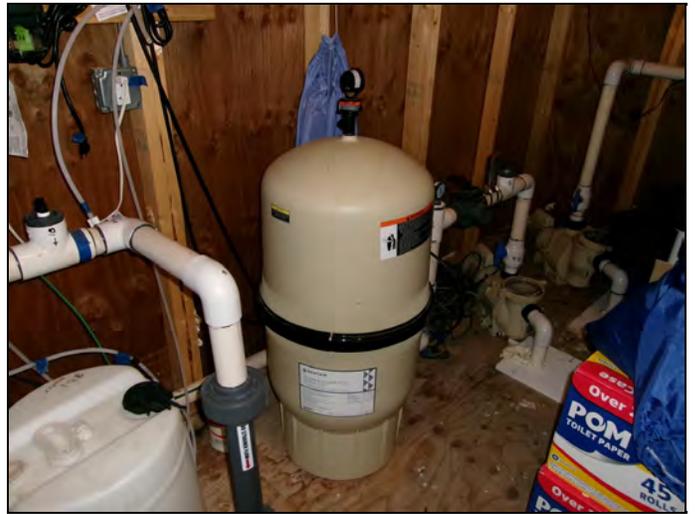
Comp #: 1109 Splash Pad Filter - Replace

The splash pad filter is in working condition. We recommend funding to replace this component approximately every 12 - 15 years. Remaining life based on current age.

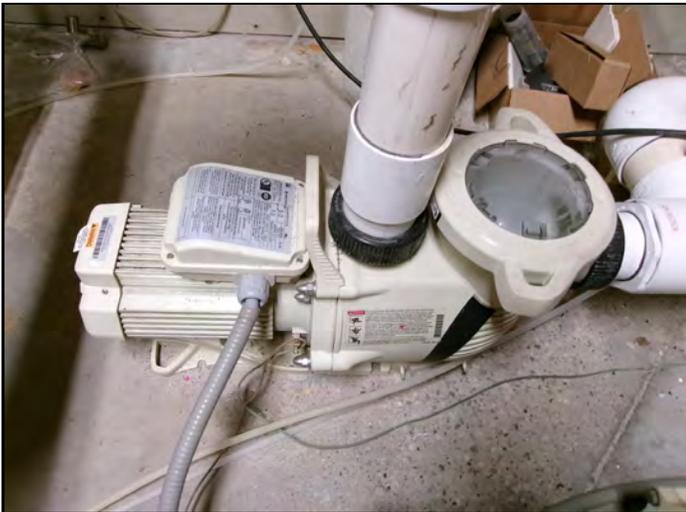
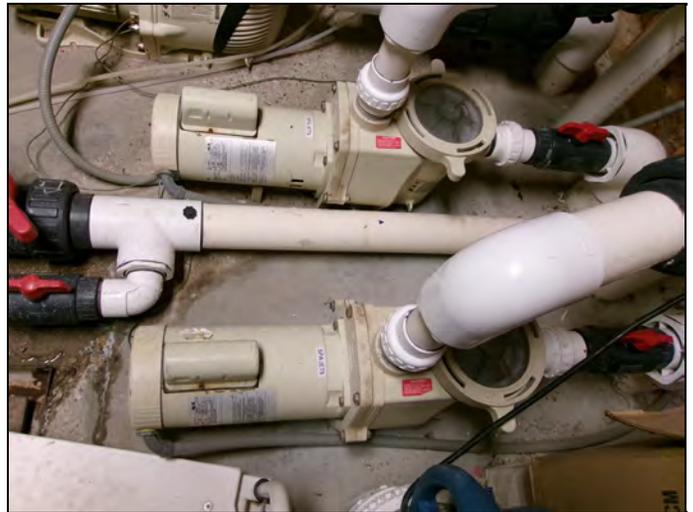
Comp #: 1110 East Pool & Spa Pumps - Replace

The pumps are in working condition. We recommend funding to replace this component approximately every 8 - 10 years. Remaining life based on current age.

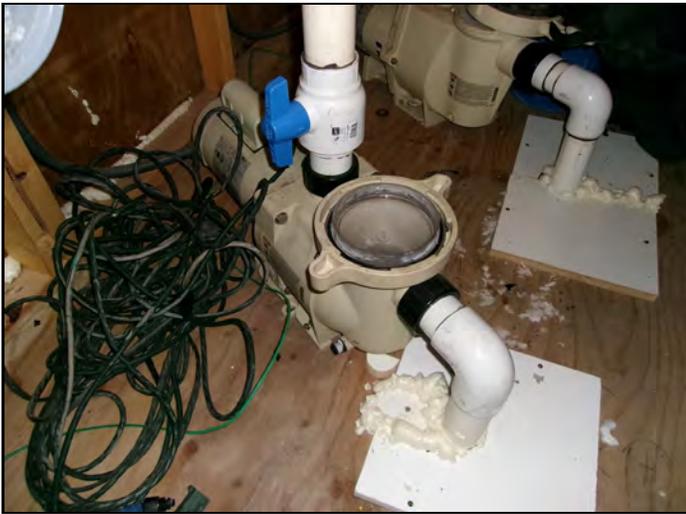
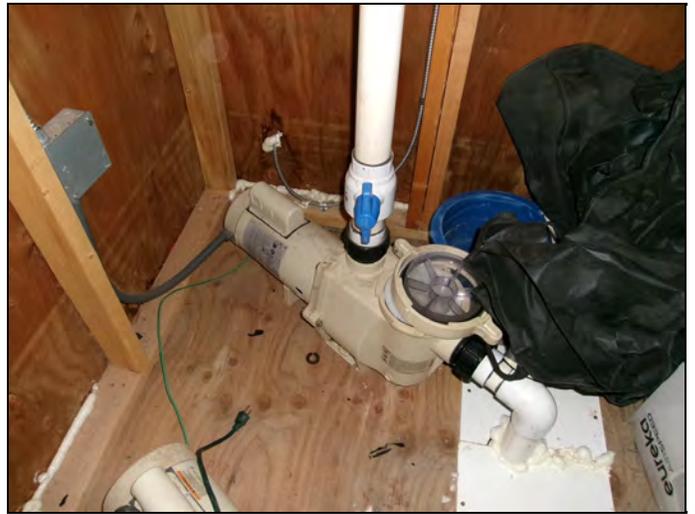
Comp #: 1110 Splash Pad Pumps - Replace

The pumps are in working condition. We recommend funding to replace this component approximately every 8 - 10 years. Remaining life based on current age.

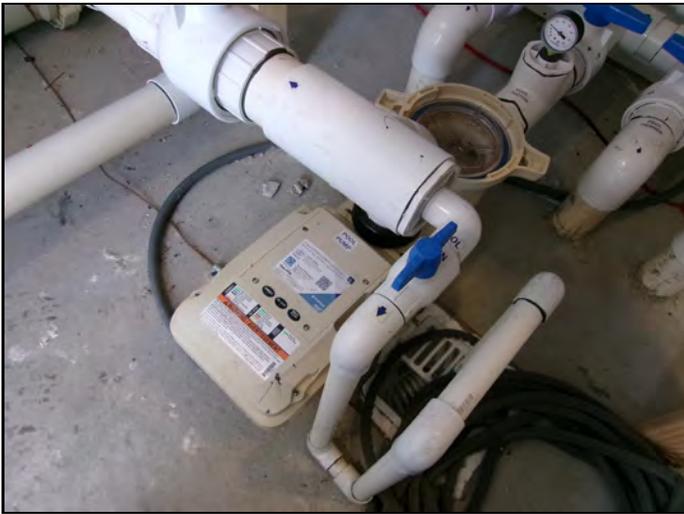
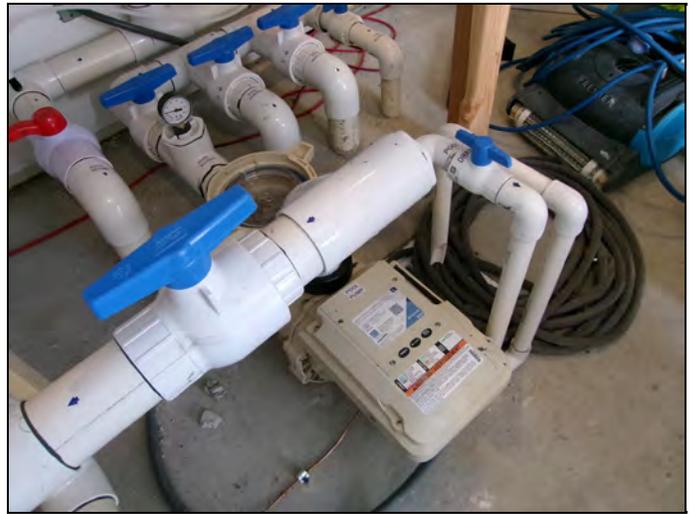
Comp #: 1110 West Pool & Spa Pumps - Replace

The pumps are in working condition. We recommend funding to replace this component approximately every 8 - 10 years. Remaining life based on current age.

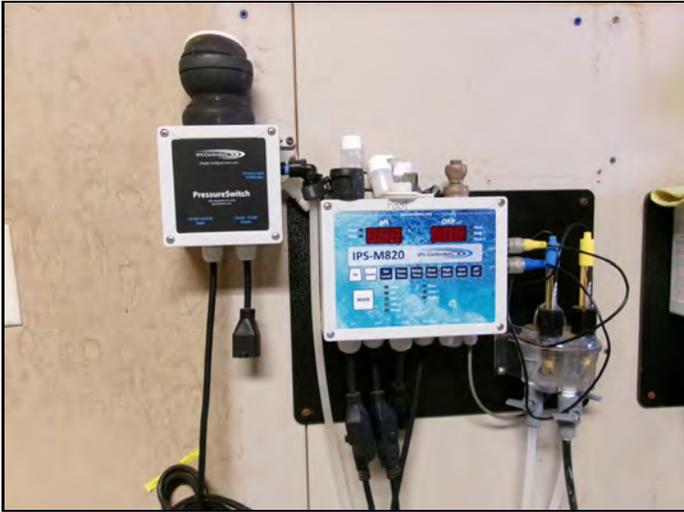
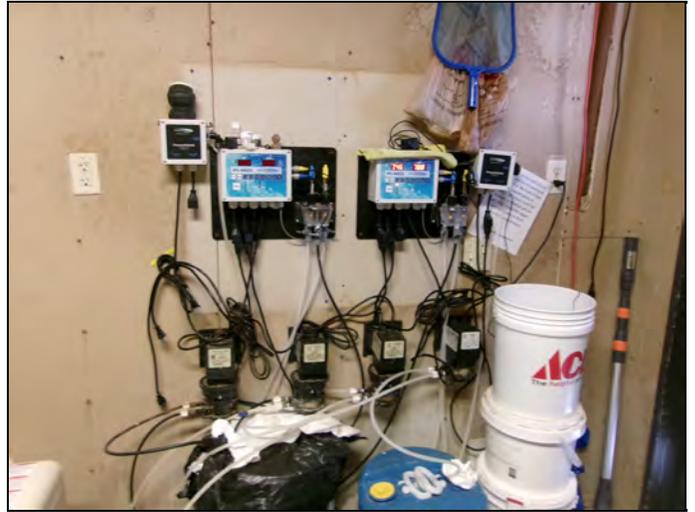
Comp #: 1111 East Chemical Controller Systems - Replace

The chemical controller systems are in working condition. We recommend funding to replace this component approximately every 10 - 12 years. Remaining life based on current age.

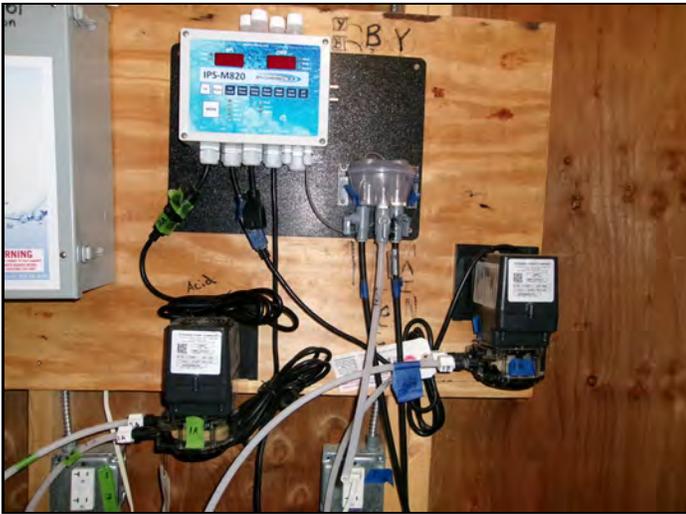
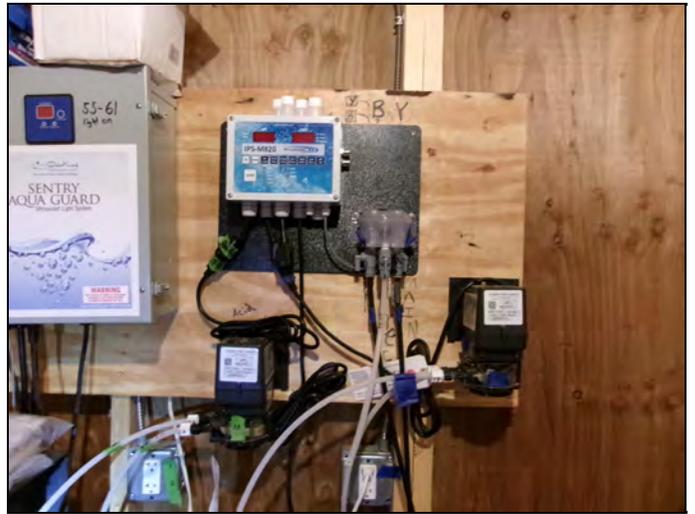
Comp #: 1111 Splash Pad Chemical Controller Sys. - Replace

The chemical controller system is in working condition. We recommend funding to replace this component approximately every 10 - 12 years. Remaining life based on current age.

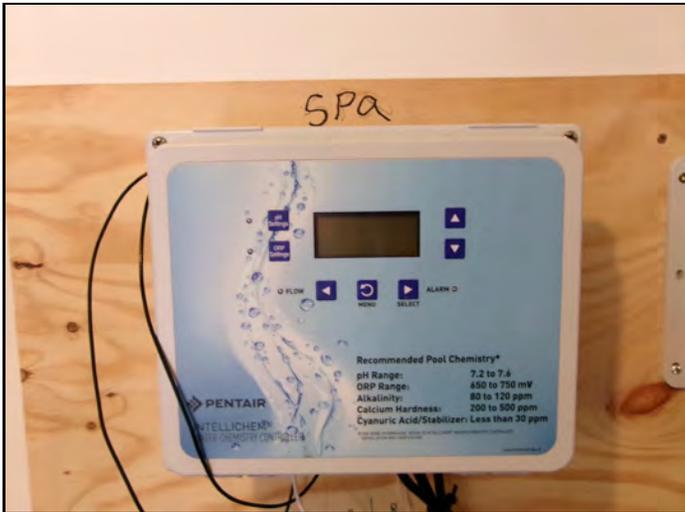
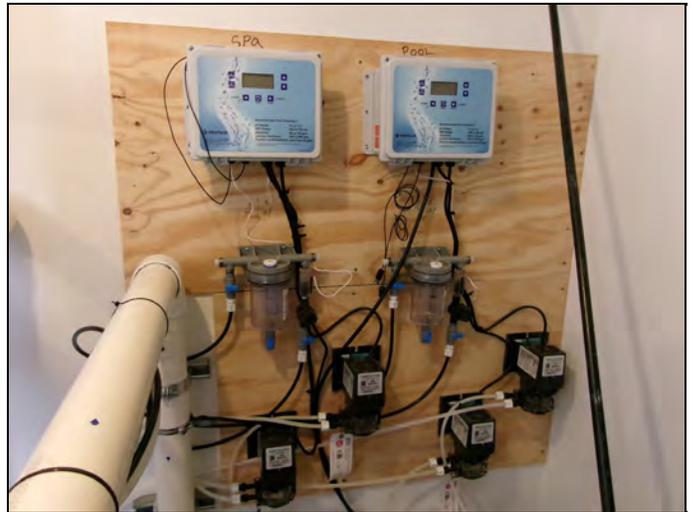
Comp #: 1111 West Chemical Controller System - Replace

The chemical controller systems are in working condition. We recommend funding to replace this component approximately every 10 - 12 years. Remaining life based on current age.

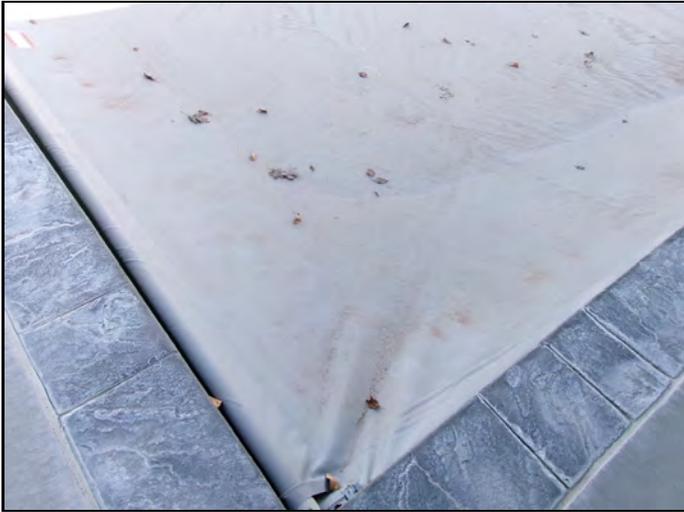
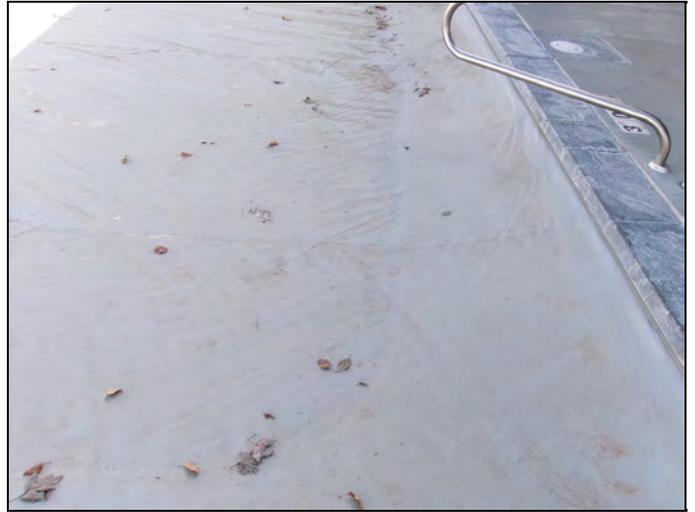
Comp #: 1112 East Pool Cover - Replace

The pool cover appears to be in good condition. We recommend funding to replace this component approximately every 10 years. Remaining life based on current age.

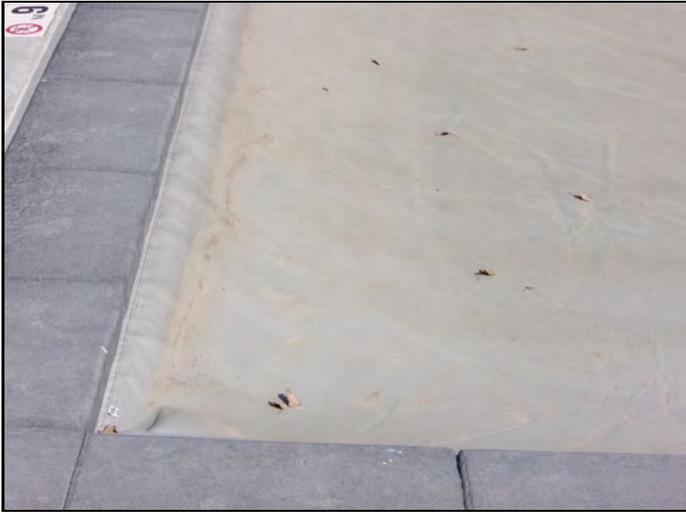
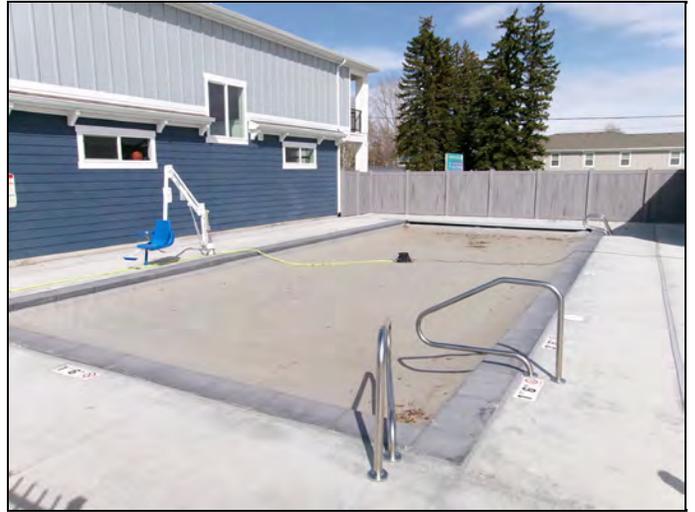
Comp #: 1112 West Pool Cover - Replace

The pool cover appears to be in good condition. We recommend funding to replace this component approximately every 10 years. Remaining life based on current age.

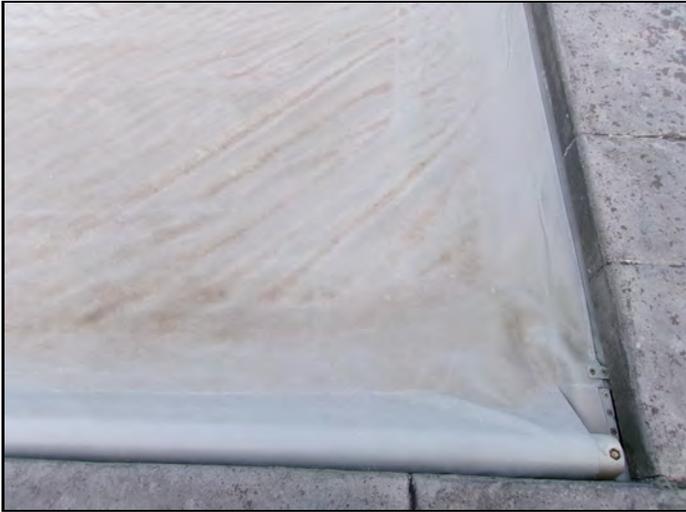
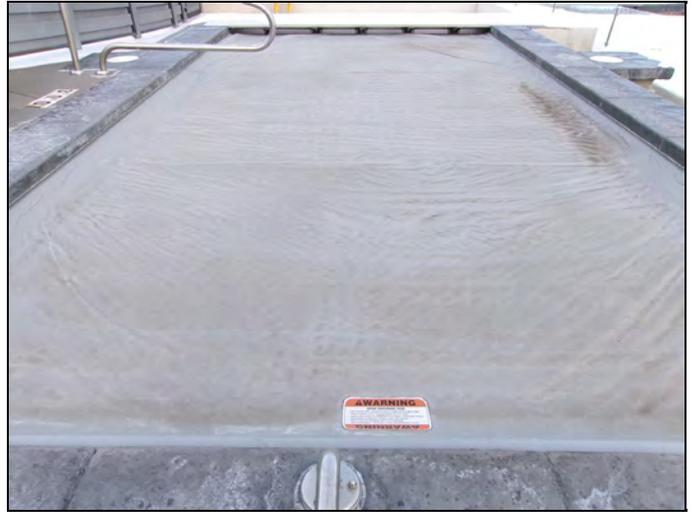
Comp #: 1113 East Spa Cover - Replace

The spa cover appears to be in good condition. We recommend funding to replace this component approximately every 10 years. Remaining life based on current age.

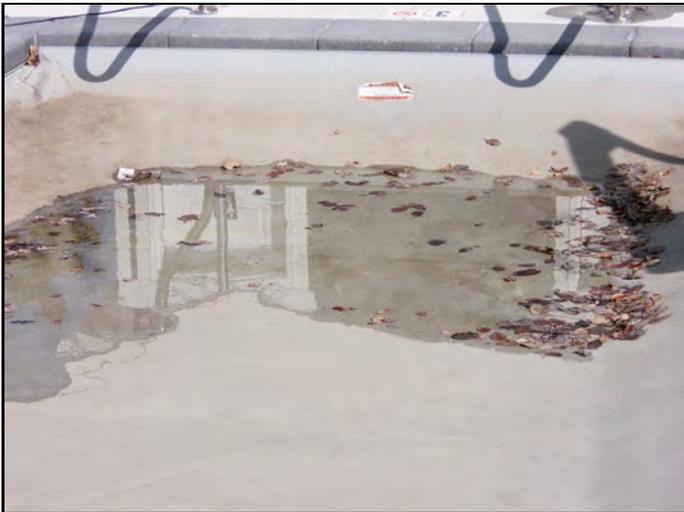
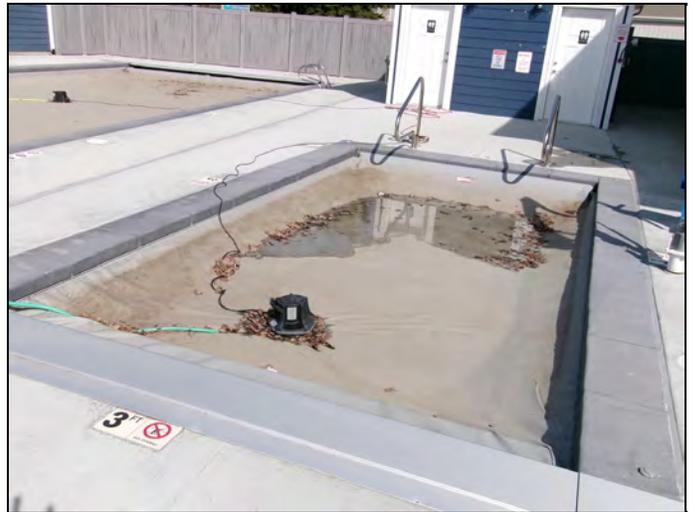
Comp #: 1113 West Spa Cover - Replace

The spa cover appears to be in good condition. We recommend funding to replace this component approximately every 10 years. Remaining life based on current age.

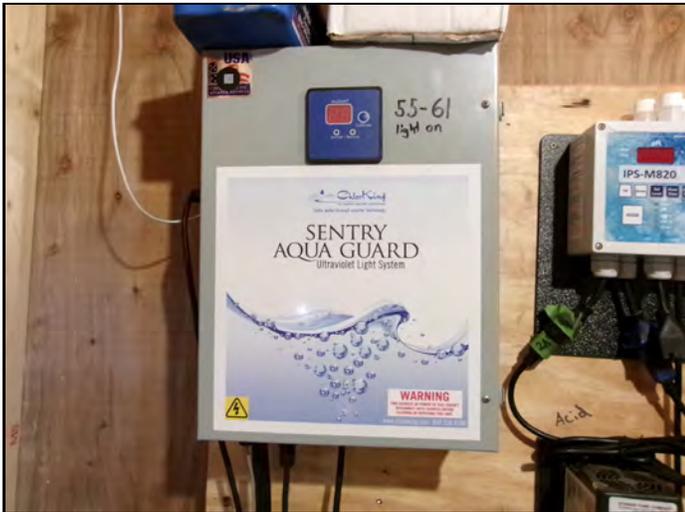
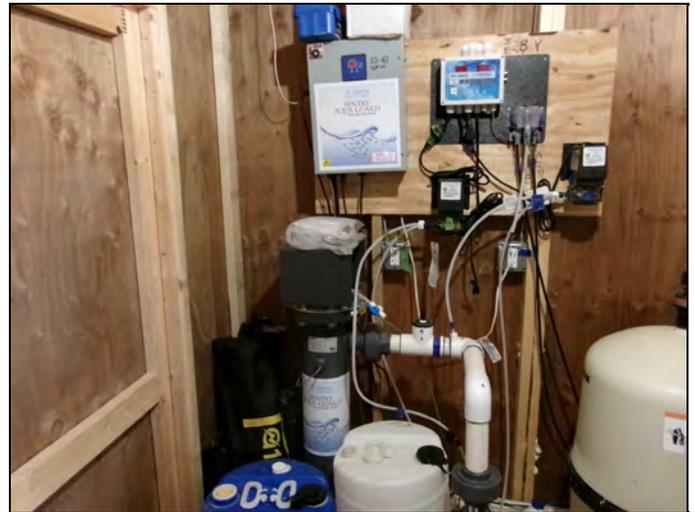
Comp #: 1114 Splash Pad UV System - Replace

The UV system is in working condition. We recommend funding to replace this component approximately every 10 - 15 years. Remaining life based on current age.

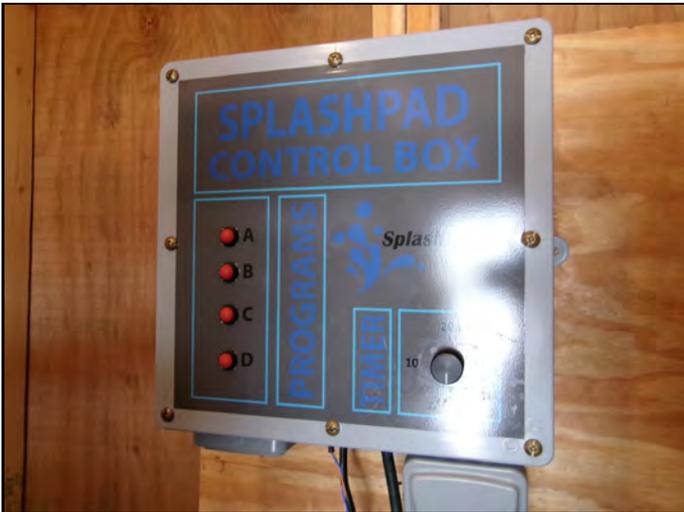
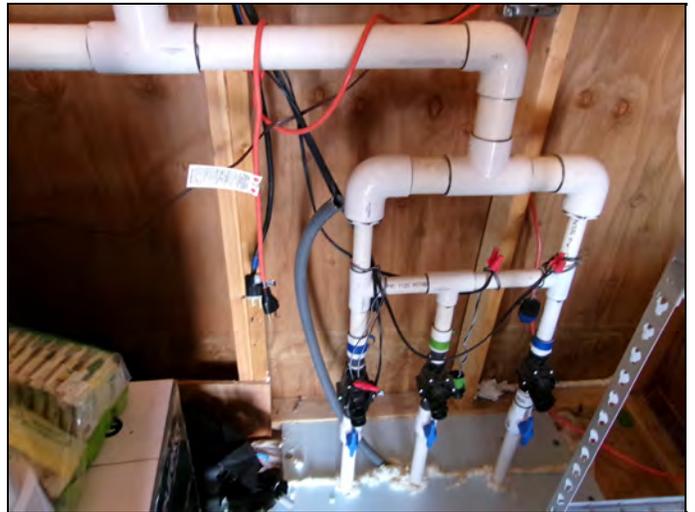
Comp #: 1115 Splash Pad System - Partial Repair/Replace

The splash pad system is in working condition. We recommend funding to partially repair/replace this component approximately every 8 - 10 years. Remaining life based on current age.

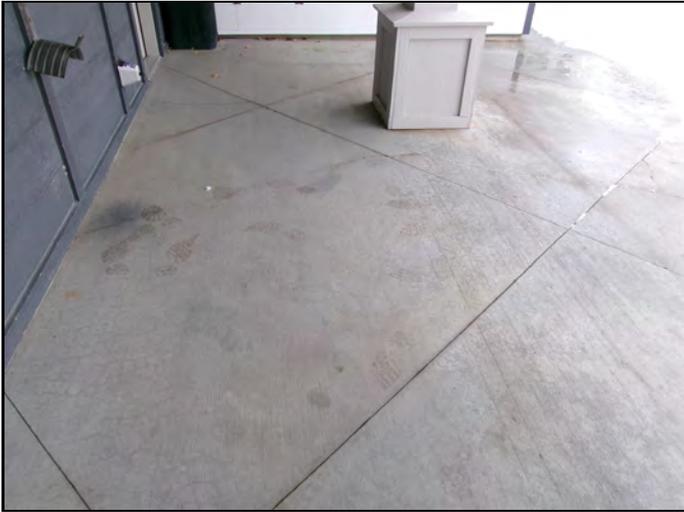
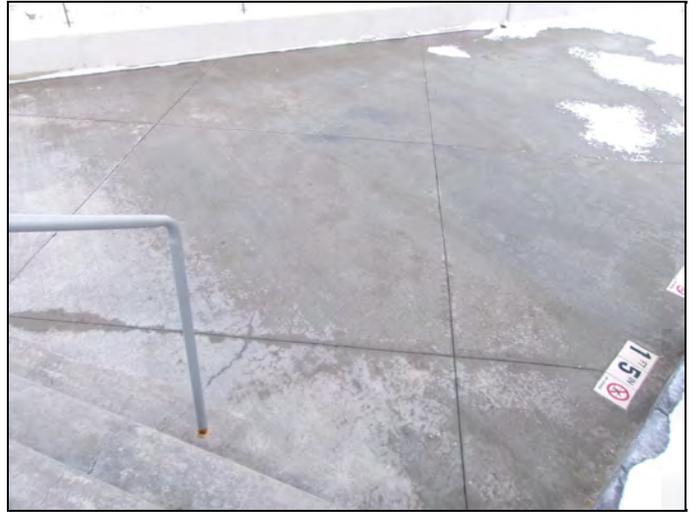
Comp #: 1116 East Pool Deck - Replace

The pool deck is in good condition. We recommend funding to replace this component approximately every 40 - 50 years. Remaining life based on current age.

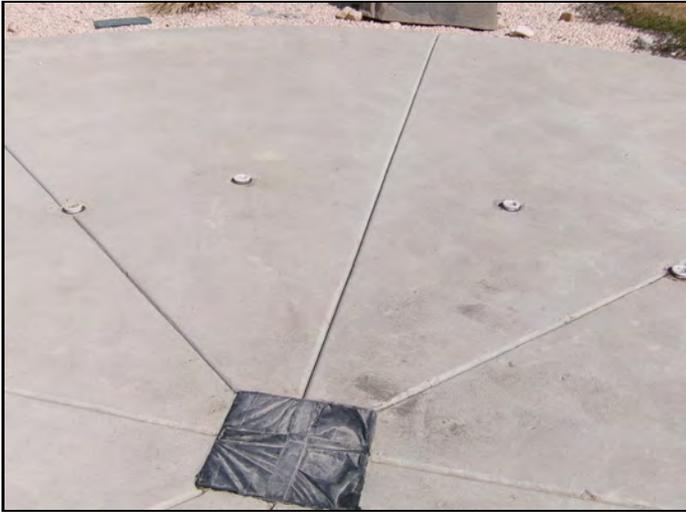
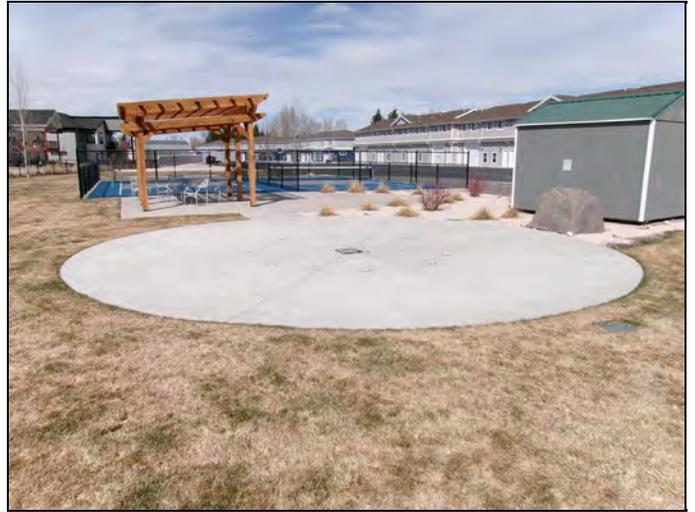
Comp #: 1116 Splash Pad Deck - Replace

The splash pad deck is in good condition. We recommend funding to replace this component approximately every 40 - 50 years. Remaining life based on current age.

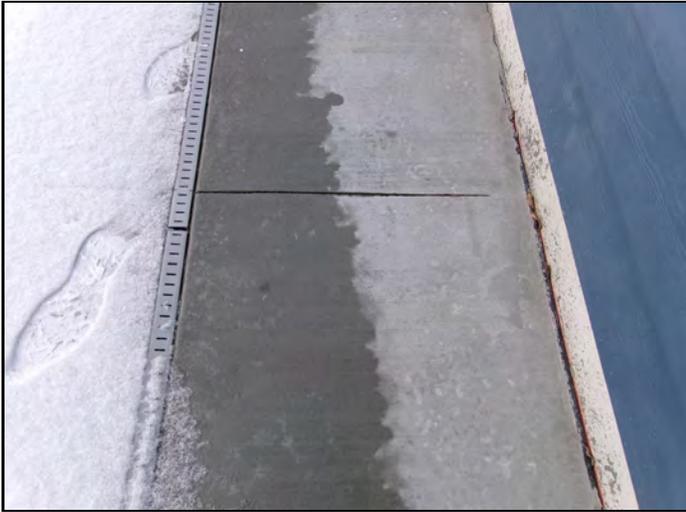
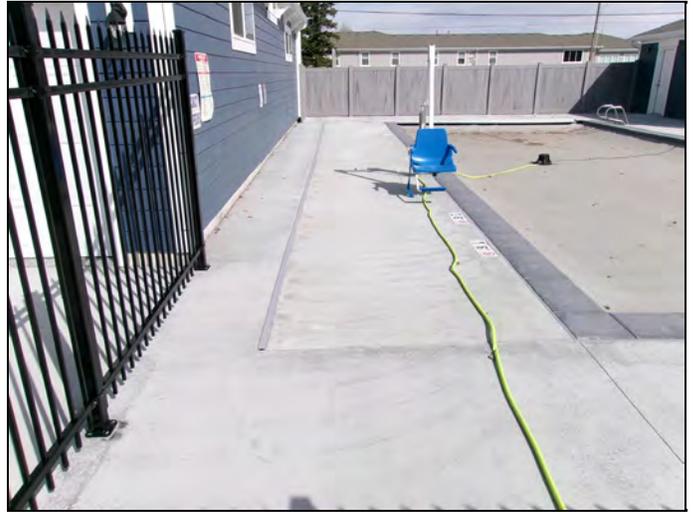
Comp #: 1116 West Pool Deck - Replace

The pool deck is in good condition. We recommend funding to replace this component approximately every 40 - 50 years. Remaining life based on current age.
