Legacy Beach HOA

Level 1 Reserve Study

Report Period – 01/01/2026 – 12/31/2026

Type of Study	Full Study
Date of Property Inspection	1/7/2025
Prepared By	Dale Gifford
Analysis Method	Cash Flow
Funding Goal	Full Funding

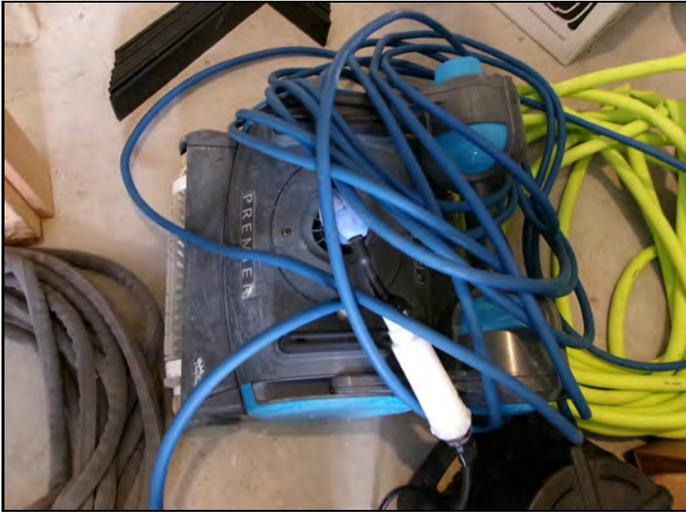
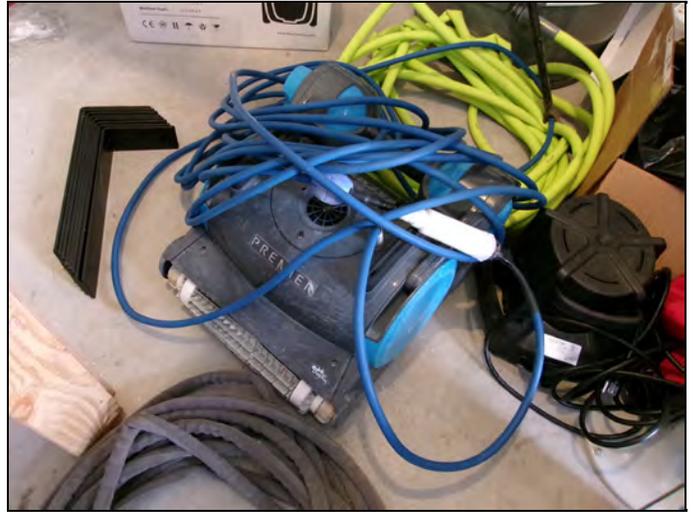
Comp #: 1117 Robotic Pool Vacuum - Replace

Due to the minimal cost of this component, reserve funding is not appropriate. Replace as necessary as an operating expense.

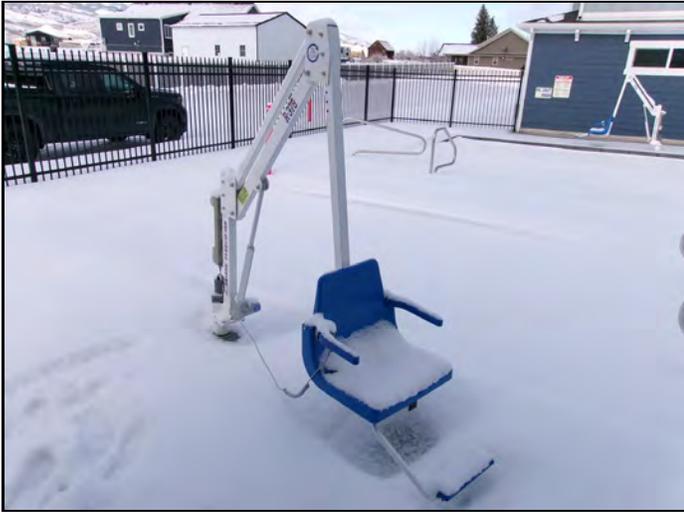
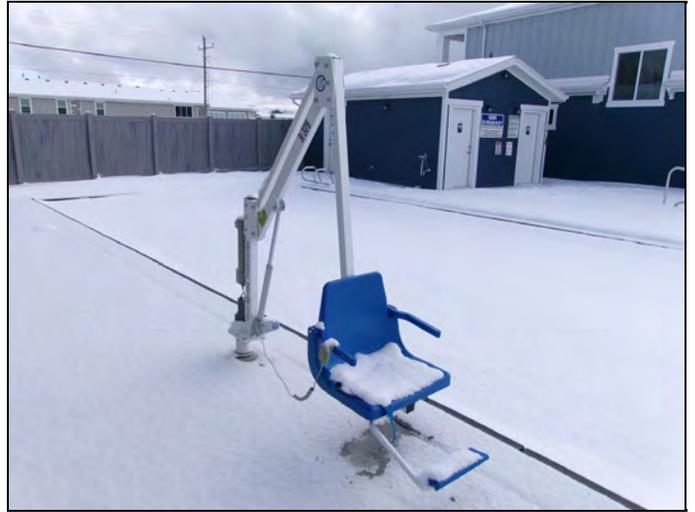
Comp #: 1119 ADA Pool Lifts - Replace

The pool lift appears to be in working condition. We recommend funding to replace this component approximately every 12 - 15 years. Remaining life based on current age.

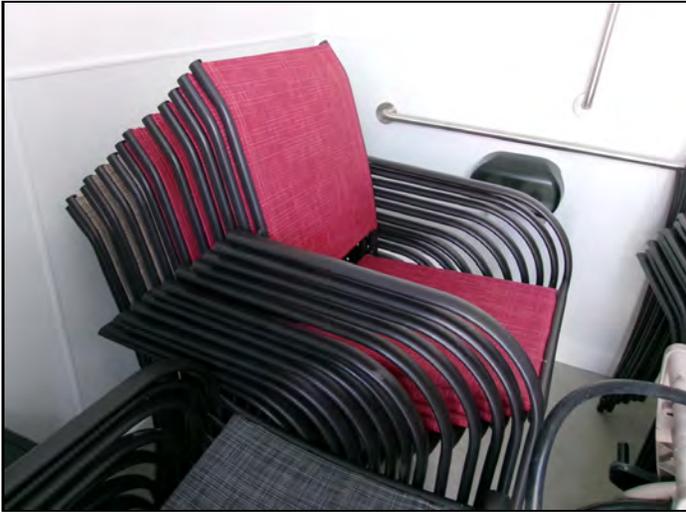
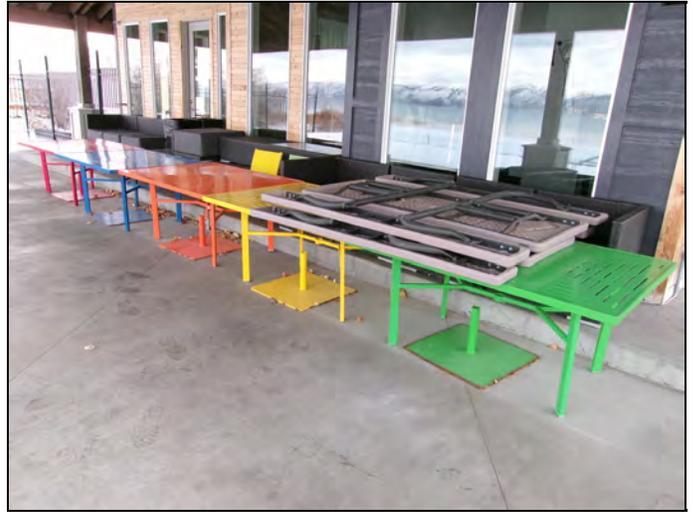
Comp #: 1121 Pool Furniture - Replace

The pool furniture is in fair condition. We recommend funding an allowance to make replacements to this component approximately every 6 years. Remaining life based on current age.

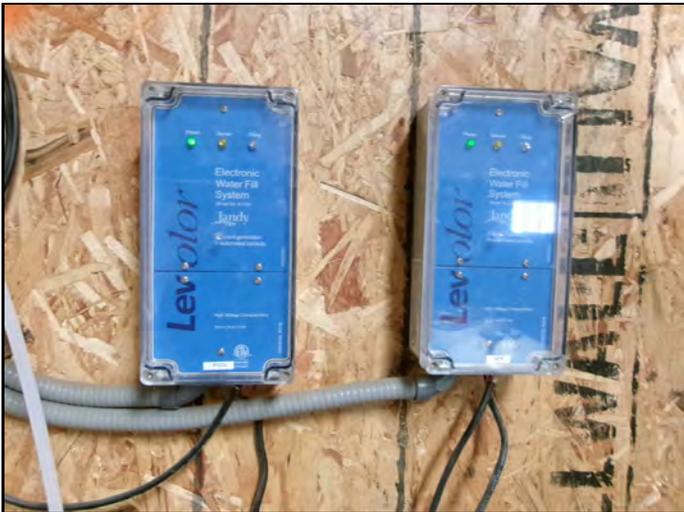
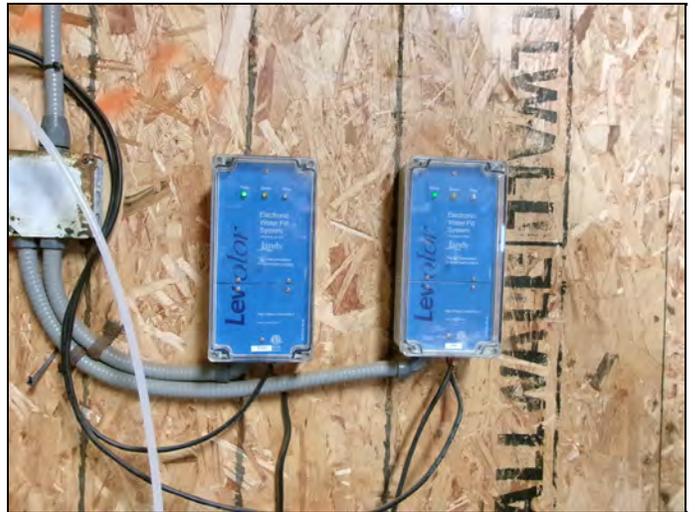
Comp #: 1190 Water Level Controller - Replace

Due to the minimal cost of this component, reserve funding is not appropriate. Replace as necessary as an operating expense.

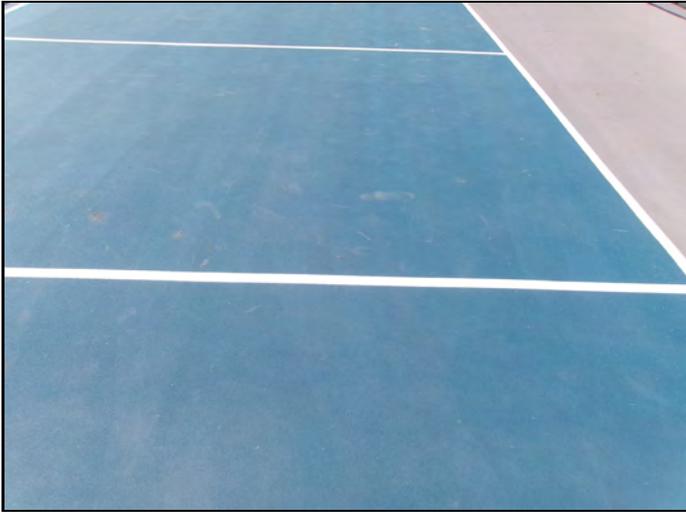
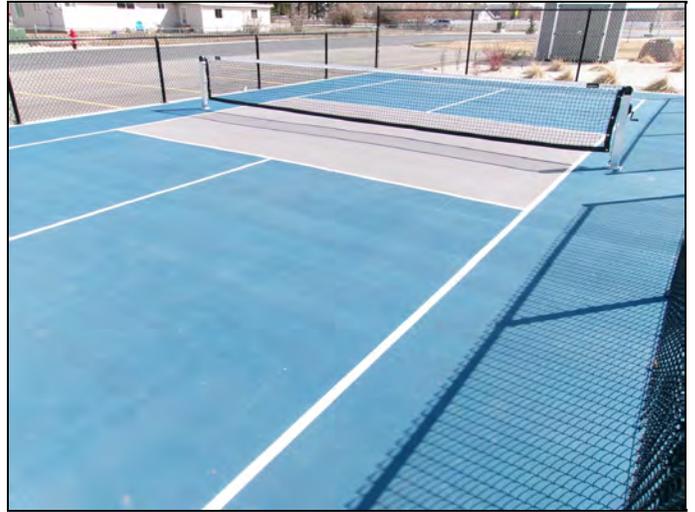
Comp #: 1201 Pickleball Courts - Resurface

The tennis court surface is in good condition. We recommend funding to resurface this component approximately every 8 - 10 years. Remaining life based on current age.

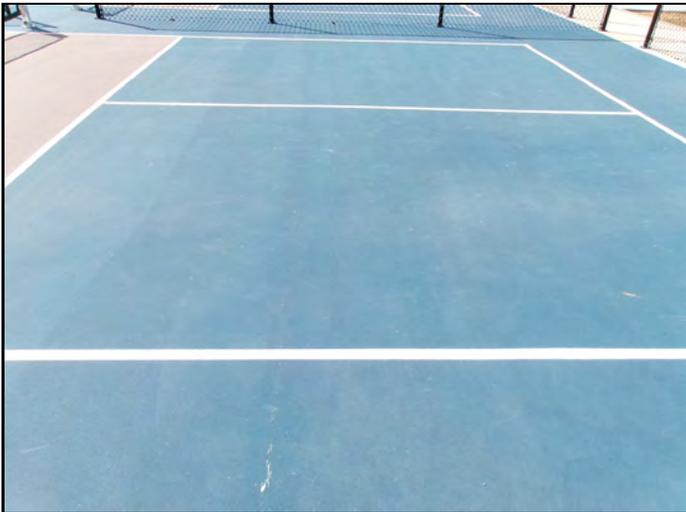
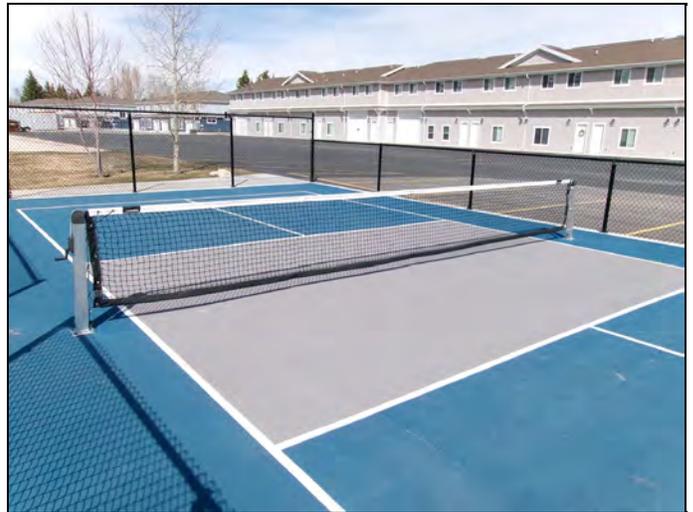
Comp #: 1203 Pickleball Courts - Replace

The pickleball courts are in good condition. We recommend funding to replace this component approximately every 40 - 50 years. Remaining life based on current age.

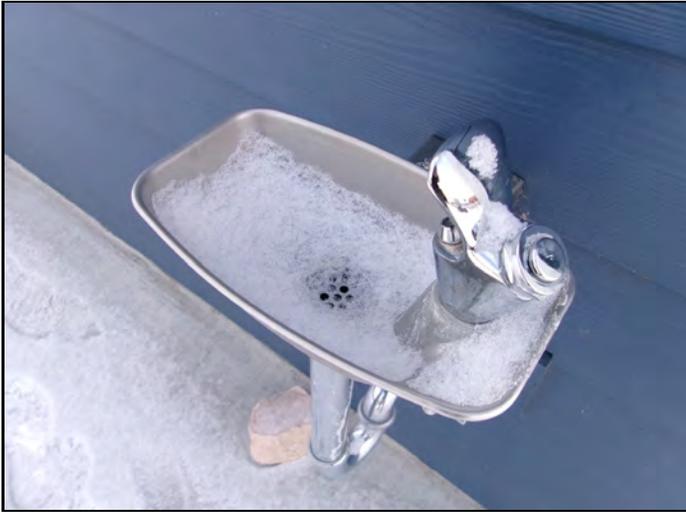
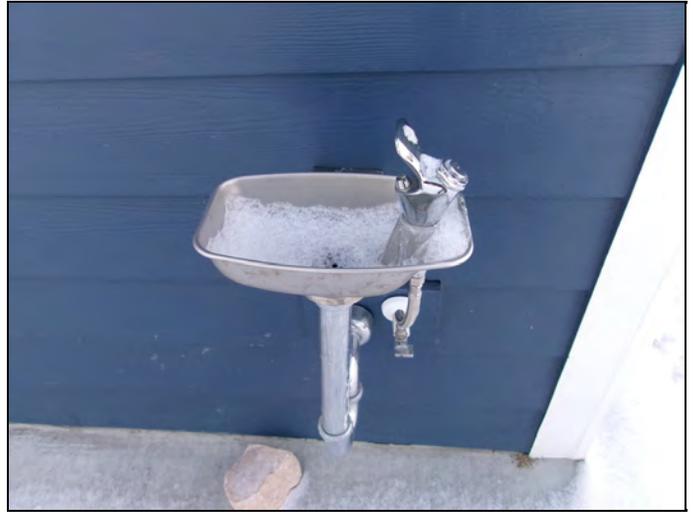
Comp #: 1304 Drinking Fountain - Replace

Due to the minimal cost of replacing this component, reserve funding is not appropriate. Replace as necessary as an operating expense.

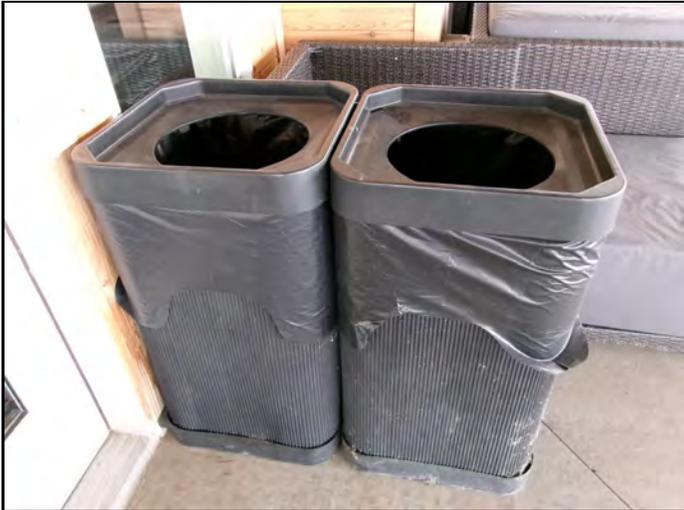
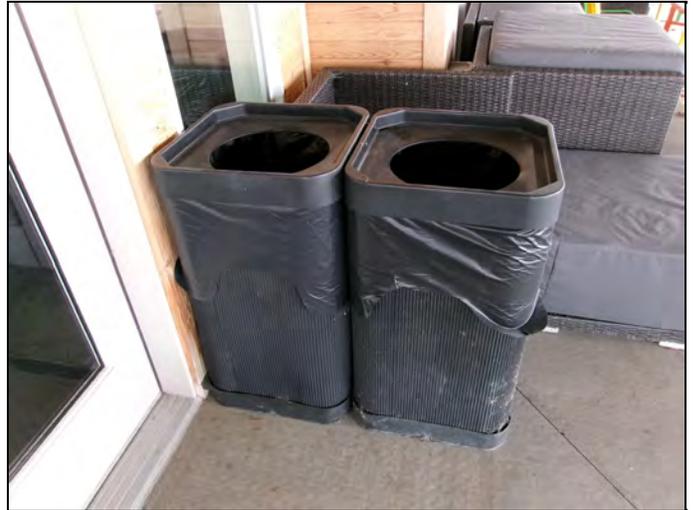
Comp #: 1308 Trash Receptacle - Replace

Due to the minimal cost of replacing this component, reserve funding is not appropriate. Replace as necessary as an operating expense.

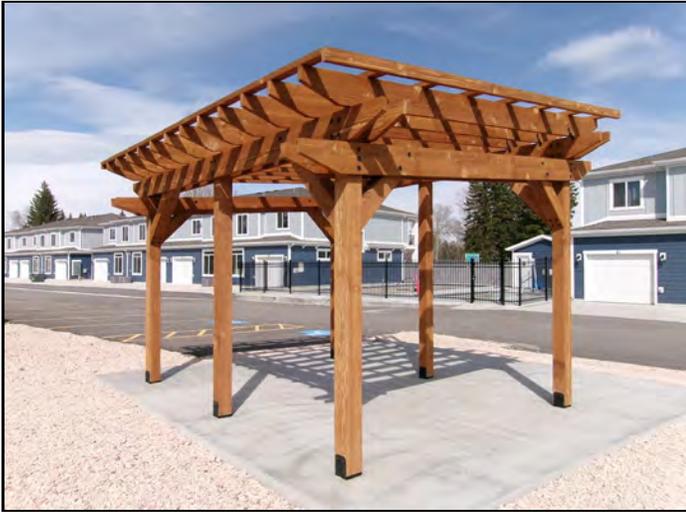
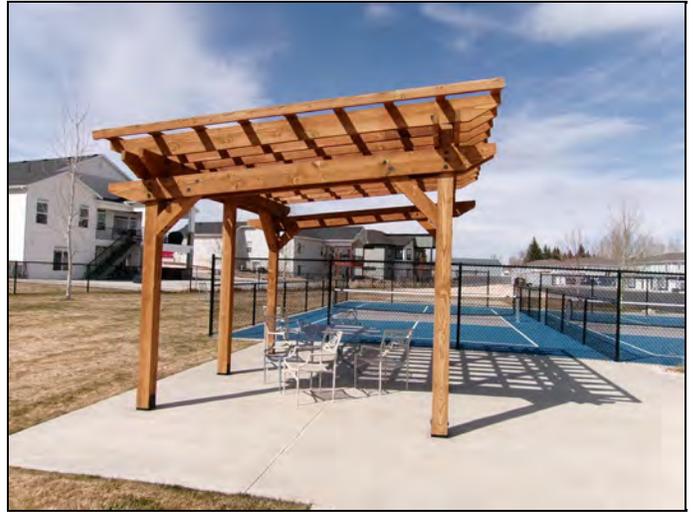
Comp #: 1309 West Pergolas - Replace

The pergolas are in good condition. We recommend funding to replace this component approximately every 25 - 30 years. Remaining life based on current age.

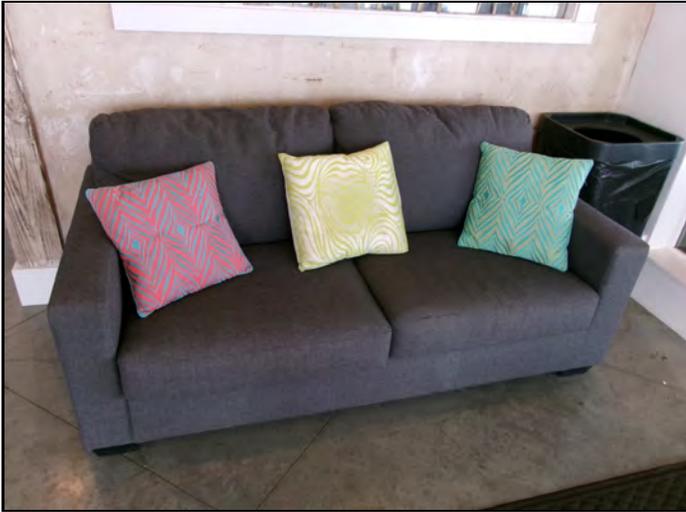
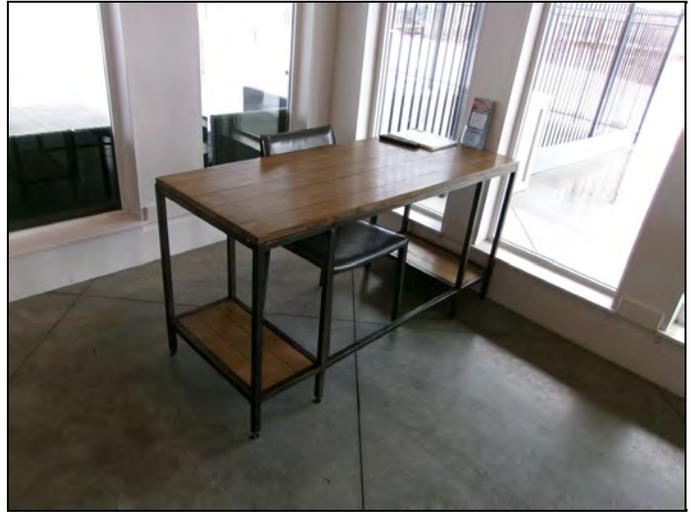
Comp #: 1405 Furniture - Replace

Due to the minimal cost of replacing this component, reserve funding is not appropriate. Replace as necessary as an operating expense.

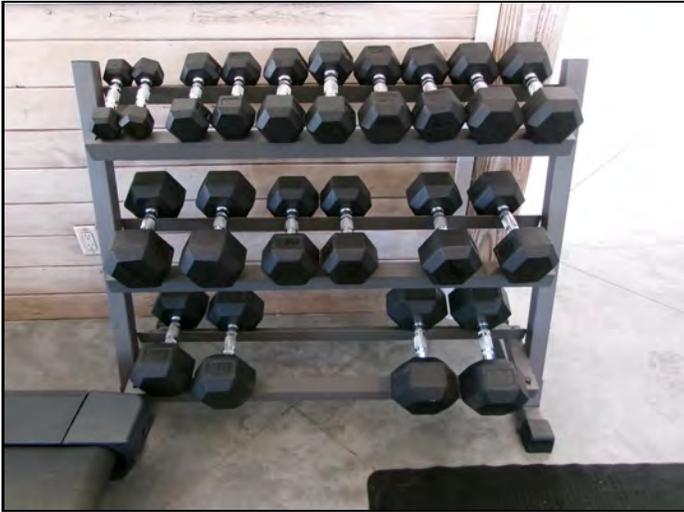
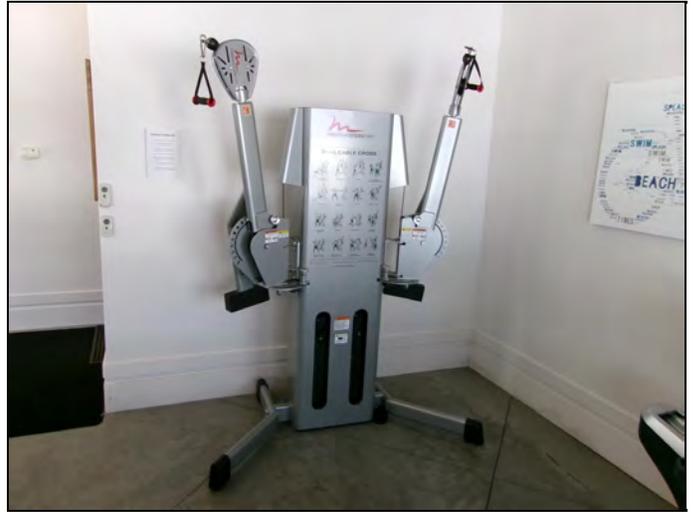
Comp #: 1406 Fitness Equipment - Replace

The fitness equipment is in working condition. We recommend funding to replace this component approximately every 15 years. Remaining life based on current age.

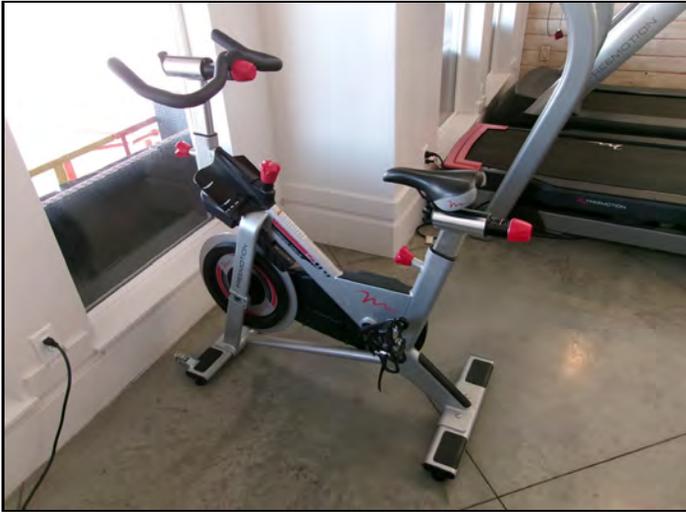
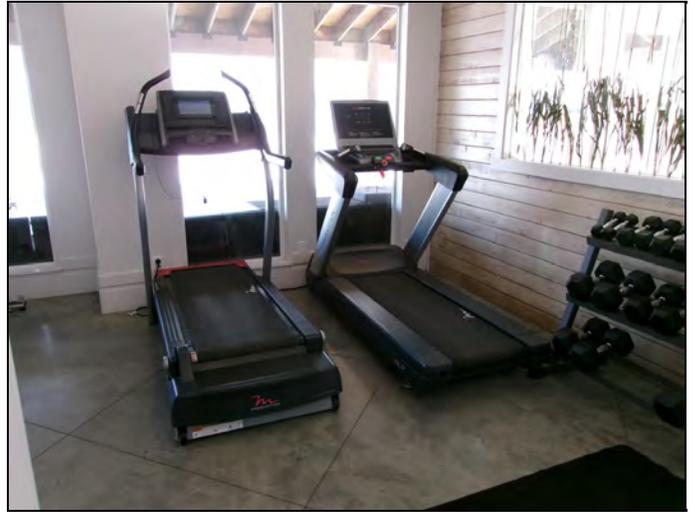
Comp #: 1407 Cardio Equipment - Replace

The cardio fitness equipment is in working condition. We recommend funding to replace this component approximately every 8 - 10 years. Remaining life based on current age.

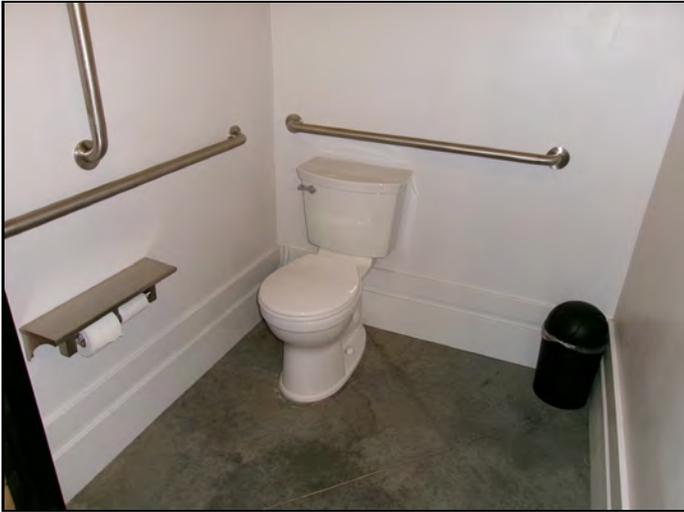
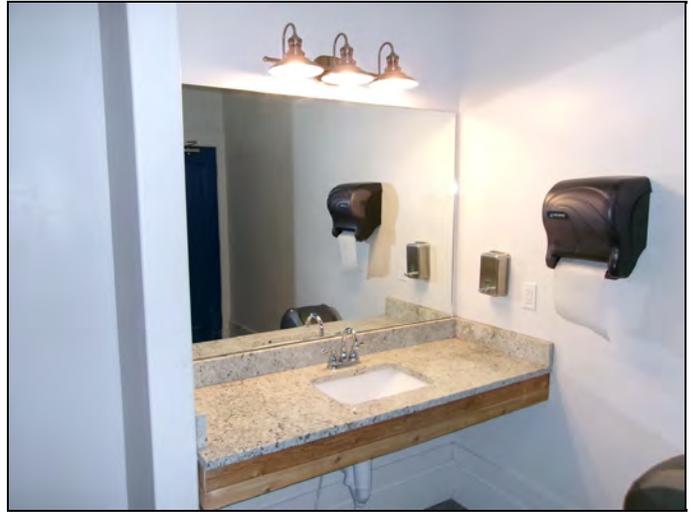
Comp #: 1413 East Restrooms & Outdoor Showers - Remodel

The restrooms and showers are in good to fair condition. We recommend funding to remodel this component approximately every 20 - 25 years. Remaining life based on current age.

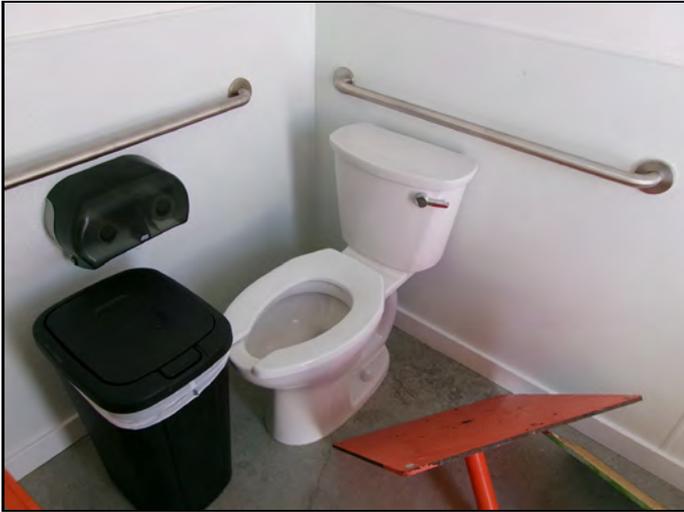
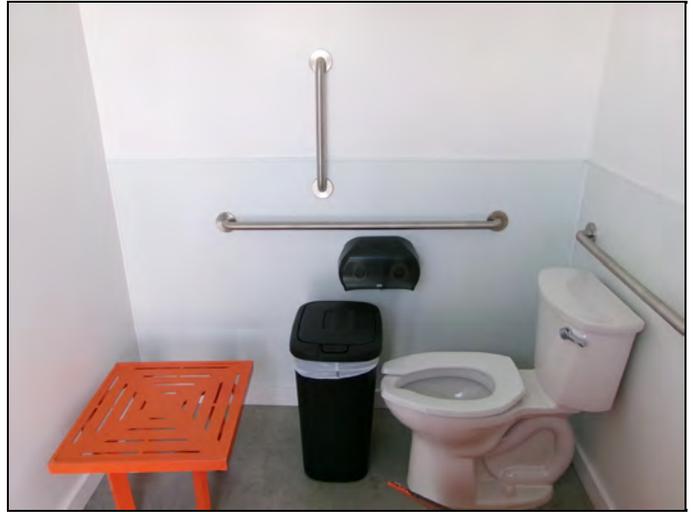
Comp #: 1413 West Restrooms - Remodel

The restrooms are in good condition. We recommend funding to remodel this component approximately every 20 - 25 years. Remaining life based on current age.

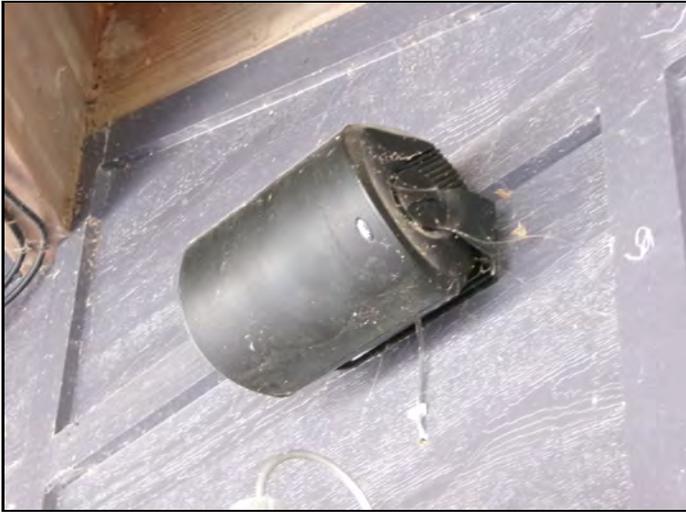
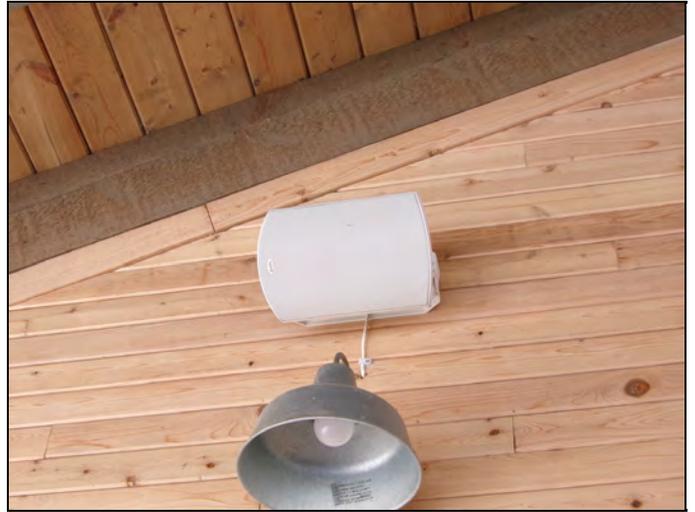
Comp #: 1419 Music System - Upgrade/Replace

The music system is in working condition. We recommend funding an allowance to upgrade/replace this component approximately every 8 - 10 years. Remaining life based on current age.

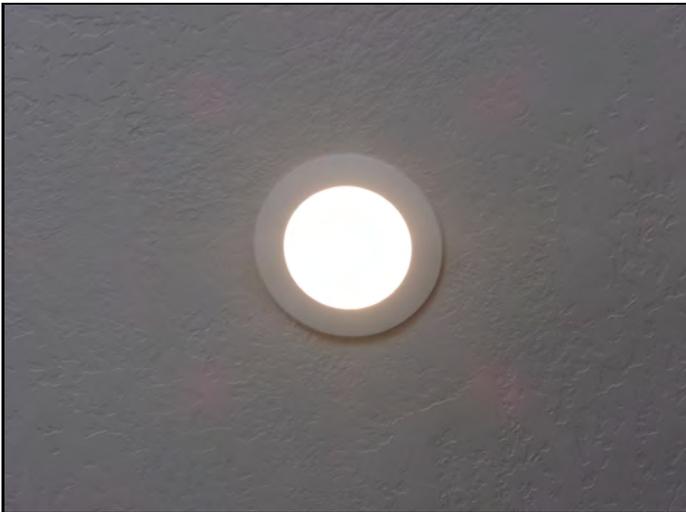
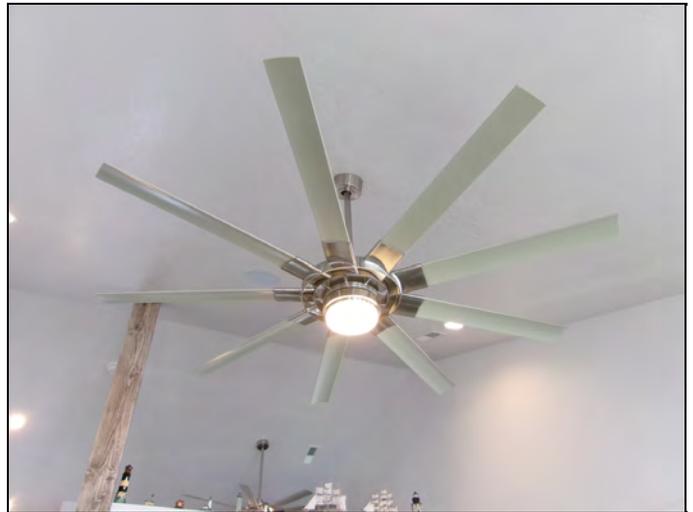
Comp #: 1601 Interior Light Fixtures - Replace

The interior light fixtures are in good condition. We recommend funding to replace this component approximately every 20 - 25 years. Remaining life based on current age.

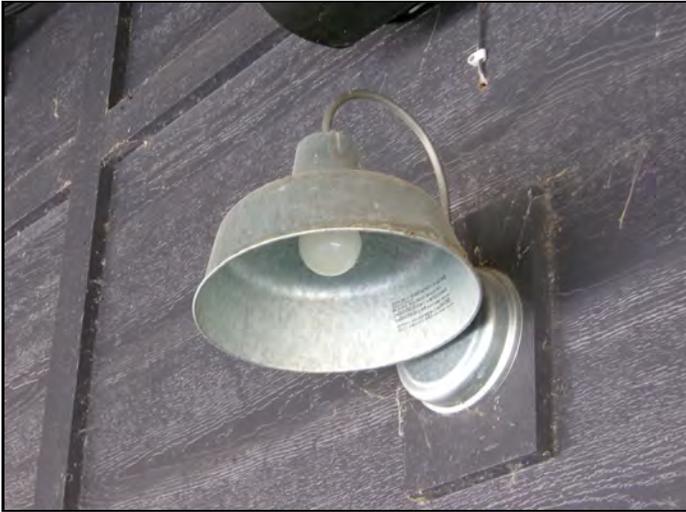
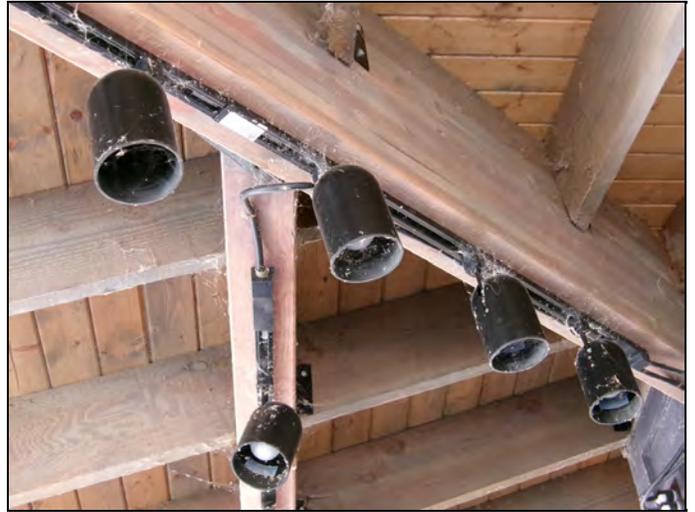
Comp #: 1602 East Exterior Light Fixtures - Replace

The exterior light fixtures are in good condition. We recommend funding to replace this component approximately every 16 - 20 years. Remaining life based on current age.

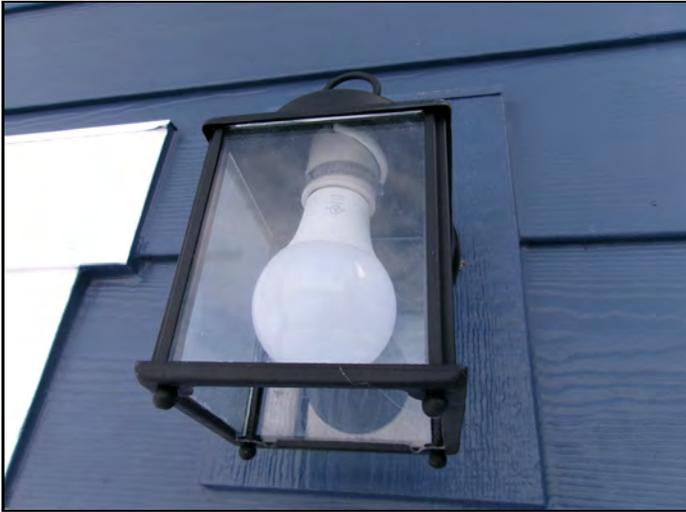
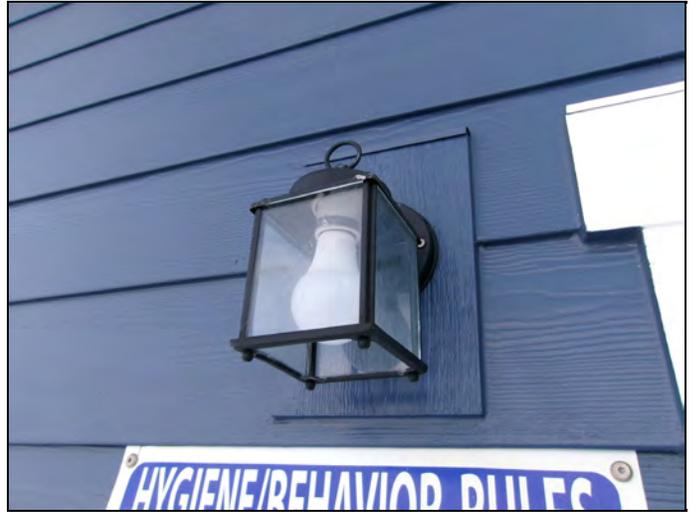
Comp #: 1602 West Exterior Light Fixtures - Replace

Due to the minimal cost of replacing this component, reserve funding is not appropriate. Replace as necessary as an operating expense.

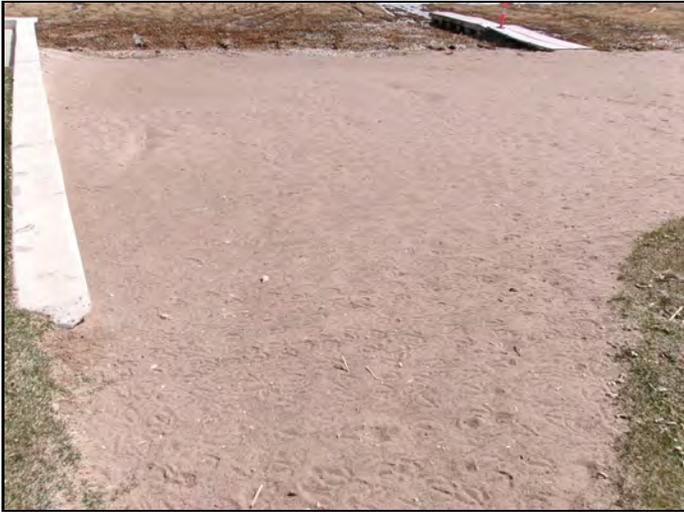
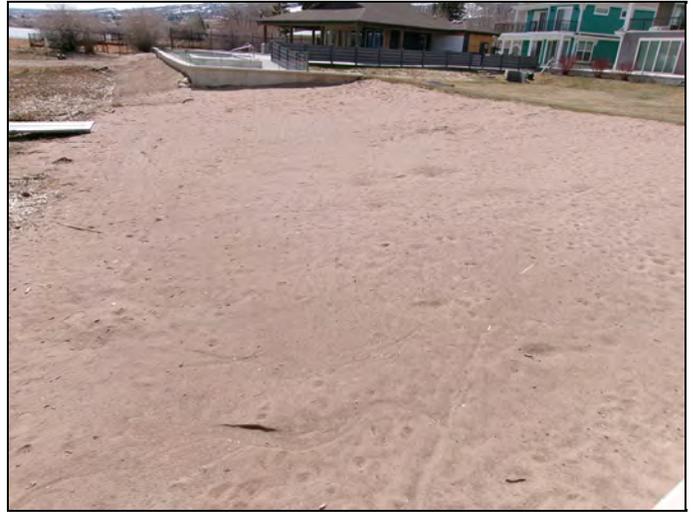
Comp #: 1807 Beach Area - Refurbish

The beach area is in fair condition. We recommend funding to refurbish this component approximately every 8 - 10 years. Remaining life based on current age.

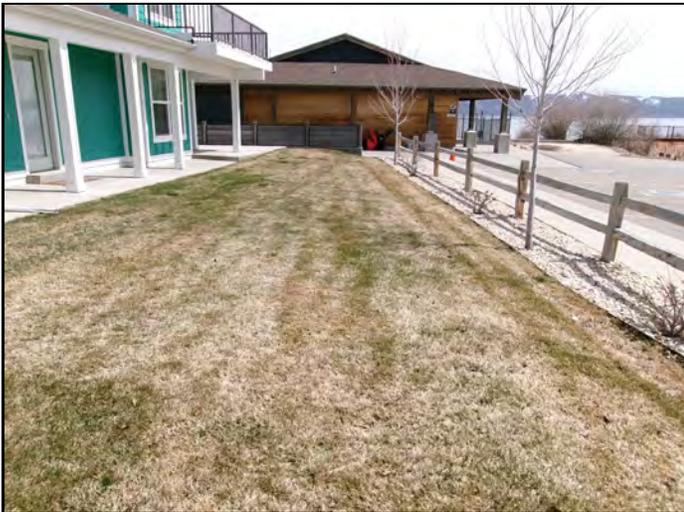
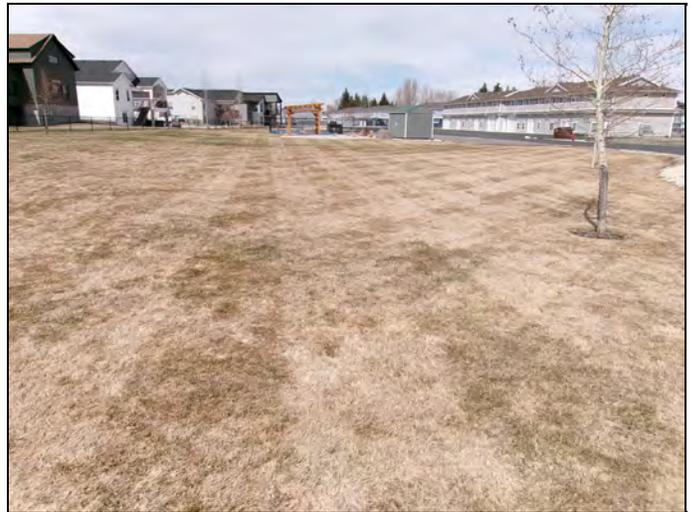
Comp #: 1812 Landscaping & Irrigation System - Renovate

The landscaping and irrigation system appear to be in good to fair condition. We recommend funding for an allowance to renovate this component approximately every 20 years. Remaining life based on current age.

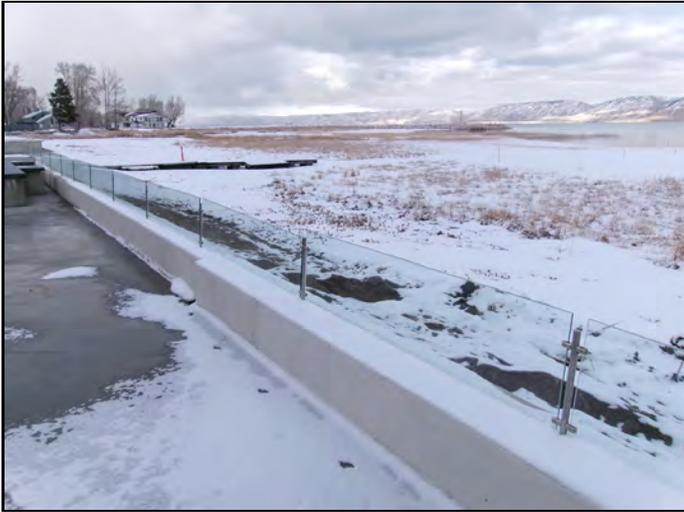
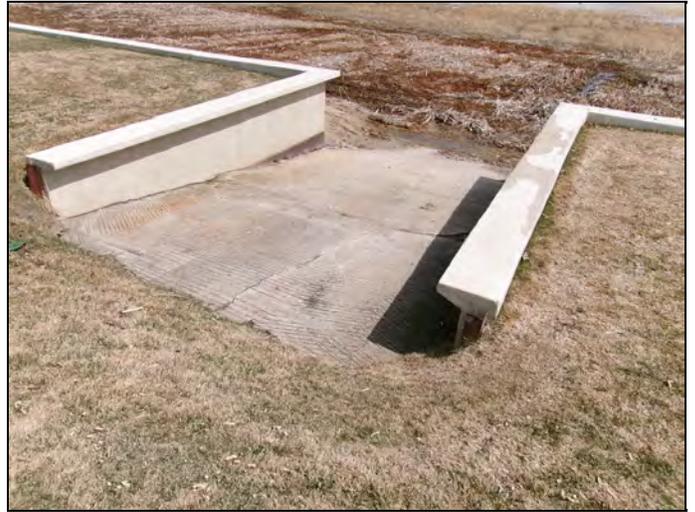
Comp #: 2201 Retaining Wall - Repair

The retaining wall appears to be in good condition. Typically this type of component has an extended useful life. We recommend funding an allowance to make repairs to this component approximately every 15 - 20 years. Remaining life based on current age.

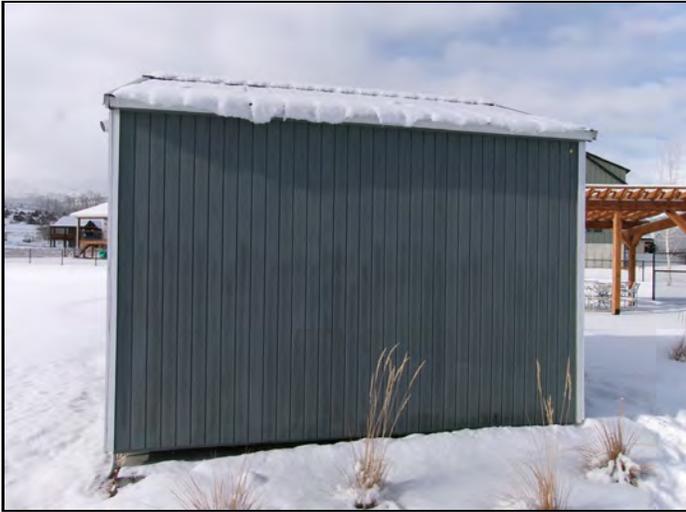
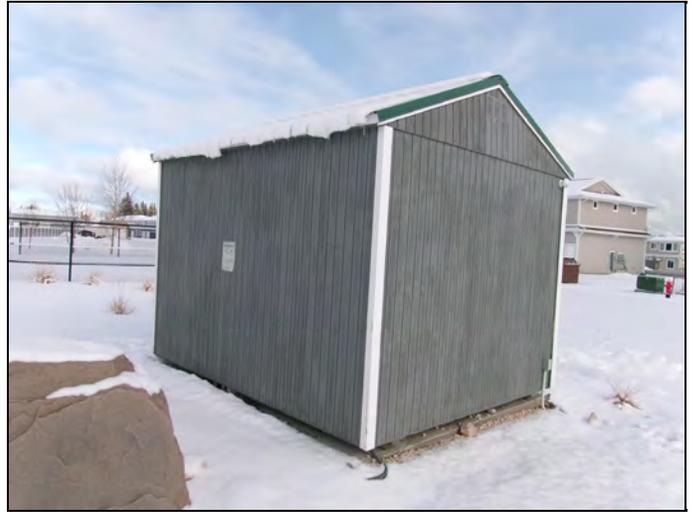
Comp #: 2301 Splash Pad Shed - 2022 - Replace

The shed is in good condition. We recommend funding to replace this component approximately every 25 - 30 years. Remaining life is based on current age.

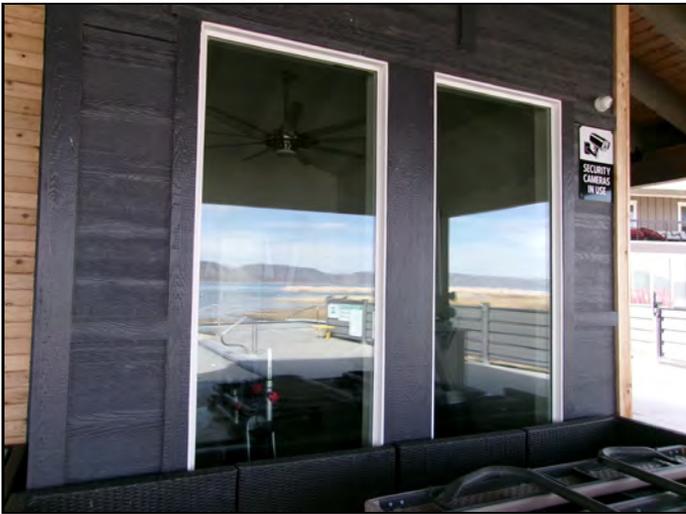
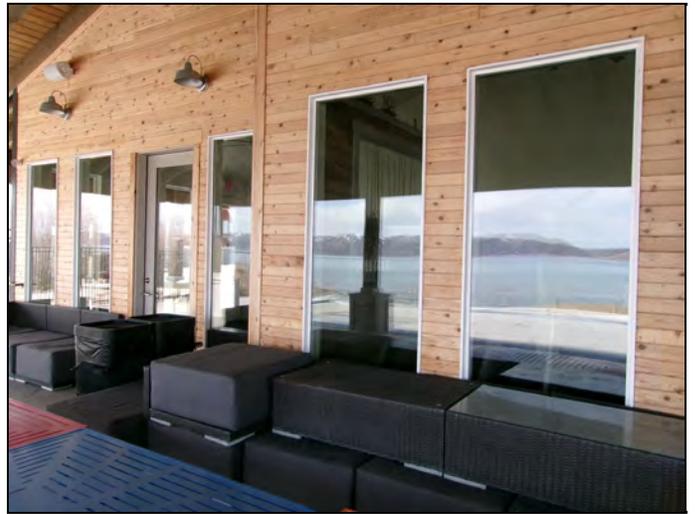
Comp #: 2303 Windows - East Pool - Replace

The windows appear to be in good condition. We recommend funding to replace this component approximately every 40 - 50 years. Remaining life based on current age.

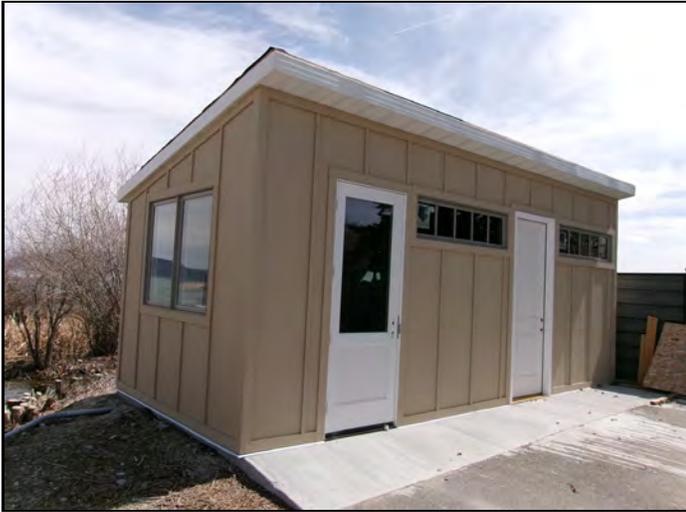
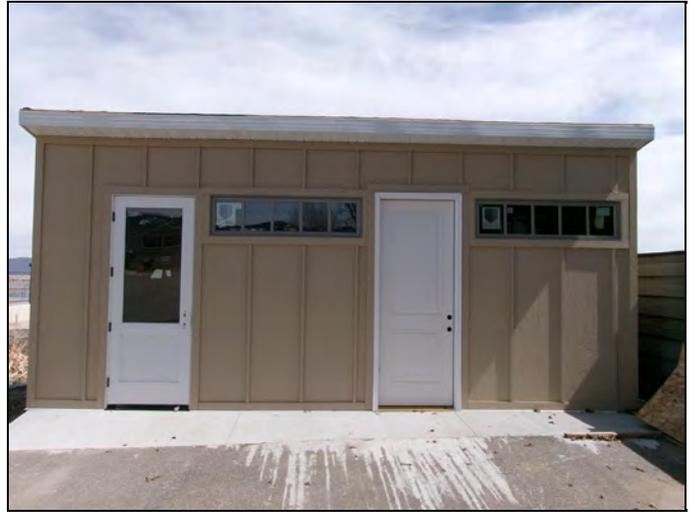
Comp #: 2303 Windows - East Shed - Replace

The windows appear to be in good condition. We recommend funding to replace this component approximately every 40 - 50 years. Remaining life based on current age.

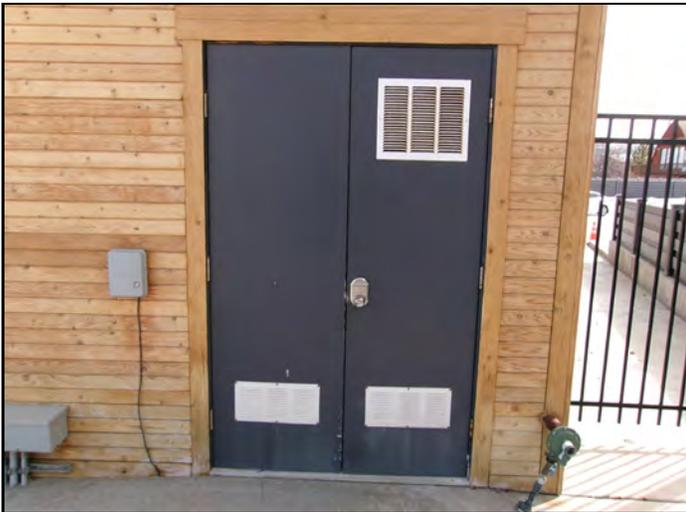
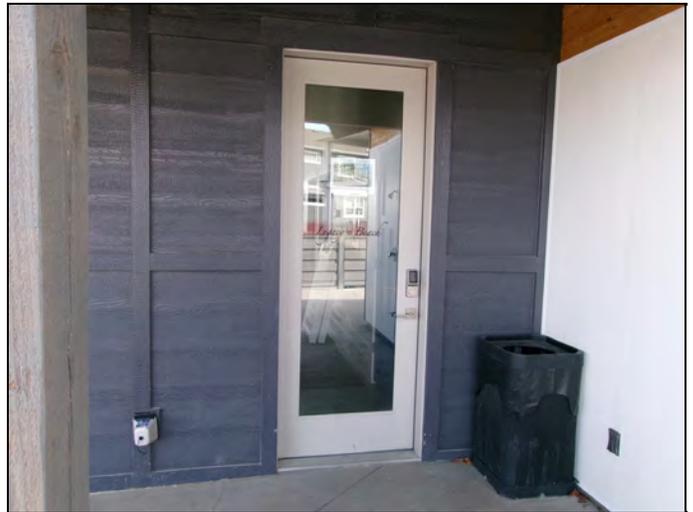
Comp #: 2304 East Exterior Doors - Replace

The doors are in good condition. We recommend funding to replace this component approximately every 40 - 50 years. Remaining life based on current age.

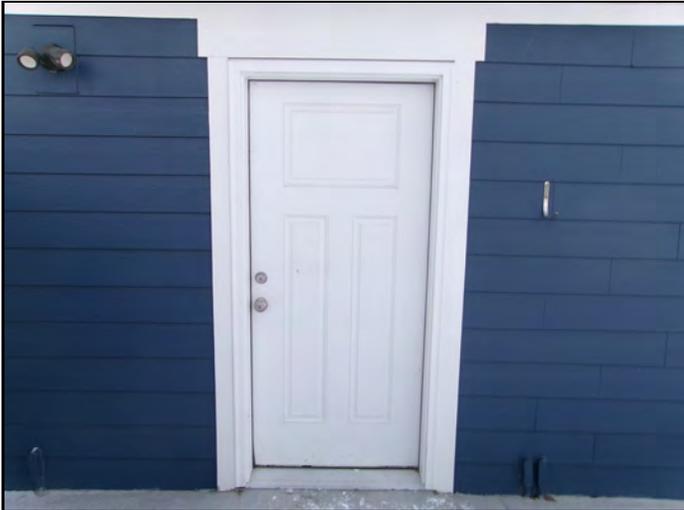
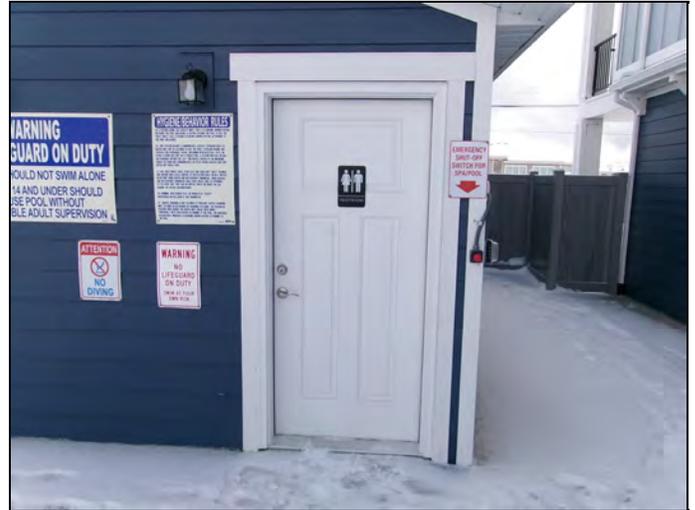
Comp #: 2304 East/West Exterior Doors - Replace

The doors are in good condition. We recommend funding to replace this component approximately every 40 - 50 years. Remaining life based on current age.
