Rodeo Lane HOA

Level 1 Reserve Study

Report Period – 01/01/2021 – 12/31/2021

Executive Summary – Rodeo Lane HOA - ID # 18801

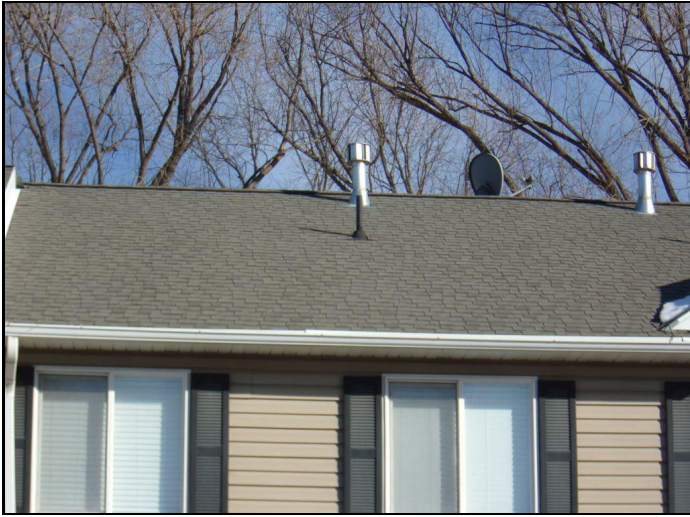
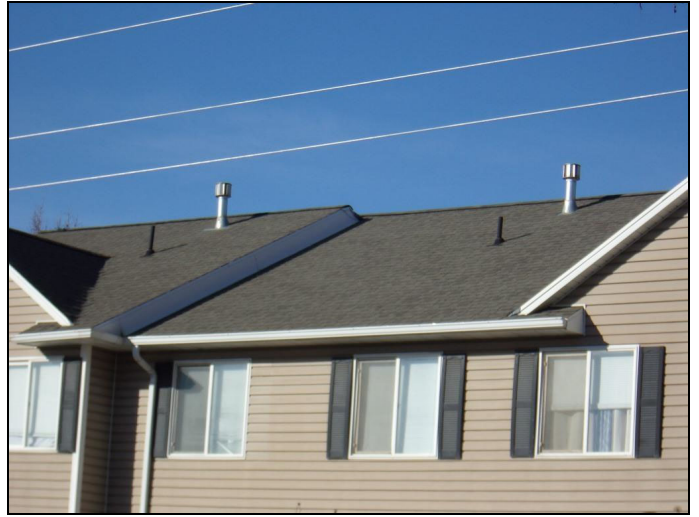
Comp #: 105 Roofs - Replace

Location: **Building Roofs**

The roofs are in fair condition. We recommend funding to replace this component approximately every 20 - 25 years. Remaining life based on current age.

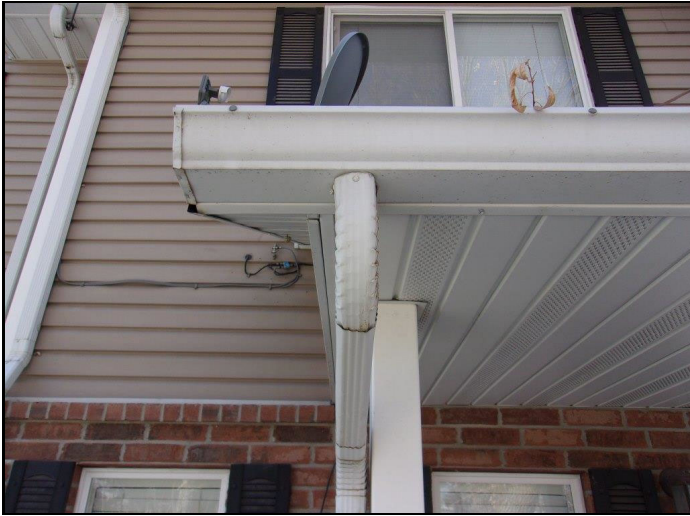
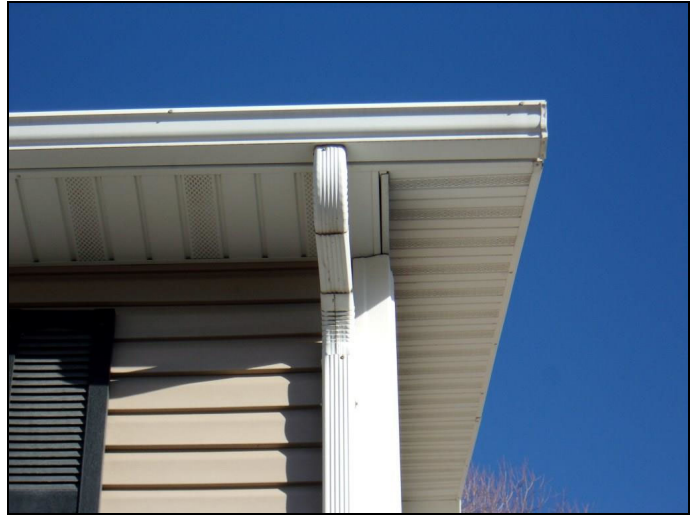
Comp #: 120 Rain Gutters/Downspouts - Replace

Location: **Building Exteriors**

The rain gutters and downspouts are in good to fair condition. We recommend funding to replace this component approximately every 25 - 30 years. Remaining life based on current age.

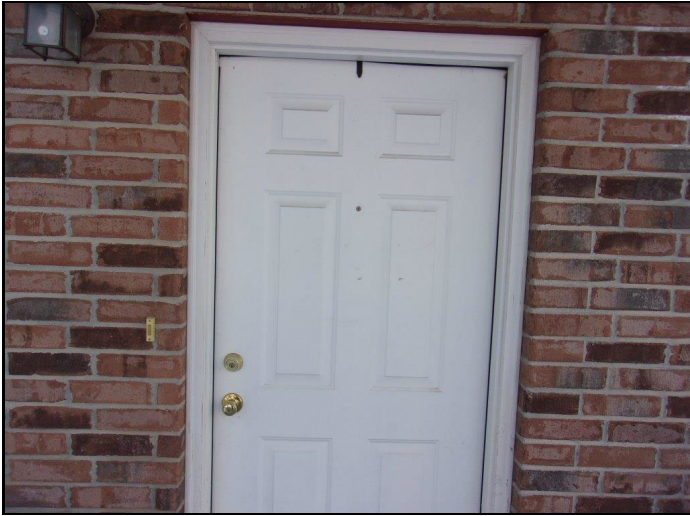
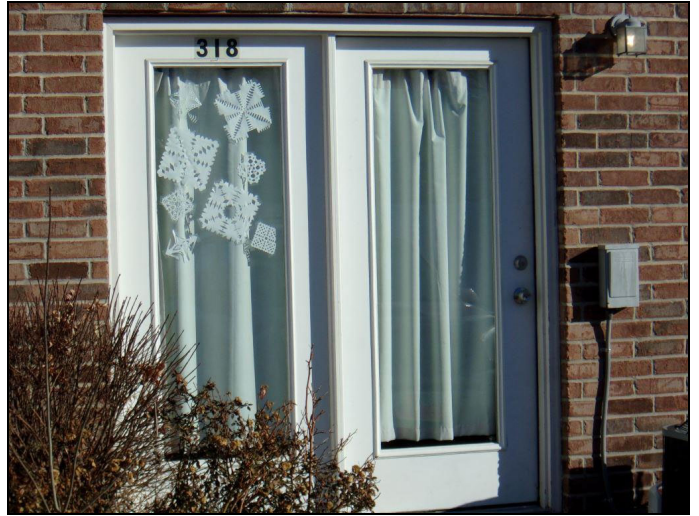
Comp #: 204 Doors - Repaint

Location: Unit Entrances

The painted door surfaces are in fair to poor condition. We recommend funding to repaint this component approximately every 8 - 10 years. Remaining life based on current age and condition.

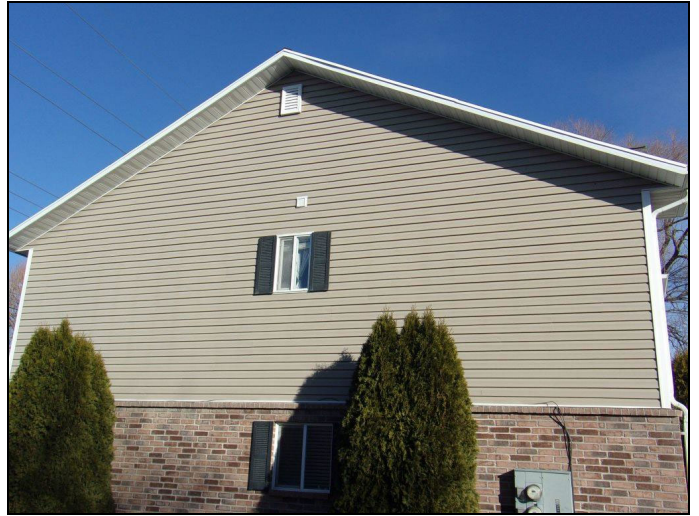
Comp #: 302 Vinyl Siding - Replace

Location: **Building Exteriors**

The vinyl siding is in good condition. We recommend funding to replace this component approximately every 40 - 50 years. Remaining life based on current age.

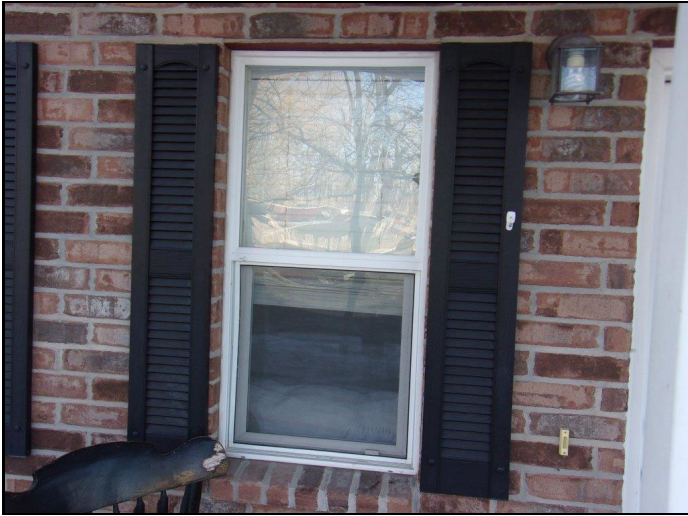
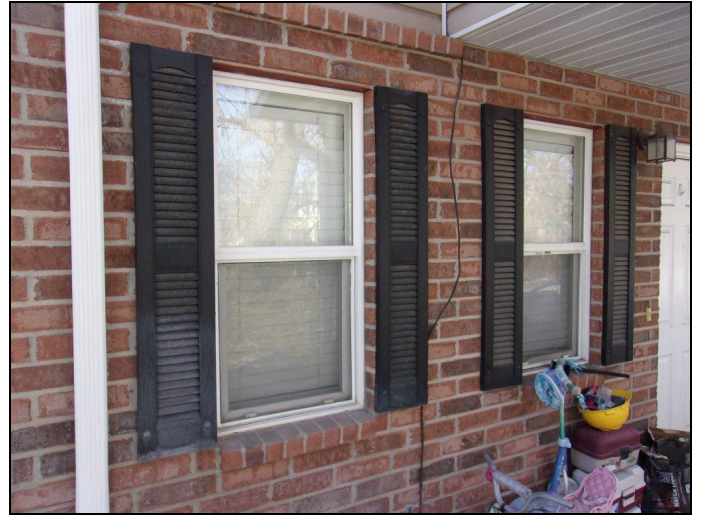
Comp #: 390 Shutters - Replace

Location: **Building Exteriors**

The shutters are in good to fair condition. We recommend funding to replace this component approximately every 30 - 40 years. Remaining life based on current age.

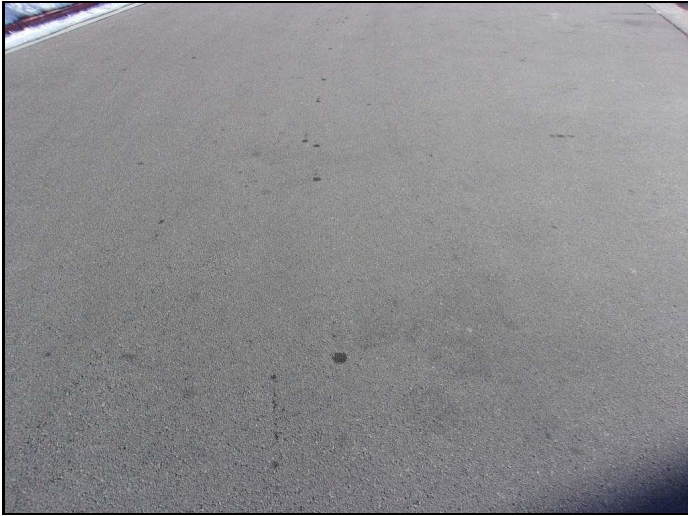
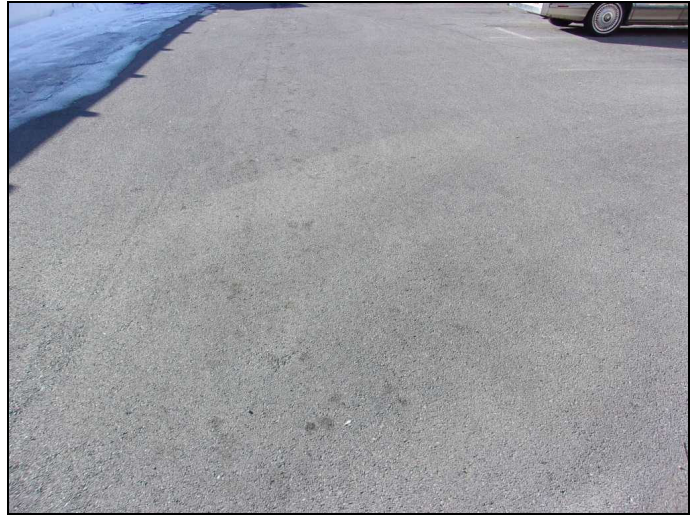
Comp #: 401 Asphalt - Major Rehab

Location: **Community Streets**

The asphalt surfaces are in good condition. We recommend funding for a major rehab of this component approximately every 25 - 30 years. Remaining life based on current age.

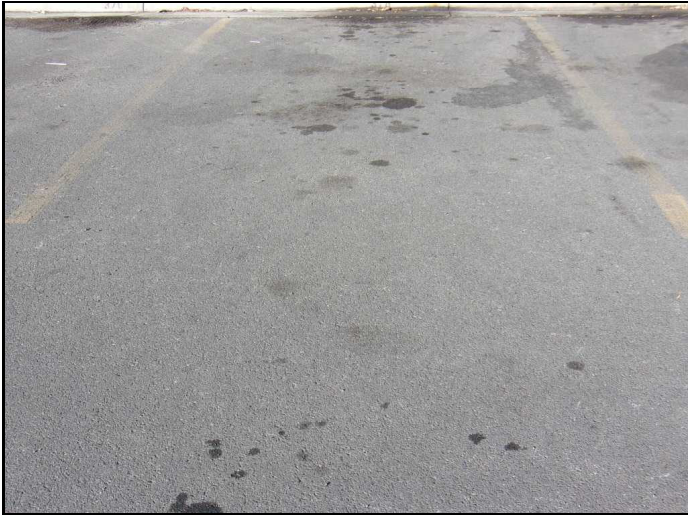
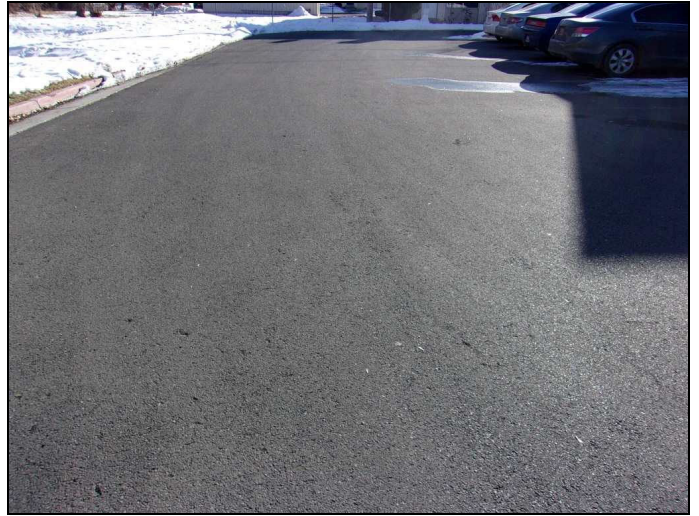
Comp #: 402 Asphalt - Seal Coat

Location: **Community Streets**

The asphalt seal coat is in poor condition. We recommend funding to seal this component approximately every 3 - 5 years. Remaining life based on current condition.

Projects programmed to occur this fiscal year (FY2021) include asphalt seal coat (Comp# 402). We have programmed an estimated \$6,500 in reserve expenditures toward the completion of these projects. (See page 15)

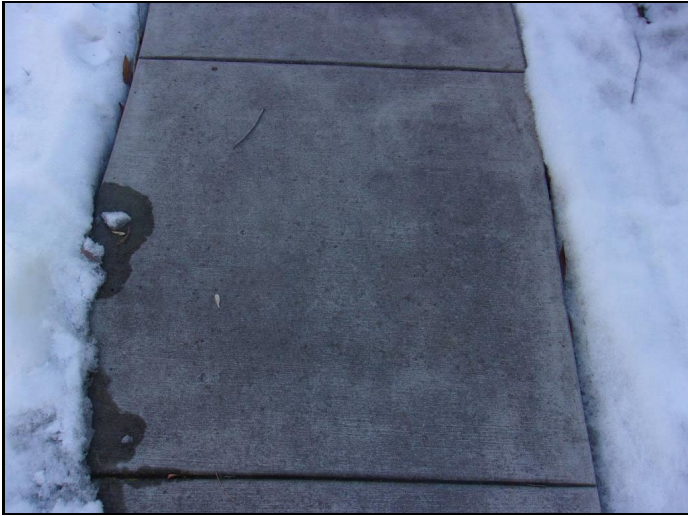
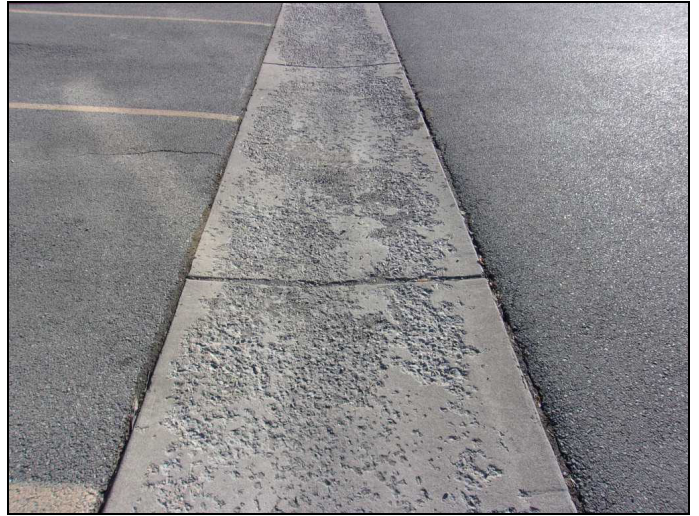
Comp #: 403 Concrete - Partial Repair/Replace

Location: Curb, Drive, Dumpster, & Sidewalk

The concrete is in good to fair condition. This component has an extended useful life under normal conditions. We recommend funding to make repairs and partially replace this component approximately every 10 years. Remaining life based on current age.

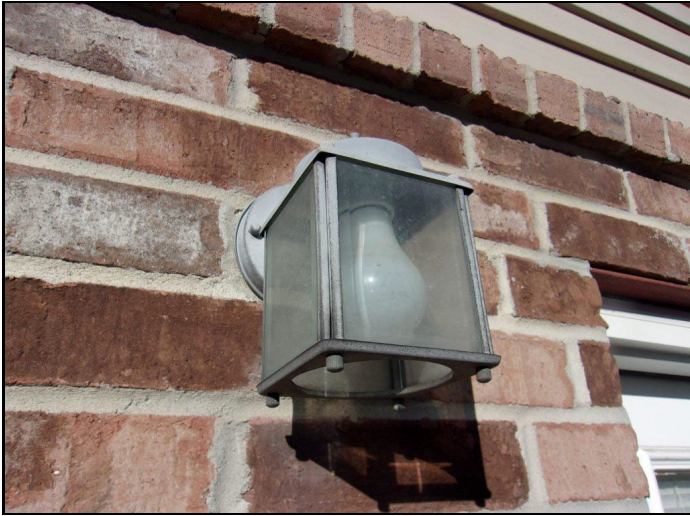
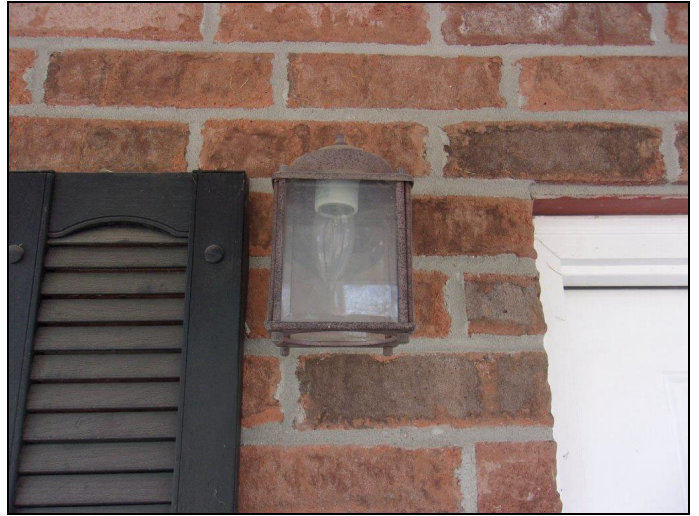
Comp #: 1602 Exterior Light Fixtures - Replace

Location: **Building Exteriors**

The exterior light fixtures are in fair condition. We recommend funding to replace this component approximately every 16 - 20 years. Remaining life based on current age.

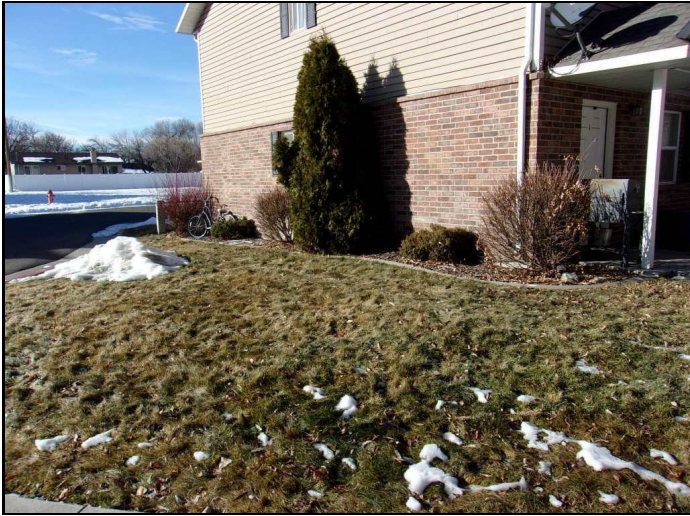
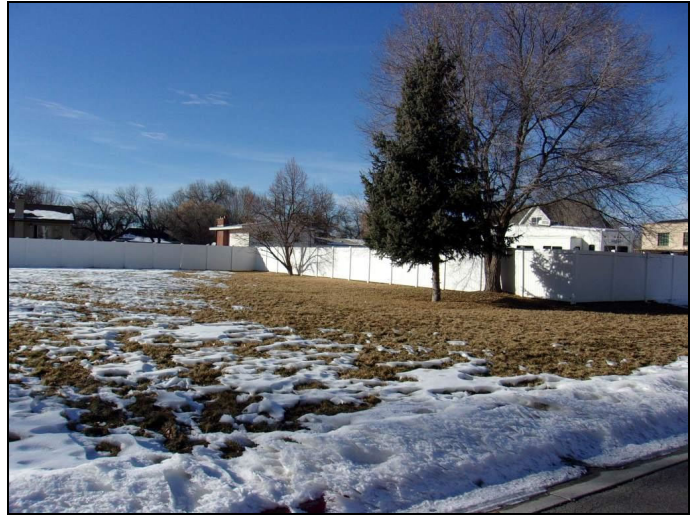
Comp #: 1812 Landscaping & Irrigation System - Renovate

Location: **Common Area**

The landscaping and irrigation system are in good to fair condition. We recommend funding for an allowance to renovate the landscaping and irrigation system approximately every 20 years. Remaining life based on current age.

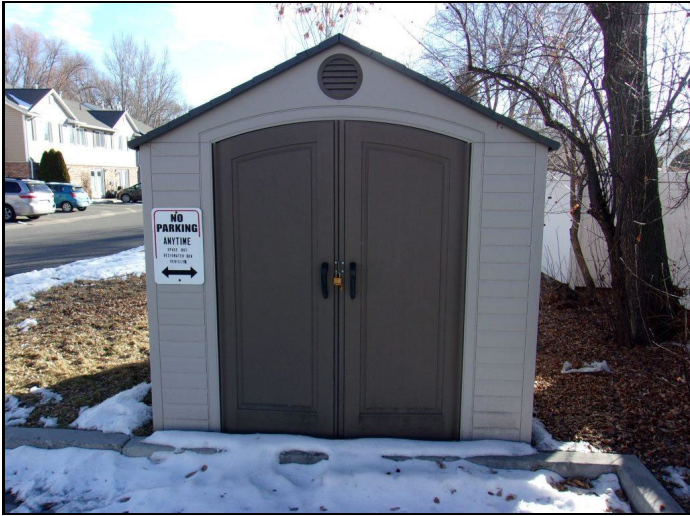
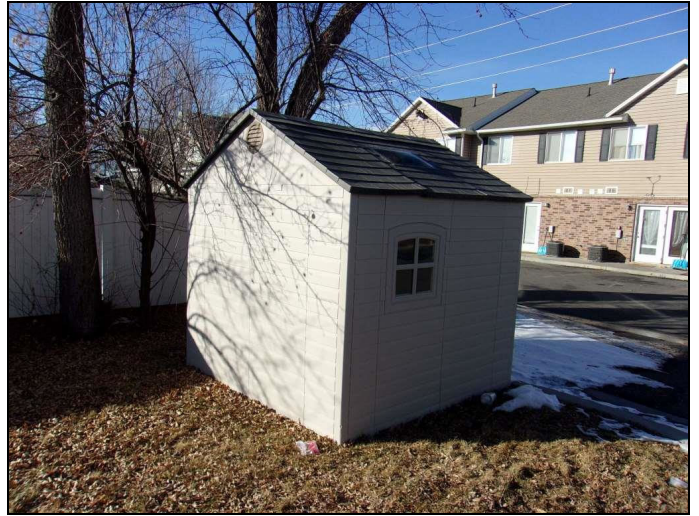
Comp #: 2301 Shed - Replace

Location: **Common Area**

Due to the minimal cost of replacing this component, reserve funding is not appropriate. Replace as necessary as an operating expense.
