# The Legends at North Park

## Level 1 Reserve Study

**Report Period – 01/01/2023 – 12/31/2023**

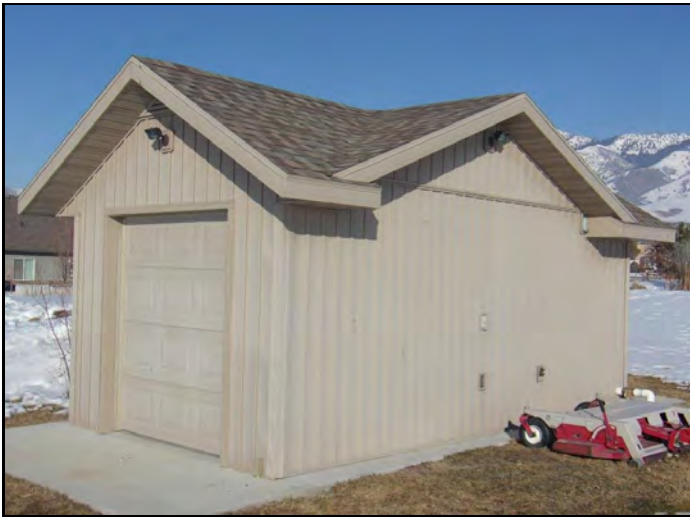
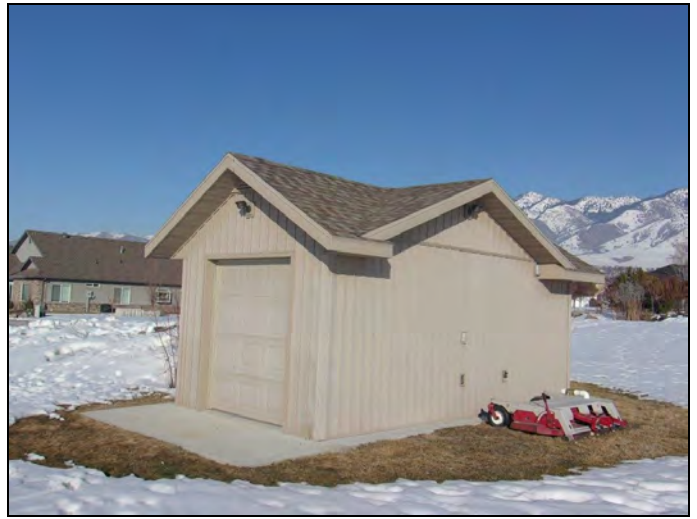
Comp #: 105 Roof - Shed - Replace

The roofs are in good condition. We recommend funding to replace this component approximately every 20 - 25 years. Remaining life based on current age.

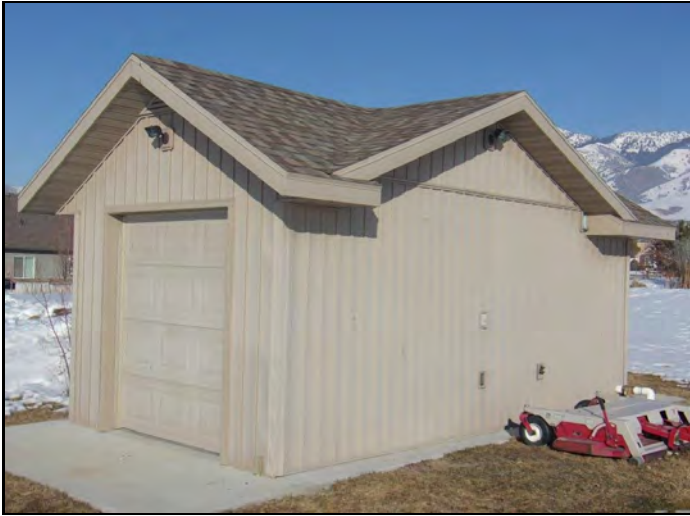
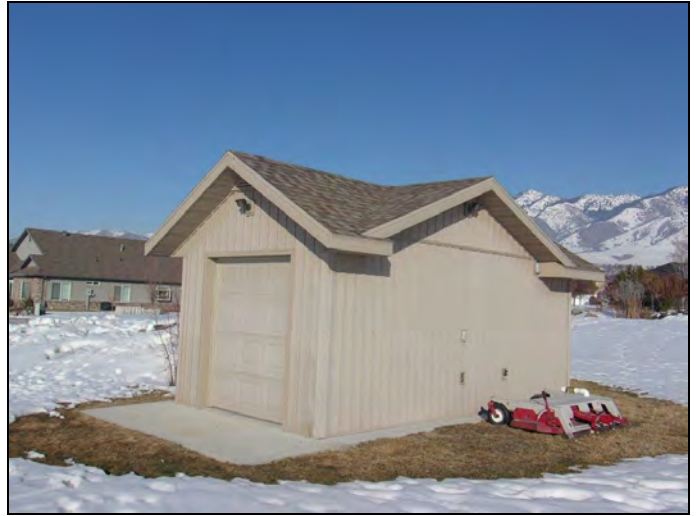
Comp #: 302 Vinyl Siding - Shed - Replace

The vinyl siding is in good condition. We recommend funding to replace this component approximately every 40 - 50 years. Remaining life based on current age.

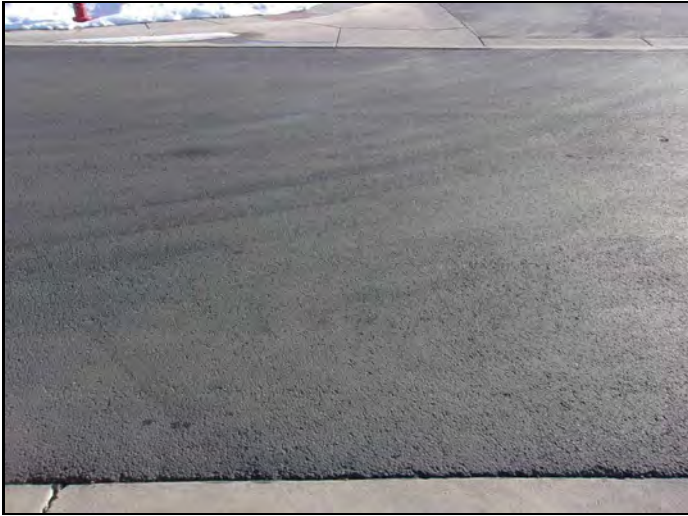
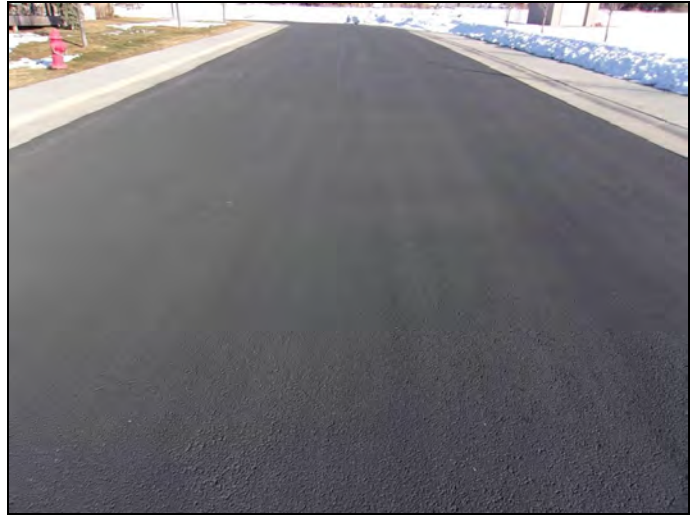
Comp #: 401 Asphalt - Major Rehab

The asphalt surfaces are in good condition. We recommend funding for a major rehab of this component approximately every 25 - 30 years. Remaining life based on current age.

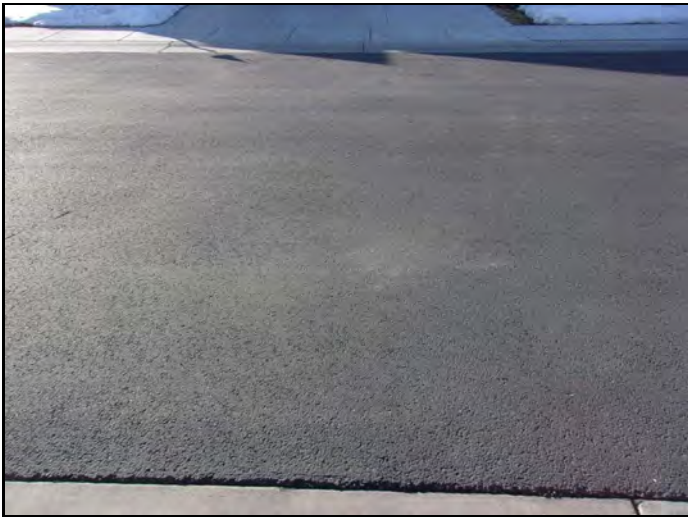
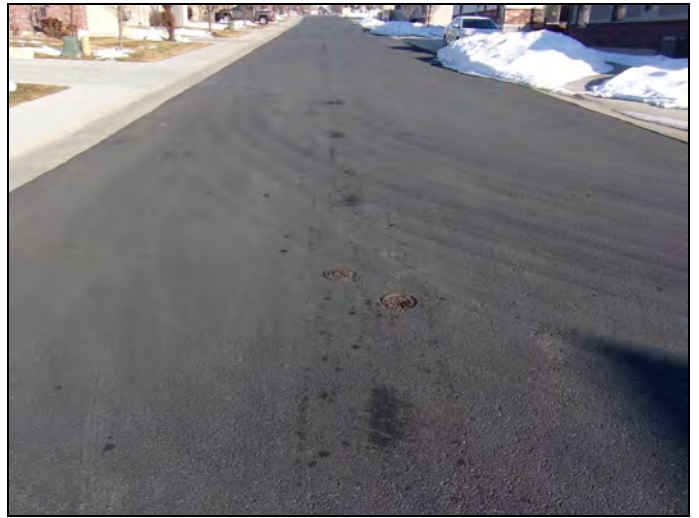
Comp #: 402 Asphalt - Seal Coat

Research with the client reveals a premium sealant was used which has a 5 - 7 year life. We recommend funding to seal this component approximately every 3 - 5 years. Remaining life based on current age.

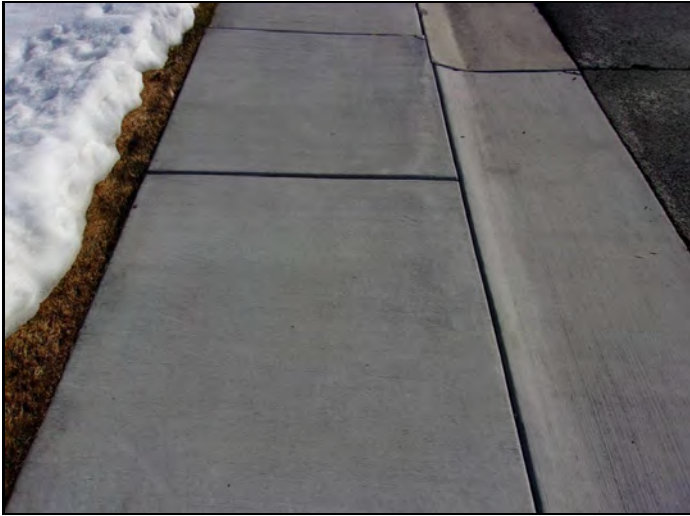
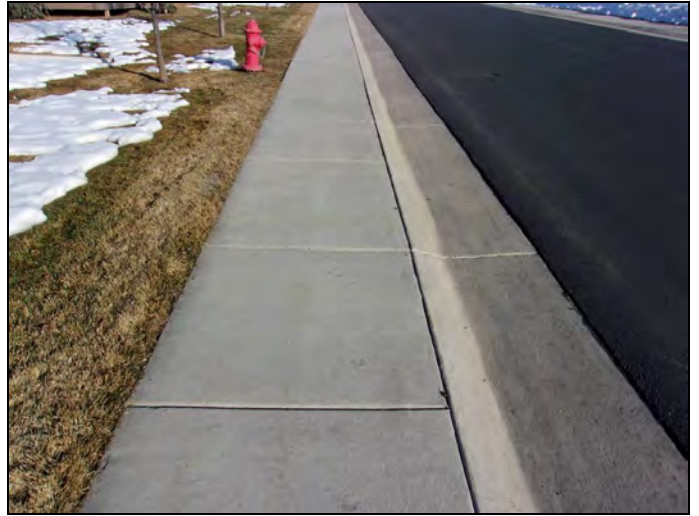
Comp #: 403 Concrete - Partial Repair/Replace

The concrete is in good condition. This component has an extended useful life under normal conditions. We recommend funding to make repairs and partially replace this component approximately every 10 years. Remaining life based on average age.

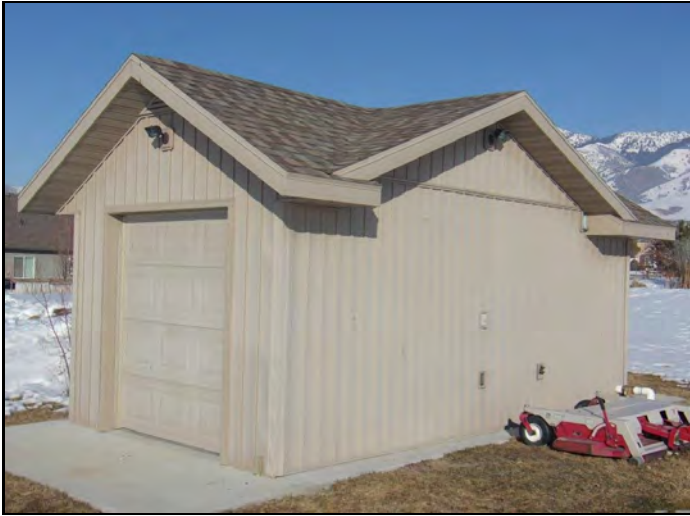
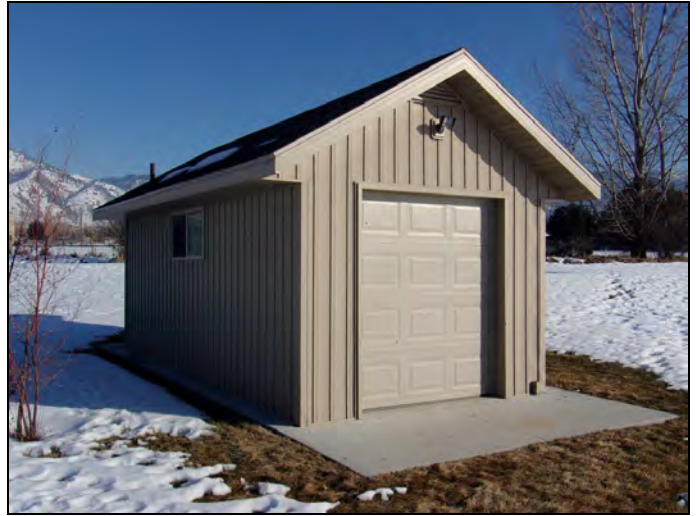
Comp #: 502 Garage Door - Shed - Replace

Due to the minimal cost of replacing this component, reserve funding is not appropriate. Replace as necessary as an operating expense.

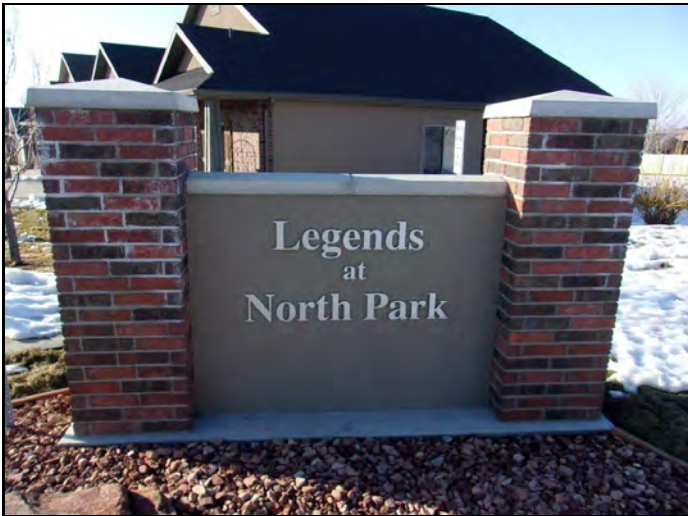
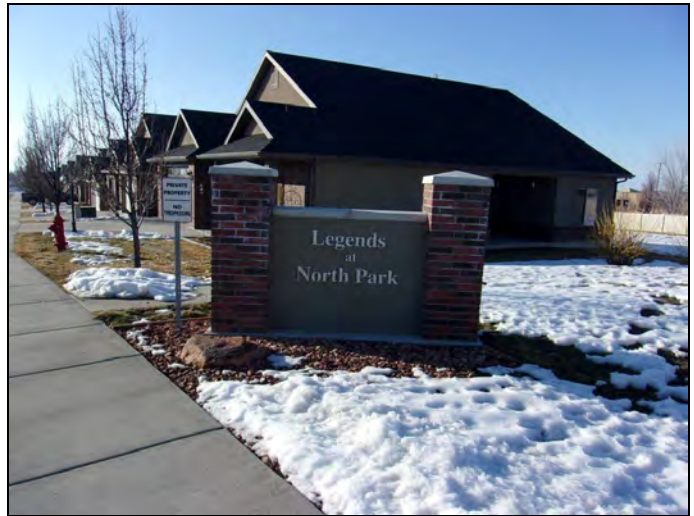
Comp #: 801 Monument Sign - Refurbish

The monument sign is in good condition. We recommend funding to refurbish this component approximately every 15 - 20 years. Remaining life is based on current age.

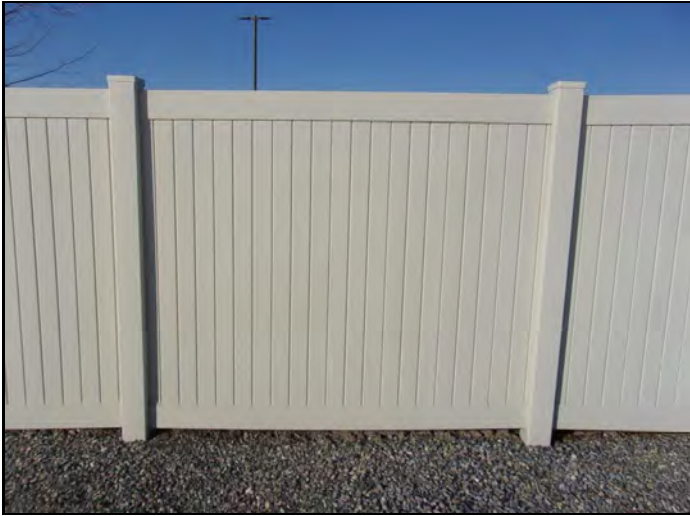
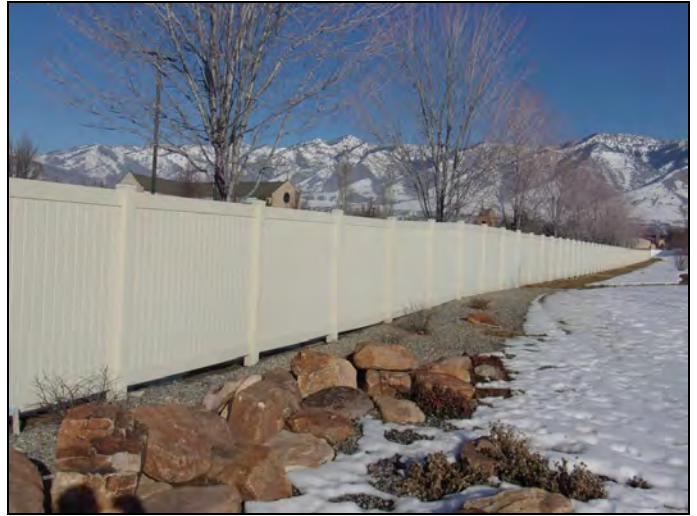
Comp #: 1008 Vinyl Fencing - Replace

The vinyl fencing is in good condition. We recommend funding to replace this component approximately every 25 - 30 years. Remaining life based on average age.

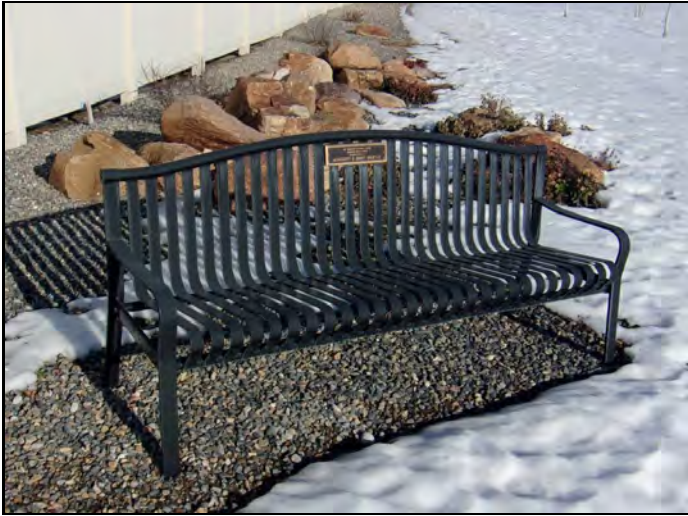
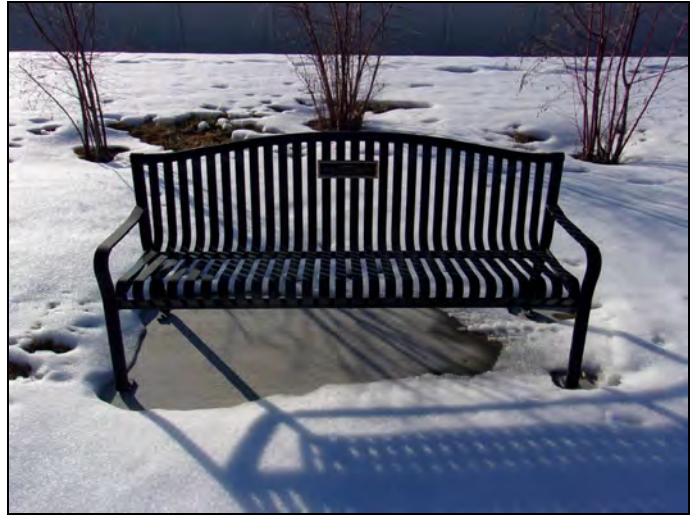
Comp #: 1307 Benches - Replace

The benches are in good condition. We recommend funding to replace this component approximately every 15 - 20 years. Remaining life based on current age.

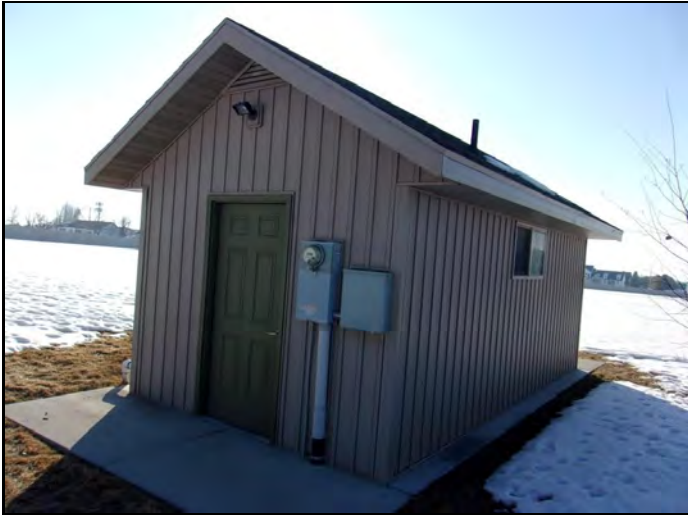
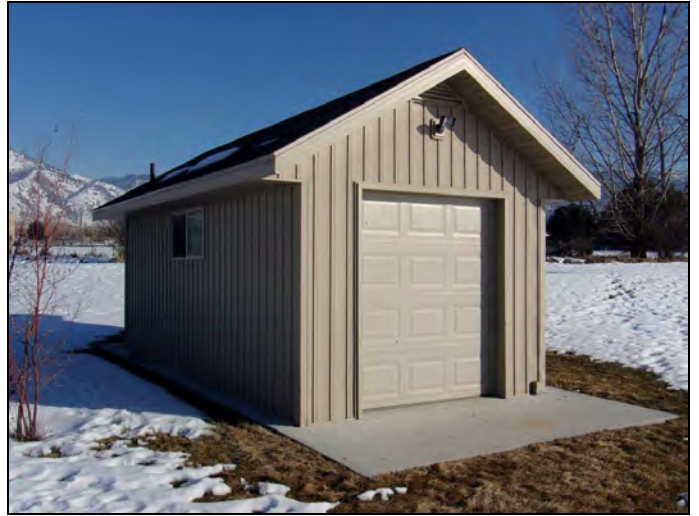
Comp #: 1602 Exterior Light Fixtures - Shed - Replace

Due to the minimal cost of replacing this component, reserve funding is not appropriate. Replace as necessary as an operating expense.

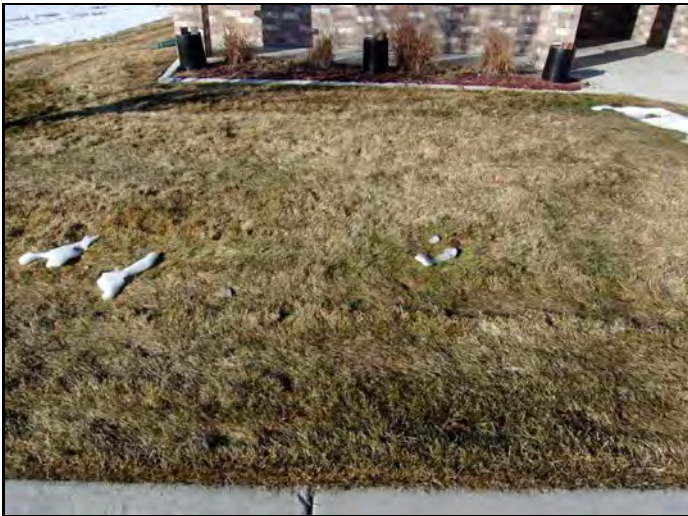
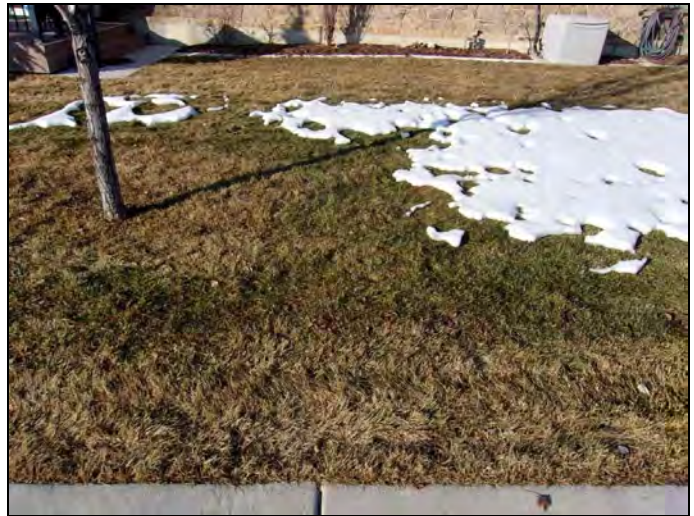
Comp #: 1812 Landscaping & Irrigation System - Renovate

The landscaping and irrigation system are in good condition. We recommend funding for an allowance to renovate the landscaping and irrigation system approximately every 20 years. Remaining life based on average age.

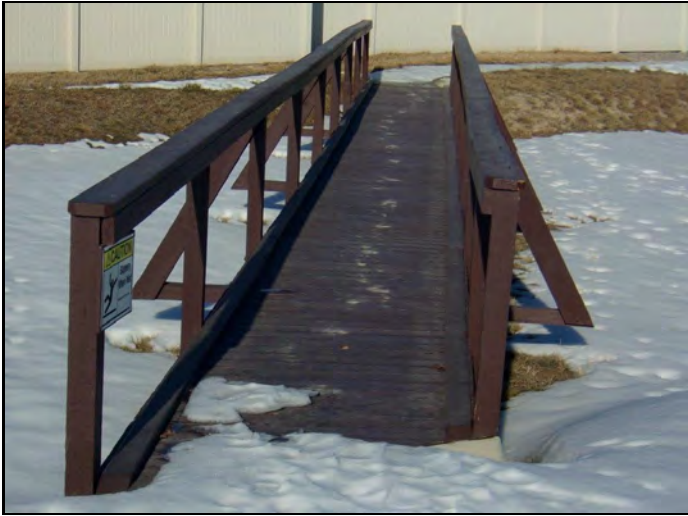
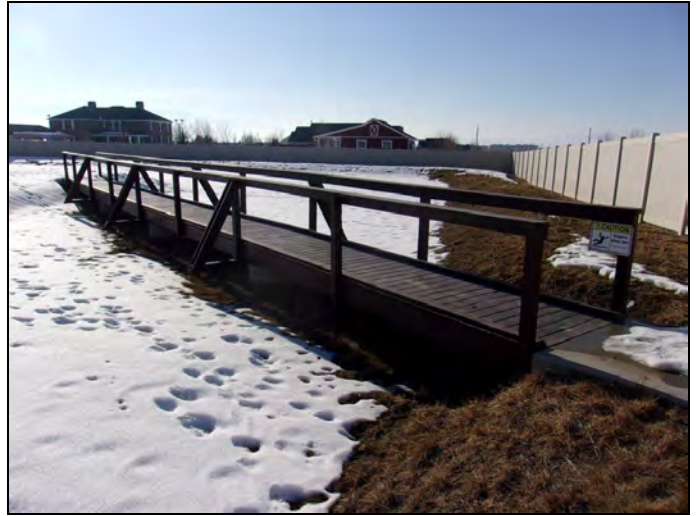
Comp #: 2302 Bridge - Replace

The bridge is in good condition. We recommend funding to replace this component approximately every 20 - 30 years. Remaining life based on current age.
