Lakewood HOA

Level 2 Reserve Study

Type of Study	Update w/Site Visit
Date of Property Inspection	08/01/2023
Prepared By	Dale Gifford
Analysis Method	Cash Flow
Funding Goal	Full Funding

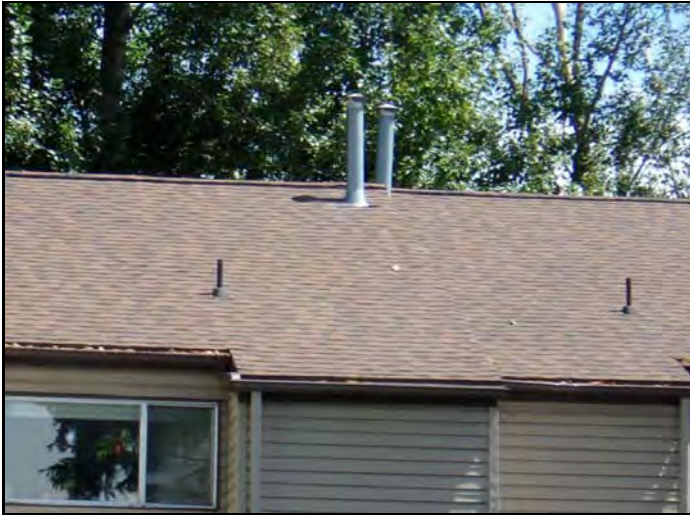
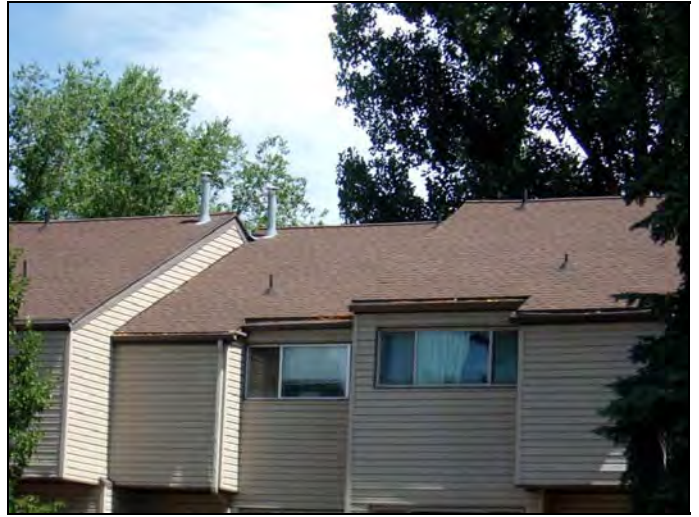
Comp #: 105 Roofs - Replace

Location: **Building Roofs**

Quantity: **Approx 12,150 SF**

Life Expectancy: **25 Remaining Life: 19**

The roofs are in good condition. We recommend funding to replace this component approximately every 20 - 25 years. Remaining life based on current age.

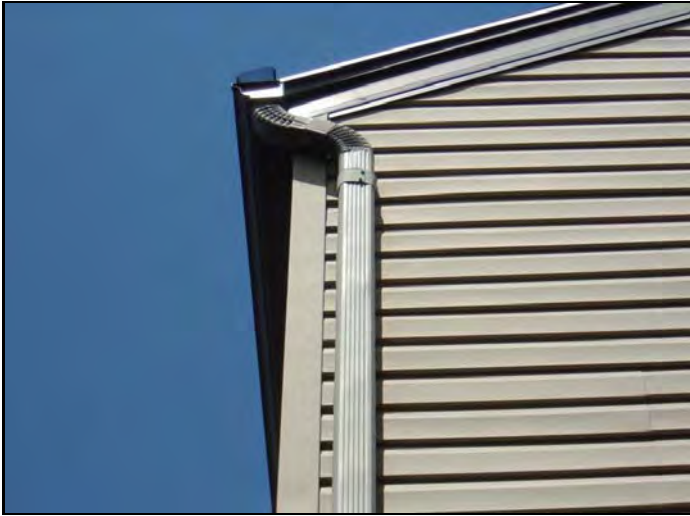
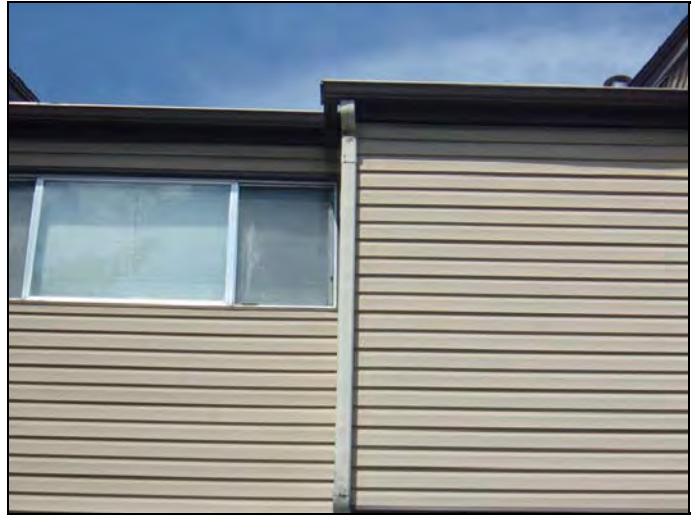
Comp #: 120 Rain Gutters/Downspouts - Replace

Location: **Building Exteriors**

Quantity: **Approx 1,950 LF**

Life Expectancy: **30** *Remaining Life:* **3**

The rain gutters and downspouts are in fair condition. We recommend funding to replace this component approximately every 25 - 30 years. Remaining life based on current age and condition.

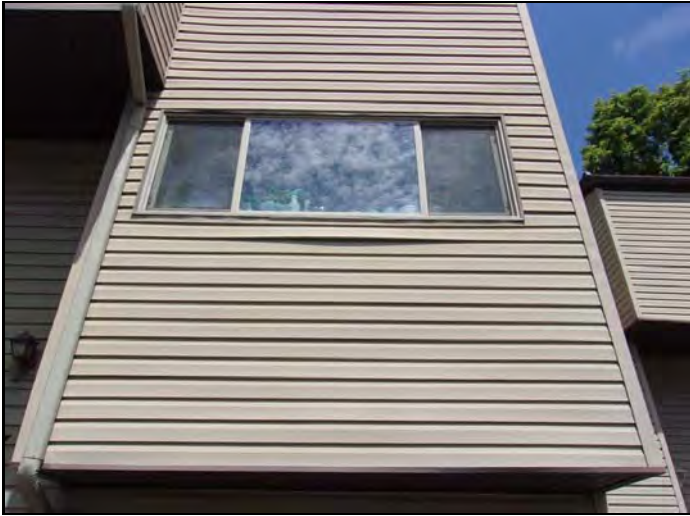
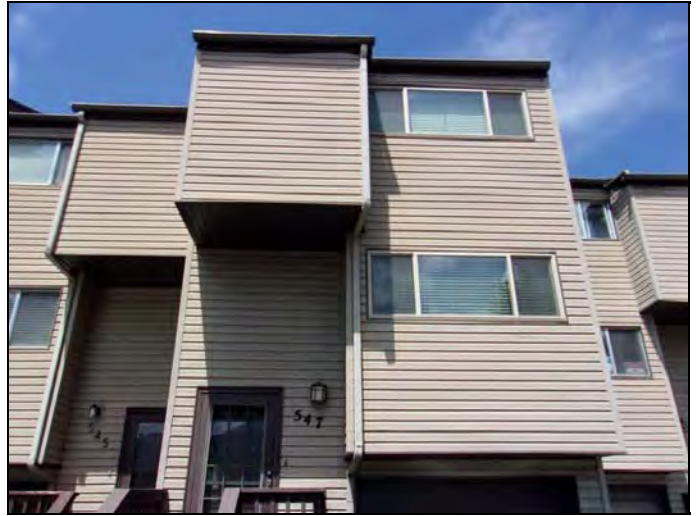
Comp #: 302 Vinyl Siding - Replace

Location: **Building Exteriors**

Quantity: **Approx 26,400 SF**

Life Expectancy: **50** *Remaining Life:* **32**

The vinyl siding is in good to fair condition. We recommend funding to replace this component approximately every 40 - 50 years. Remaining life based on current age.

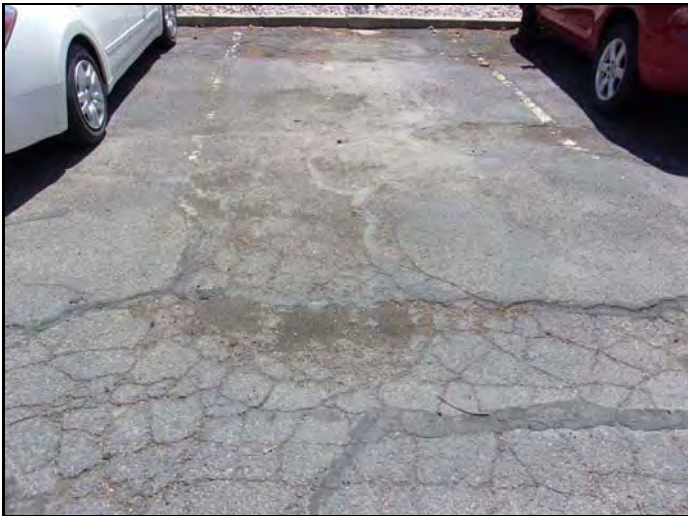
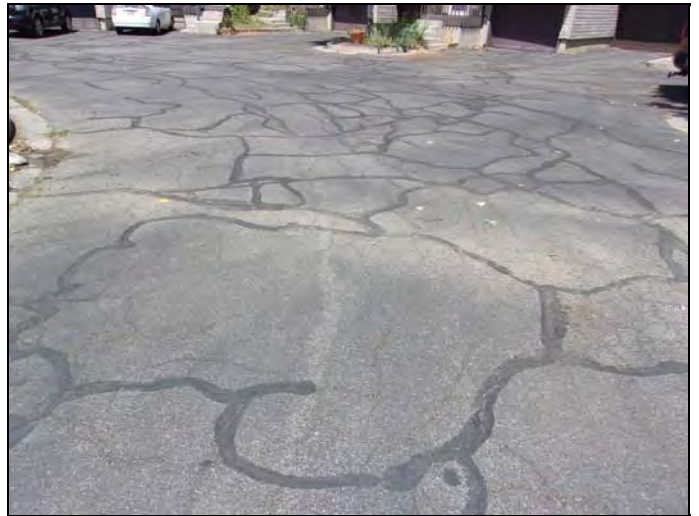
Comp #: 401 Asphalt - Major Rehab

Location: **Community Streets**

Quantity: **Approx 12,600 SF**

Life Expectancy: **30** *Remaining Life:* **5**

The asphalt surfaces are in good condition. We recommend funding for a major rehab of this component approximately every 25 - 30 years. Remaining life based on current age and condition.

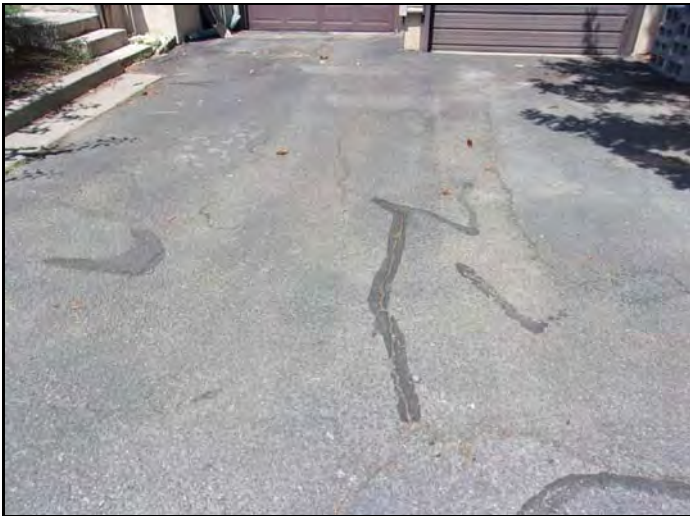
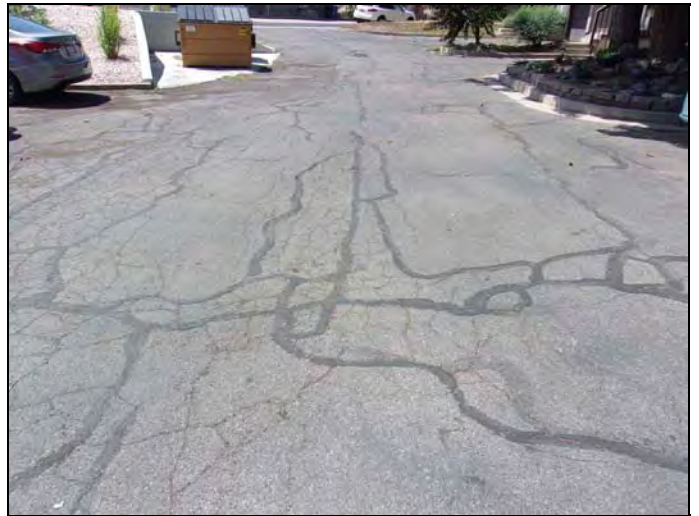
Comp #: 402 Asphalt - Seal Coat

Location: **Community Streets**

Quantity: **Approx 12,600 SF**

Life Expectancy: **5** *Remaining Life:* **0**

The asphalt seal coat is in poor condition. We recommend funding to seal this component approximately every 3 - 5 years. Remaining life based on current condition.

Projects programmed to occur this fiscal year (FY2024) include asphalt seal coat (Comp# 402). We have programmed an estimated \$4,500 in reserve expenditures toward the completion of these projects. (See page 15)

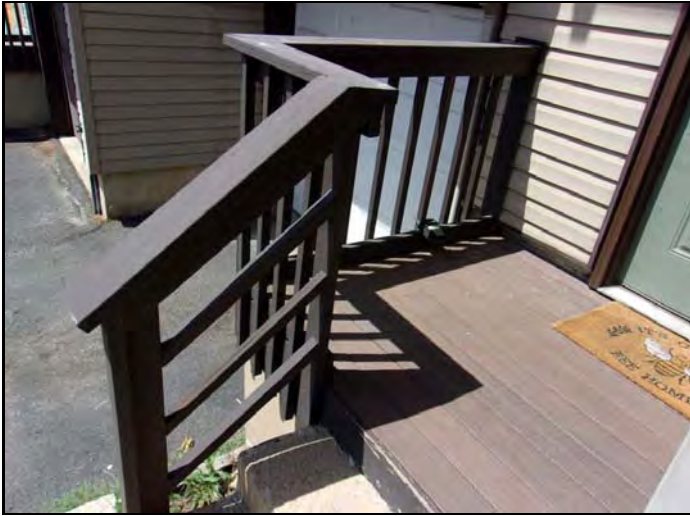
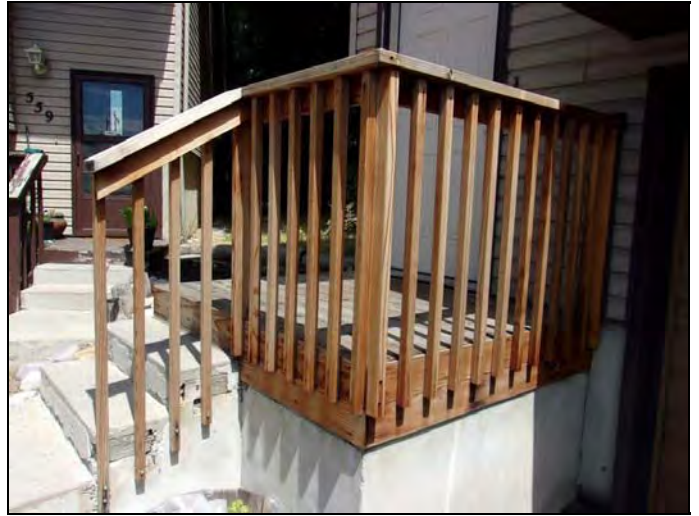
Comp #: 607 Entrance Patios - Replace

Location: **Unit Entrances**

Quantity: **(20) Units**

Research with the client reveals this component is not a responsibility of the association.

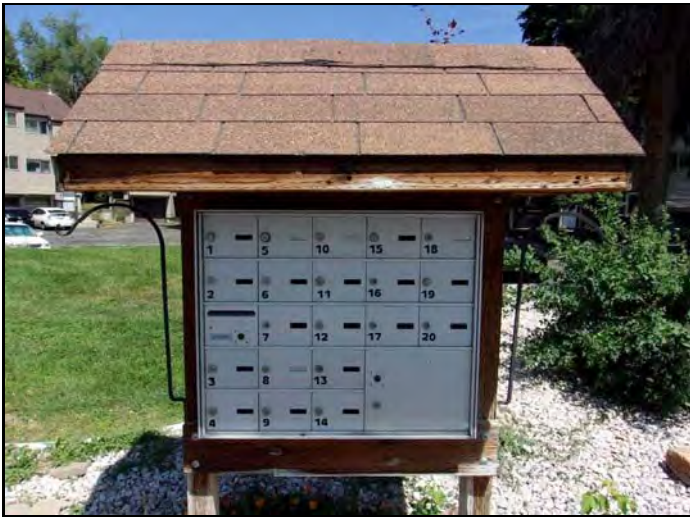
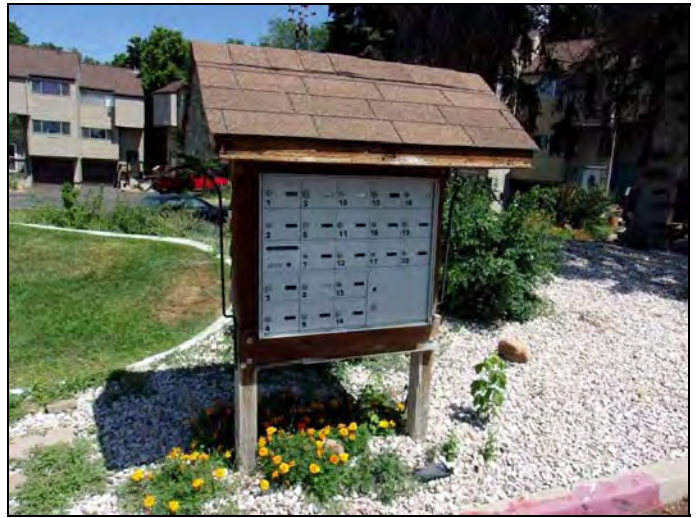
Comp #: 803 Mailboxes - Replace

Location: **Common Area**

Quantity: **(1) Cluster**

Life Expectancy: **25** *Remaining Life:* **11**

The mailboxes are in fair condition. We recommend funding to replace this component approximately every 20 - 25 years. Remaining life based on current age.

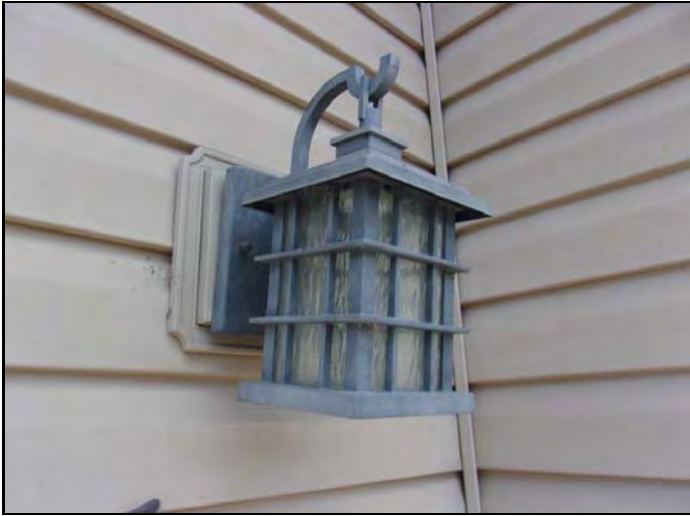
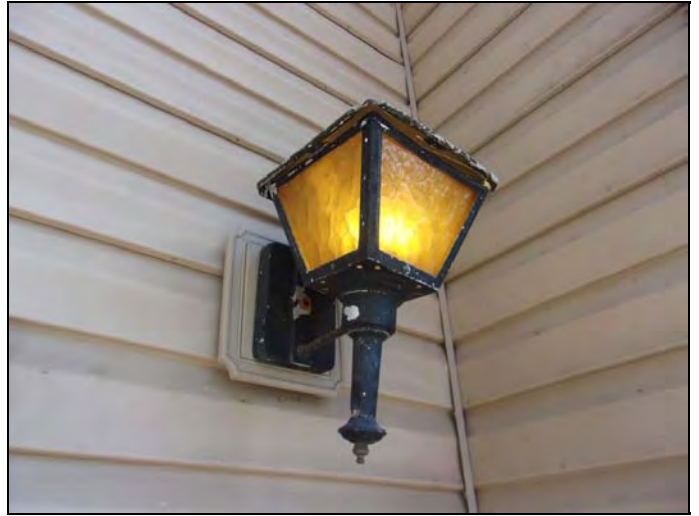
Comp #: 1602 Exterior Light Fixtures - Replace

Location: **Building Exteriors**

Quantity: **(20) Fixtures**

Research with the client reveals this component is not a responsibility of the association.

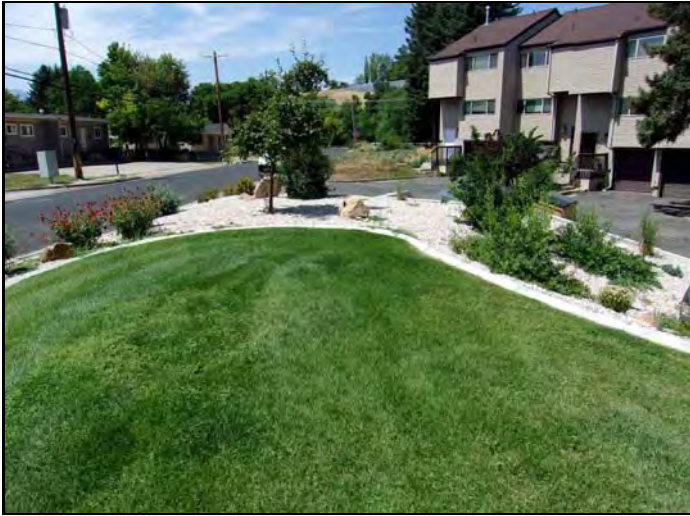
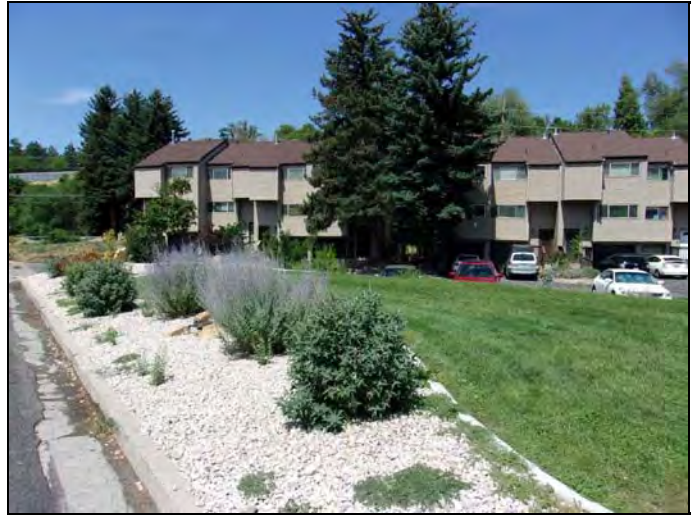
Comp #: 1812 Landscaping & Irrigation System - Renovate

Location: **Common Area**

Quantity: **Moderate SF**

Life Expectancy: **20** *Remaining Life:* **15**

The landscaping and irrigation system appear to be in fair to poor condition. We recommend funding for an allowance to renovate this component approximately every 20 years. Remaining life based on current condition.
