# Cove at Hyde Park Homeowners Association, INC.

## Level 1 Reserve Study

**Report Period – 01/01/2022 – 12/31/2022**

**Executive Summary – Cove at Hyde Park Homeowners Association, INC. - ID # 18832**

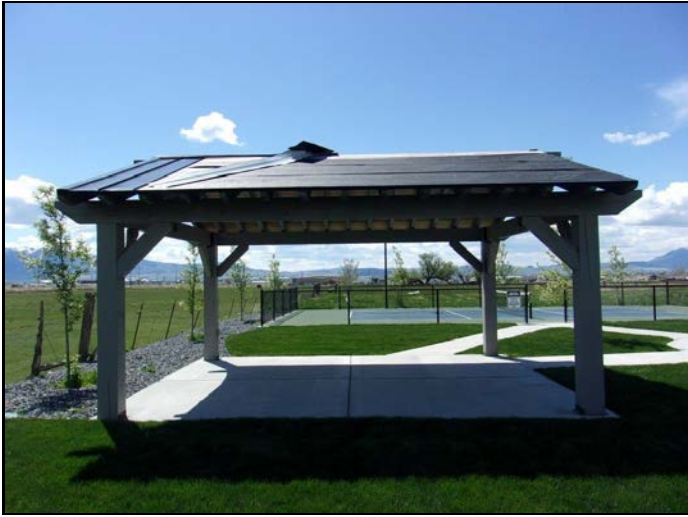
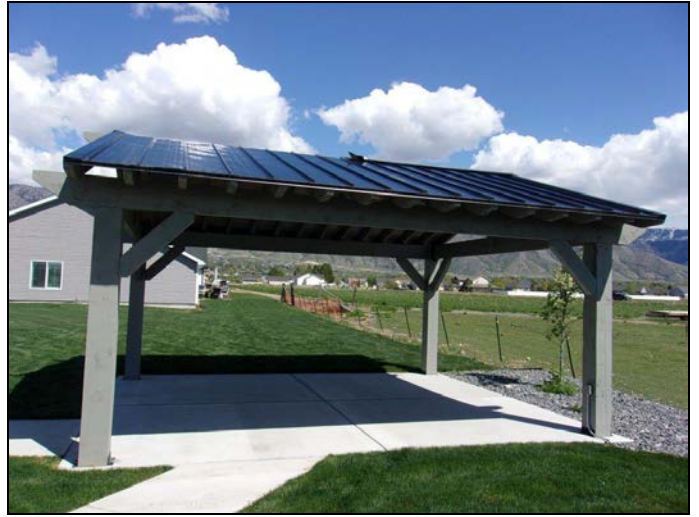
Comp #: 108 Pavilion Roof - Replace

Wind damage was noted at the time of the site visit. We recommend funding to replace this component approximately every 50 - 60 years. Remaining life based on current age.

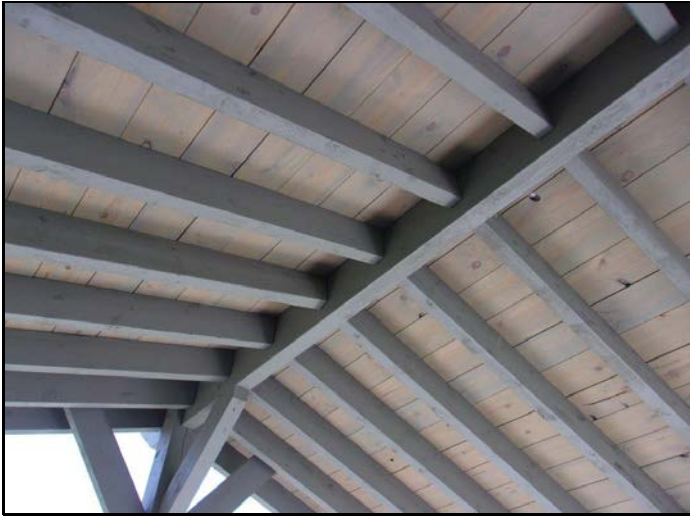
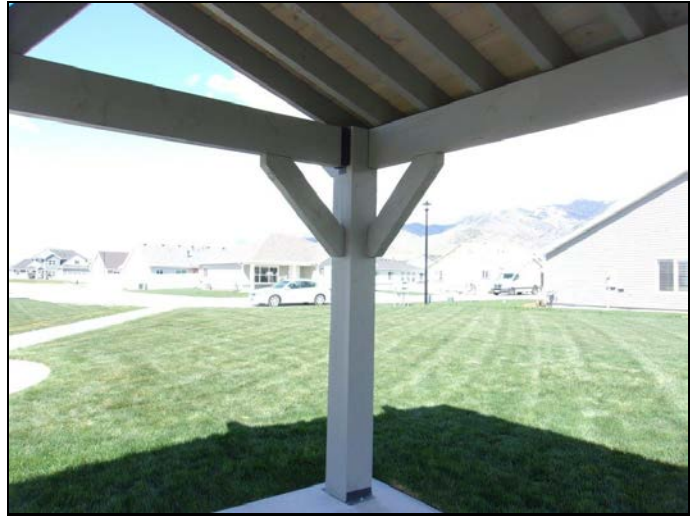
Comp #: 218 Pavilion - Repaint

The painted surfaces are in fair condition. We recommend funding to repaint this component approximately every 6 - 8 years. Remaining life based on current age.

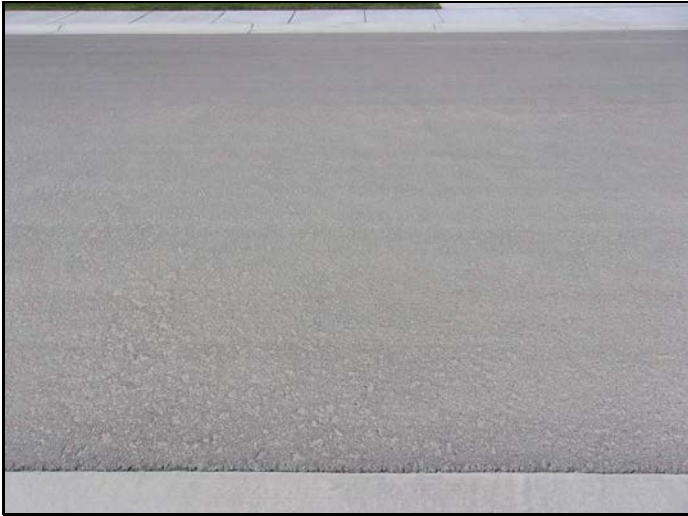
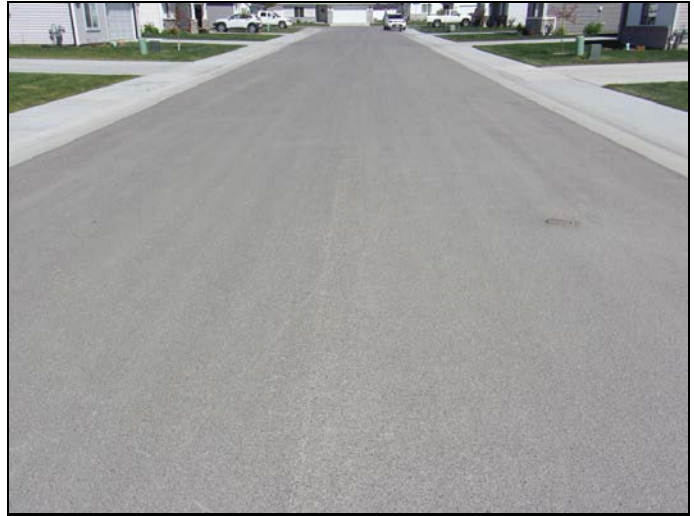
Comp #: 401 Asphalt - Major Rehab

The asphalt surfaces are in good condition. We recommend funding for a major rehab of this component approximately every 25 - 30 years. Remaining life based on current age.

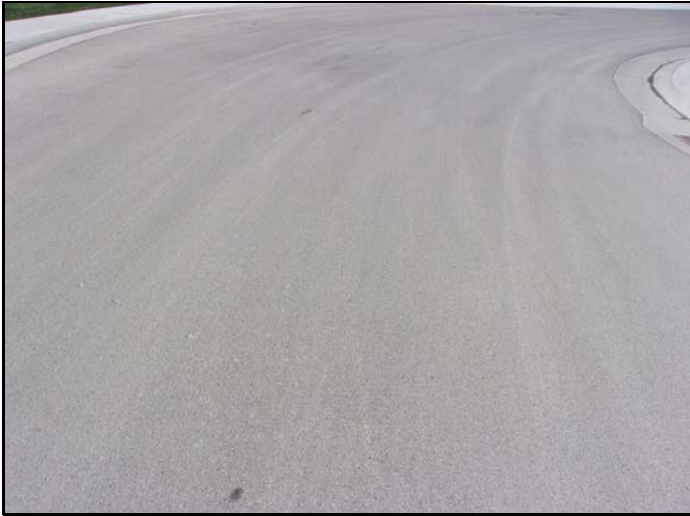
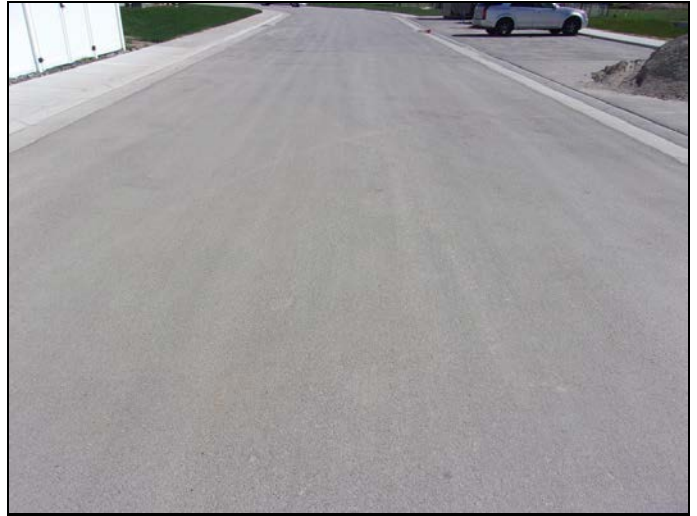
Comp #: 402 Asphalt - Seal Coat

The asphalt seal coat is in poor condition. We recommend funding to seal this component approximately every 3 - 5 years. Remaining life based on current condition.

Projects programmed to occur this fiscal year (FY2022) include asphalt seal coat (Comp# 402). We have programmed an estimated \$10,000 in reserve expenditures toward the completion of these projects. (See page 15)

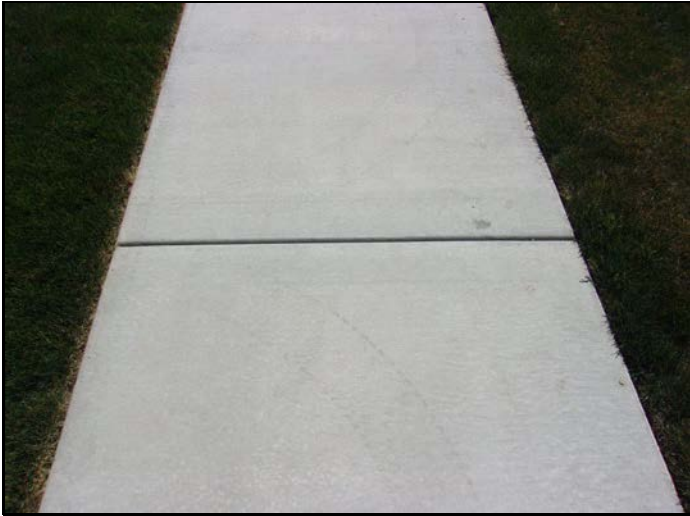
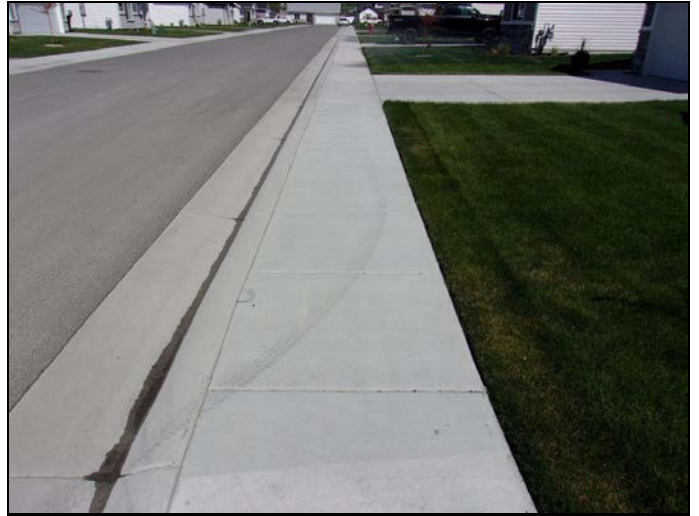
Comp #: 403 Concrete - Partial Repair/Replace

The concrete is in good condition. This component has an extended useful life under normal conditions. We recommend funding to make repairs and partially replace this component approximately every 10 years. Remaining life based on current age.

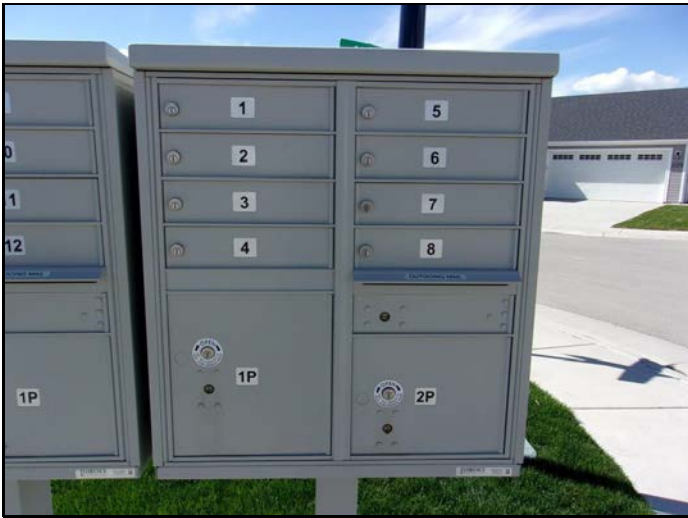
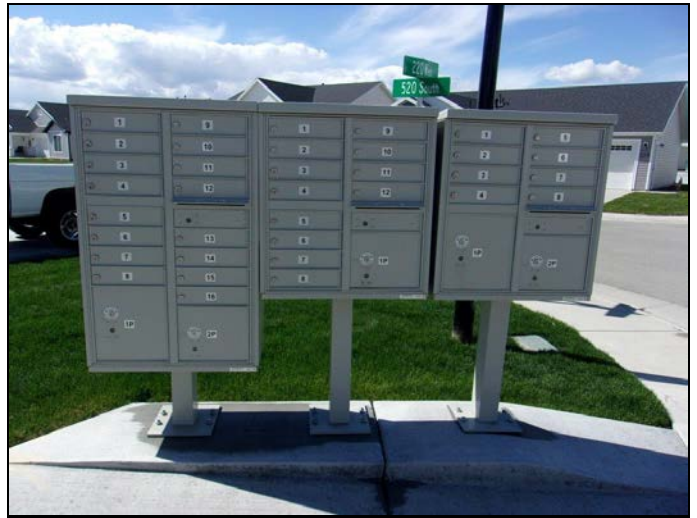
Comp #: 803 Mailboxes - Replace

The mailboxes are in good condition. We recommend funding to replace this component approximately every 20 - 25 years. Remaining life based on current age.

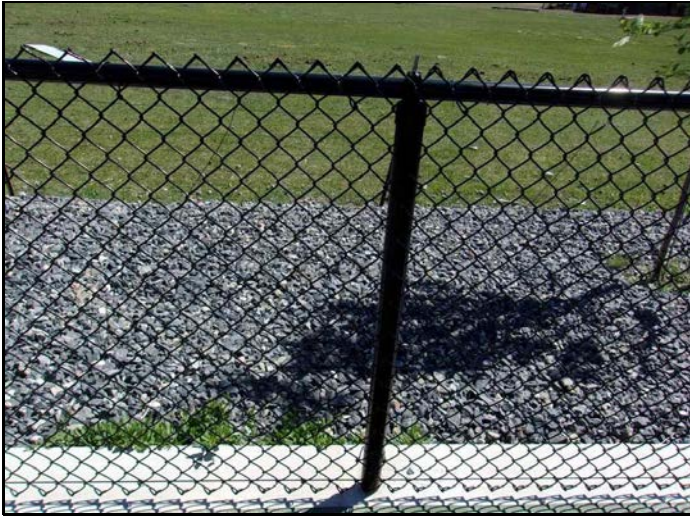
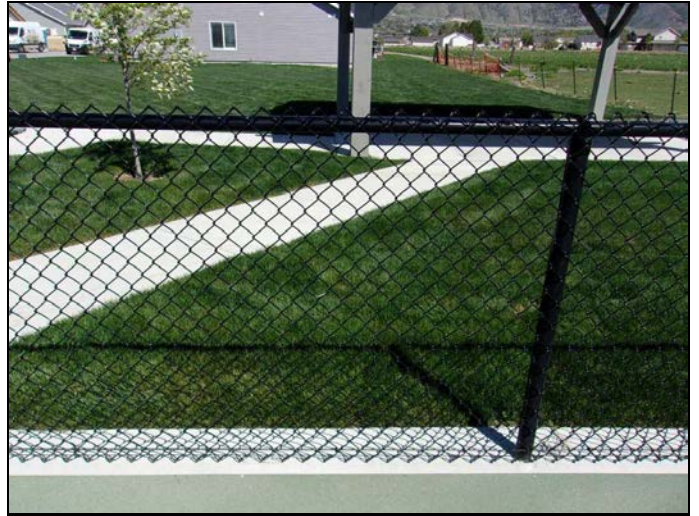
Comp #: 1003 Chain Link Fencing - Replace

The chain link fencing is in good condition. We recommend funding to replace this component approximately every 30 - 40 years. Remaining life based on current age.

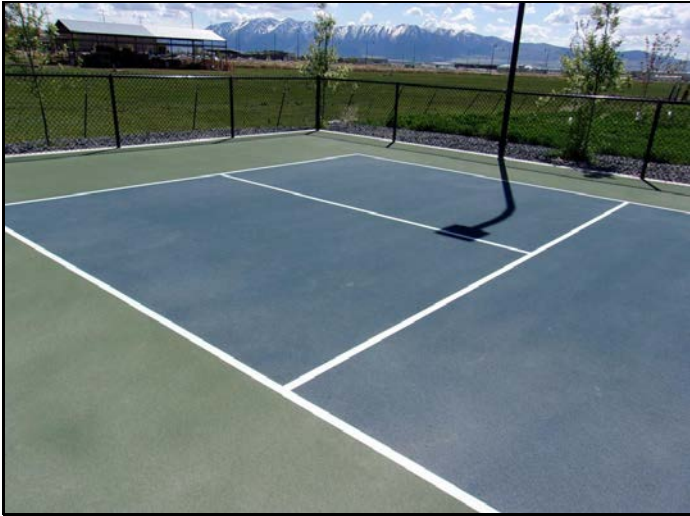
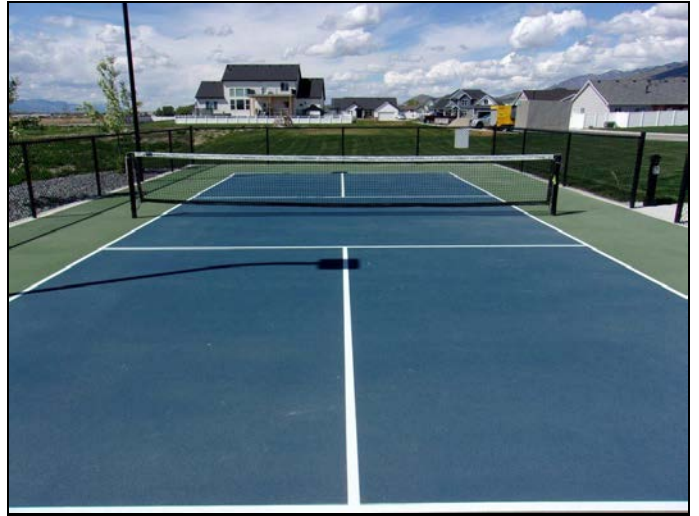
Comp #: 1201 Pickle Ball Court - Resurface

The pickle ball court surface is in good condition. We recommend funding to resurface this component approximately every 8 - 10 years. Remaining life based on current age.

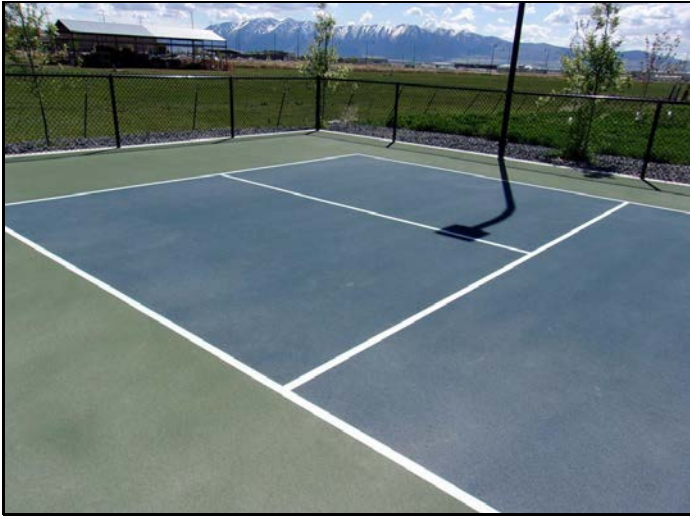
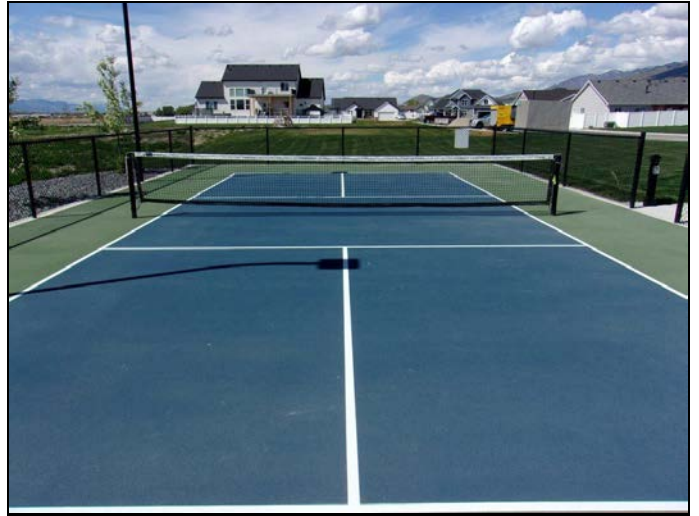
Comp #: 1203 Pickle Ball Court - Replace

The pickle ball court is in good condition. We recommend funding to replace this component approximately every 40 - 50 years. Remaining life based on current age.

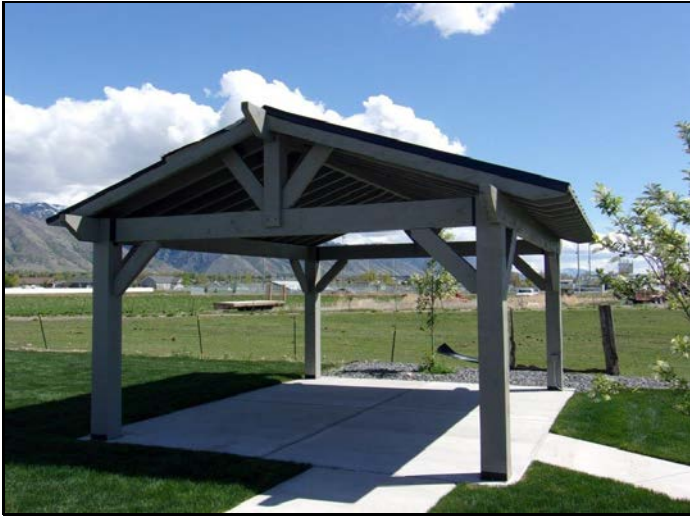
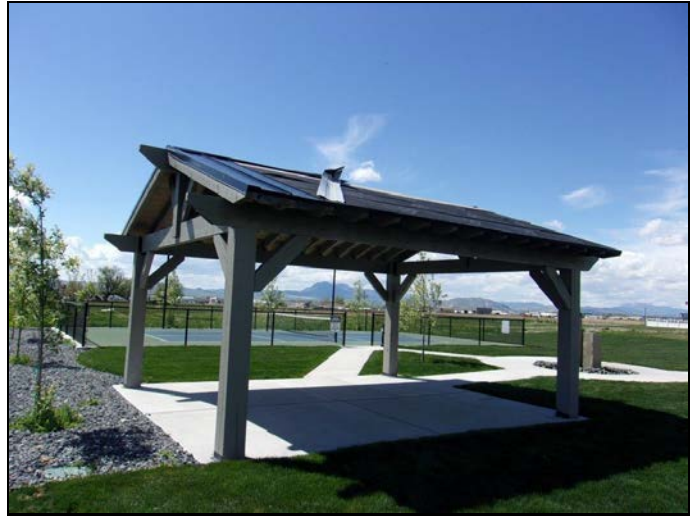
Comp #: 1309 Pavilion - Replace

This component should have an extended useful life under normal conditions. Make repairs as necessary as an operating expense.

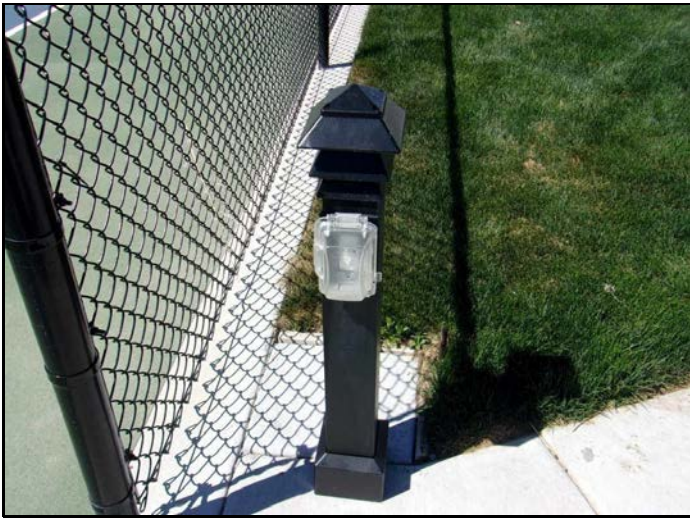
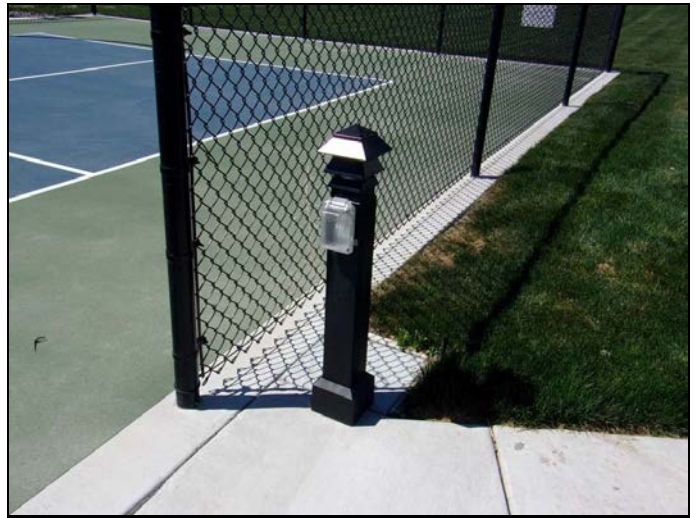
Comp #: 1605 Bollard Lights - Replace

Due to the minimal cost associated with replacing this component, reserve funding is not appropriate. Replace as necessary as an operating expense.

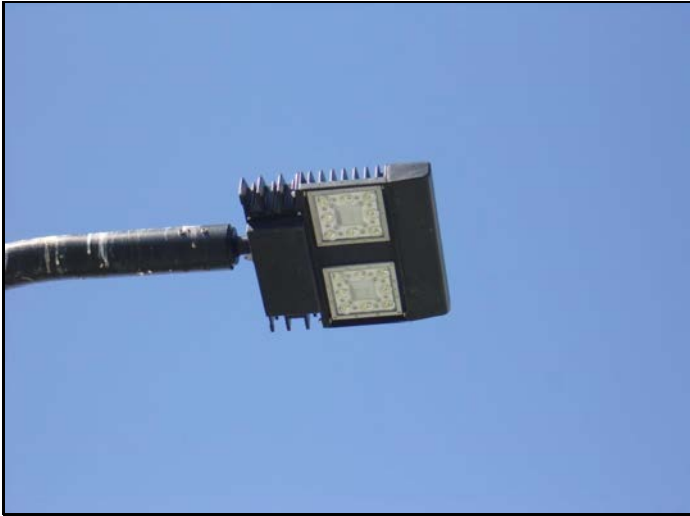
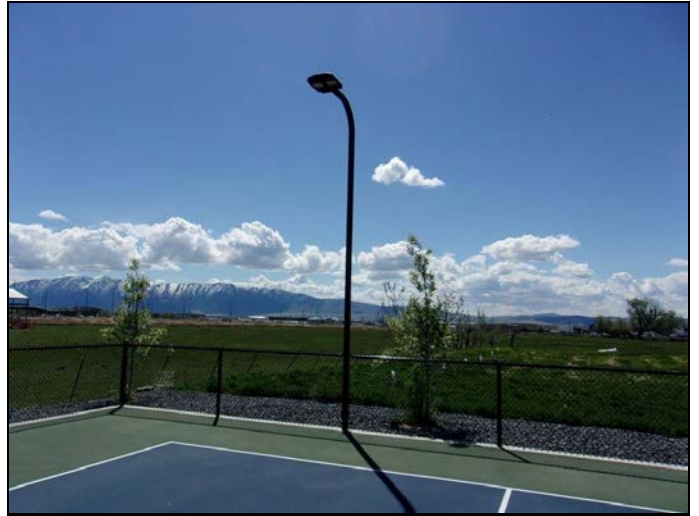
Comp #: 1606 Pickle Ball Court Light Fixtures - Replace

The pickle ball court light fixtures are in good condition. No expectation to replace the light poles. Paint poles as necessary as an operating expense. We recommend funding to replace this component approximately every 20 years. Remaining life based on current age.

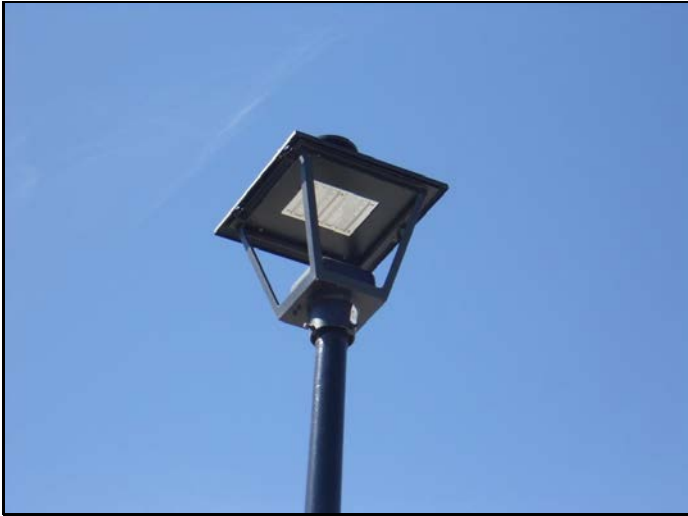
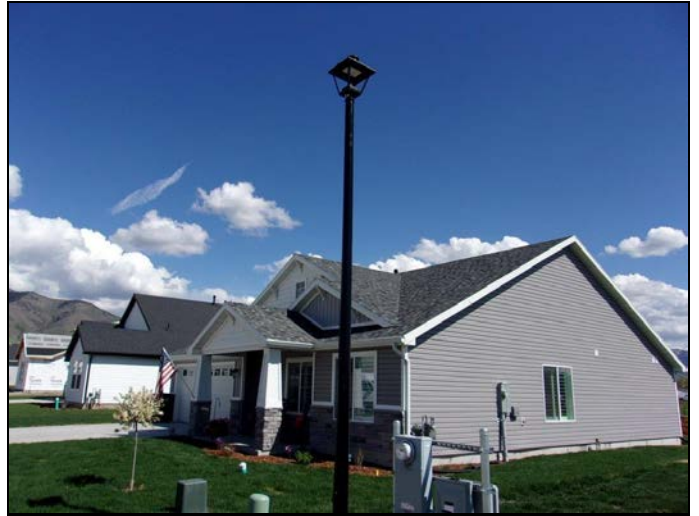
Comp #: 1609 Street Light Fixtures - Replace

The street light fixtures are in good condition. No expectation to replace the light poles. Paint poles as necessary as an operating expense. We recommend funding to replace this component approximately every 20 years. Remaining life based on current age.

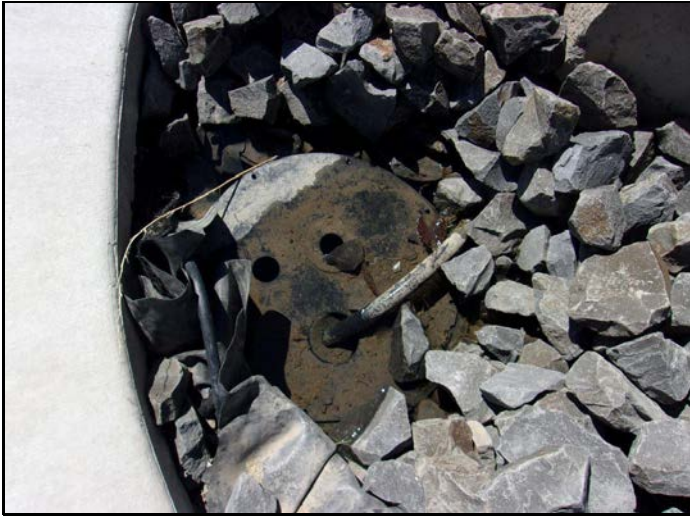
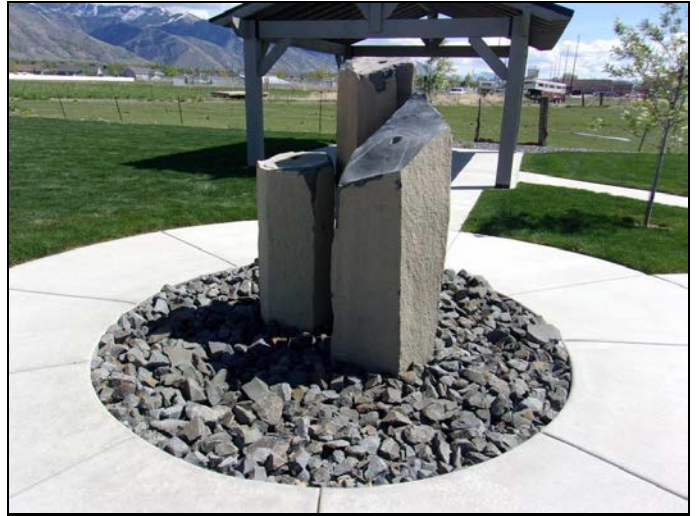
Comp #: 1810 Fountain Equipment - Replace

Due to the minimal cost associated with replacing this component, reserve funding is not appropriate. Replace as necessary as an operating expense.

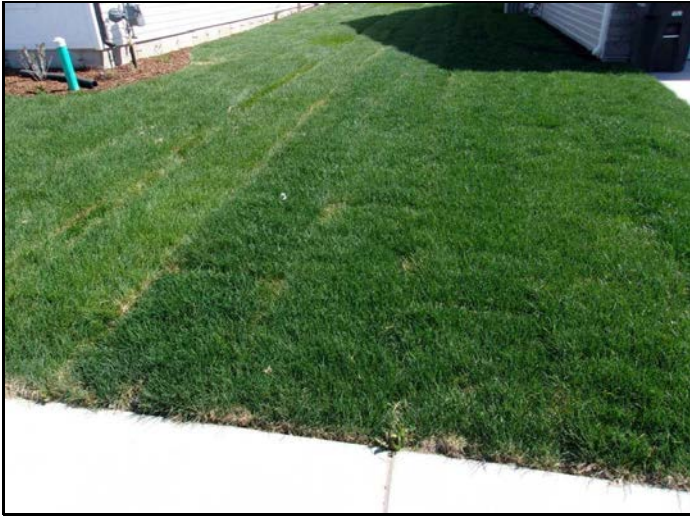
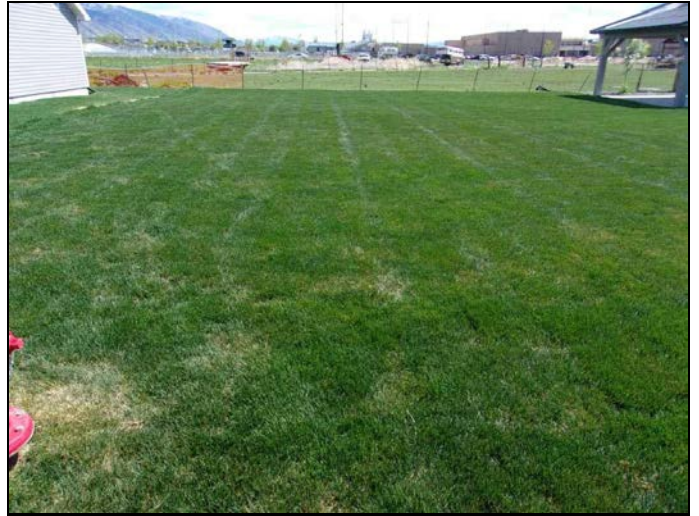
Comp #: 1812 Landscaping & Irrigation System - Renovate

The landscaping and irrigation system are in good condition. We recommend funding for an allowance to renovate the landscaping and irrigation system approximately every 20 years. Remaining life based on current age.
