Devonshire Court

Level 1 Reserve Study

Report Period – 01/01/2026 – 12/31/2026

Type of Study	Full Study
Date of Property Inspection	3/12/2025
Prepared By	Dale Gifford
Analysis Method	Cash Flow
Funding Goal	Full Funding

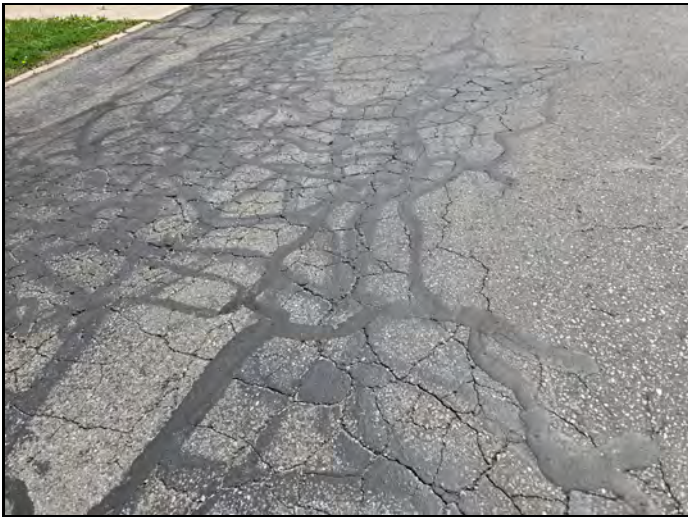
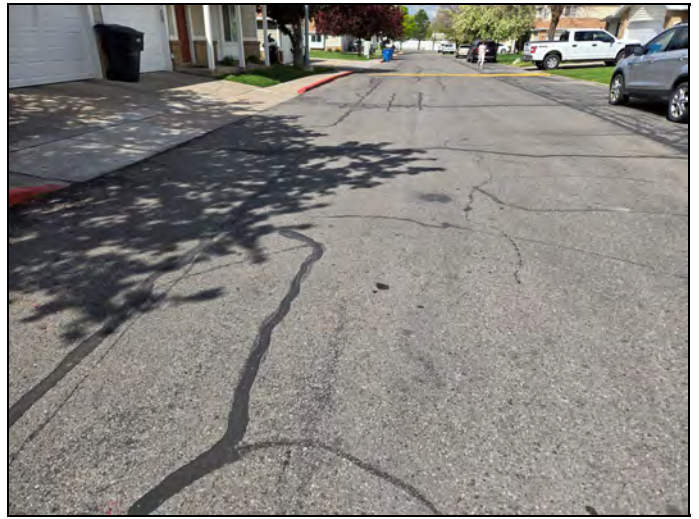
Comp #: 401 Asphalt - Major Rehab

Location: **Community Streets**

Quantity: **Approx. 15,970 SF**

Life Expectancy: **30** *Remaining Life:* **10**

The asphalt surfaces are in fair to poor condition. We recommend funding for a major rehab of this component approximately every 25 - 30 years. Remaining life based on current age and condition.

Best Cost: **\$48,000**

Estimate for major rehab

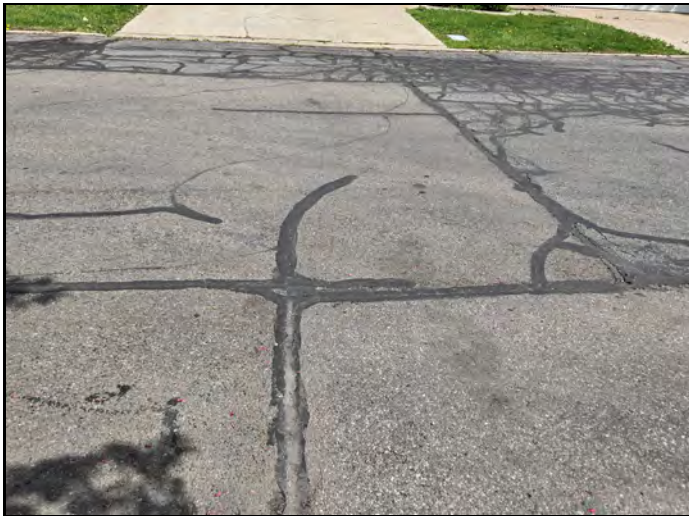
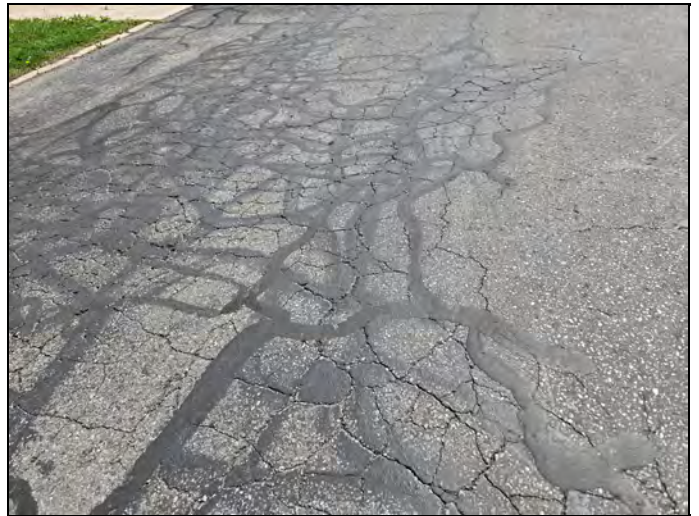
Comp #: 402 Asphalt - Seal Coat

Location: **Community Streets**

Quantity: **Approx. 15,970 SF**

Life Expectancy: **5** *Remaining Life:* **0**

The asphalt seal coat is in poor condition. We recommend funding to seal this component approximately every 3 - 5 years. Remaining life based on current condition.

Best Cost: **\$7,000**

Estimate for seal coat

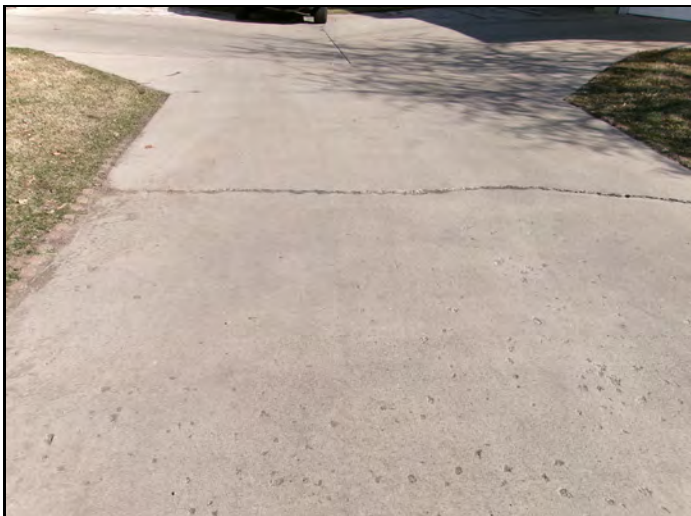
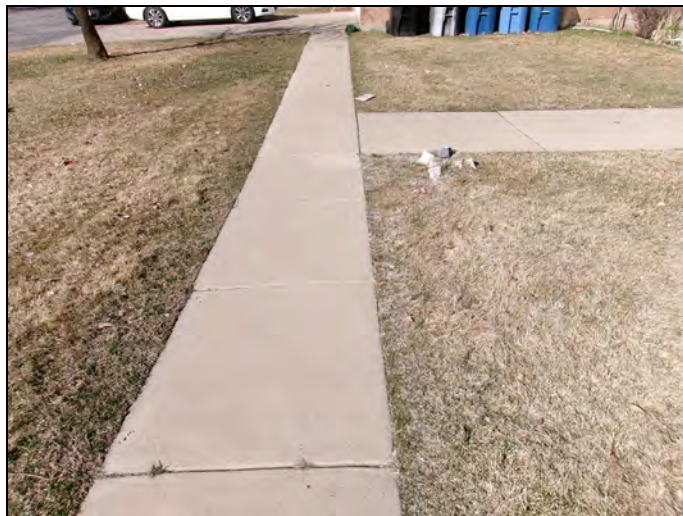
Comp #: 403 Concrete - Partial Repair/Replace

Location: **Driveways, & Sidewalks**

Quantity: **Minimal SF**

Life Expectancy: **10** *Remaining Life:* **10**

The concrete is generally in fair to poor condition. This component has an extended useful life under normal conditions. We recommend funding to make repairs and partially replace this component approximately every 10 years. Remaining life based on current age.

Best Cost: **\$8,000**

Allowance to repair/replace

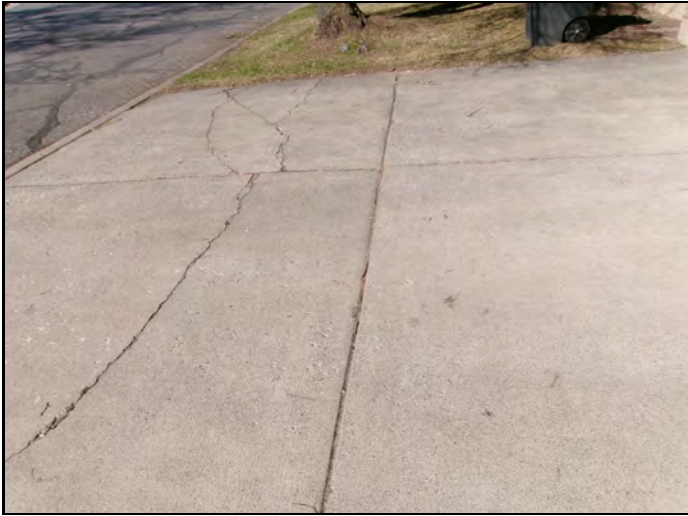
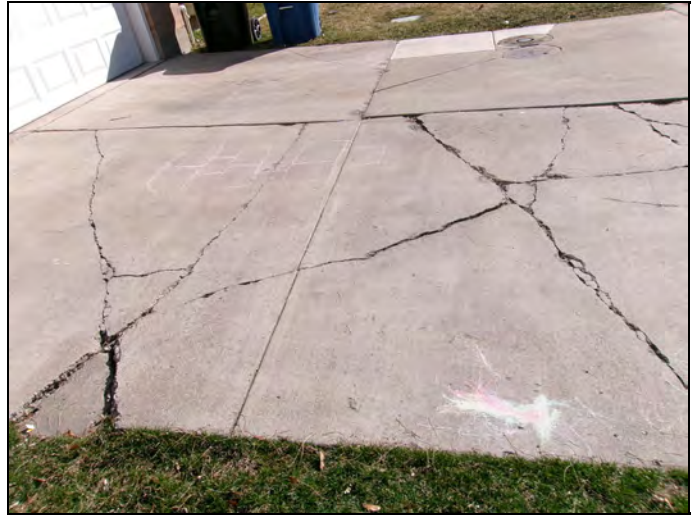
Comp #: 490 Driveways - Partial Replace

Location: **Driveways**

Quantity: **(12) Units**

Life Expectancy: **99** *Remaining Life:* **0**

The driveways are generally in fair to poor condition. We recommend funding to partially replace this component as a one-time project.

Best Cost: **\$60,000**

Allowance to replace

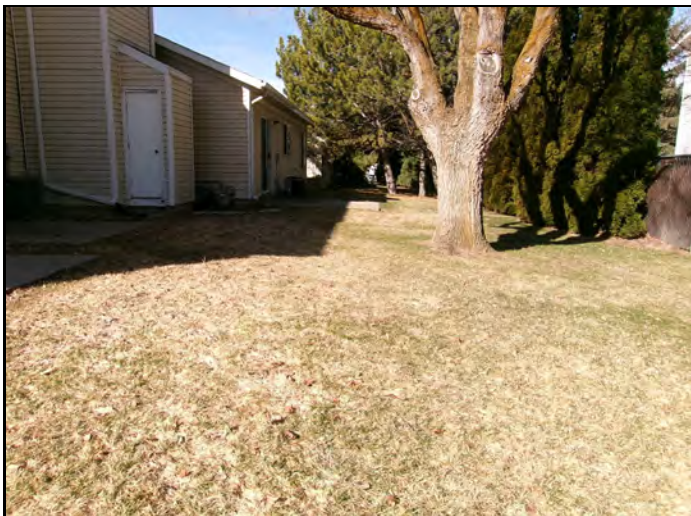
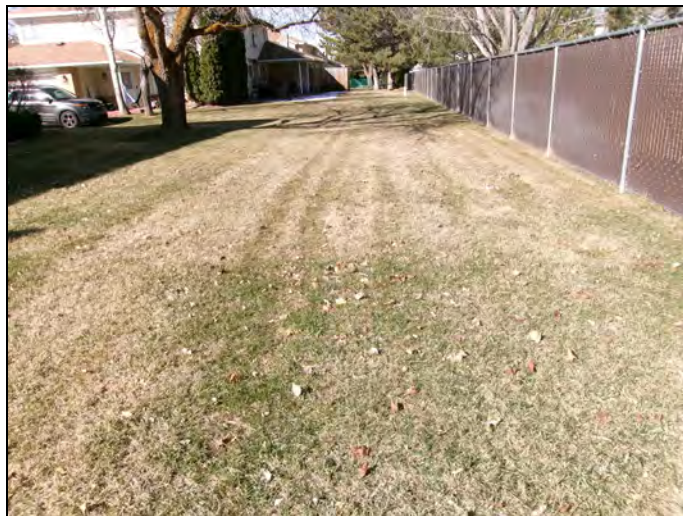
Comp #: 1812 Landscaping & Irrigation System - Renovate

Location: **Common Area**

Quantity: **Moderate SF**

Life Expectancy: **20** *Remaining Life:* **10**

The landscaping and irrigation system appear to be in fair condition. We recommend funding for an allowance to renovate this component approximately every 20 years. Remaining life based on current age.

Best Cost: **\$15,000**

Allowance to renovate
