Ellie's Landing

Level 1 Reserve Study

Executive Summary – Ellie's Landing - ID # 19416

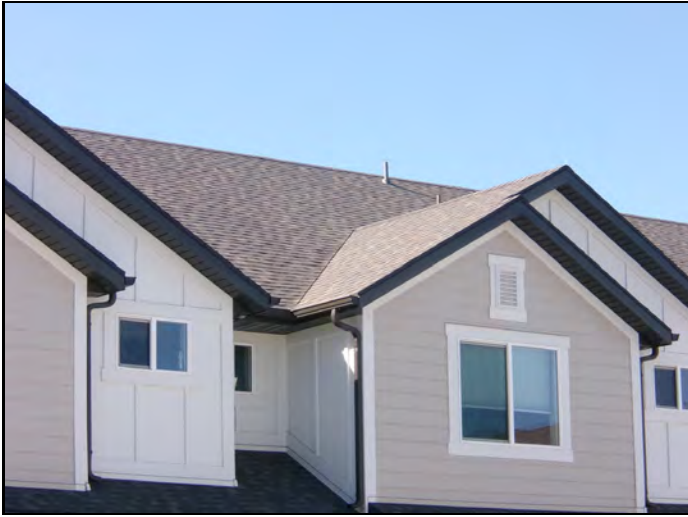
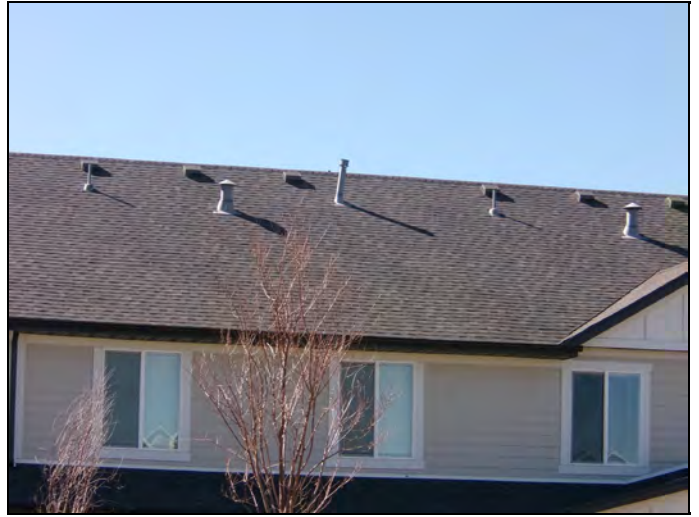
Comp #: 105 Roofs - Replace

The roofs appear to be in good condition. We recommend funding to replace this component approximately every 20 - 25 years. Remaining life based on current age.

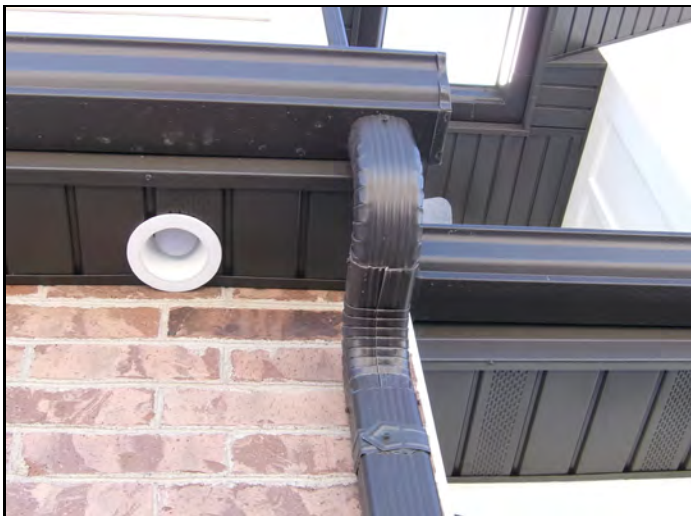
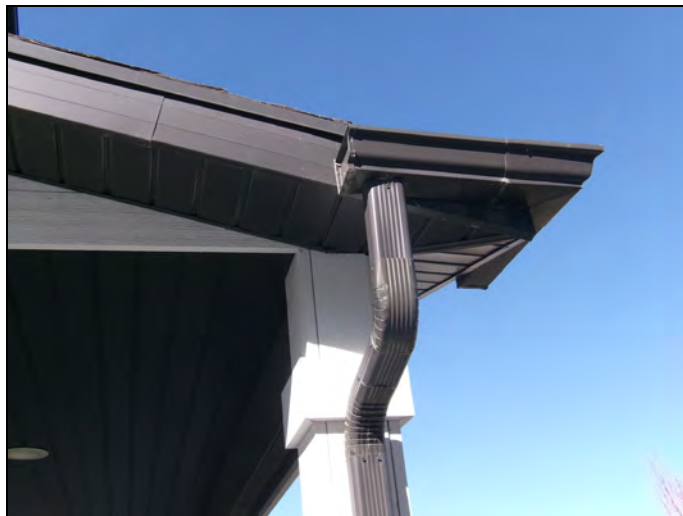
Comp #: 120 Rain Gutters/Downspouts - Replace

The rain gutters and downspouts appear to be in good condition. We recommend funding to replace this component approximately every 25 - 30 years. Remaining life based on current age.

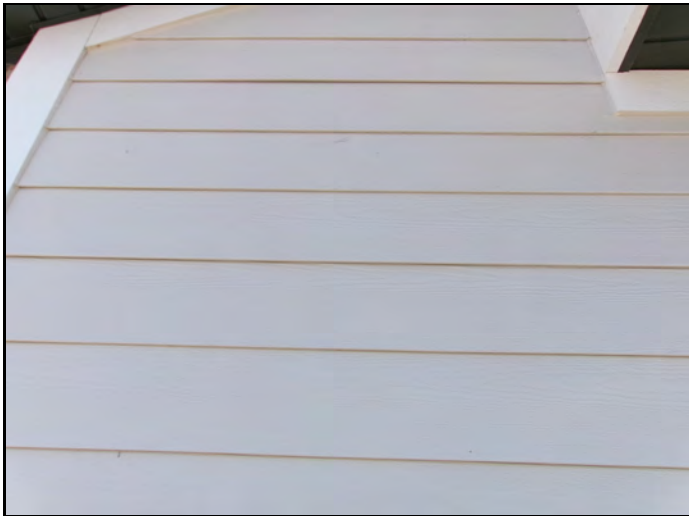
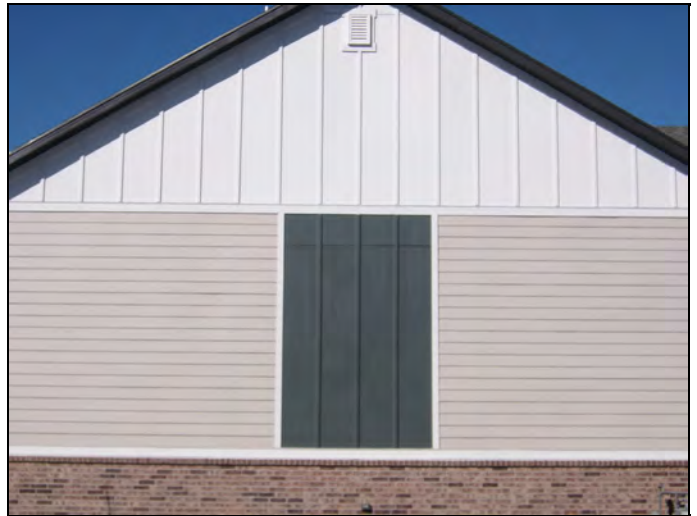
Comp #: 215 Siding - Repair/Repaint

The siding painted surfaces appear to be in good condition. We recommend funding to repair/repaint this component approximately every 8 - 10 years. Remaining life is based on current age.

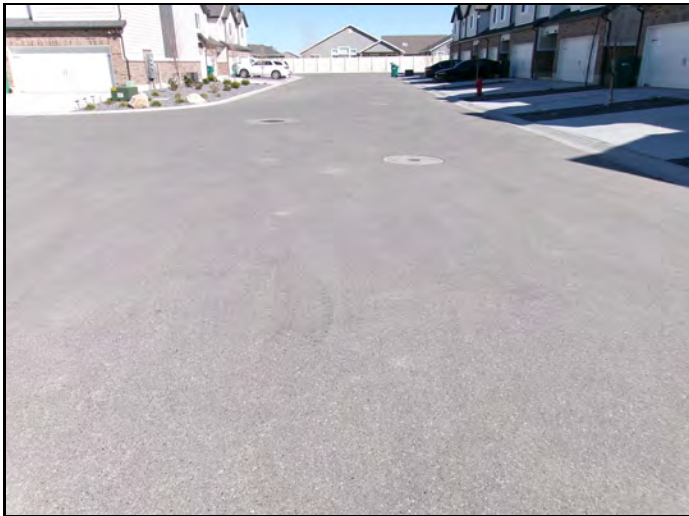
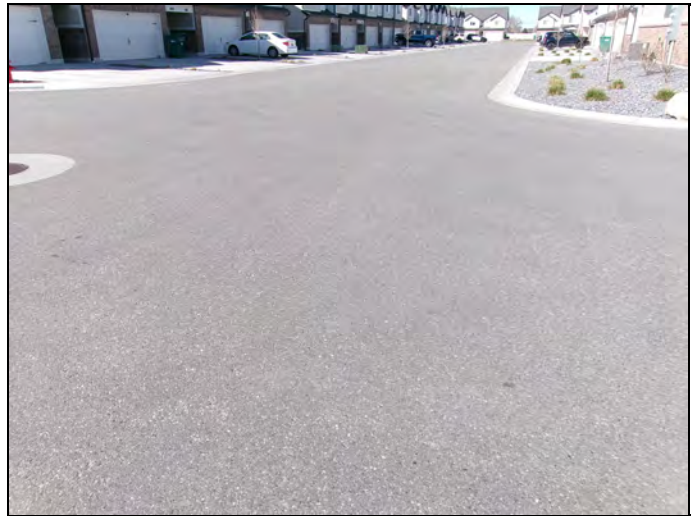
Comp #: 401 Asphalt - Major Rehab

The asphalt surfaces are in good condition. We recommend funding for a major rehab of this component approximately every 25 - 30 years. Remaining life based on current age.

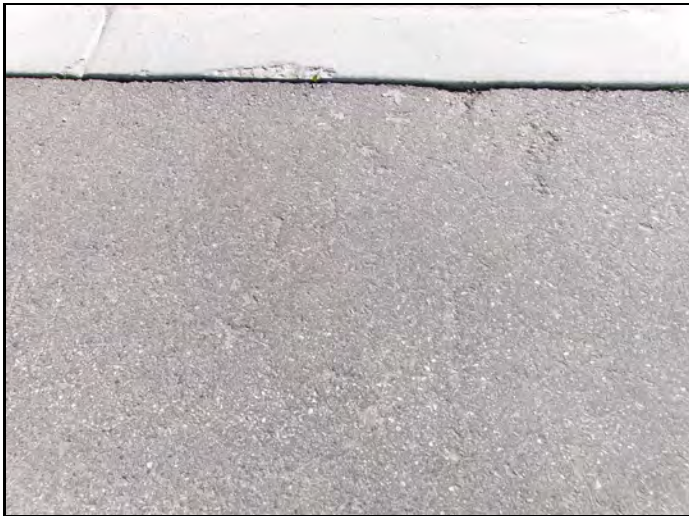
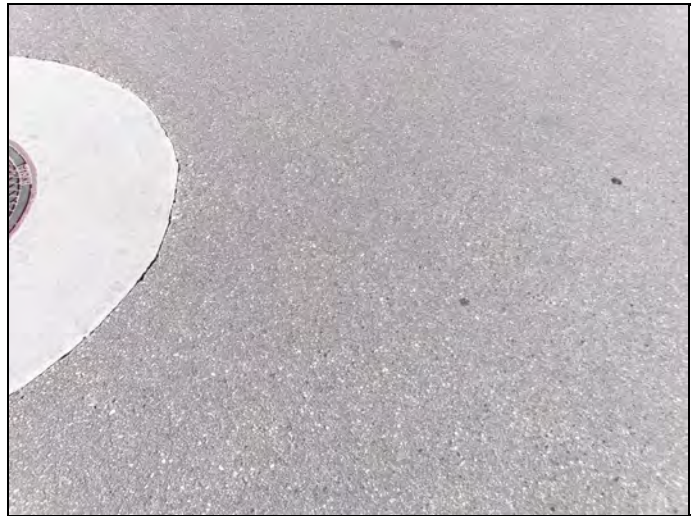
Comp #: 402 Asphalt - Seal Coat

The asphalt seal coat is in poor condition. We recommend funding to seal this component approximately every 3 - 5 years. Remaining life based on current condition.

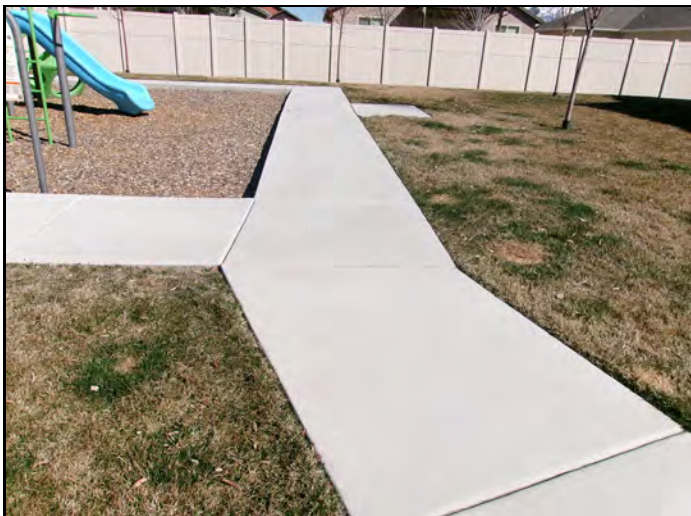
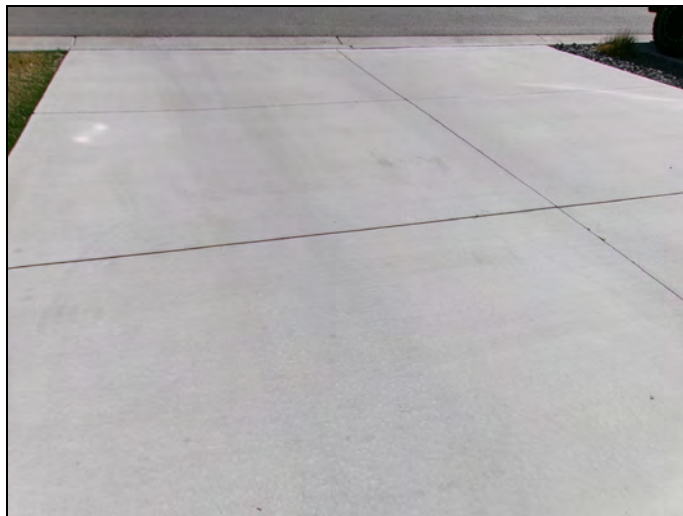
Comp #: 403 Concrete - Partial Repair/Replace

The concrete is in good condition. This component has an extended useful life under normal conditions. We recommend funding to make repairs and partially replace this component approximately every 10 years. Remaining life based on current age.

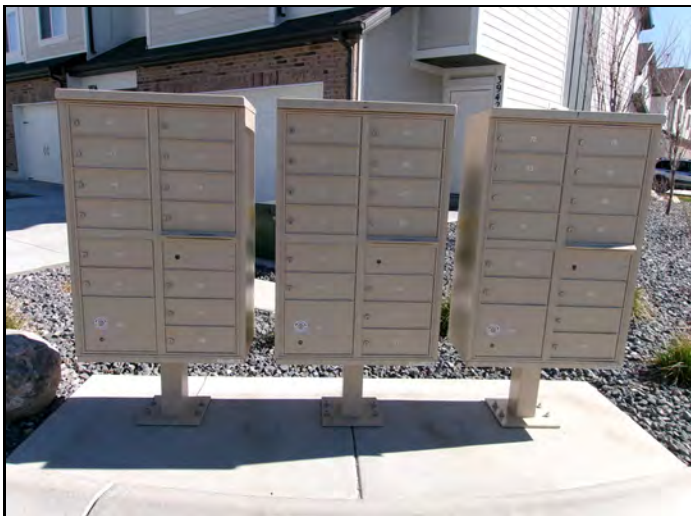
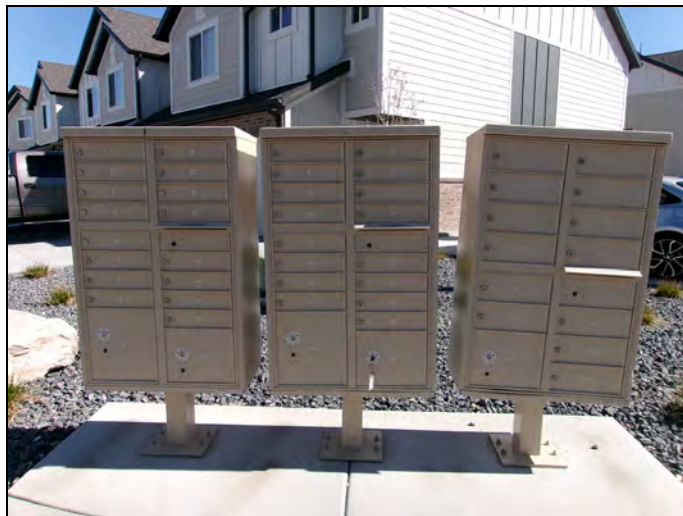
Comp #: 803 Mailboxes - Replace

The mailboxes are in good condition. We recommend funding to replace this component approximately every 20 - 25 years. Remaining life based on current age.

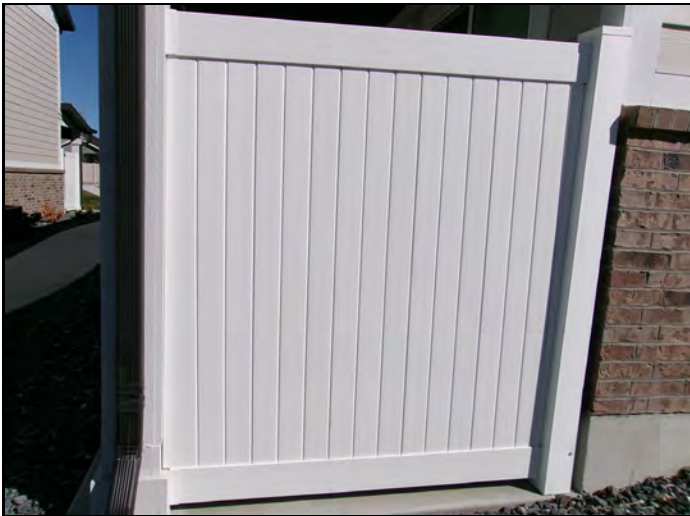
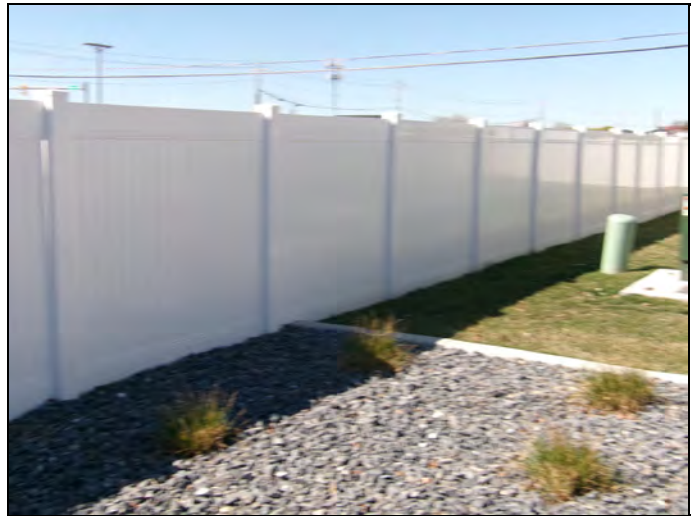
Comp #: 1008 Vinyl Fencing - Replace

The vinyl fencing is in good condition. We recommend funding to replace this component approximately every 25 - 30 years. Remaining life based on current age.

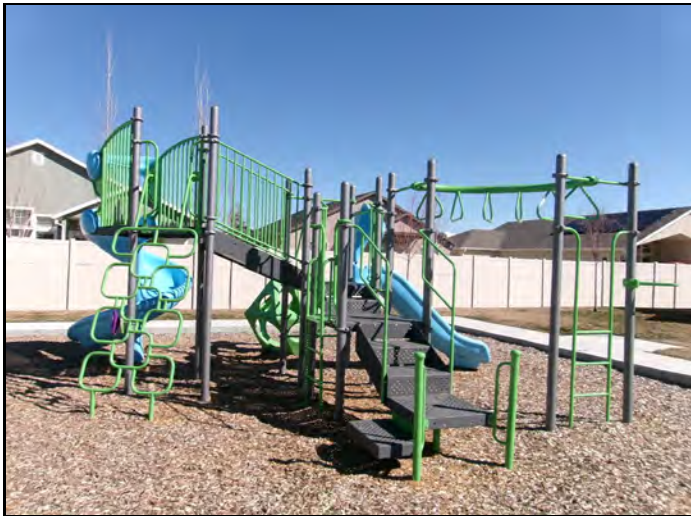
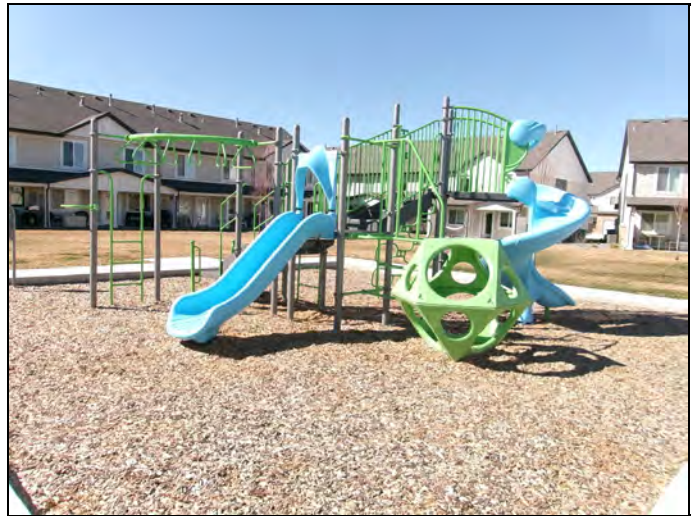
Comp #: 1301 Play Structure - Replace

The play structure is in good condition. We recommend funding to replace this component approximately every 20 - 25 years. Remaining life based on current age.

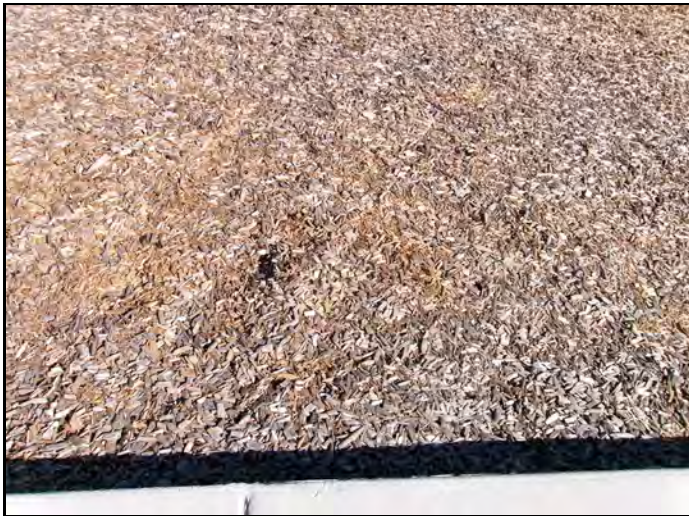
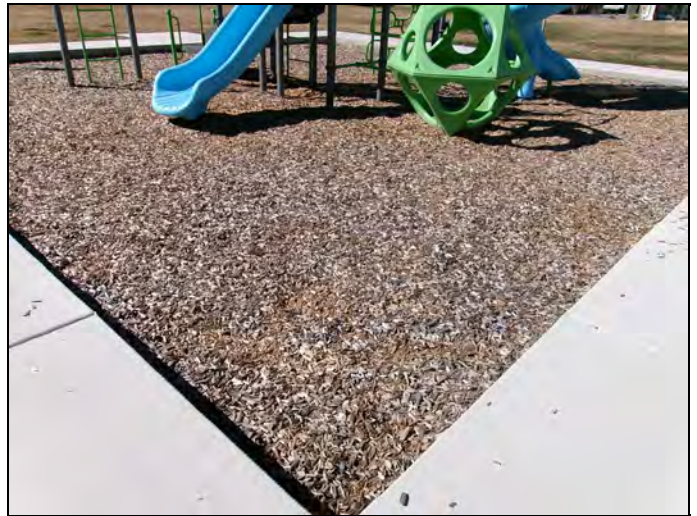
Comp #: 1303 Play Area Groundcover - Refill

The play area groundcover is in good condition. We recommend funding to refill this component approximately every 3 - 5 years. Remaining life is based on current age.

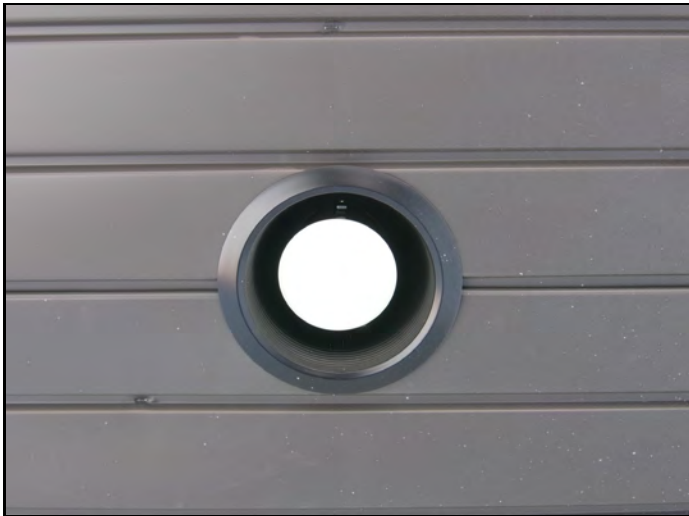
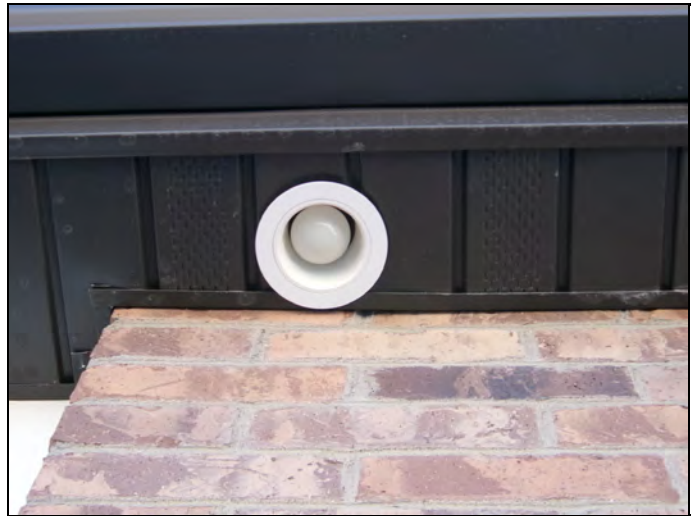
Comp #: 1602 Exterior Light Fixtures - Replace

The exterior light fixtures are in good condition. We recommend funding to replace this component approximately every 16 - 20 years. Remaining life based on current age.

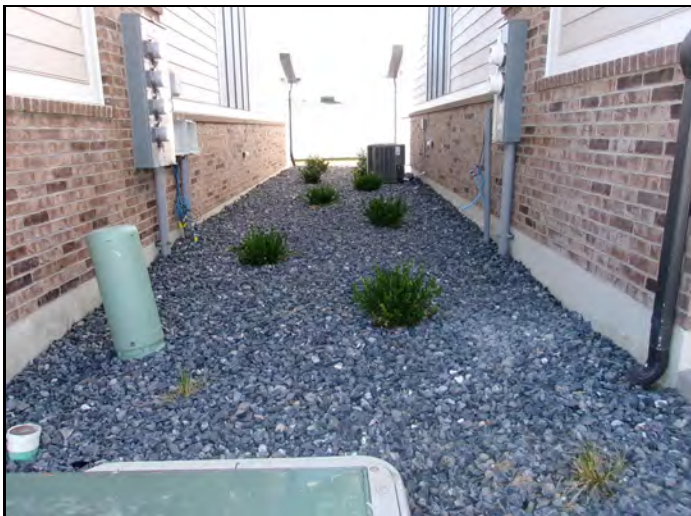
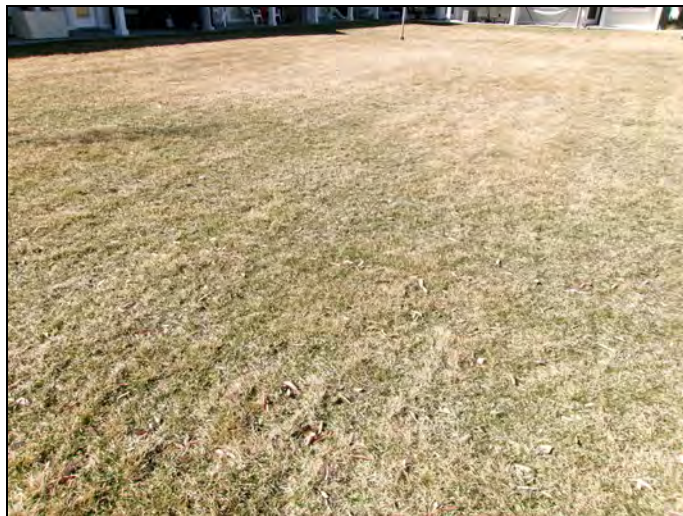
Comp #: 1812 Landscaping & Irrigation System - Renovate

The landscaping and irrigation system appear to be generally in good condition. We recommend funding for an allowance to renovate this component approximately every 20 years. Remaining life based on current age.
