Le Ruisseau

Level 1 Reserve Study

Executive Summary – Le Ruisseau - ID # 19419

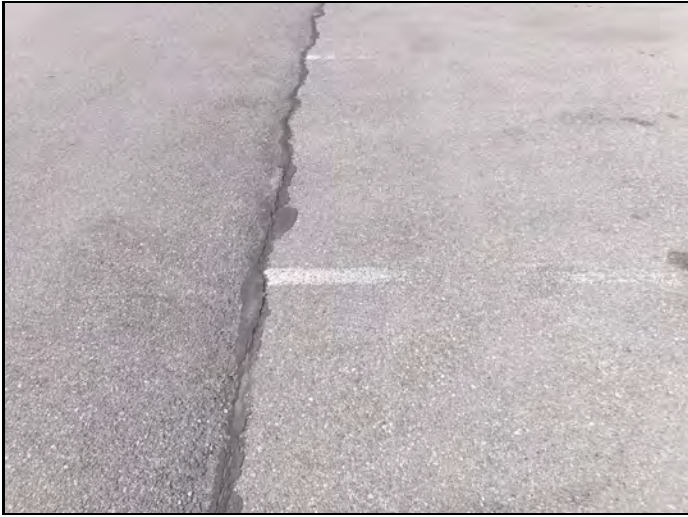
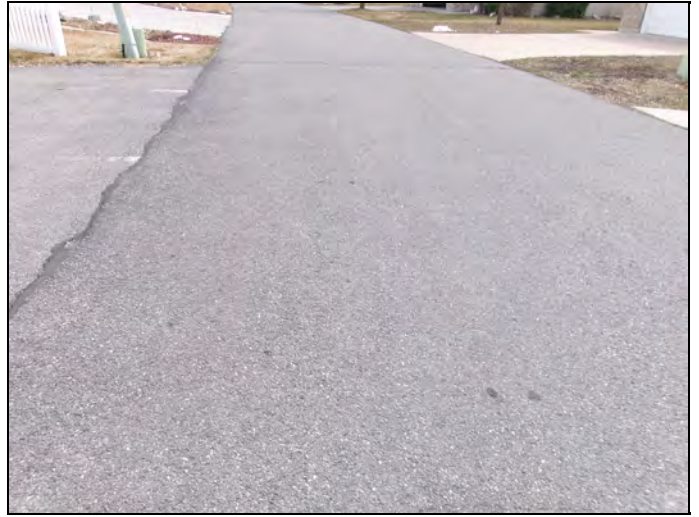
Comp #: 401 Asphalt - Major Rehab

Location: **Community Streets**

Quantity: **Approx. 8,720 SF**

Life Expectancy: **30** *Remaining Life:* **10**

The asphalt surfaces are in fair condition. We recommend funding for a major rehab of this component approximately every 25 - 30 years. Remaining life based on current age and condition.

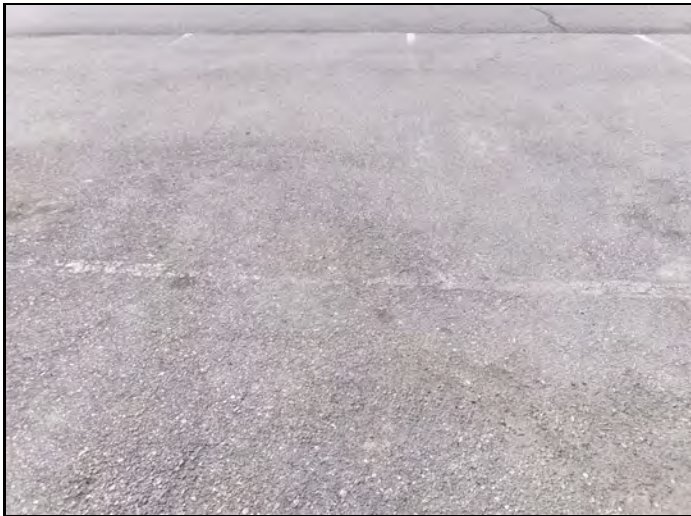
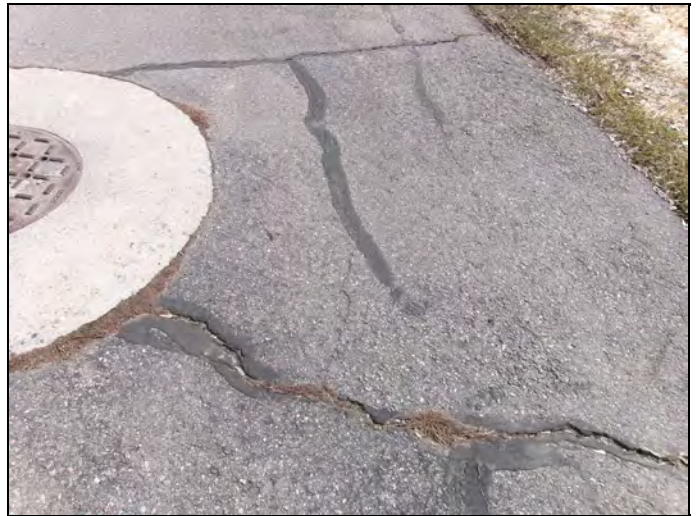
Comp #: 402 Asphalt - Seal Coat

Location: **Community Streets**

Quantity: **Approx. 8,720 SF**

Life Expectancy: **5** *Remaining Life:* **0**

The asphalt seal coat is in poor condition. We recommend funding to seal this component approximately every 3 - 5 years. Remaining life based on current condition.

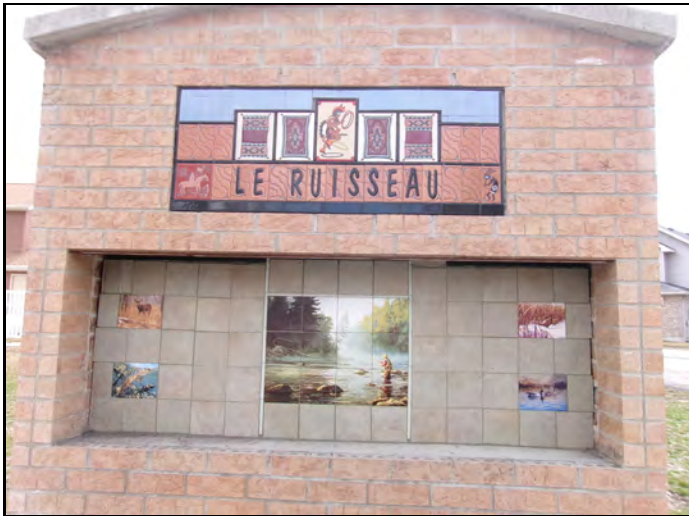
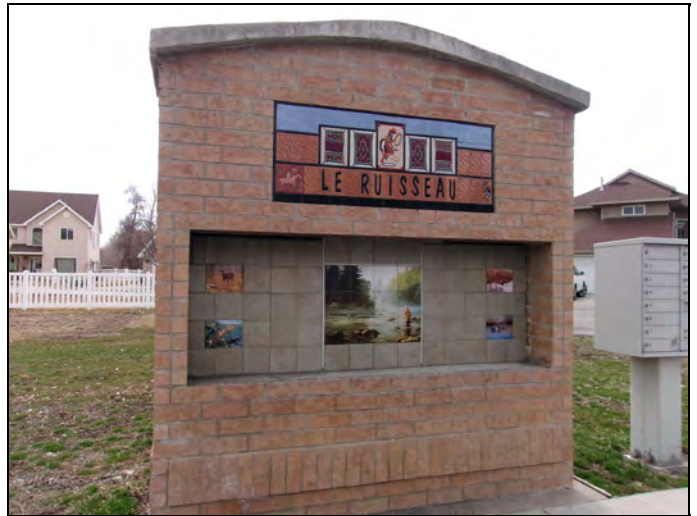
Comp #: 801 Monument Sign - Refurbish

Location: **Community Entrance**

Quantity: **(1) Sign**

Life Expectancy: **20** *Remaining Life:* **17**

The monument sign is in good condition. We recommend funding to refurbish this component approximately every 15 - 20 years. Remaining life is based on current age.

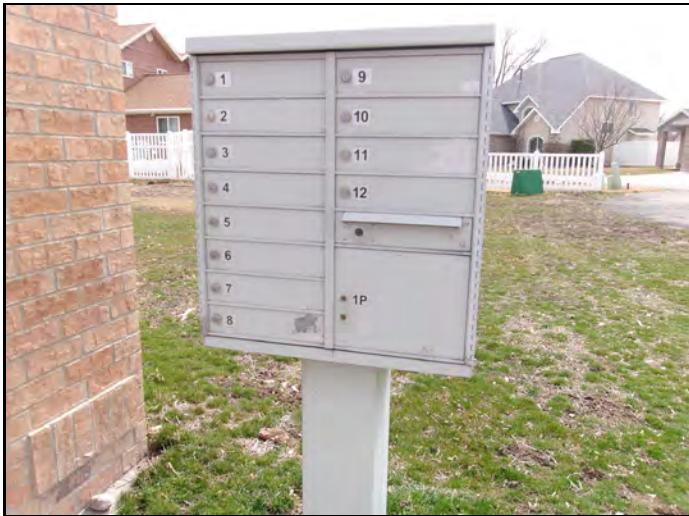
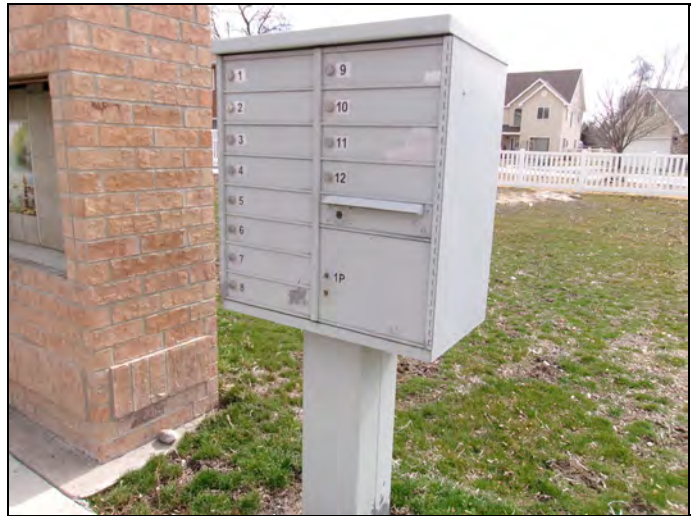
Comp #: 803 Mailbox - Replace

Location: **Community Entrance**

Quantity: **(1) Cluster**

Life Expectancy: **20** *Remaining Life:* **3**

The mailboxes are in fair condition. We recommend funding to replace this component approximately every 20 - 25 years. Remaining life based on current age and condition.

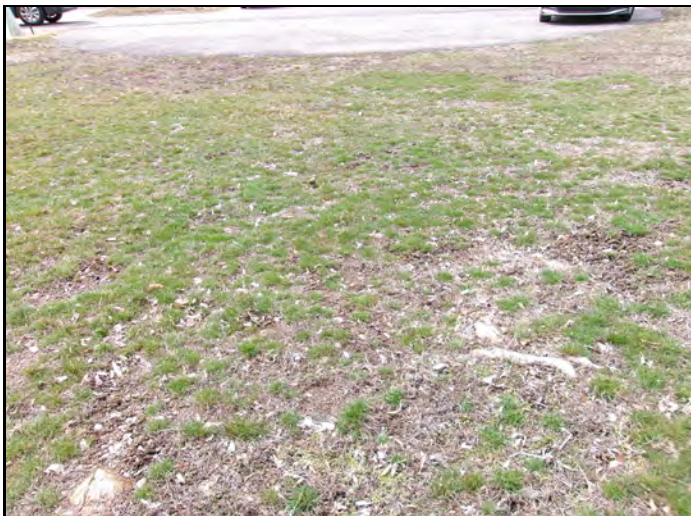
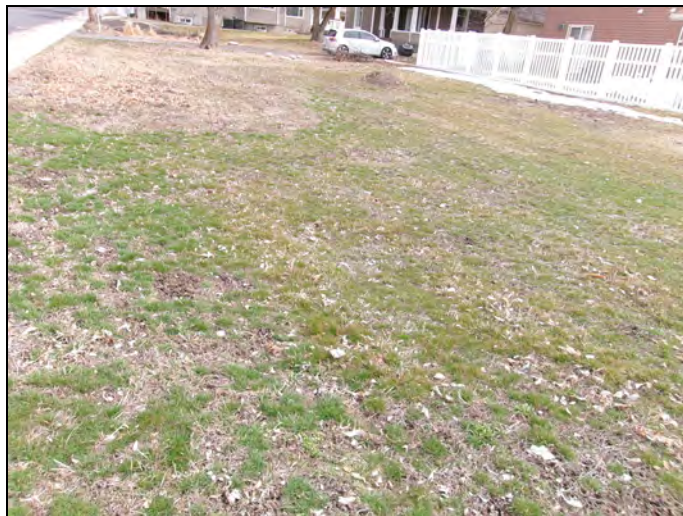
Comp #: 1812 Landscaping & Irrigation System - Renovate

Location: **Common Area**

Quantity: **Minimal SF**

Life Expectancy: **20** *Remaining Life:* **0**

The landscaping and irrigation system appear to be in fair to poor condition. We recommend funding for an allowance to renovate this component approximately every 20 years. Remaining life based on current age.
