Skyview Meadows

Level 1 Reserve Study

Client Reference Number	19427
Property Type	Townhouse
Number of Units	25
Fiscal Year End	12/31

Type of Study	Full Study
Date of Property Inspection	3/13/2025
Prepared By	Dale Gifford
Analysis Method	Cash Flow
Funding Goal	Full Funding

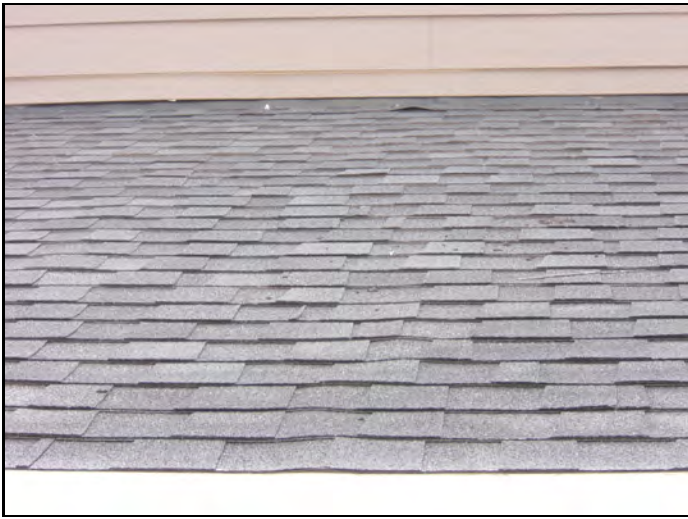
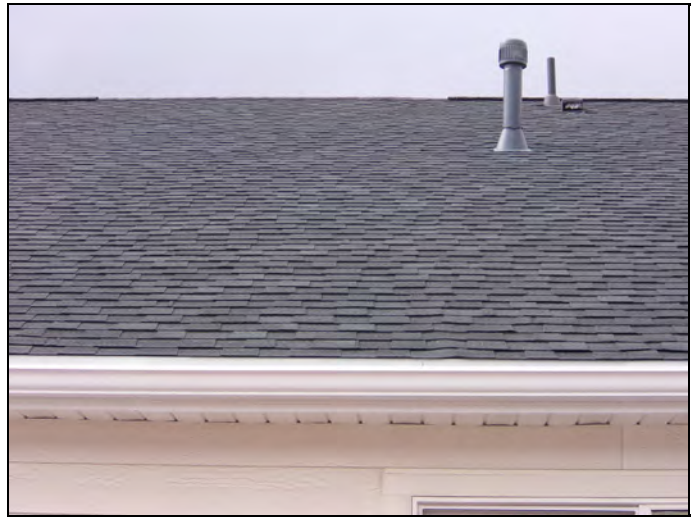
Comp #: 105 Roofs - Replace

Location: **Building Roofs**

Quantity: **Approx. 53,200 SF**

Life Expectancy: **25 Remaining Life: 22**

The roofs appear to be in good condition. We recommend funding to replace this component approximately every 20 - 25 years. Remaining life based on current age.

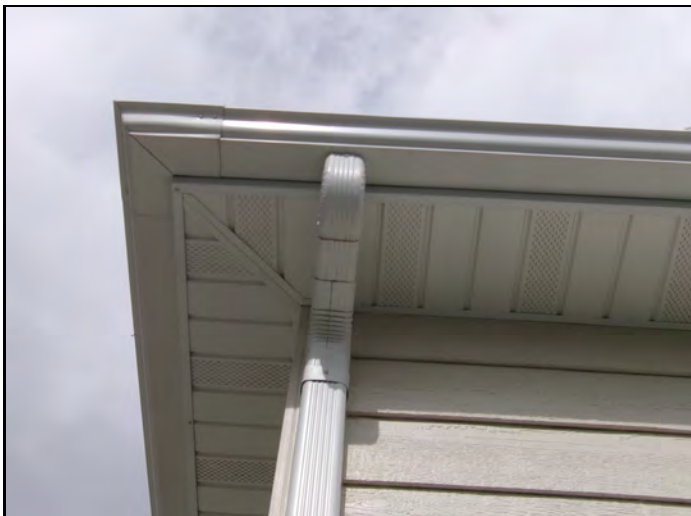
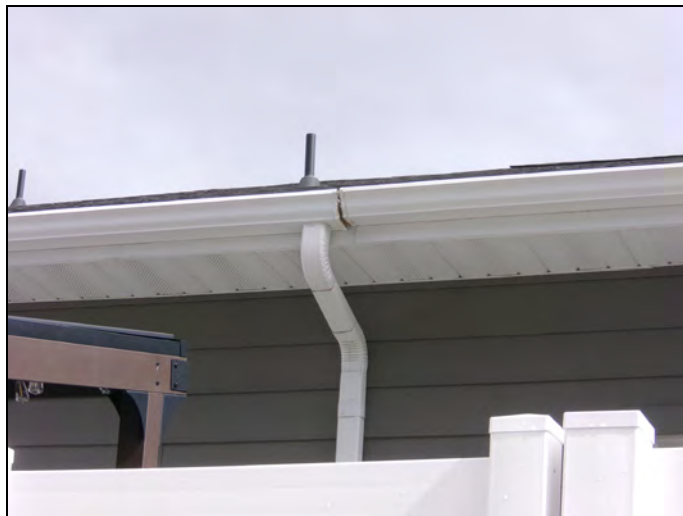
Comp #: 120 Rain Gutters/Downspouts - Replace

Location: **Building Exterior**

Quantity: **Approx. 2,900 LF**

Life Expectancy: **30** *Remaining Life:* **27**

The rain gutters and downspouts appear to be in good condition. We recommend funding to replace this component approximately every 25 - 30 years. Remaining life based on current age.

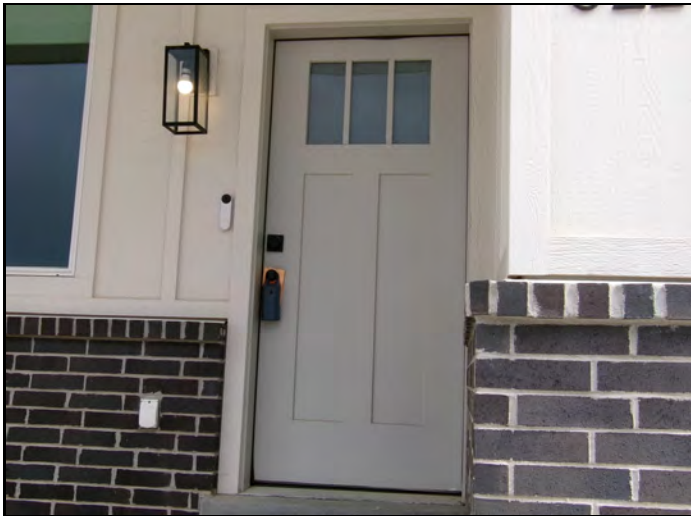
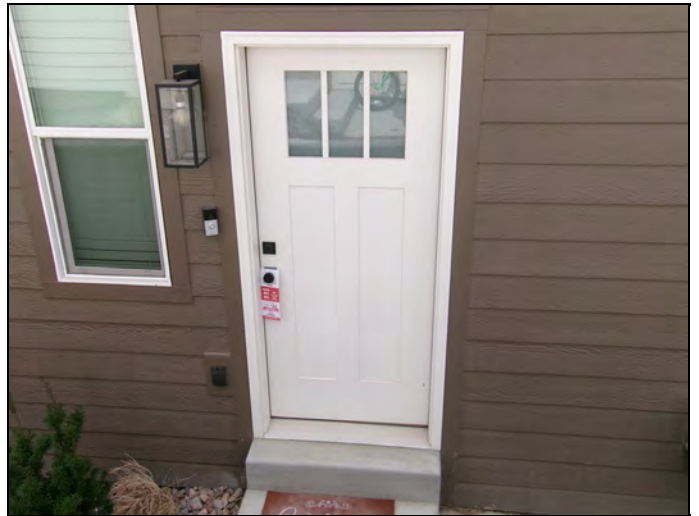
Comp #: 204 Front Doors - Repaint

Location: **Building Exterior**

Quantity: **(25) Doors**

Research with the client reveals this component is not a responsibility of the association.

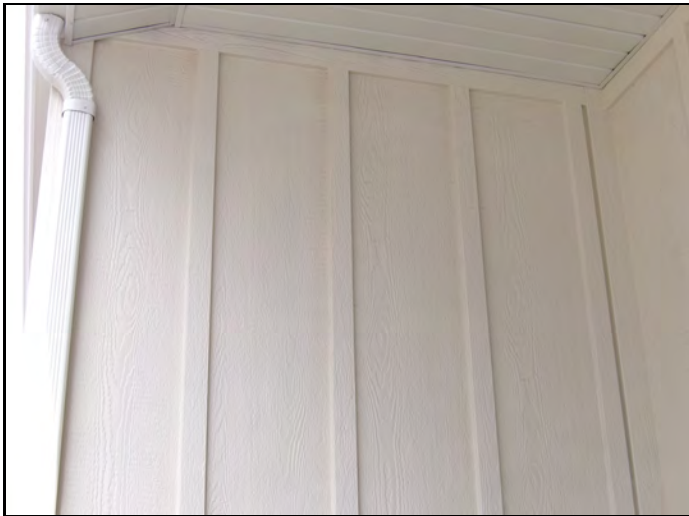
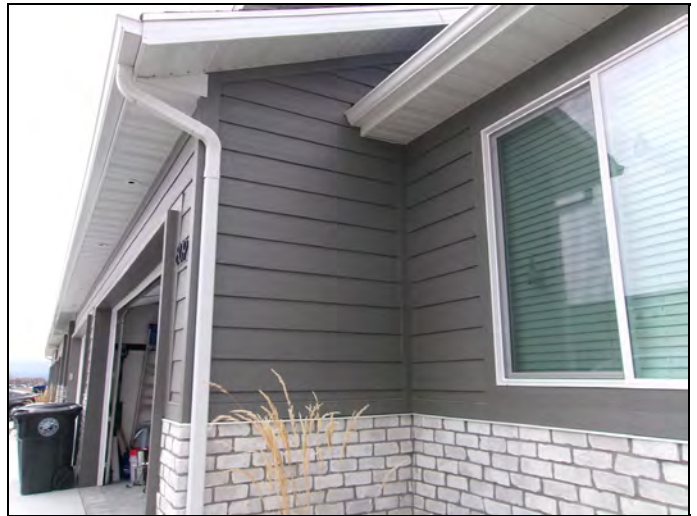
Comp #: 215 Siding - Repair/Repaint

Location: **Building Exterior**

Quantity: **Approx. 19,250 SF**

Life Expectancy: **10** *Remaining Life:* **7**

The siding painted surfaces appear to be in good to fair condition. We recommend funding to repair/repaint this component approximately every 8 - 10 years. Remaining life is based on current age.

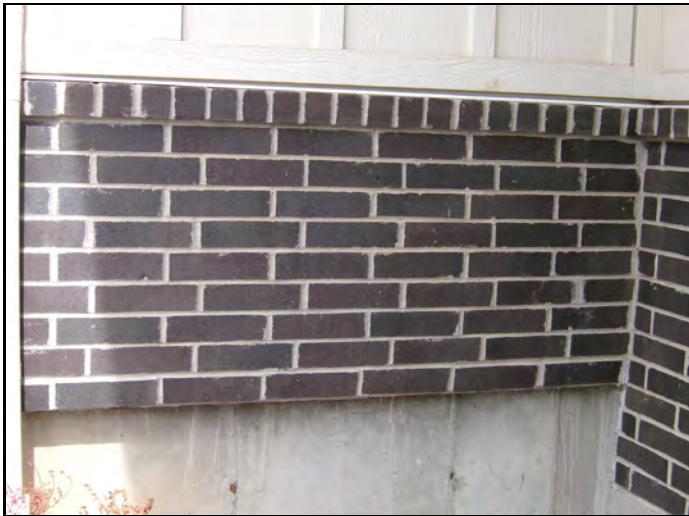
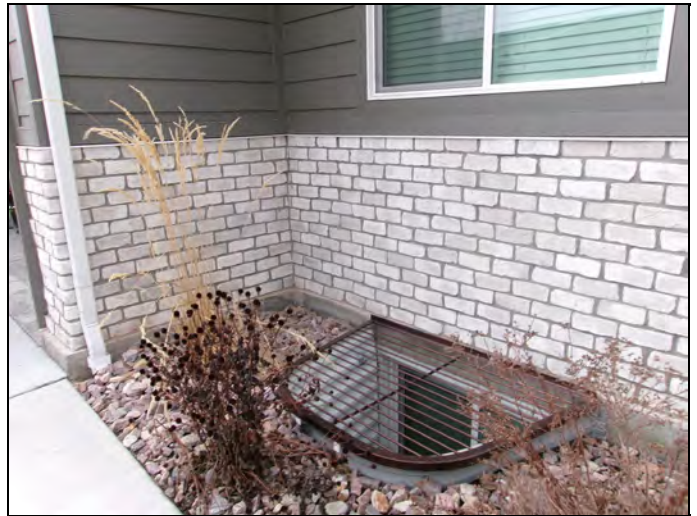
Comp #: 390 Brick Siding - Replace

Location: **Building Exterior**

Quantity: **Approx. 2,475 SF**

This component has an extended useful life. We recommend making repairs as necessary as an operating expense. No reserve funding necessary.

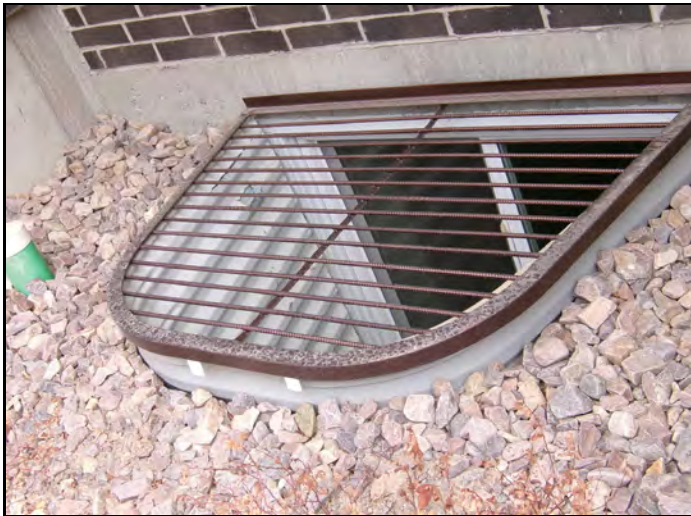
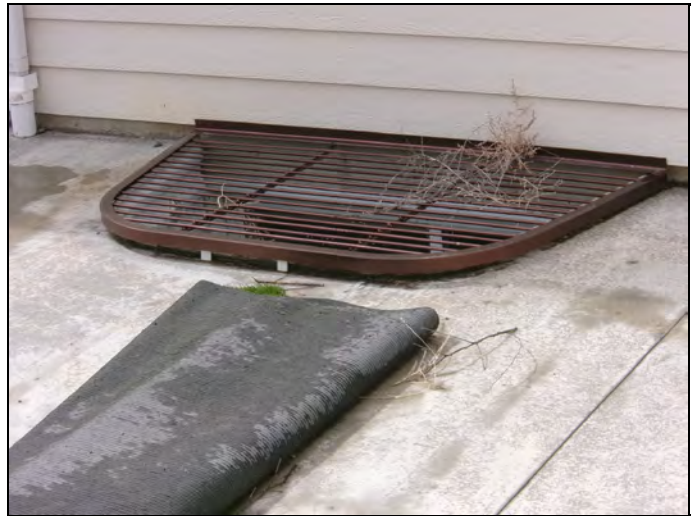
Comp #: 390 Window Wells & Covers - Replace

Location: **Building Exterior**

Quantity: **(85) Covers**

Research with the client reveals this component is not a responsibility of the association.

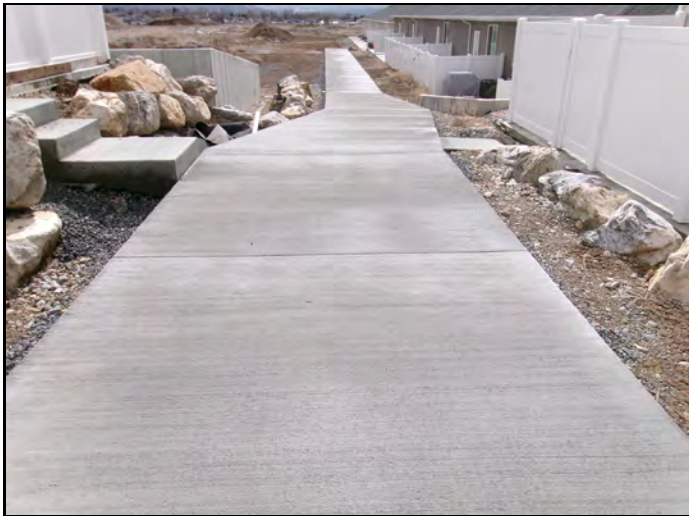
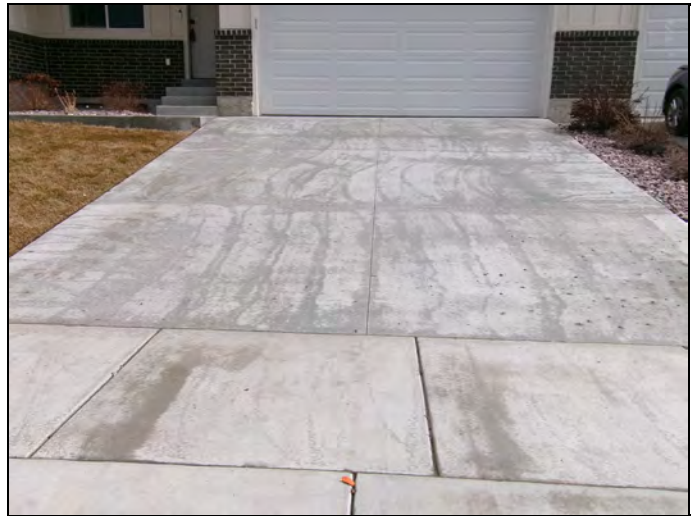
Comp #: 403 Concrete - Partial Repair/Replace

Location: **Common & Limited Common Area**

Quantity: **Moderate SF**

Life Expectancy: **10** *Remaining Life:* **7**

The concrete is in good condition. This component has an extended useful life under normal conditions. We recommend funding to make repairs and partially replace this component approximately every 10 years. Remaining life based on current age.

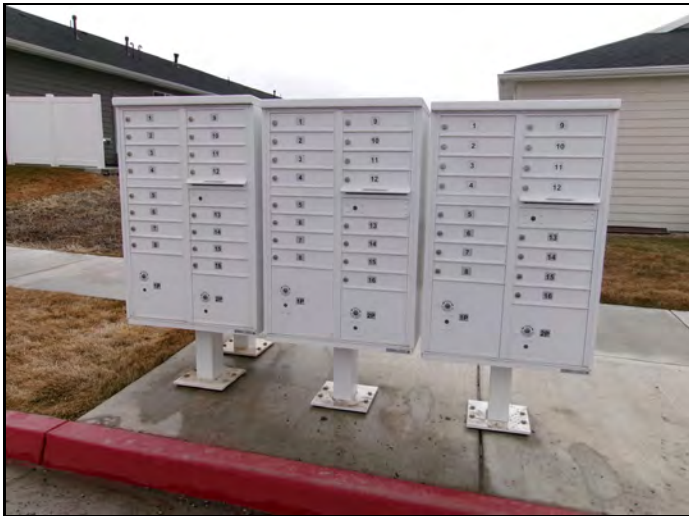
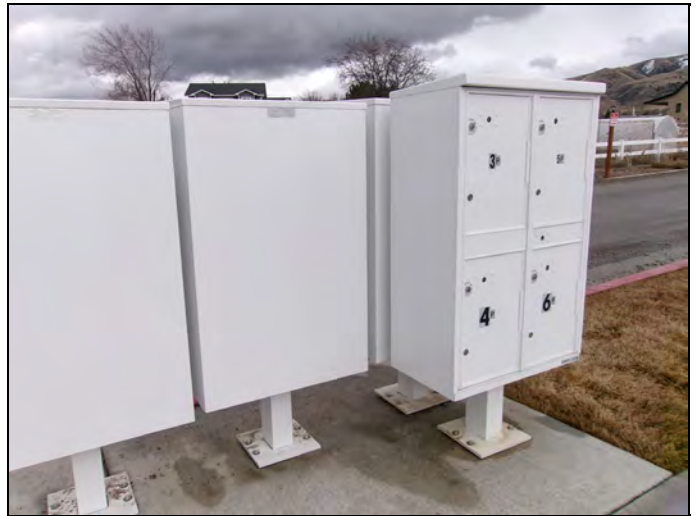
Comp #: 803 Mailboxes - Replace

Location: Common Area

Quantity: (5) Clusters

Life Expectancy: 20 *Remaining Life:* 17

The mailboxes are in good condition. We recommend funding to replace this component approximately every 20 - 25 years. Remaining life based on current age.

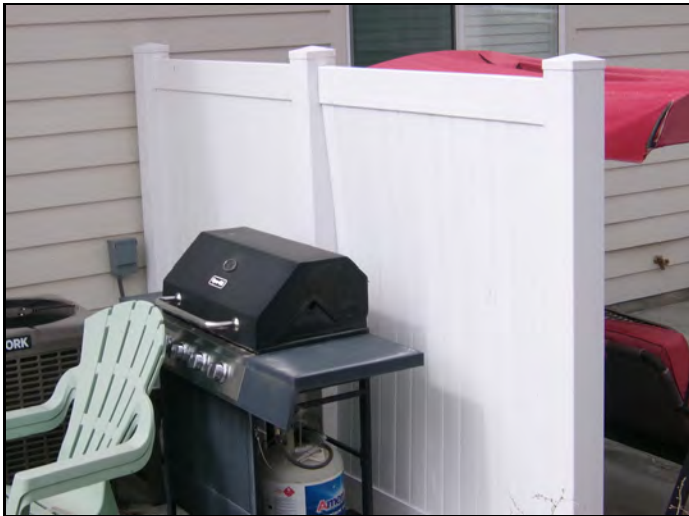
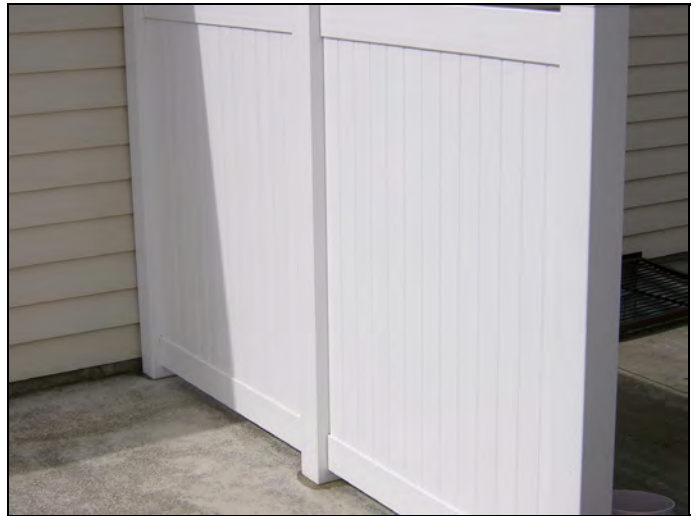
Comp #: 1008 Vinyl Fencing - Replace

Location: **Limited Common Area**

Quantity: **Approx 300 LF**

The vinyl fencing is in good condition. We recommend funding to replace this component approximately every 25 - 30 years. Remaining life based on current age.

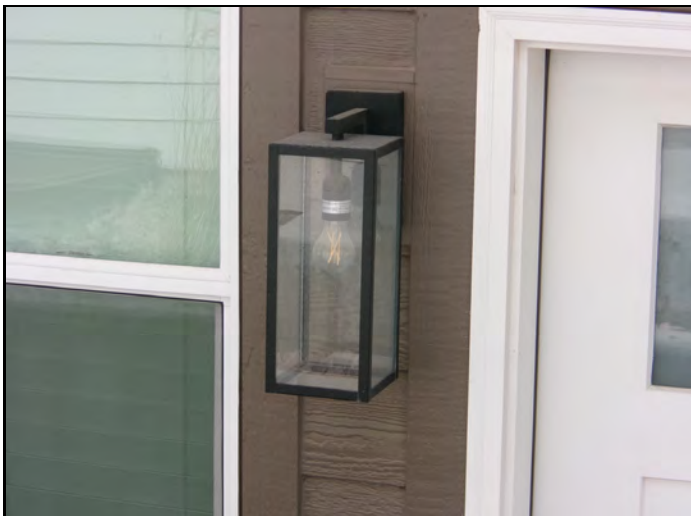
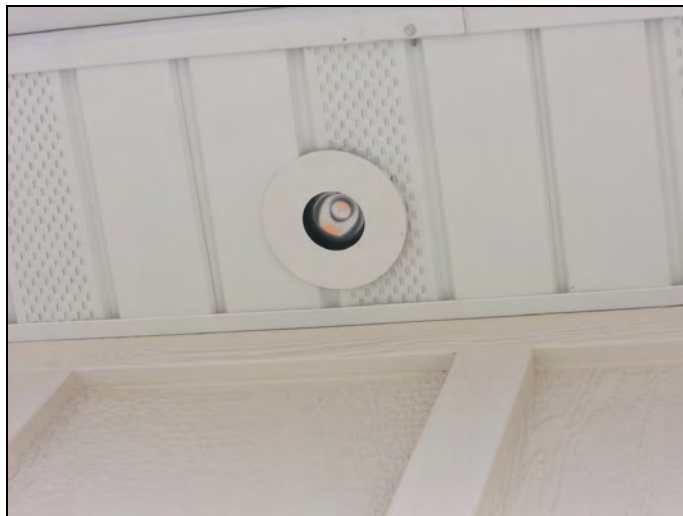
Comp #: 1602 Exterior Light Fixtures - Replace

Location: **Building Exteriors**

Quantity: **(125) Lights**

The exterior light fixtures are in good condition. We recommend funding to replace this component approximately every 16 - 20 years. Remaining life based on current age.

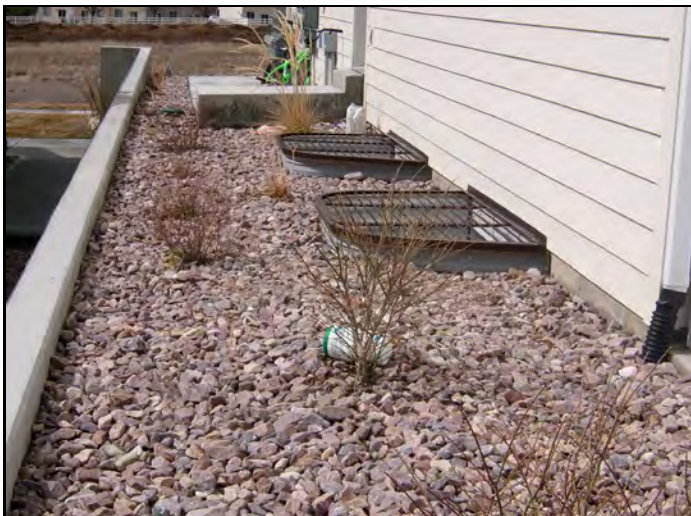
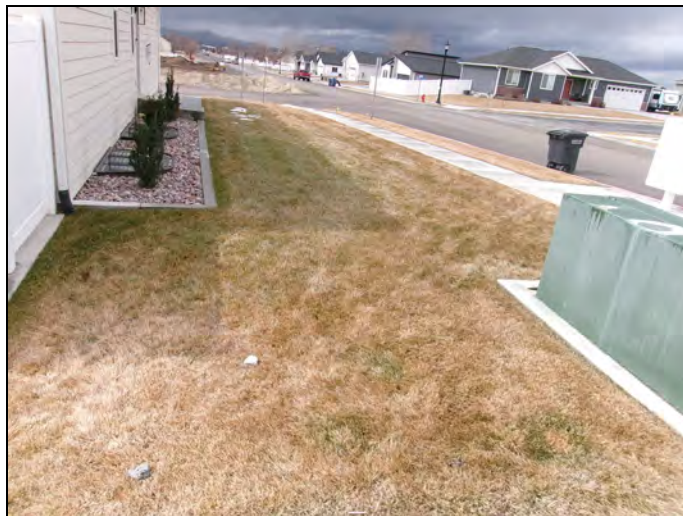
Comp #: 1812 Landscaping & Irrigation System - Renovate

Location: **Common Area**

Quantity: **Moderate SF**

The landscaping and irrigation system appear to be in good to fair condition. We recommend funding for an allowance to renovate this component approximately every 20 years. Remaining life based on current age.
