Spring Legacy

Level 1 Reserve Study

Client Reference Number	19428
Property Type	Single Family Homes
Number of Units	24
Fiscal Year End	12/31

Type of Study	Full Study
Date of Property Inspection	4/4/2025
Prepared By	Dale Gifford
Analysis Method	Cash Flow
Funding Goal	Full Funding

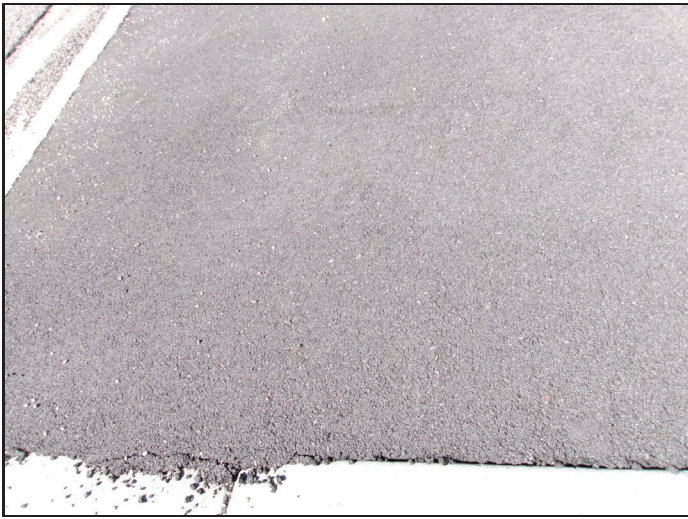
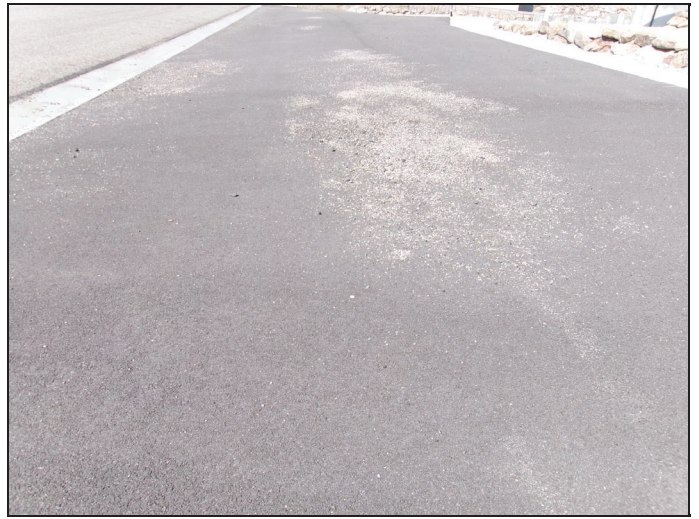
Comp #: 401 Asphalt - Major Rehab

Location: **Parking Lot**

Quantity: **Approx 3,900 SF**

Life Expectancy: **30** *Remaining Life:* **26**

The asphalt surfaces are in good condition. We recommend funding for a major rehab of this component approximately every 25 - 30 years. Remaining life based on current age.

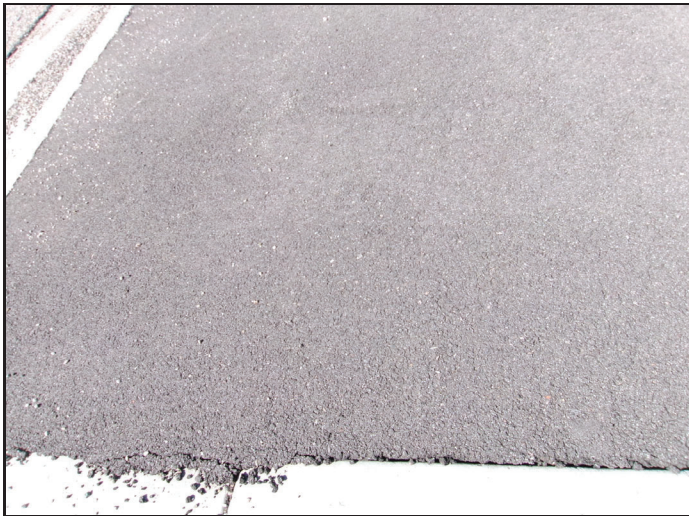
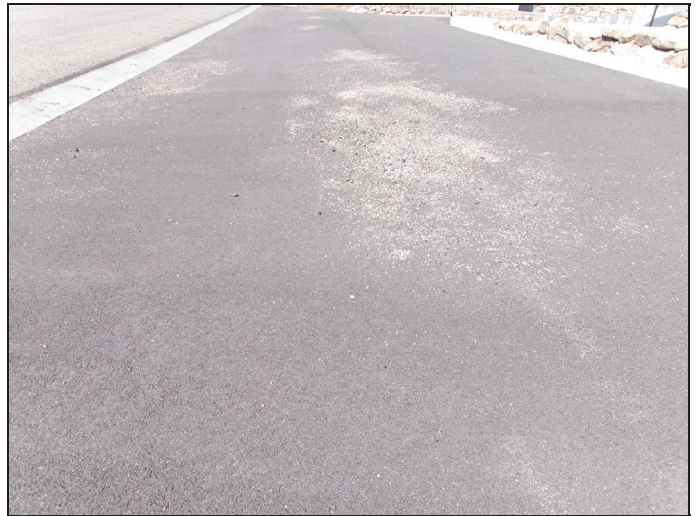
Comp #: 402 Asphalt - Seal Coat

Location: **Parking Lot**

Quantity: **Approx 3,900 SF**

Life Expectancy: **5** *Remaining Life:* **0**

The asphalt seal coat is in poor condition. We recommend funding to seal this component approximately every 3 - 5 years. Remaining life based on current condition.

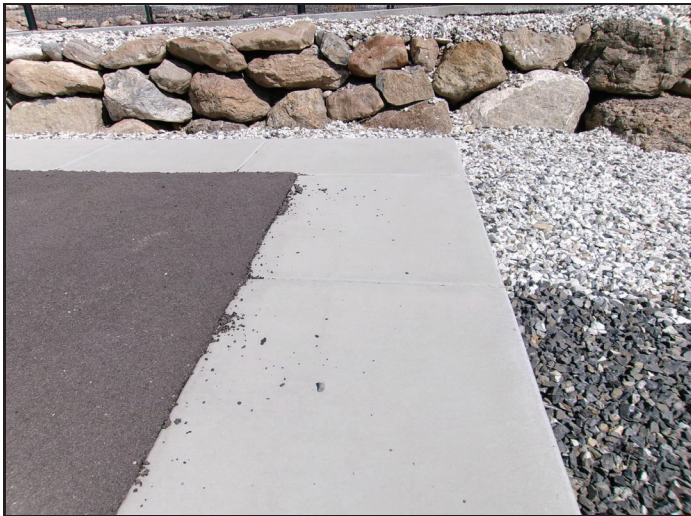
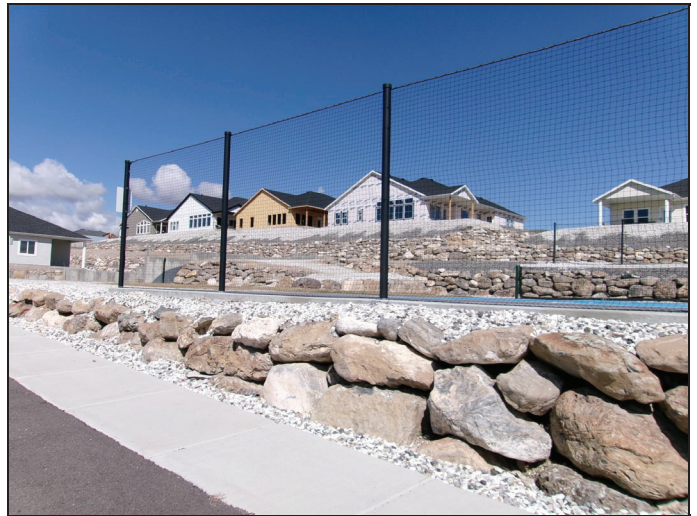
Comp #: 403 Concrete - Partial Repair/Replace

Location: Common Area

Quantity: Minimal SF

Life Expectancy: 10 *Remaining Life:* 6

The concrete is in good condition. This component has an extended useful life under normal conditions. We recommend funding to make repairs and partially replace this component approximately every 10 years. Remaining life based on current age.

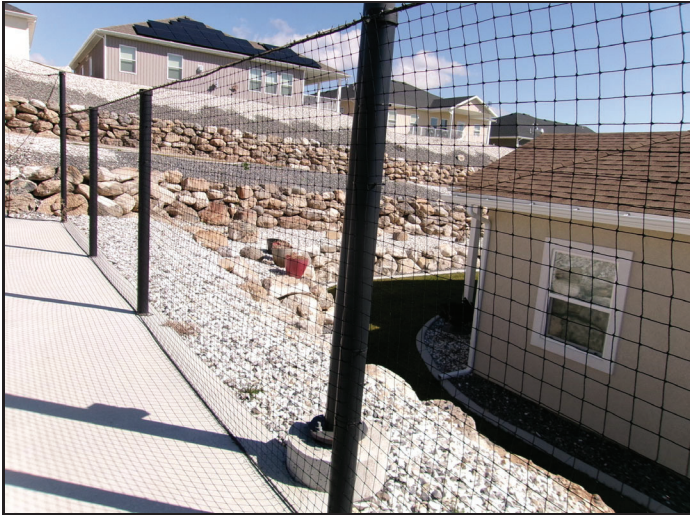
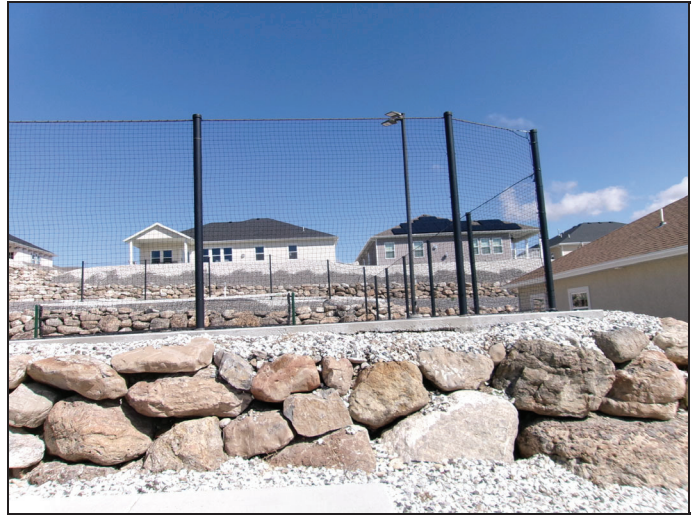
Comp #: 1090 Pickleball Court Mesh Netting - Replace

Location: **Pickleball Court**

Quantity: **Approx. 125 LF**

Due to the minimal cost of replacing this component, reserve funding is not appropriate. Replace as necessary as an operating expense.

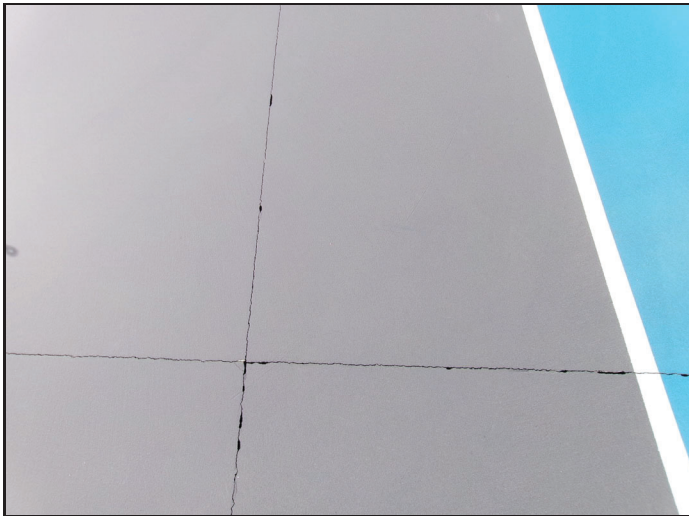
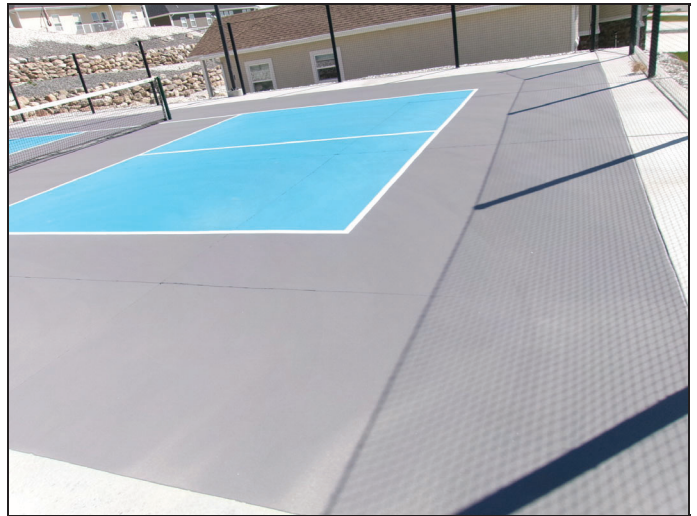
Comp #: 1201 Pickleball Court - Resurface

Location: Common Area

Quantity: (1) Court

Life Expectancy: 10 *Remaining Life:* 7

The pickleball court surface is in good condition. We recommend funding to resurface this component approximately every 8 - 10 years. Remaining life based on current age.

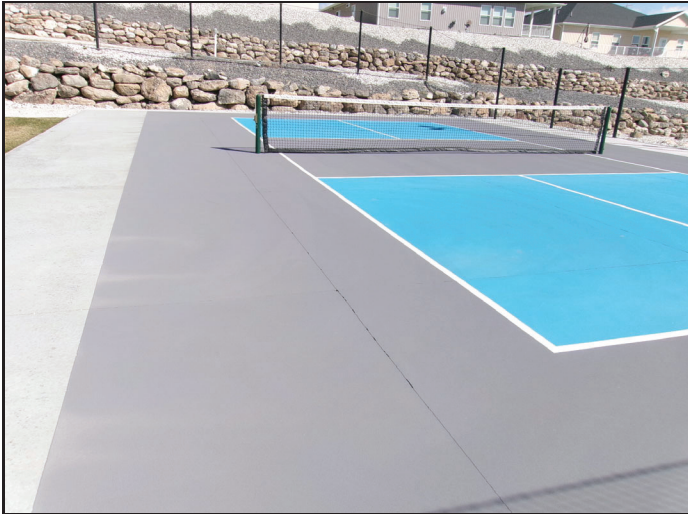
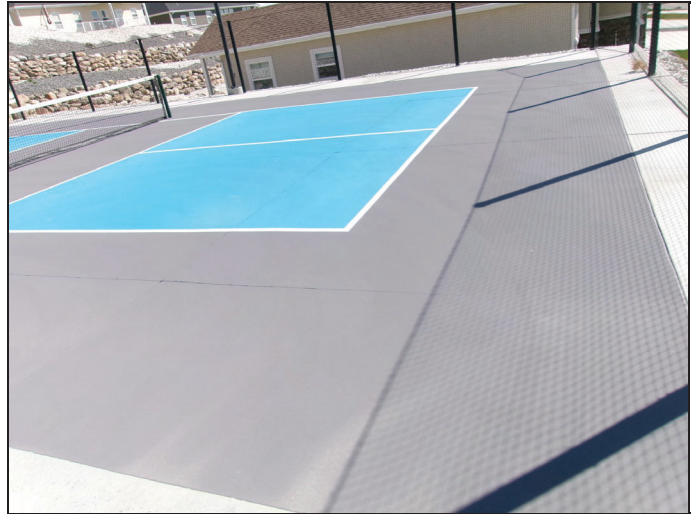
Comp #: 1203 Pickleball Court - Replace

Location: Common Area

Quantity: (1) Court

Life Expectancy: 50 *Remaining Life:* 47

The pickleball court is in good condition. We recommend funding to replace this component approximately every 40 - 50 years. Remaining life based on current age.

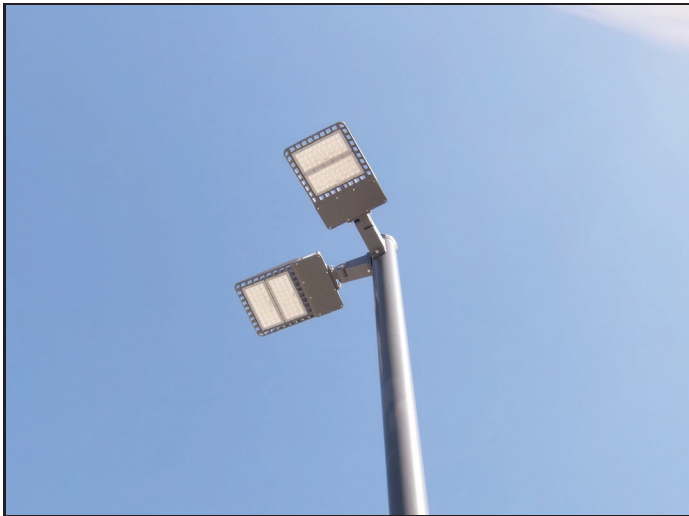
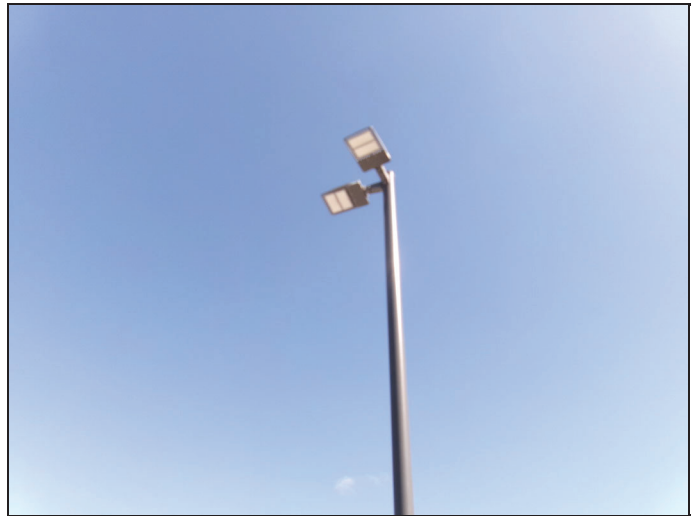
Comp #: 1606 Pickleball Court Light Fixtures - Replace

Location: **Pickleball Court**

Quantity: **(2) Lights**

Life Expectancy: **20** *Remaining Life:* **17**

The pickleball court light fixtures are in good condition. No expectation to replace the light poles. Paint poles as necessary as an operating expense. We recommend funding to replace this component approximately every 20 years. Remaining life based on current age.

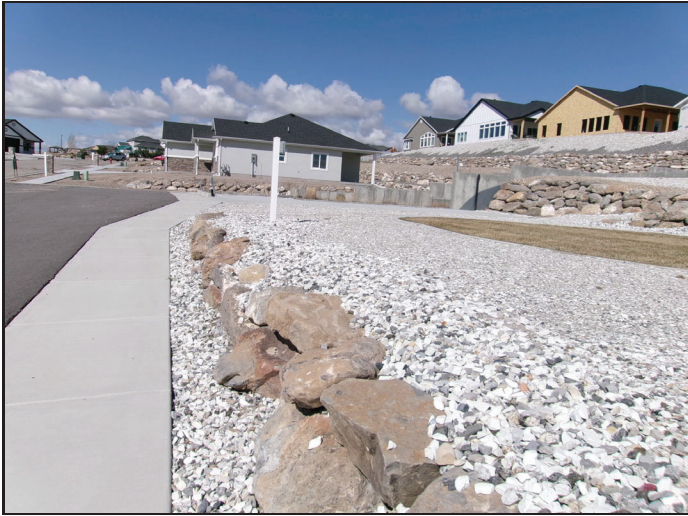
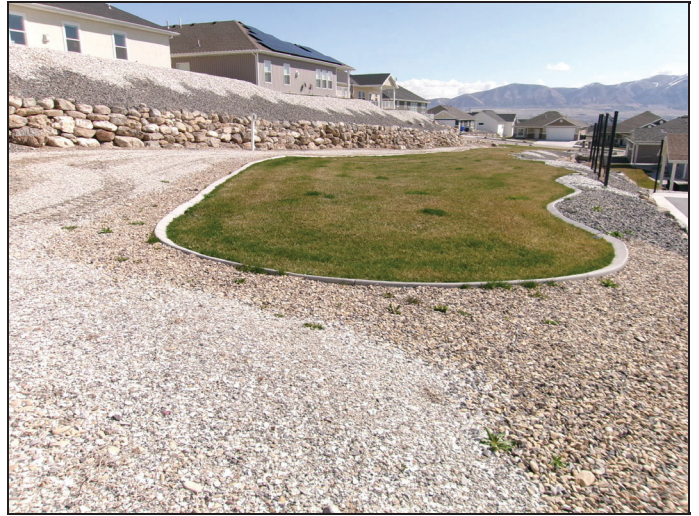
Comp #: 1812 Landscaping & Irrigation System - Renovate

Location: **Common Area**

Quantity: **Extensive SF**

Life Expectancy: **20** *Remaining Life:* **16**

The landscaping and irrigation system appear to be in good condition. We recommend funding for an allowance to renovate this component approximately every 20 years. Remaining life based on current age.
