# Highland Estates

## Level 2 Reserve Study

**Report Period – 01/01/2026 – 12/31/2026**

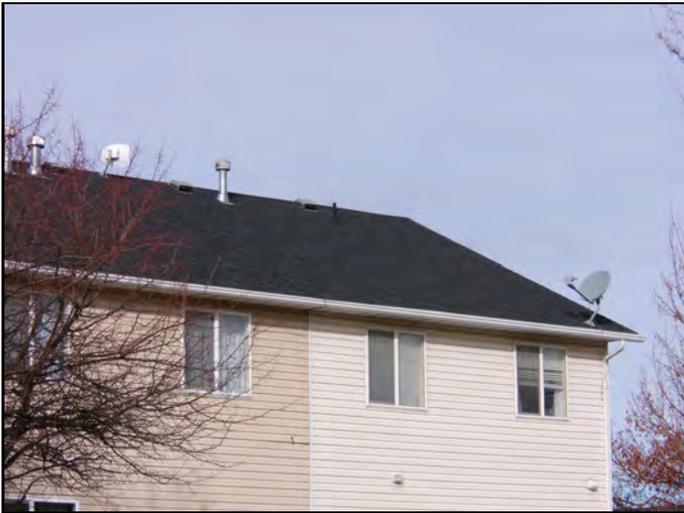
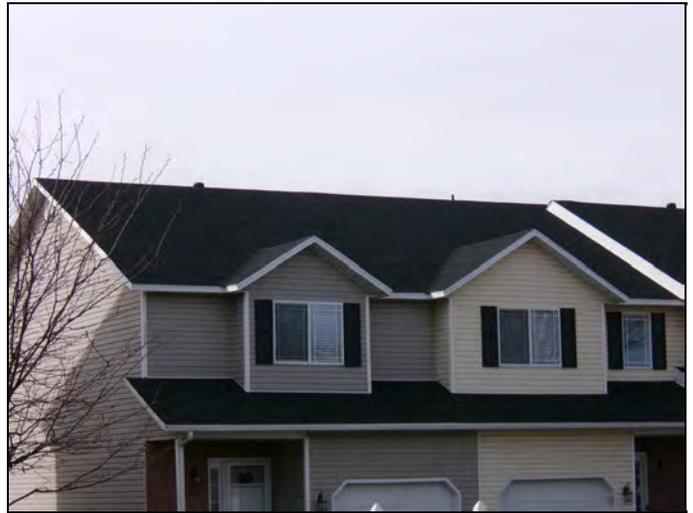
Comp #: 105 Roofs - Replace

The roofs appear to be in good condition. We recommend funding to replace this component approximately every 20 - 25 years. Remaining life based on current age.

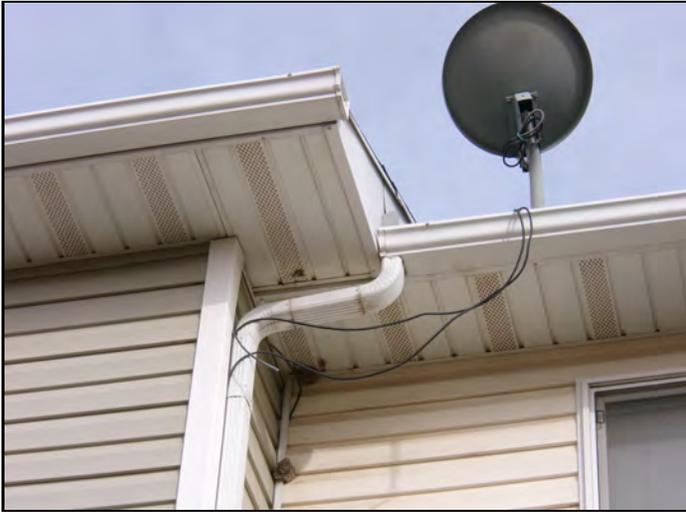
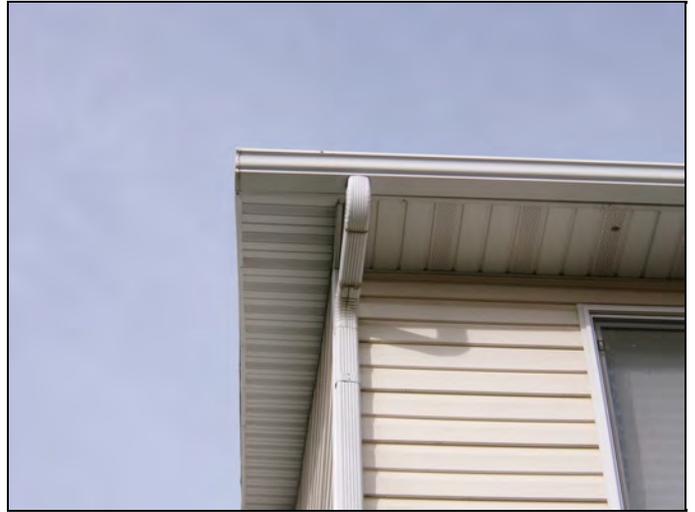
Comp #: 120 Rain Gutters/Downspouts - Replace

The rain gutters and downspouts appear to be in fair condition. We recommend funding to replace this component approximately every 25 - 30 years. Remaining life based on current age.

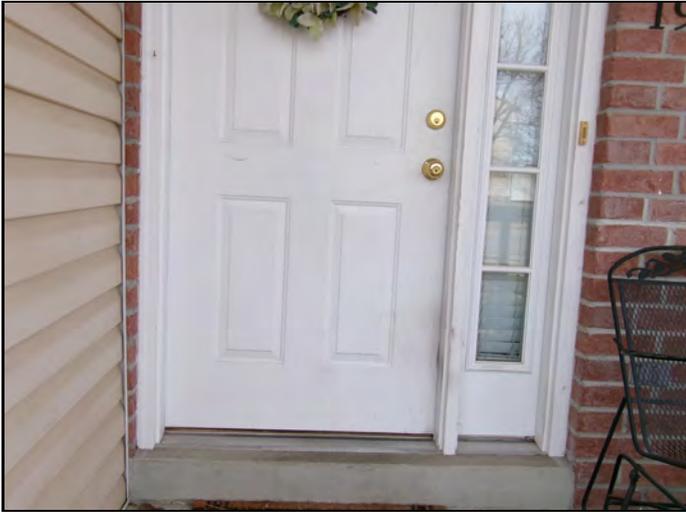
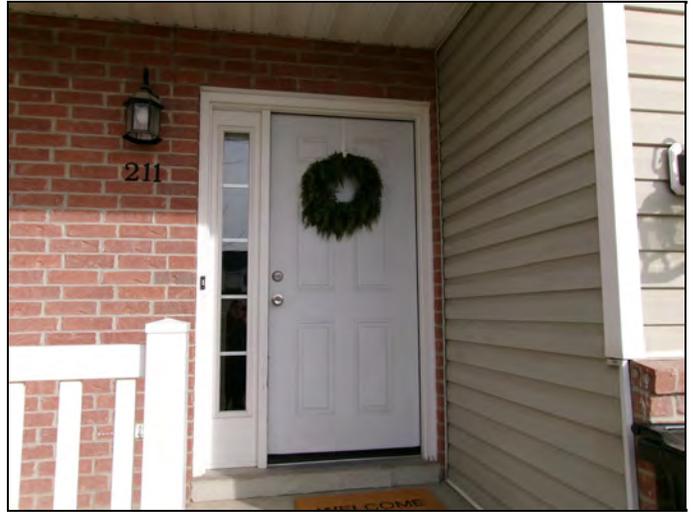
Comp #: 204 Front Doors - Repaint

The painted door surfaces are in fair to poor condition. We recommend funding to repaint this component approximately every 8 - 10 years. Remaining life based on current condition.

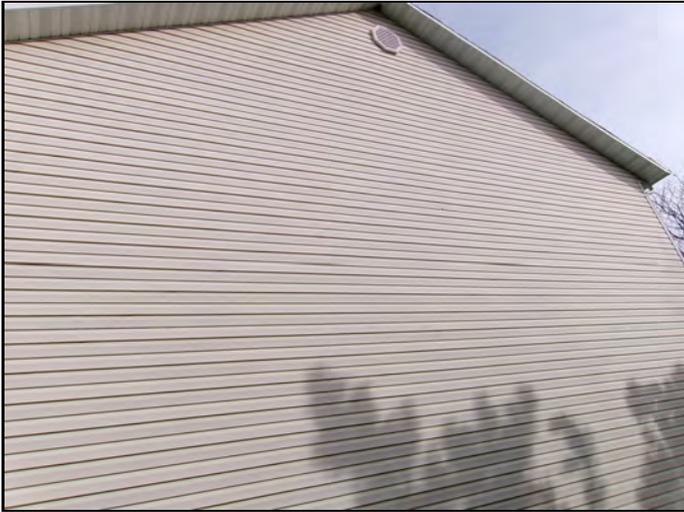
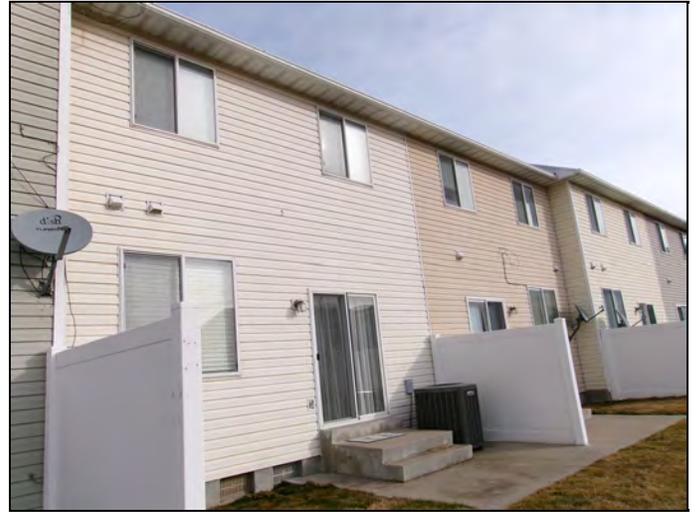
Comp #: 302 Vinyl Siding - Replace

The vinyl siding appears to be in good to fair condition. We recommend funding to replace this component approximately every 40 - 50 years. Remaining life based on current age.

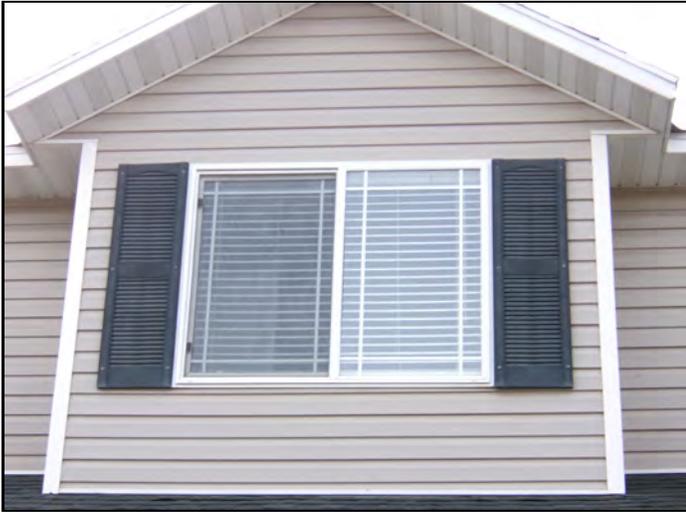
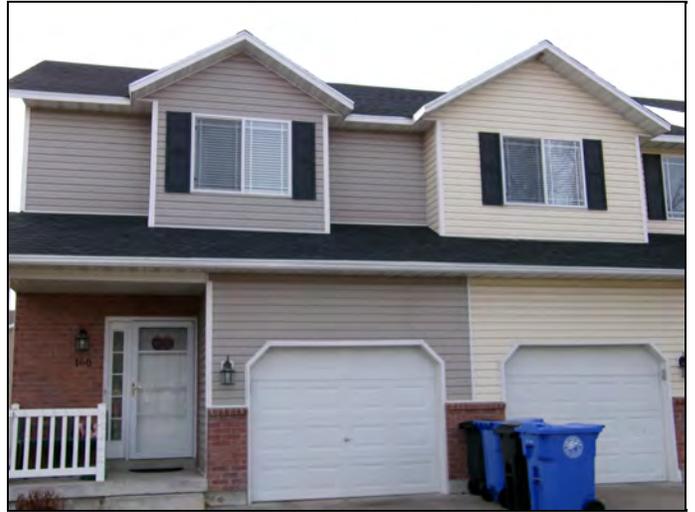
Comp #: 390 Vinyl Shutters - Replace

The vinyl shutters are in fair condition. We recommend funding to replace this component approximately every 30 - 40 years. Remaining life based on current age.

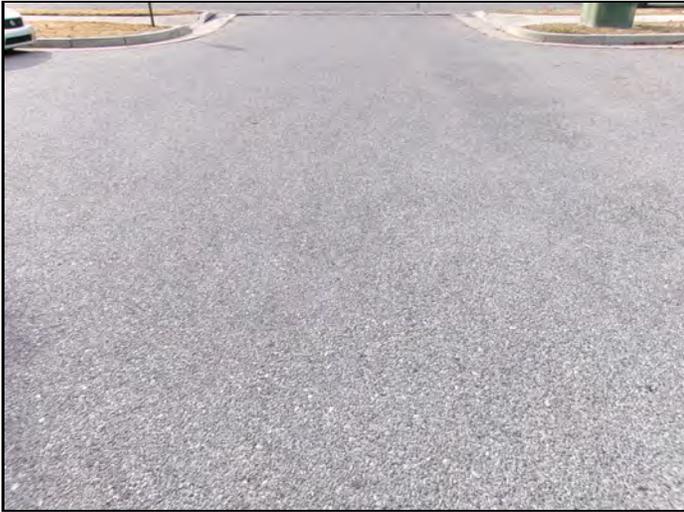
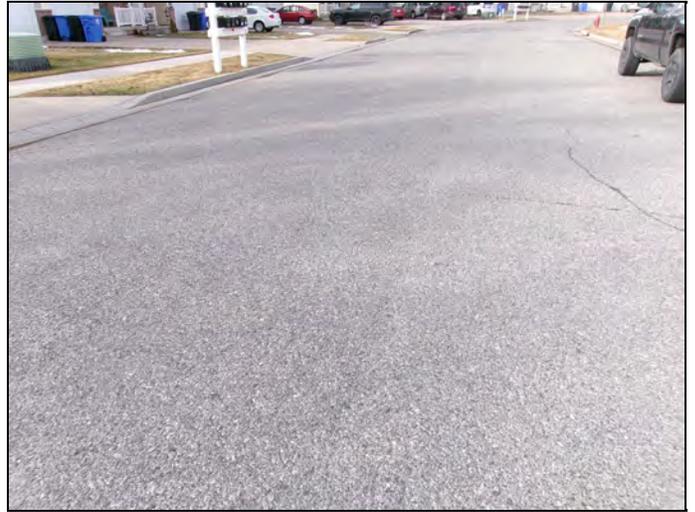
Comp #: 401 Asphalt - Major Rehab

The asphalt surfaces appear to be in good to fair condition. We recommend funding for a major rehab of this component approximately every 25 - 30 years. Remaining life based on current age and condition.

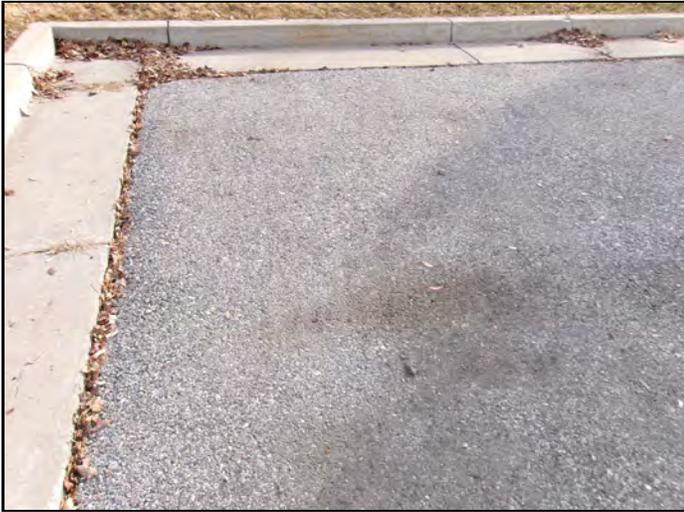
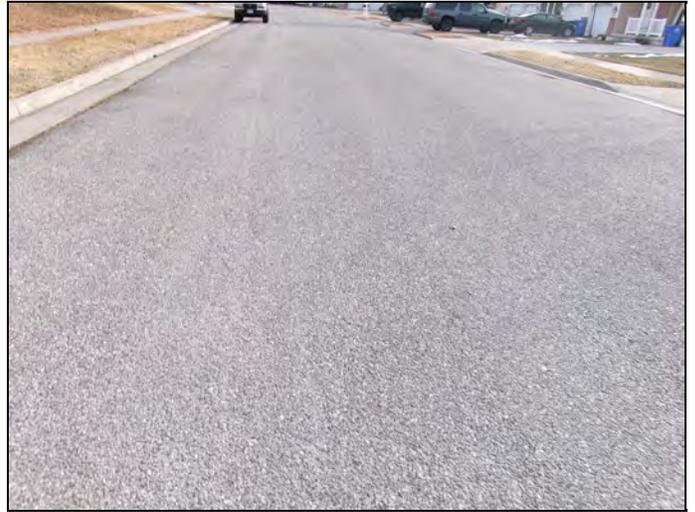
Comp #: 402 Asphalt - Seal Coat

The asphalt seal coat is in poor condition. We recommend funding to seal this component approximately every 3 - 5 years. Remaining life based on current condition.

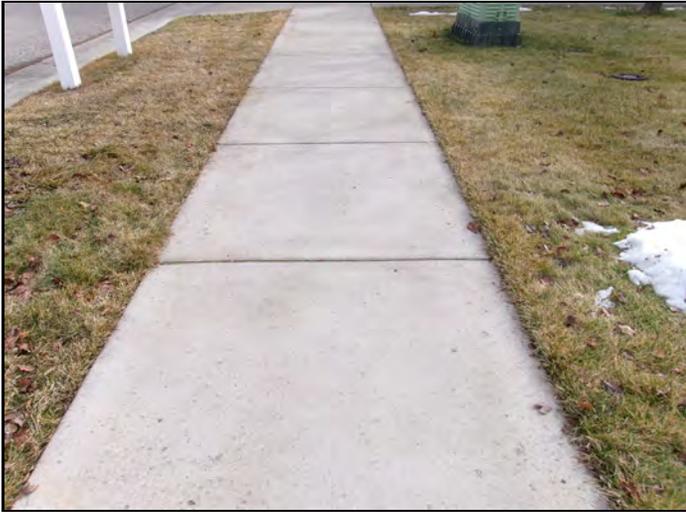
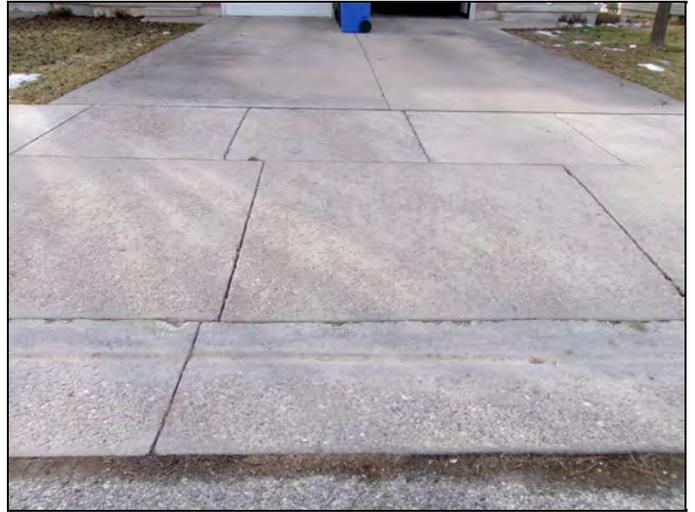
Comp #: 403 Concrete - Partial Repair/Replace

The concrete appears to be in good to poor condition. This component has an extended useful life under normal conditions. We recommend funding to make repairs and partially replace this component approximately every 10 years. Remaining life based on current condition.

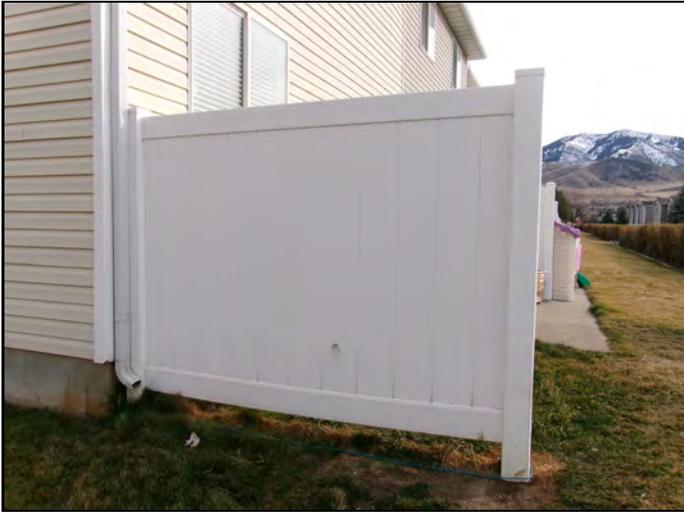
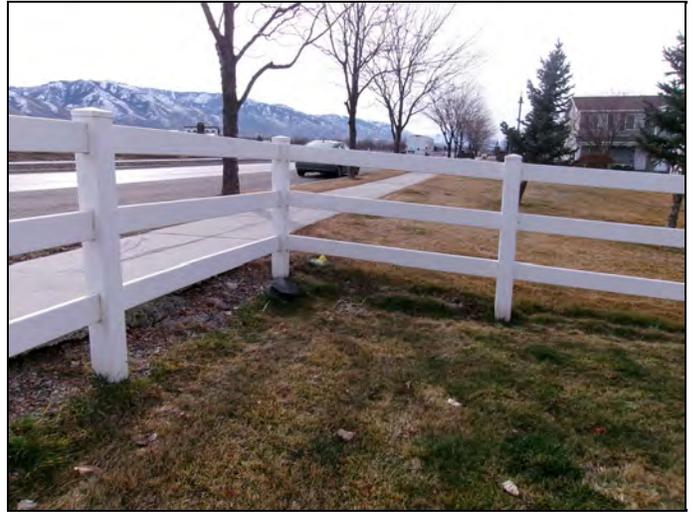
Comp #: 1008 Vinyl Fencing - Replace

The vinyl fencing appears to be in good to fair condition. We recommend funding to replace this component approximately every 25 - 30 years. Remaining life based on current age.

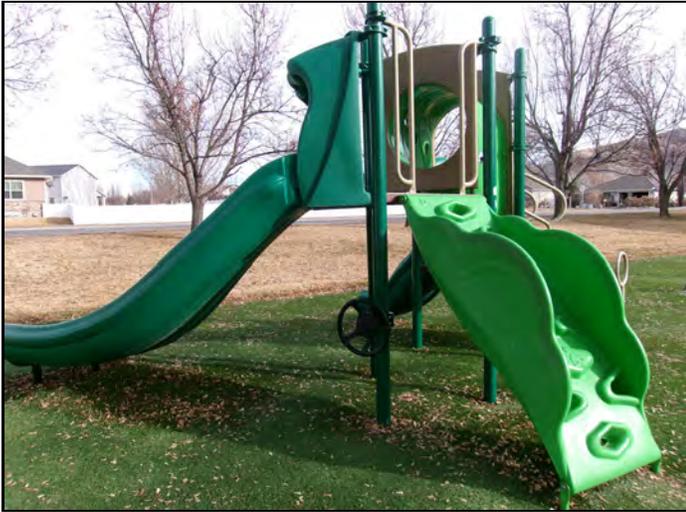
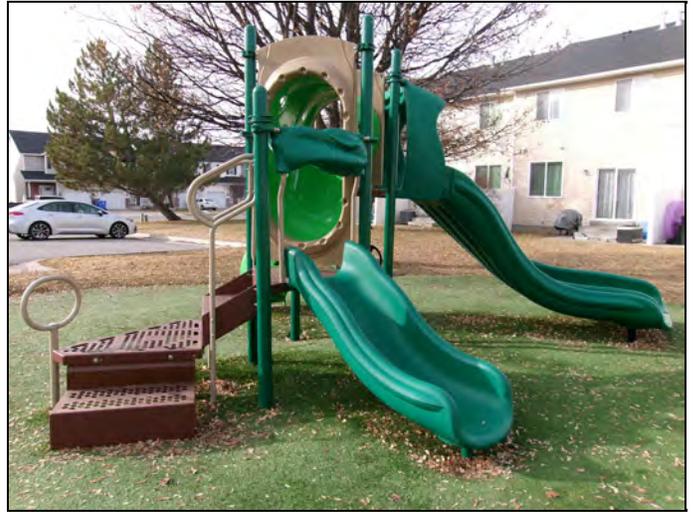
Comp #: 1301 Play Structure - Replace

The play structure appears to be in good condition. We recommend funding to replace this component approximately every 20 - 25 years. Remaining life based on current age.

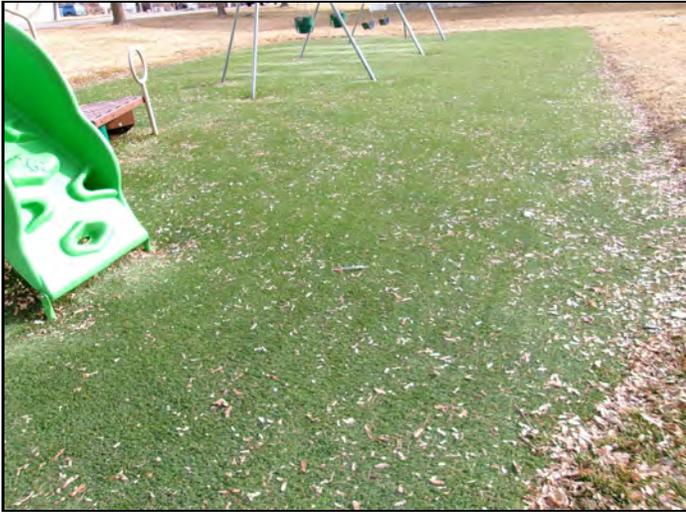
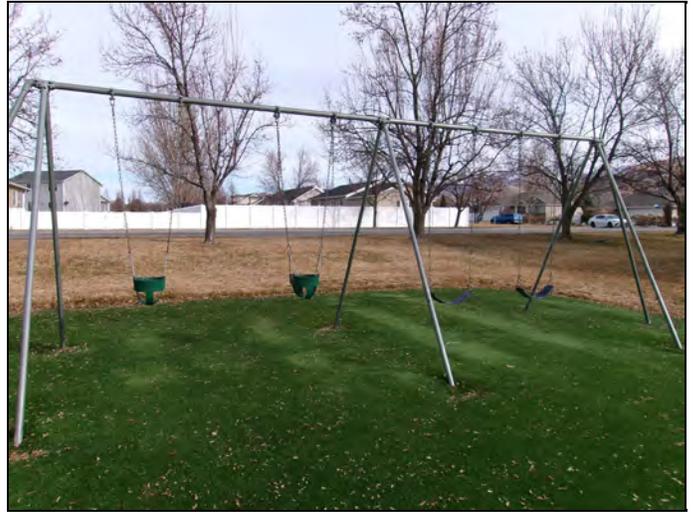
Comp #: 1303 Play Area Groundcover - Replace

The play area groundcover appears to be in good condition. We recommend funding to replace this component approximately every 15 - 20 years. Remaining life is based on current age.

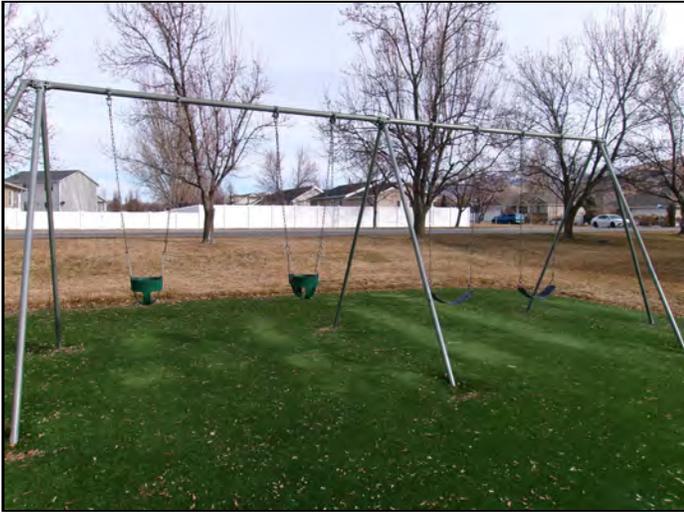
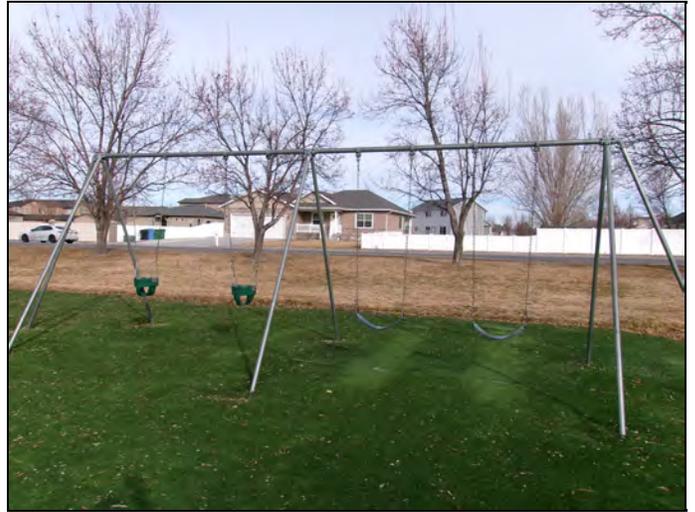
Comp #: 1390 Swing Set - Replace

The swing set is in fair condition. We recommend funding to replace this component approximately every 30 - 40 years. Remaining life based on current age.

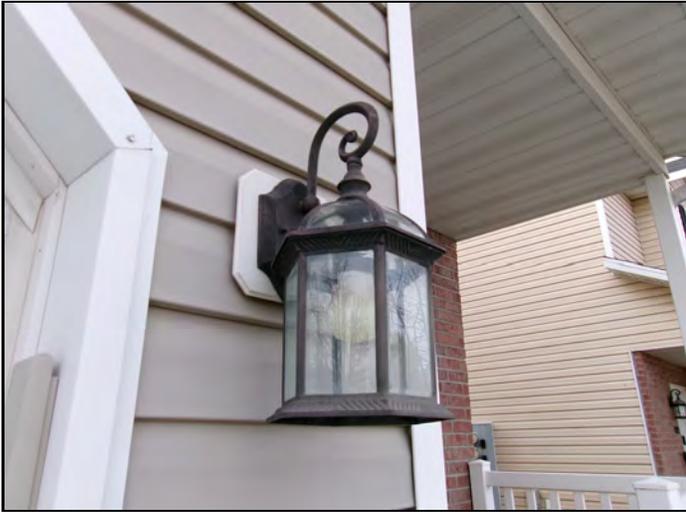
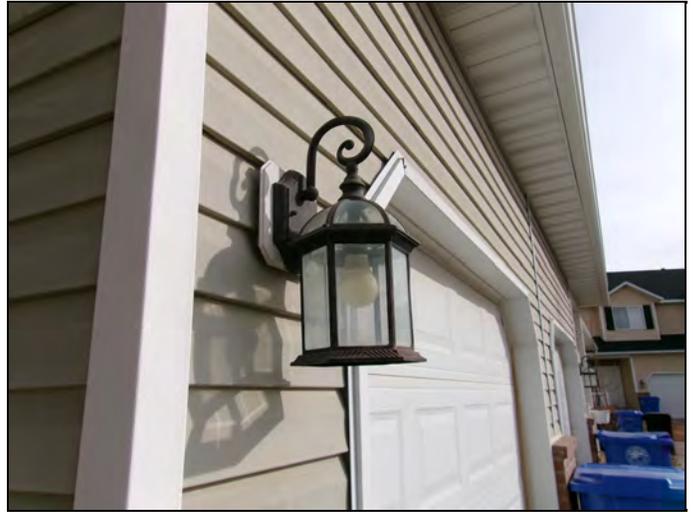
Comp #: 1602 Exterior Light Fixtures - Front - Replace

The exterior light fixtures appear to be in good to fair condition. We recommend funding to replace this component approximately every 16 - 20 years. Remaining life based on current age.

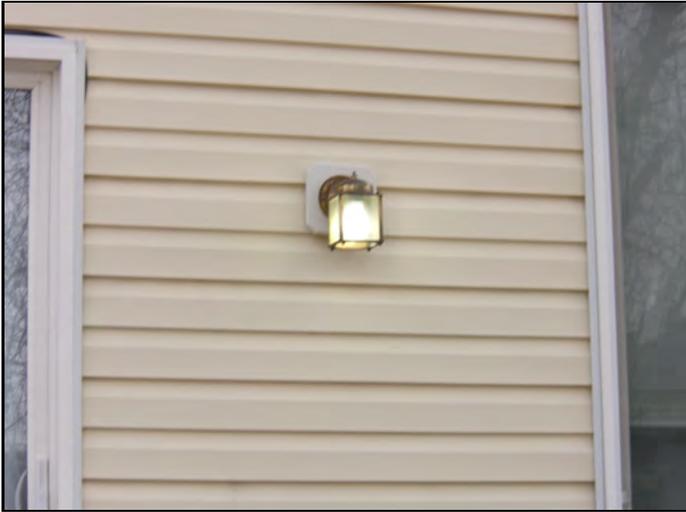
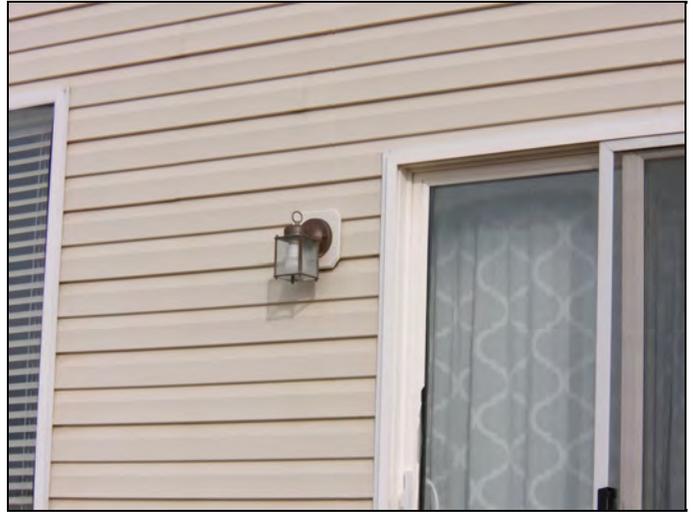
Comp #: 1602 Exterior Light Fixtures - Rear - Replace

The exterior light fixtures appear to be in fair to poor condition. We recommend funding to replace this component approximately every 16 - 20 years. Remaining life based on current condition.

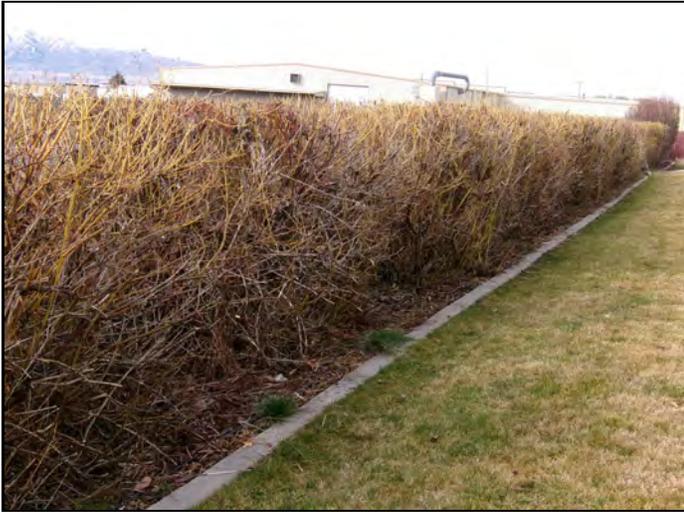
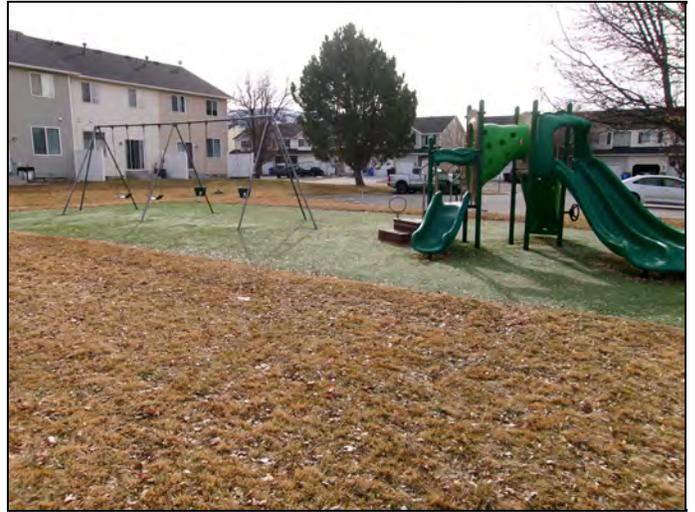
Comp #: 1812 Landscaping & Irrigation System - Renovate

The landscaping and irrigation system appear to be in good to fair condition. We recommend funding for an allowance to renovate this component approximately every 20 years. Remaining life based on current age.
