Mt. Aire Gardens

Level 1 Reserve Study

Report Period – 01/01/2021 – 12/31/2021

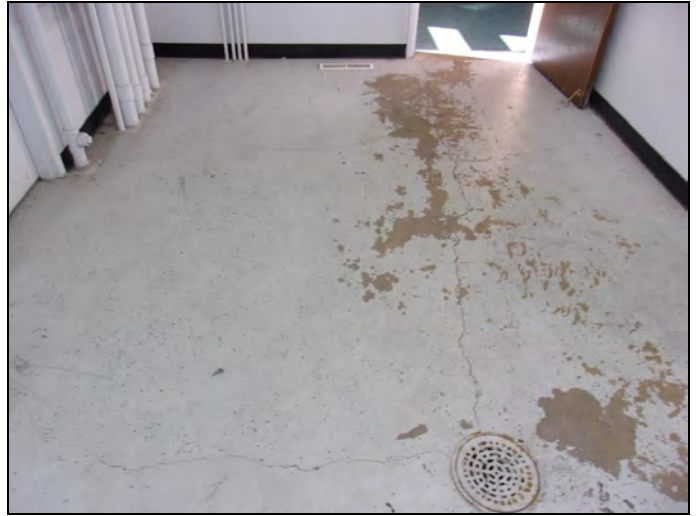
Comp #: 290 Laundry Room Floor - Repaint

Location: **Laundry Room**

Quantity: **Approx 605 Sq.ft.**

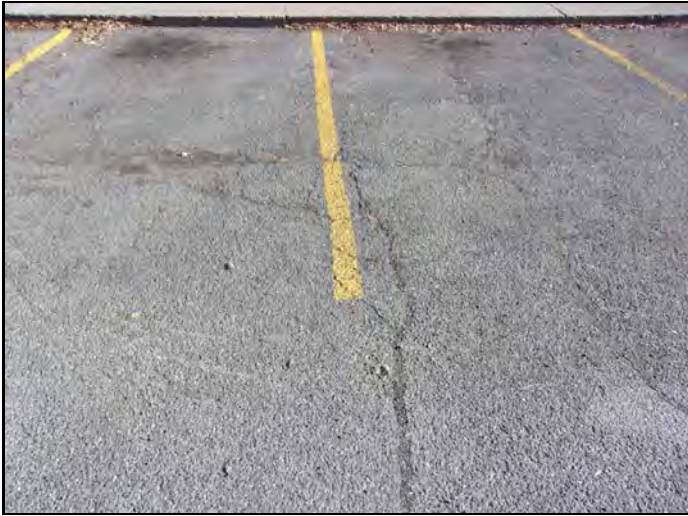
Comp #: 401 Asphalt - Major Rehab

Location: **Parking Lot**

Quantity: **Approx 42,000 Sq.ft.**

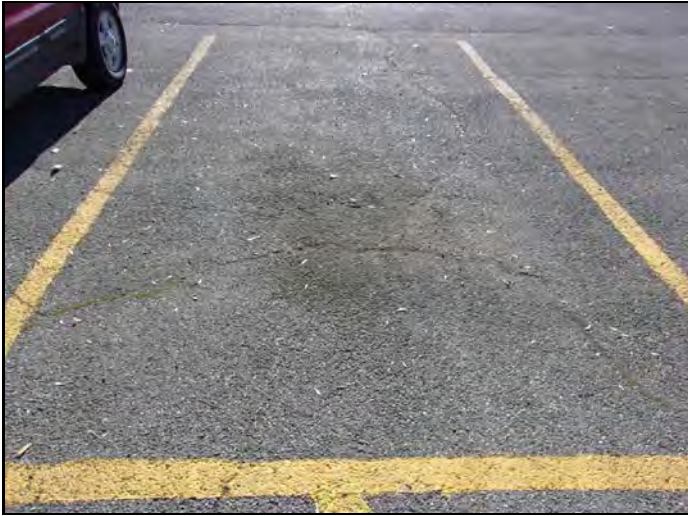
Comp #: 402 Asphalt - Seal Coat

Location: **Parking Lot**

Quantity: **Approx 42,000 Sq.ft.**

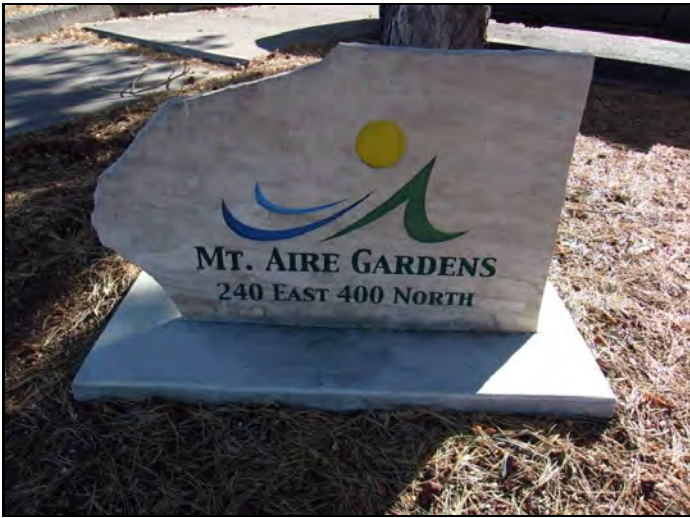
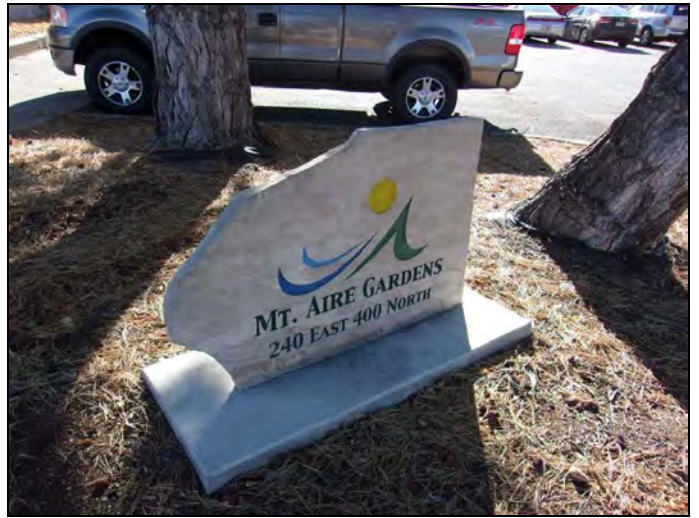
Comp #: 801 Monument Sign - Replace

Location: **Community Entrance**

Quantity: **(1) Monument**

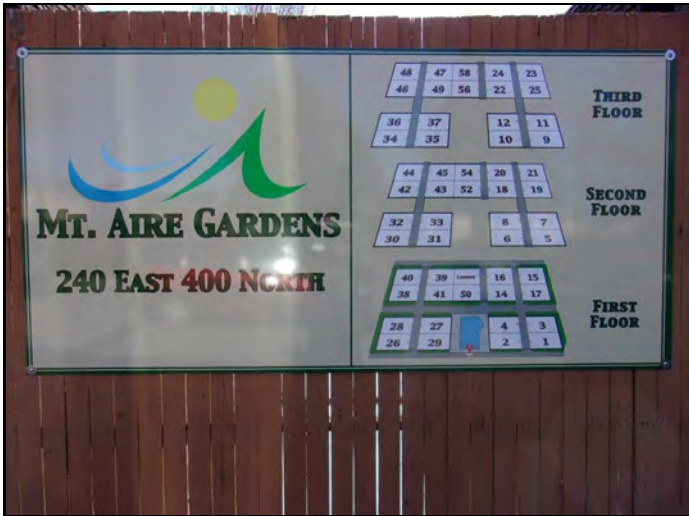
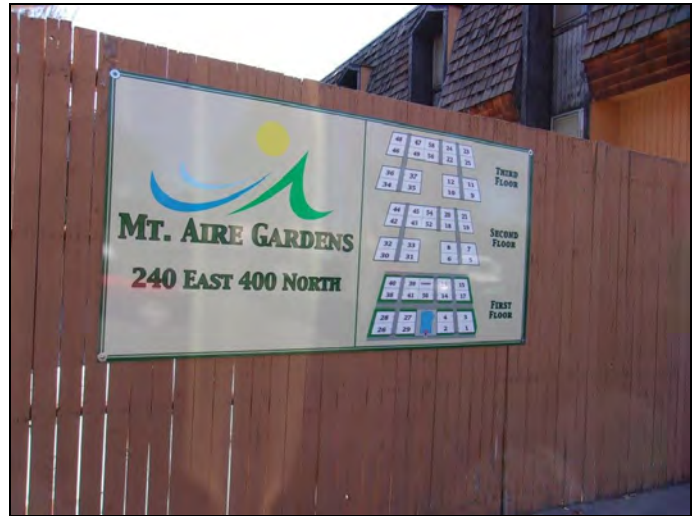
Comp #: 802 Map - Replace

Location: Pool Area Fence

Quantity: (1) Map

Due to the minimal cost of this component, reserve funding is not appropriate. Replace as necessary as an operating expense.

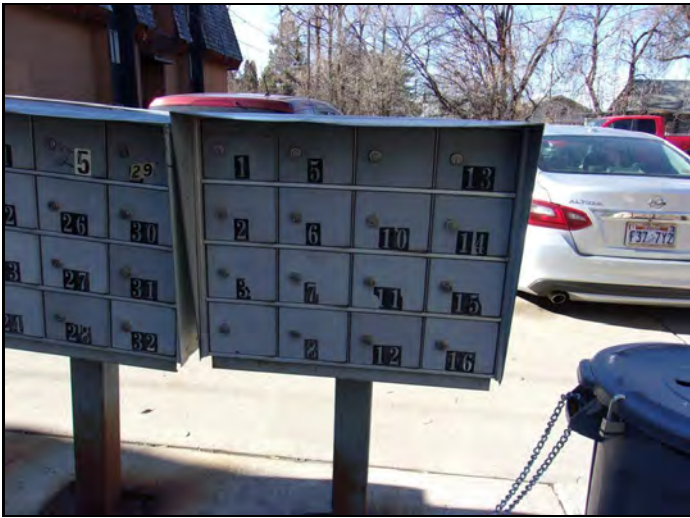
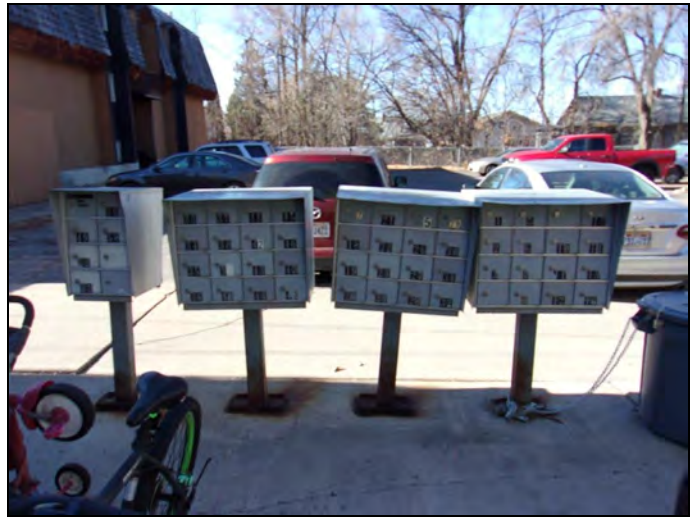
Comp #: 803 Mailboxes - Replace

Location: **Common Area**

Quantity: **(4) Clusters**

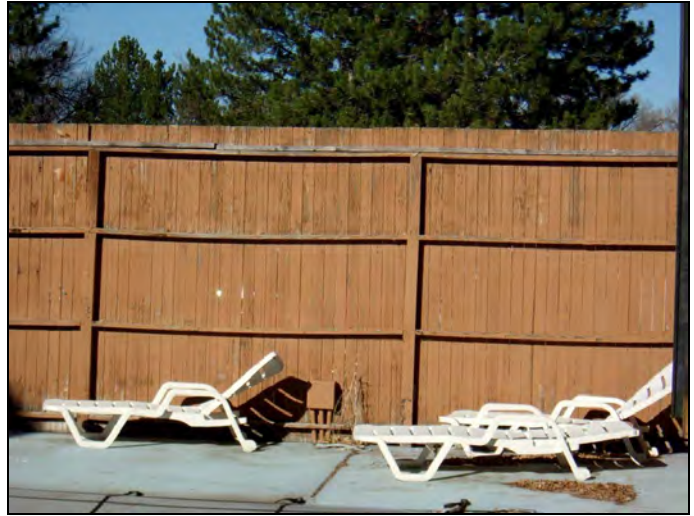
Comp #: 1001 Wood Fencing - Replace

Location: **Pool Area**

Quantity: **Approx 90 Linear ft.**

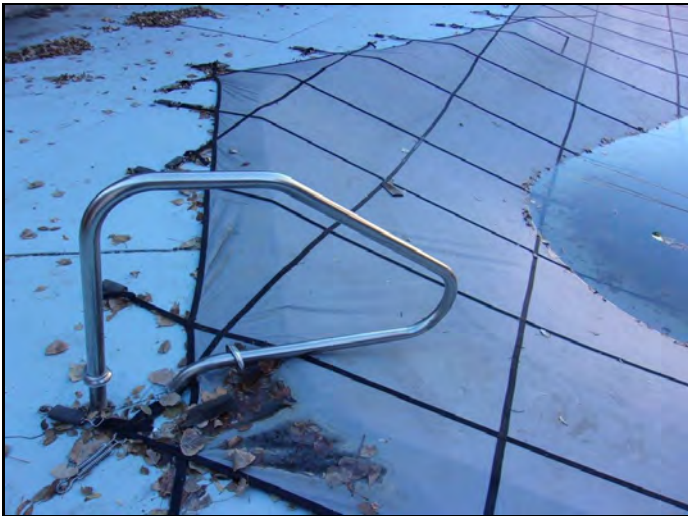
Comp #: 1101 Pool - Resurface

Location: **Pool Area**

Quantity: **(1) Pool**

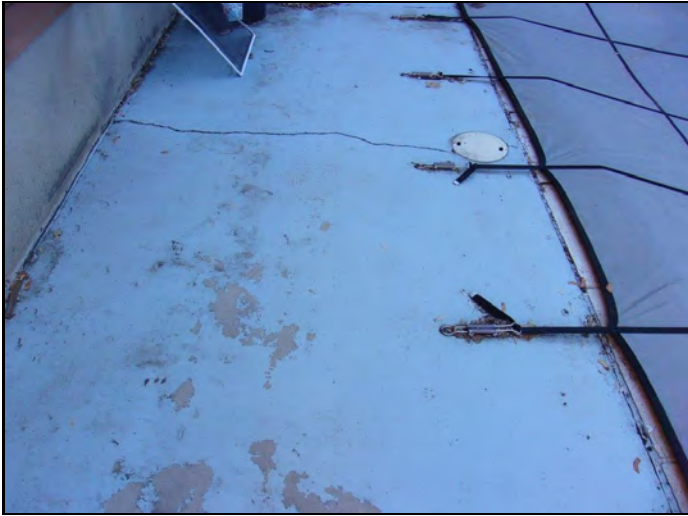
Comp #: 1116 Pool Deck - Repaint

Location: **Pool Area**

Quantity: **Approx 1,725 Sq.ft.**

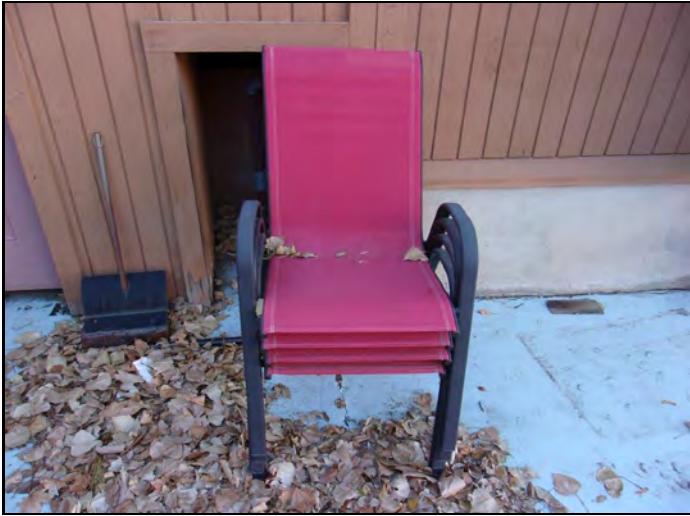
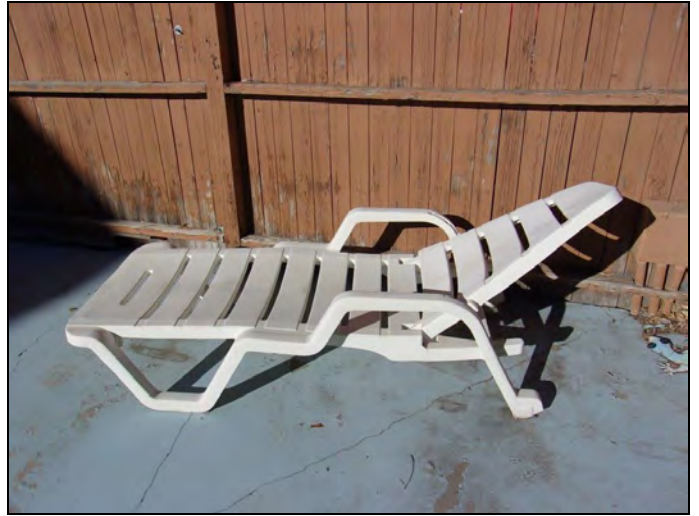
Comp #: 1121 Pool Furniture - Replace

Location: **Pool Area**

Quantity: **Assorted Pieces**

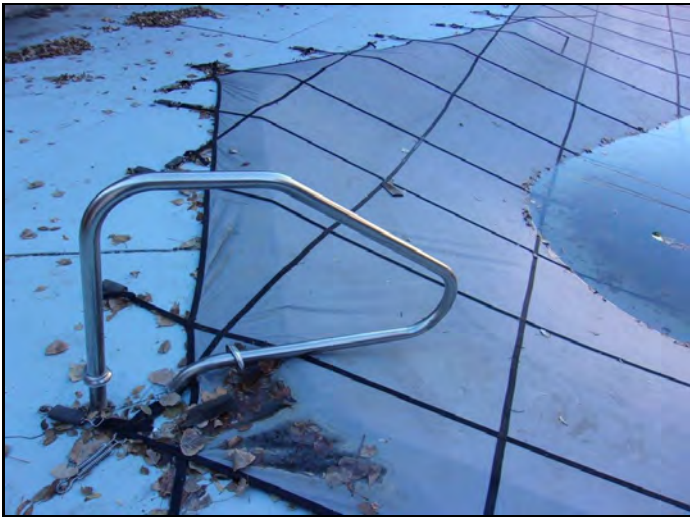
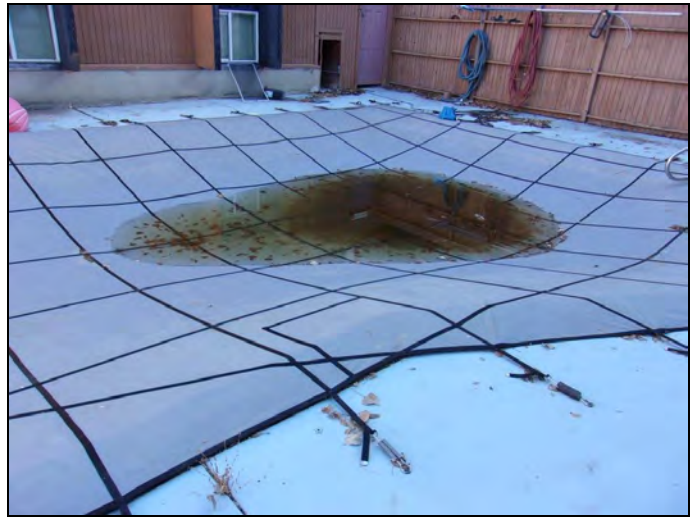
Comp #: 1190 Pool Upgrades - Install

Location: **Pool Area**

Quantity: **(1) Pool**

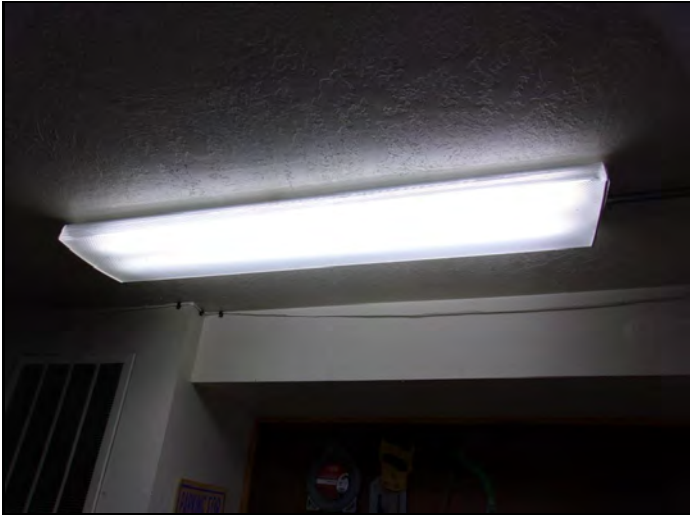
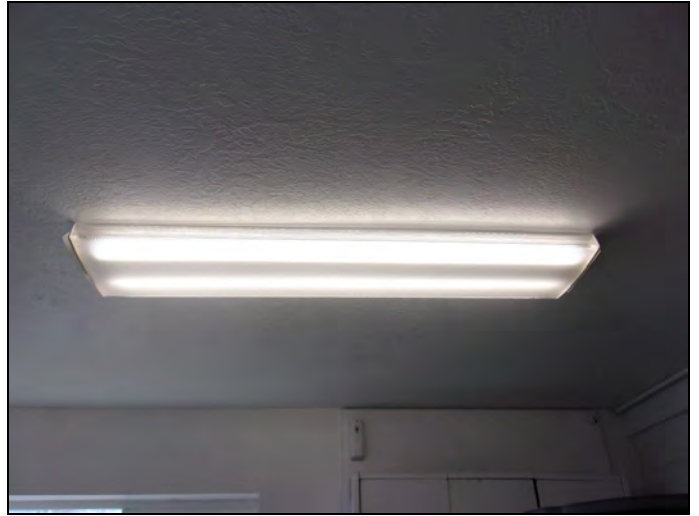
Comp #: 1601 Laundry Room Light Fixtures - Replace

Location: **Laundry Room**

Quantity: **(6) Fixtures**

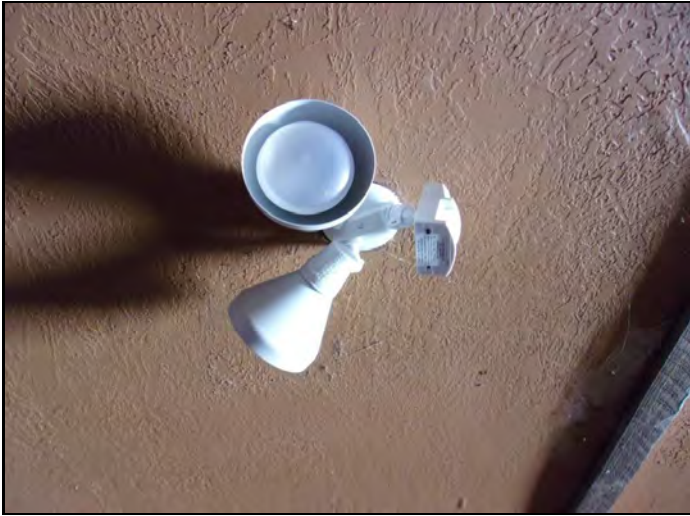
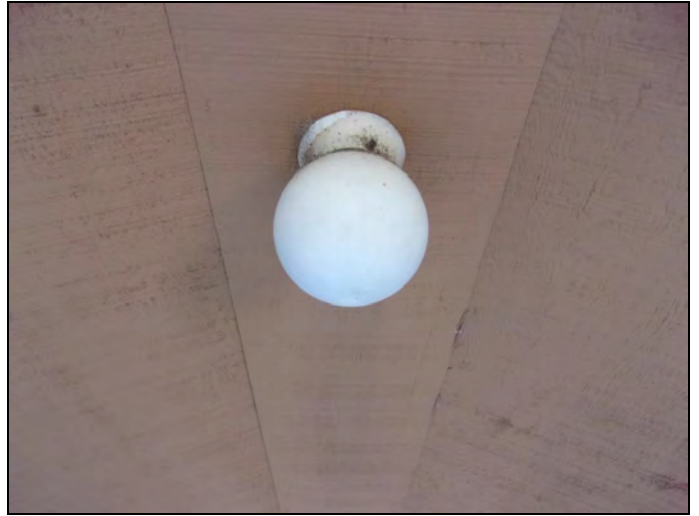
Comp #: 1602 Exterior Light Fixtures - Replace

Location: **Building Exteriors & Breezeways**

Quantity: **(53) Fixtures**

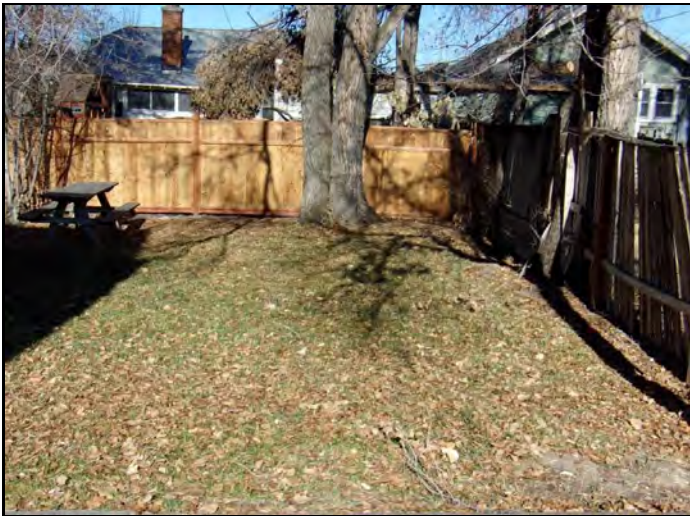
Comp #: 1812 Landscaping & Irrigation System - Renovate

Location: **Common Area**

Quantity: **Approx 11,500 Sq.ft.**
